## Cheshire Cheese, Penley

### BS5837:2012 Tree Survey and Arboricultural Impact Assessment

April 2021

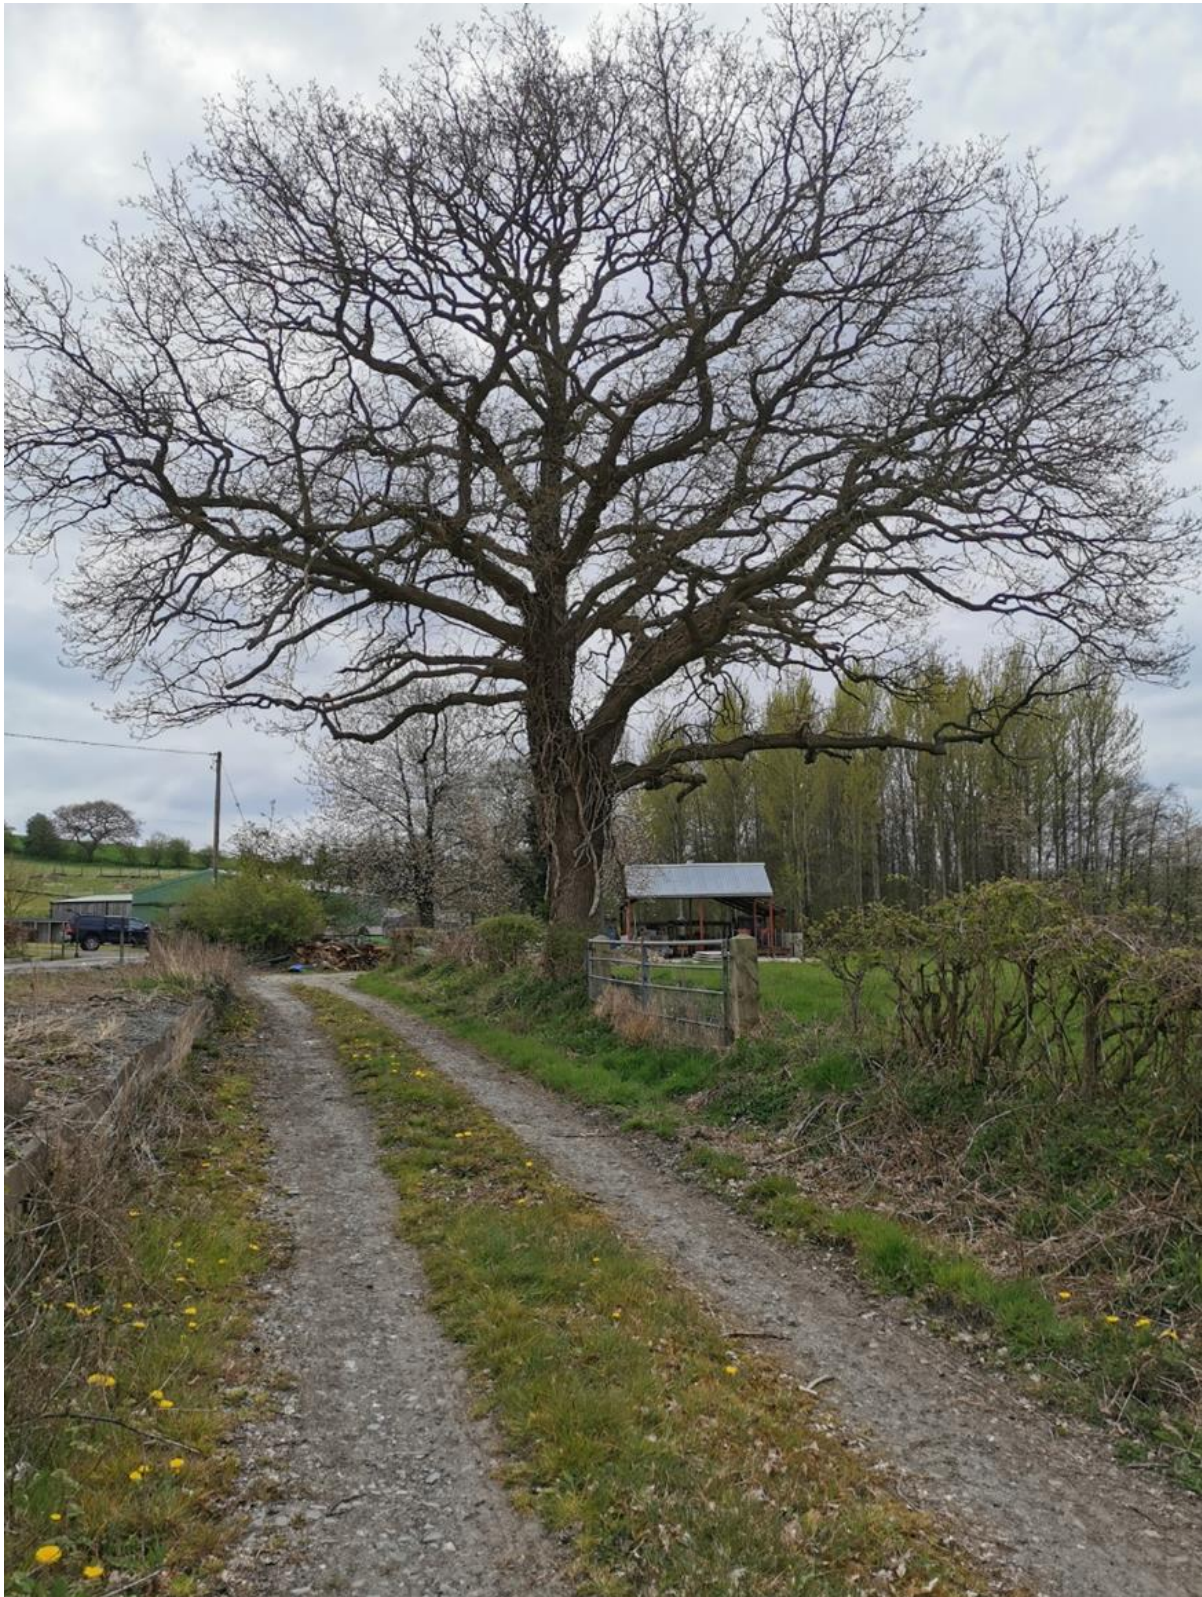
**T1** is a mature English Oak that is generally in good overall condition. It is a prominent landscape feature, with a large symmetrical crown. There is minor deadwood present.

Minor black staining observed on West side of lower main stem of T1. Associated with acute oak decline, however no other signs or bleeding were observed and the specimen appears to be in generally good condition. Minor bark damage also observed on West side of lower main stem.

**Plate 1:** Showing T1

Solid barrier protection is thought to be necessary for this site, in order to protect the main stems of T1 from any potential accidental damage. A sturdy "Heras" type fencing or similar type is recommended for this site. The protective fencing must display suitable signage, and this must be placed so as to be clear and visible. The location of recommended fencing is shown as red dashed line on the drawings.

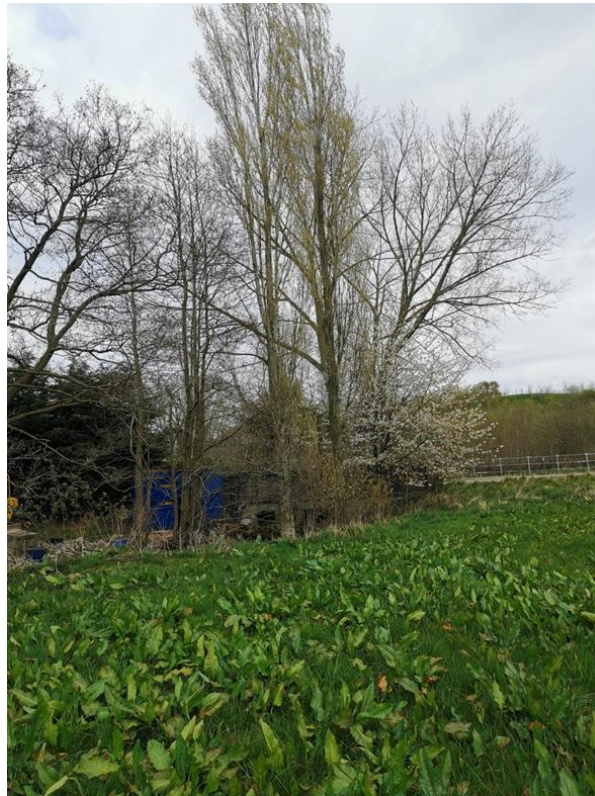
**T2** is a cherry tree situated on the eastern bank of the brook, adjacent to the road. This tree is in generally good condition and form.

**T3 and T4** are Lombardy Poplars that are situated on the eastern bank of the brook. They are generally in good condition and form, but are of no special merits.

The species is well known for developing structural faults and weaknesses during maturity, along with cavities and pockets of decay. Both trees are within close proximity of the adjacent A539 and pose a moderate future threat should stem failure occur. The species is known for being able to achieve a height of approximately 28 - 30 meters, and although the crowns are not extensive, they are dense and can effectively capture wind force. The prevailing wind comes mainly from the south-west and this pushes the trees towards the A539. As there is now an opportunity for mitigation planting, it is thought to be prudent to remove these trees and replace them with native species situated along the new access road.

**Plate 2:** Showing T2 (lower right) with T3 and T4 (centre).

**T3 and T4 are two semi-mature Lombardy Poplars. These trees are recommended for removal.**

T3 and T4 are recommended to be removed and replaced.

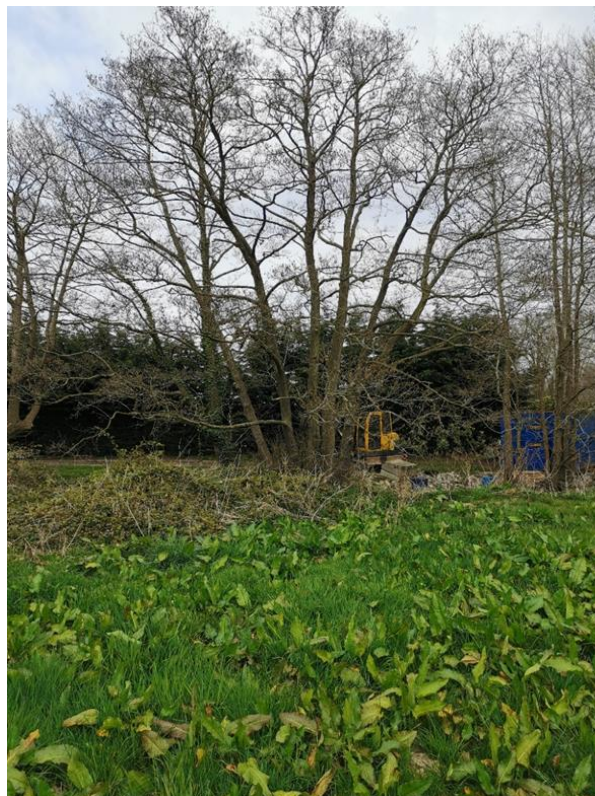
**T5 and T6** are semi-mature Alders situated on the western bank of the brook. They are generally in good condition and form.

These trees are all within relatively close proximity to the new access road and may pose minor conflict between their canopies and vehicles. As an alternative to selective pruning and management, it is recommended that these trees be coppiced and allowed to regenerate. It is thought that this will prolong the life cycle of the trees and maintain their importance within the local environment, whilst also ensuring a clear route for the new access road.

**Plate 3:** Showing T5 (centre) and T6 (behind, left) with G2 (background).

**T5, T6 and G1 are semi-mature Alder trees. These trees are recommended to be coppiced.**

T5 and T6 are recommended to be coppiced to a height of 1 meter.

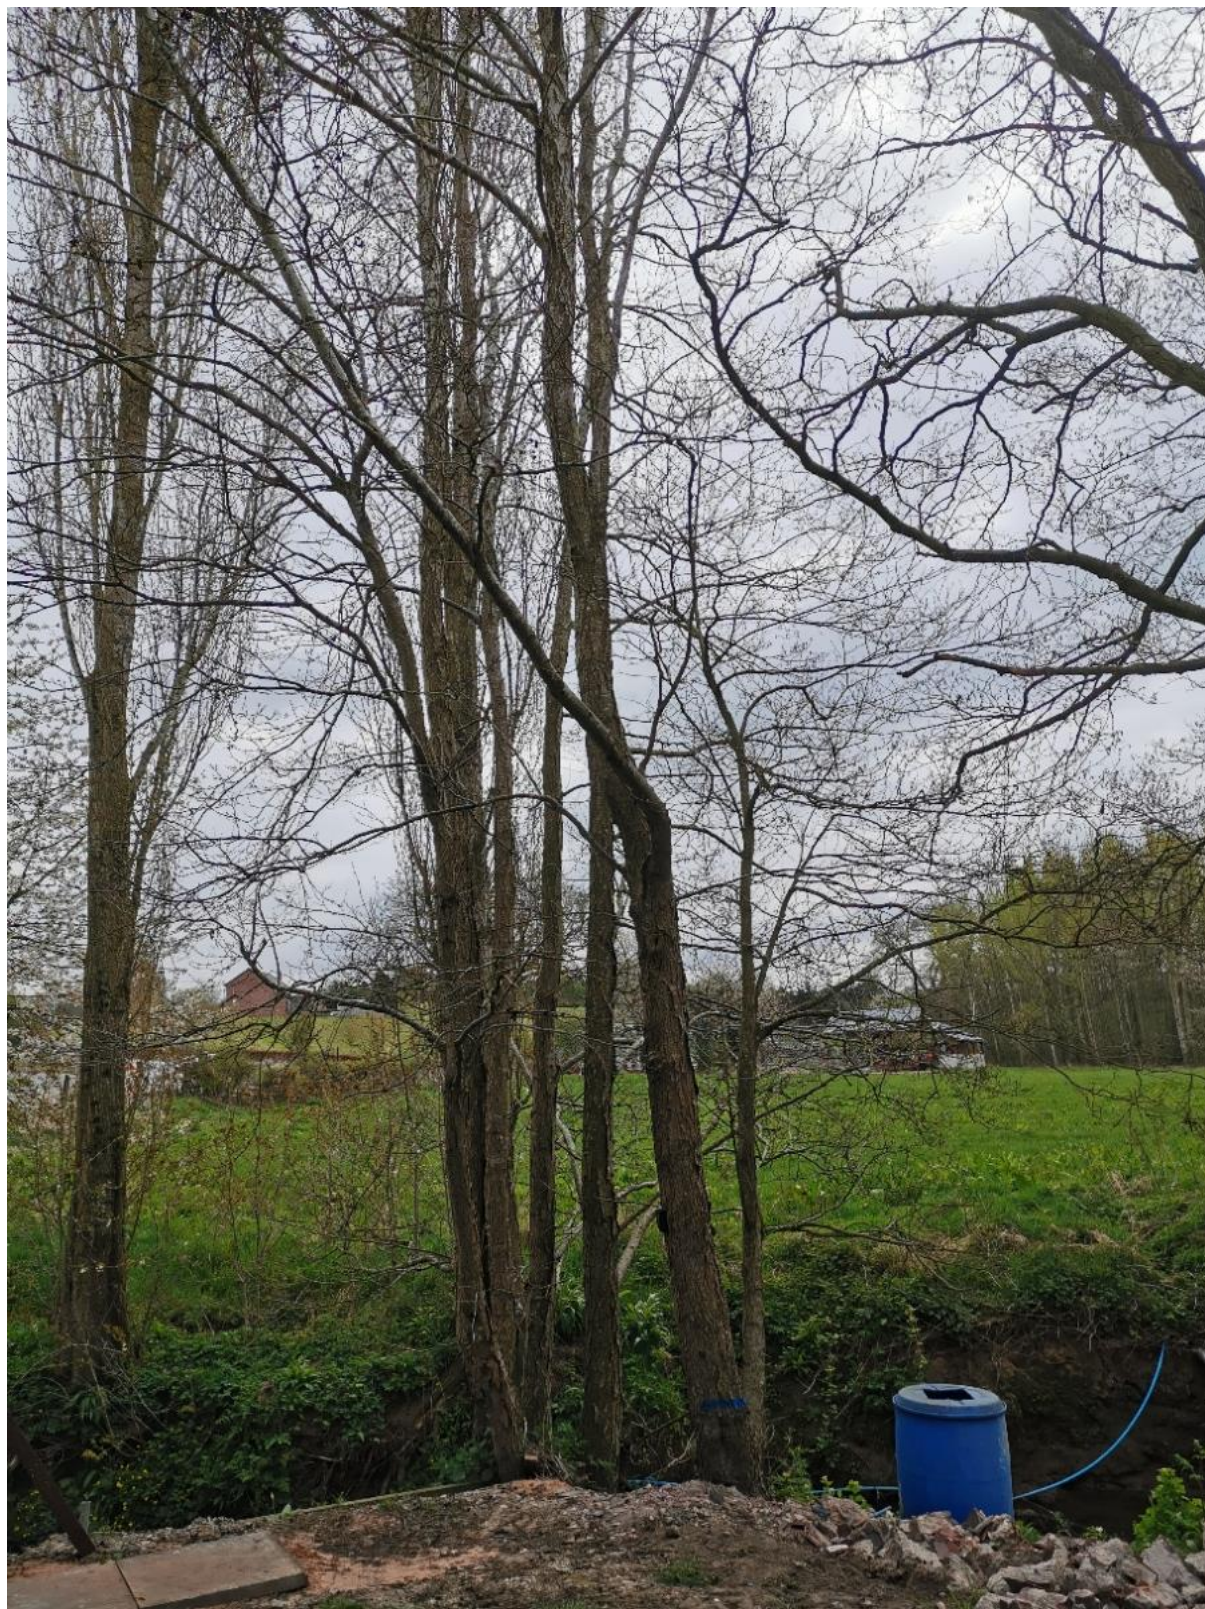
**Plate 4: G1.**

**G1** is a small group of Alder trees situated on the west bank of the brook. It is generally in good condition, but is of no special merits.

G1 are recommended to be coppiced to 6 inches above ground level.
