## **BS.3998 (2010) TREE CONDITION REPORT**

**Pen-y-Nant,**

**Church Road, Minera, Wrexham, LL11 3DA**

**Matthews of Chester Block Management Ltd**

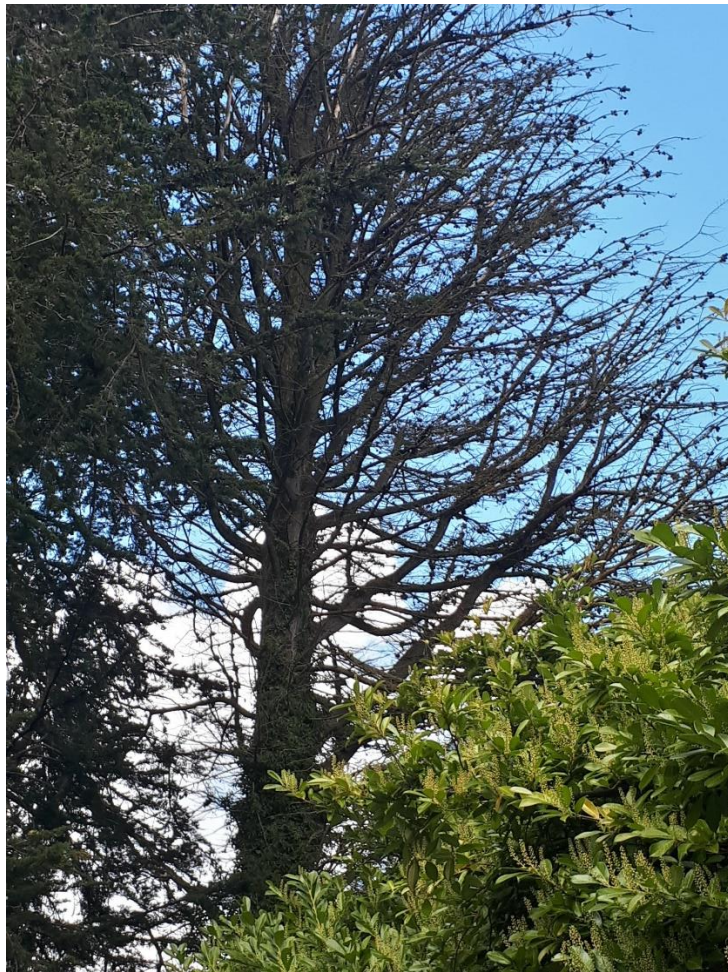
- Specimen T014 (*Cupressus macrocarpa*) is dead, and from resonance sounding there is advancing decay from the basal area of the tree extending upwards on the North aspect of the main stem. Its removal is recommended with some urgency. Ownership, however, was inconclusive; the client may wish to confirm whether it is within the curtilage of the property boundary.

| Ref. | Other Reference | Common | Botanical | Structure | Num. Stems | Height (m) | DBH (cm) | Crown Radius (m) | Life Stage | Life Expectancy | Inspect Period | Description | Survey Notes | Condition | Risk of Harm | Control Measures | Distance to main target (m) |
|---|---|---|---|---|---|---|---|---|---|---|---|---|---|---|---|---|---|
| T014 | 0141 | Monterey Cypress | <i>Cupressus macrocarpa</i> | Tree | 1 | 25 | 100 | 7 | Dead | Dead | 6 Months | Target # - car park.<br>Target # - road. | Dead tree over target, deadwood greater than 25mm over target, ivy cover minor | Dead | 1/400 | Fell tree. | 1 |

Fig 8.1.1 T013 Dead Monterey Cypress (*Cupressus macrocarpa*)

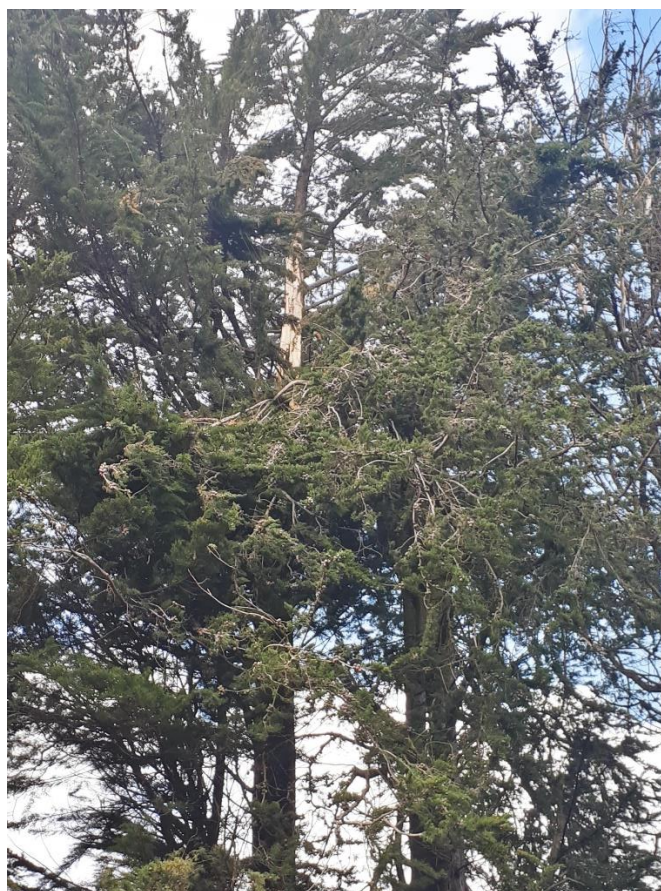
| Ref. | Other Reference | Common | Botanical | Structure | Num. Stems | Height (m) | DBH (cm) | Crown Radius (m) | Life Stage | Life Expectancy | Inspect Period | Description | Survey Notes | Condition | Risk of Harm | Control Measures | Distance to main target (m) |
|---|---|---|---|---|---|---|---|---|---|---|---|---|---|---|---|---|---|
| T012 | 0143 | Monterey Cypress | <i>Cupressus macrocarpa</i> | Tree | 1 | 25 | 88 | 8 | Mature | 20+ Years | 1 Year | Target # - car park.<br>Target # - road. | Crown Spread: N8, S8 E4 W4, upper primary branch tear failure, branches hung up at height over car park, deadwood 25mm in diameter, secondary branch tear lower crown South aspect | Fair | 1/3K | Crown clean. Crown reduce by 3m | 3 |

8.5 On T012 Monterey Cypress has a significant and extensive failure at the point of an included branch union, leaving a weakened primary limb and exposure to pathogenic decay. The size of the wound is so significant that occlusion of wound wood is unlikely to form sufficiently, and the loss of structural strength means further upper crown failures are likely, especially under loading from high winds. A substantial part of the failed area is 'hung up' at height on existing intact branches. It's removal and mitigation of the damaged section (s) of the tree by a full crown reduction is recommended and should be undertaken with some urgency. This is also the case for T009 Monterey Cypress, though the level of damage is of a lesser degree, crown reduction on this particular specimen is considered in paragraph 8.6.

Fig 8.5.1 Storm Damage on T012 Monterey Cypress (*Cupressus macrocarpa*)

8.6 Unnecessary wounding of trees by the removal of large areas of the live crown, because of 'perceived risk' by lay people, is all too common. Crown reductions lead to multiple exposed wounds (and therefore to avenues for decay pathogens to enter the tree at pruning points), reduced photosynthetic area leading to tree stress and the distribution of the dampening effect of wind loading to the main stem and root systems via the tertiary and secondary branch structure. However, trees T006 -T012 (*Cupressus macrocarpa*) will experience change of exposure from the loss of T013 and the essential crown reduction of T012. It is deemed necessary due to the disturbance to the optimisation of all trees in the group, that crown reduction is an acceptable strategy to mitigate further failures. This should follow the guidance of BS3998 Tree Work Guidance and should ideally be phased over multiple growing periods. The optimal whole tree crown reduction is approximately 2 - 3.5m from crown height and less than 1-1.5m from the tertiary branches (retaining leaf bearing branches) to the side of the trees. Crown cleaning, if undertaken should retain internal 'natural bracing' i.e., branch to branch or branch to stem contacts, which supports weakened branch unions. Dead wood may be removed only if it is not a natural brace or has safety implications. Consideration to apply the same management methodology to T005 and 6, though exposure change is less significant, is recommended, due the existing included unions with the crown architecture. T011 Monterey Cypress is a suppressed specimen, with asymmetry of the crown radius to the North (overhanging the road). It will not require crown height reduction, but a limited lateral crown reduction is recommended.

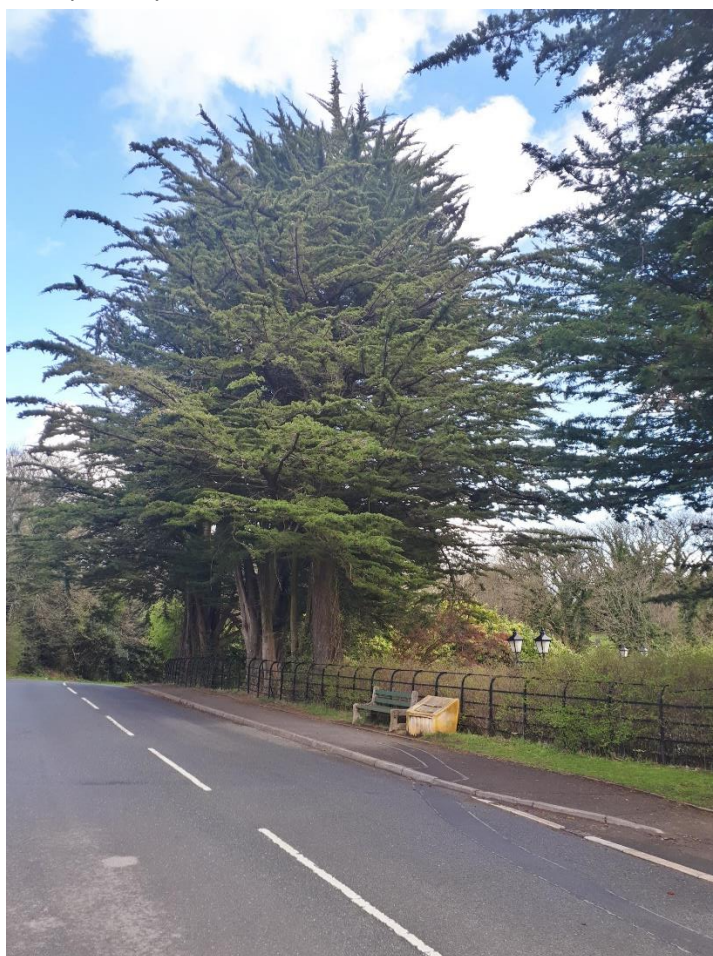
8.7 All Monterey Cypress (*Cupressus macrocarpa*) are very low over the Church Road (below a recommended clearance of 5.8m above a highway) and the low branches may cause damage to vehicles from impacts, and as a result the trees themselves may suffer significant wounding that would be hard to mitigate from pruning. Crown lifting over the road is recommended but should not be excessive or undertaken at the same time as crown reduction due to potential loss of photosynthetic area.

Fig 8.7.1 Low Canopy Height over Church Road

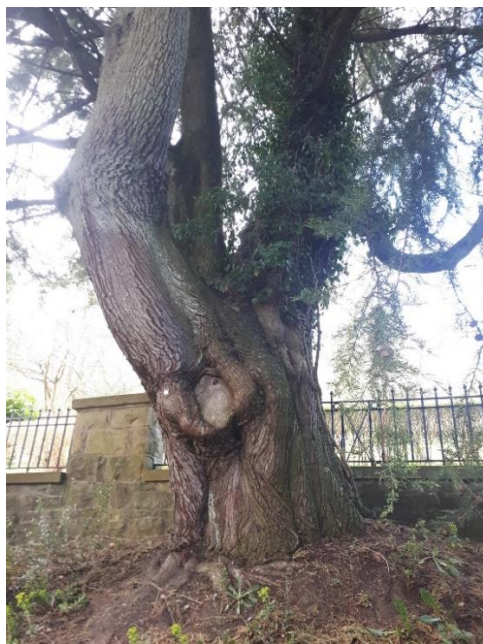
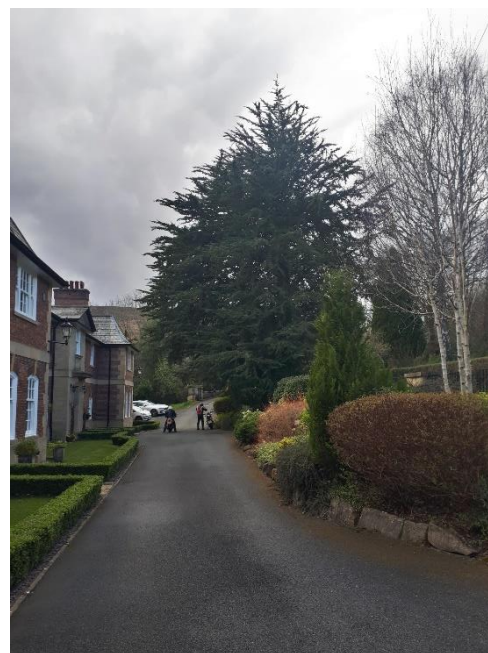
Fig 8.8.1 T002 Monterey Cypress (*Cupressus macrocarpa*)

| Ref. | Other Reference | Common | Botanical | Structure | Num. Stems | Height (m) | DBH (cm) | Crown Radius (m) | Life Stage | Life Expectancy | Inspect Period | Description | Survey Notes | Condition | Risk of Harm | Control Measures | Distance to main target (m) |
|---|---|---|---|---|---|---|---|---|---|---|---|---|---|---|---|---|---|
| T002 | 152 | Monterey Cypress | <i>Cupressus macrocarpa</i> | Tree | 1 | 23.5 | 134 | 9 | Mature | 20+ Years | 1 Year | Target # - dwelling.<br>Target # - road. | Crown Spread: N9 S7 W6 E8. Root affecting structure low wall, raised ground restricted root pattern, large wound 30cm x 20cm South aspect partially occluded, shear crack large primary union, phototropic/ geotropic direction change, low over highway 4m. Included primary union, minor deadwood less than 25mm in diameter. Bark wounds on branches and main stem less than 15cm not occluding., strong reactive wood response on primary unions. Minor ivy on primary stem. 1m from road and 0.5m from low wall, root system causing minor structural damage. | Fair | 1/5K | Crown clean but retain natural bracing, Crown reduce by 3m over successive growth periods. Crown lift to 5.2 m for highway clearance. | 10 |

8.8. T002 Monterey Cypress (*Cupressus macrocarpa*) was highlighted by the QTRA (Quantified Tree Risk Assessment) methodology as being of a higher Risk of harm than T006 -12, this is primarily because of the value of hazard target i.e., the main building of high occupancy. It does have the same structural weaknesses as all the other *Macrocarpa* on site, in the form of included branch unions and additionally has significant stress loading to trifurcated primary main stem unions, and a large wound partially occluded on the South aspect primary union. The tree has responded by the formation of significant reaction wood at the primary zones of stress. Its crown canopy colour density is very good and vigorous, and the tree is certainly active in its structural optimisation, which is causing the low wall to fail. **Under normal conditions** it is highly unlikely to experience whole tree failure (as with all the trees on site), as there is no observable or apparent pathogenic infection, and though its rooting pattern is restricted, the tree is somewhat sheltered by the building itself. More likely is the potential for failures at included unions and only under environmental loading. However, the UK is experiencing ever more regular storm conditions, and therefore the impact of storms on trees is becoming more unpredictable. Mitigation in the form of approved tree risk management cannot give any guarantees of protection. In terms of the site exposure to high wind loads we can refer to Quine and Gardiner (2007) 'The stochastic nature of storm occurrence means that the degree of wind damage can vary significantly from year to year. A succession of quiet winters (or decades) can be followed by a sequence of winters (or decades) with very damaging storms. The occurrence of a particularly severe storm in one year does not modify the chance of the same intensity of storm occurring in the following year.'

The client has the option to accept the risk of failure or mitigate; this should follow the guidance of BS3998 Tree Work Guidance and should ideally be phased over multiple growing periods. The optimal whole tree crown reduction is approximately 3 -3.75m from total crown height and less than 2m from the tertiary branches (retaining leaf bearing branches) from the sides of the canopy. Crown cleaning if undertaken should retain internal 'natural bracing' i.e., branch to branch or branch to stem contacts, which supports weakened branch unions. Dead wood may be removed only if it is not a natural brace or has safety implications. As highlighted previously, no tree is entirely risk free when subject to unpredictable conditions beyond its mechanically optimised structure. The recommendation of crown reduction will have a moderate effect on the stress load to the primary main stem unions, but will not entirely remove the risk of damage to the property any failure of the tree in part or whole.
