Pre-Development Site Survey

### Arboricultural Impact Assessment

Clays Touring & Leisure Park  
Bryn Estyn Rd, Holt,  
Wrexham LL13 9UB

Ref: NEB 21005 AIA

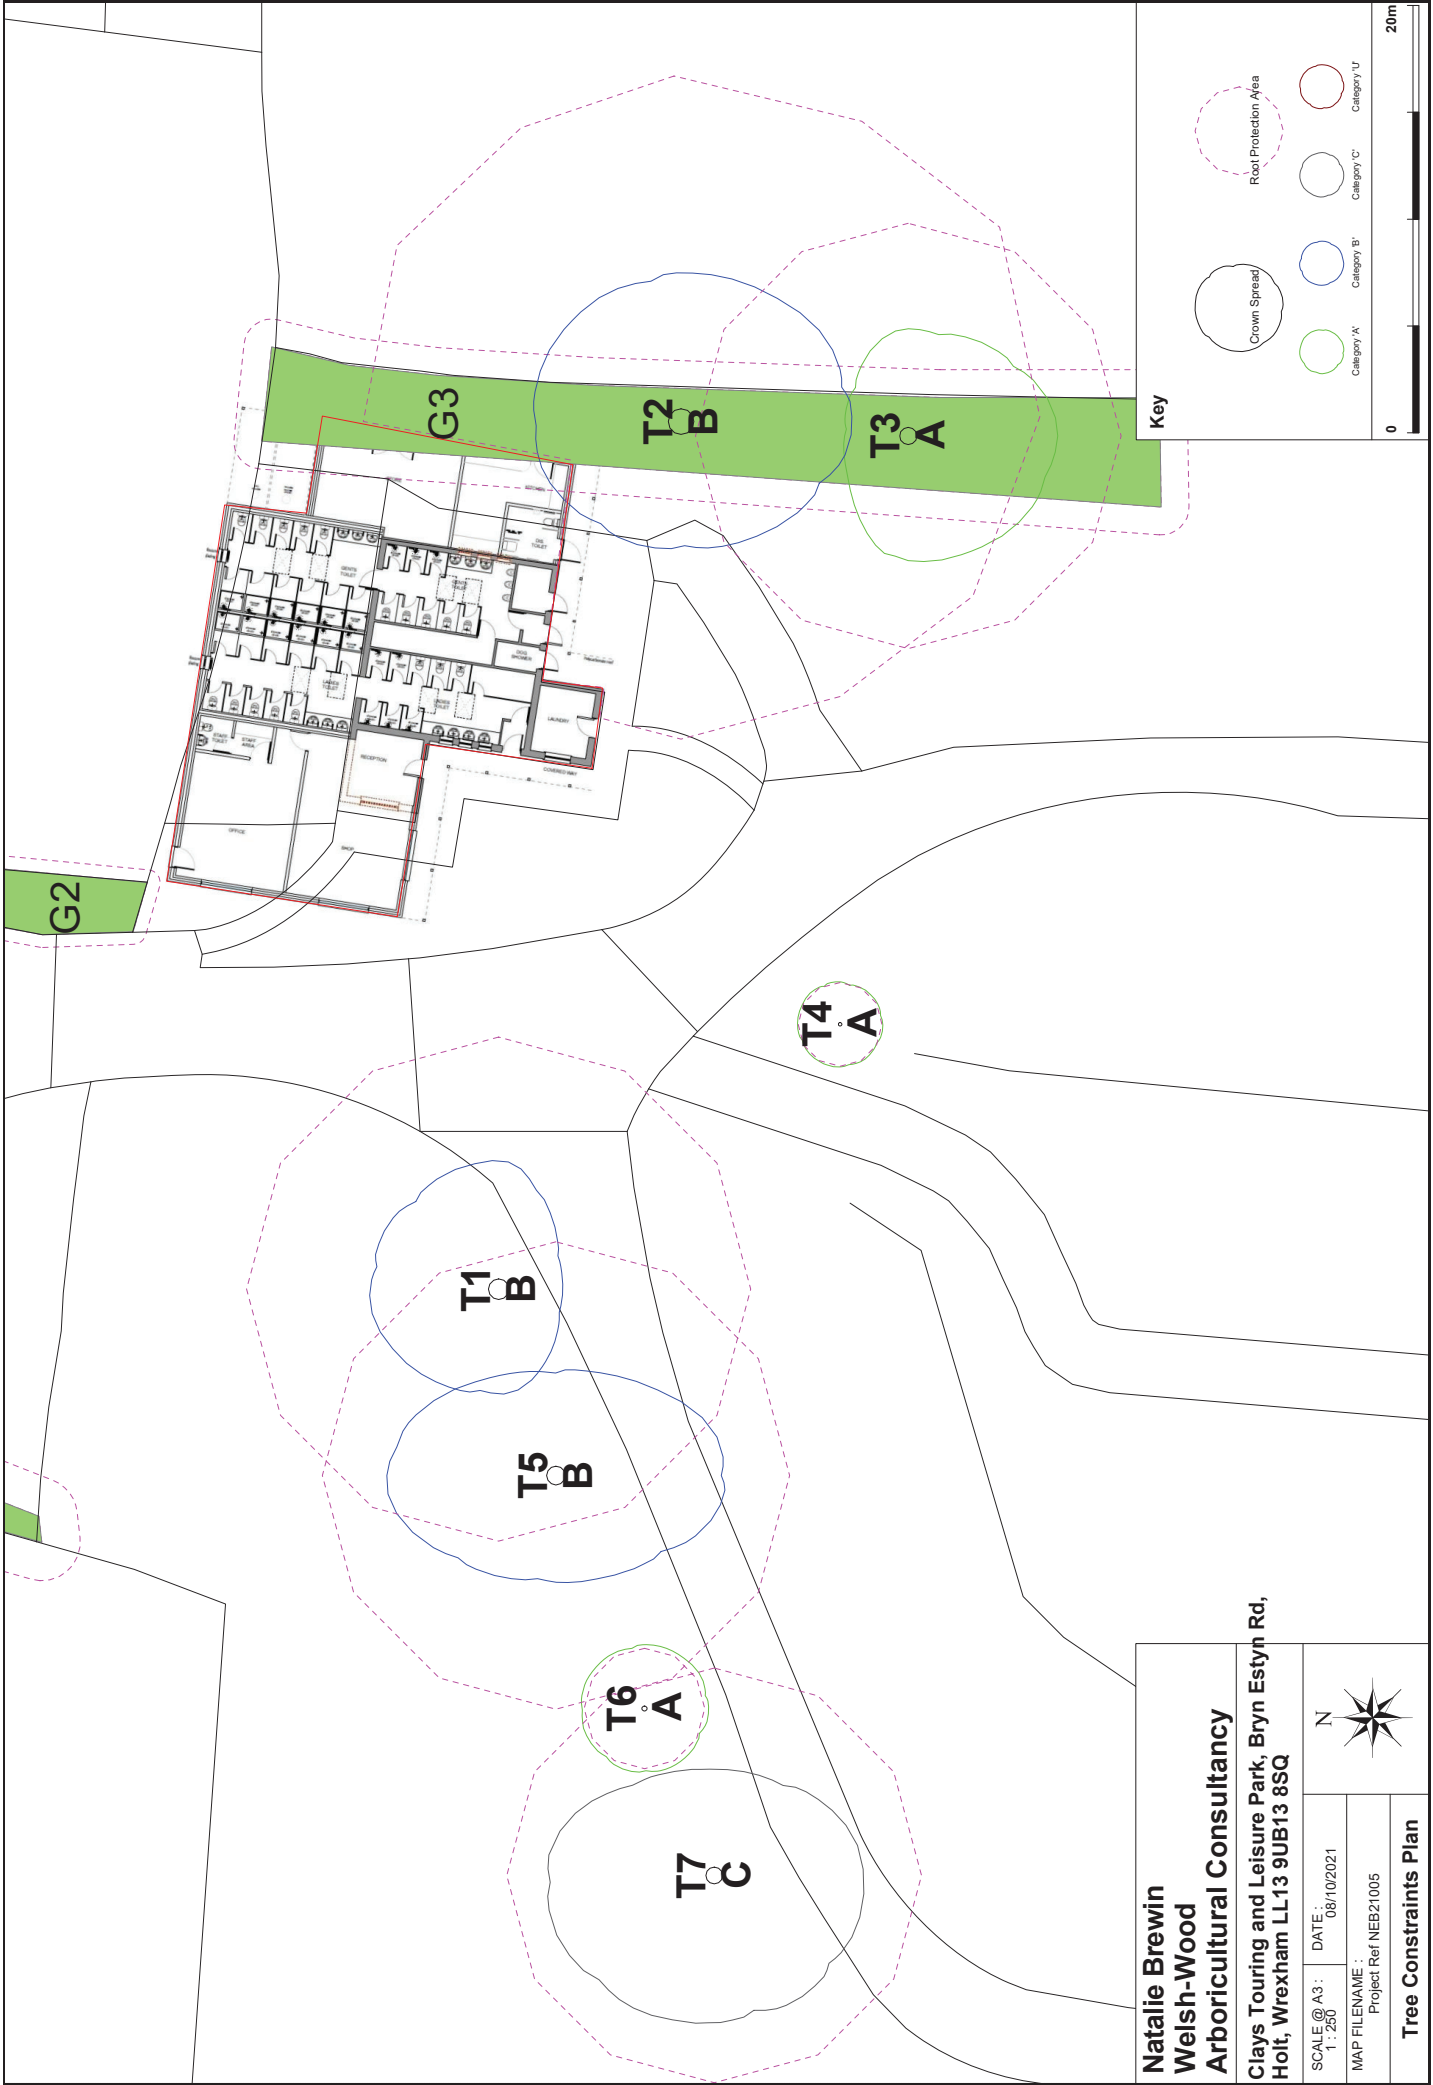
3.8.2.1 As shown on TCP 2.1 the proposed extension of the existing reception area and shower block conflicts with a portion of G3 Cypress hedge. For the development to proceed a portion of this hedge would need to be removed.

3.8.2.3 There is also a slight conflict between with the edge of the RPA for T2 oak and the proposed reception block extension. It is proposed that given the small extent of the conflict the development could proceed with supervised hand digging of this portion of the site, as would be specified within the Arboricultural Method Statement.

3.8.2.2 G3 provides a screen between the reception block and the adjacent agricultural field. Any proposed tree removals will be mitigated against with replacement planting in a suitable location.

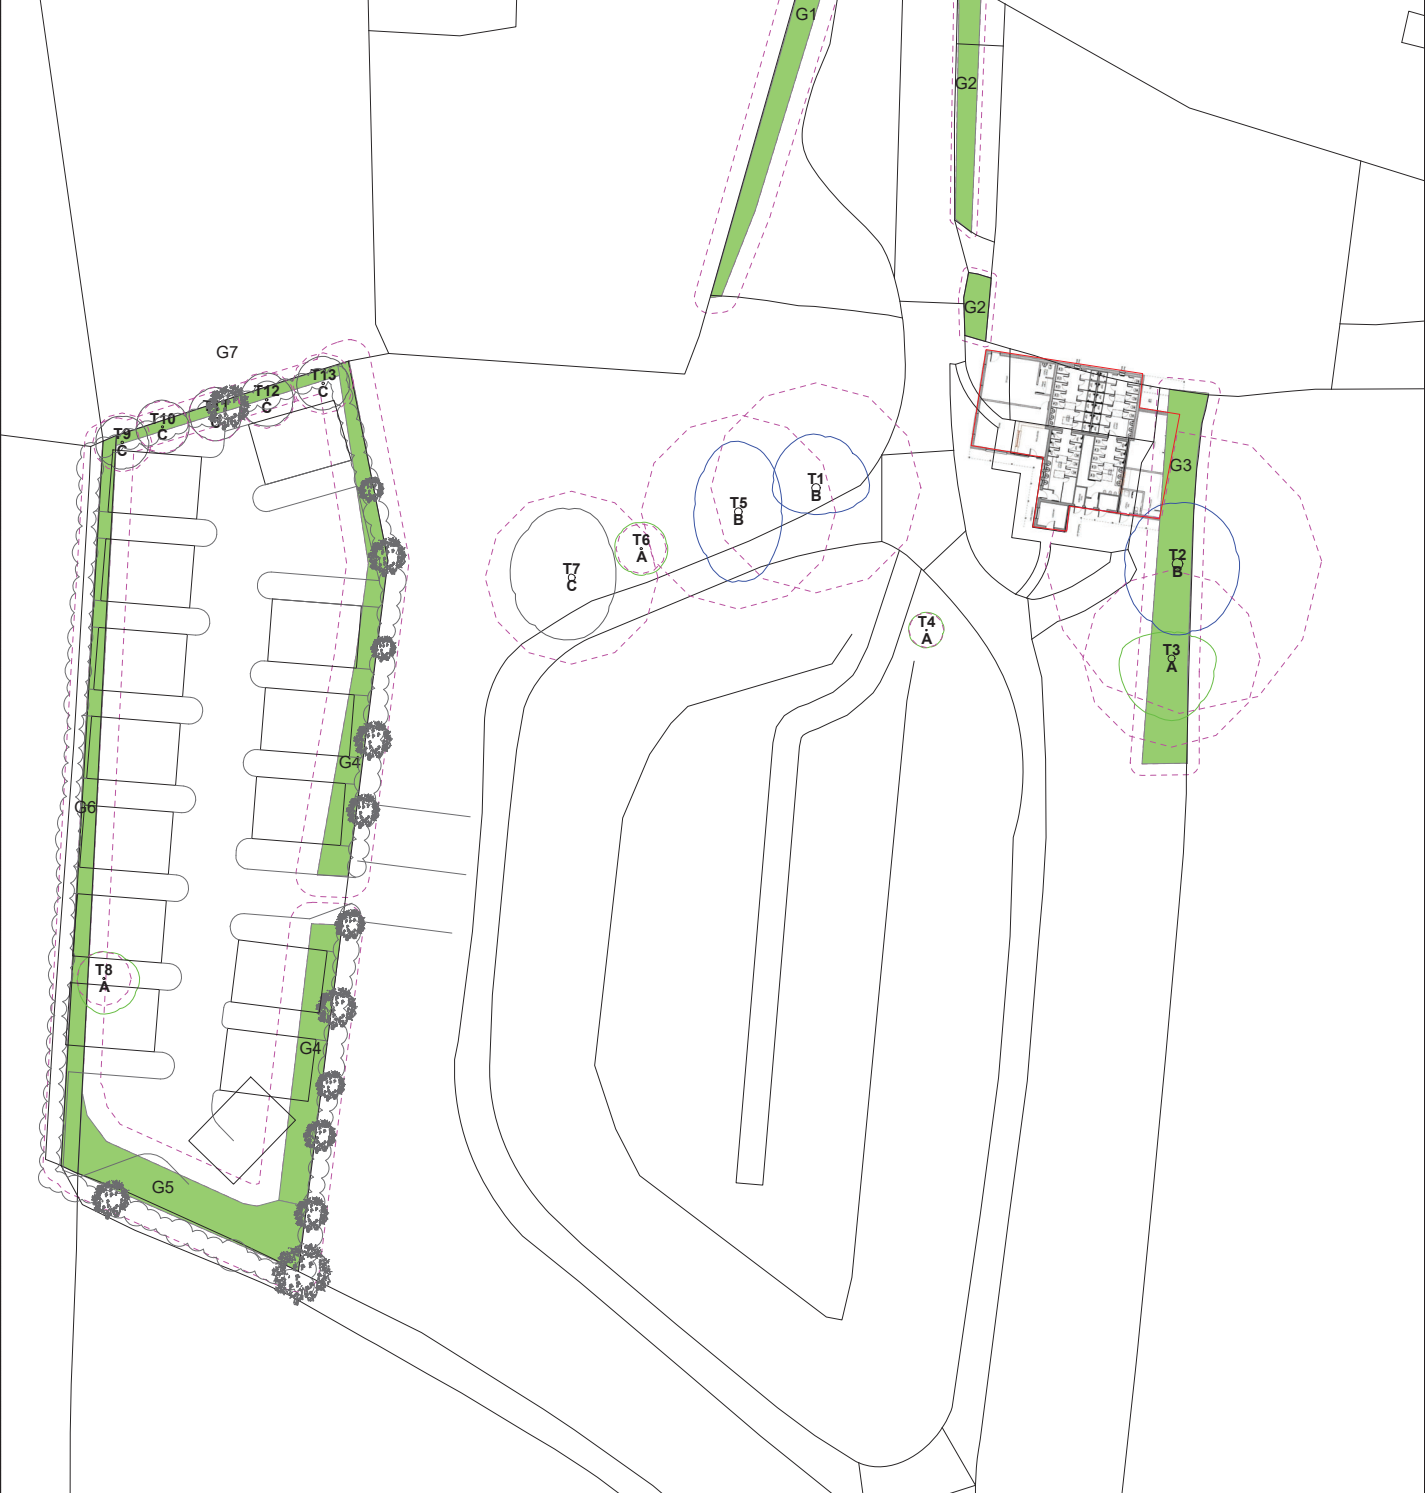
Tree Constraints Plan

3.8.3.1 As can be seen on TCP 2.2 there is some conflict between the RPA's for retained trees and the proposed location of the static pitches. It is proposed that this is mitigated by means of hand digging and geoweb textiles to minimise root damage and deter future ground compaction.

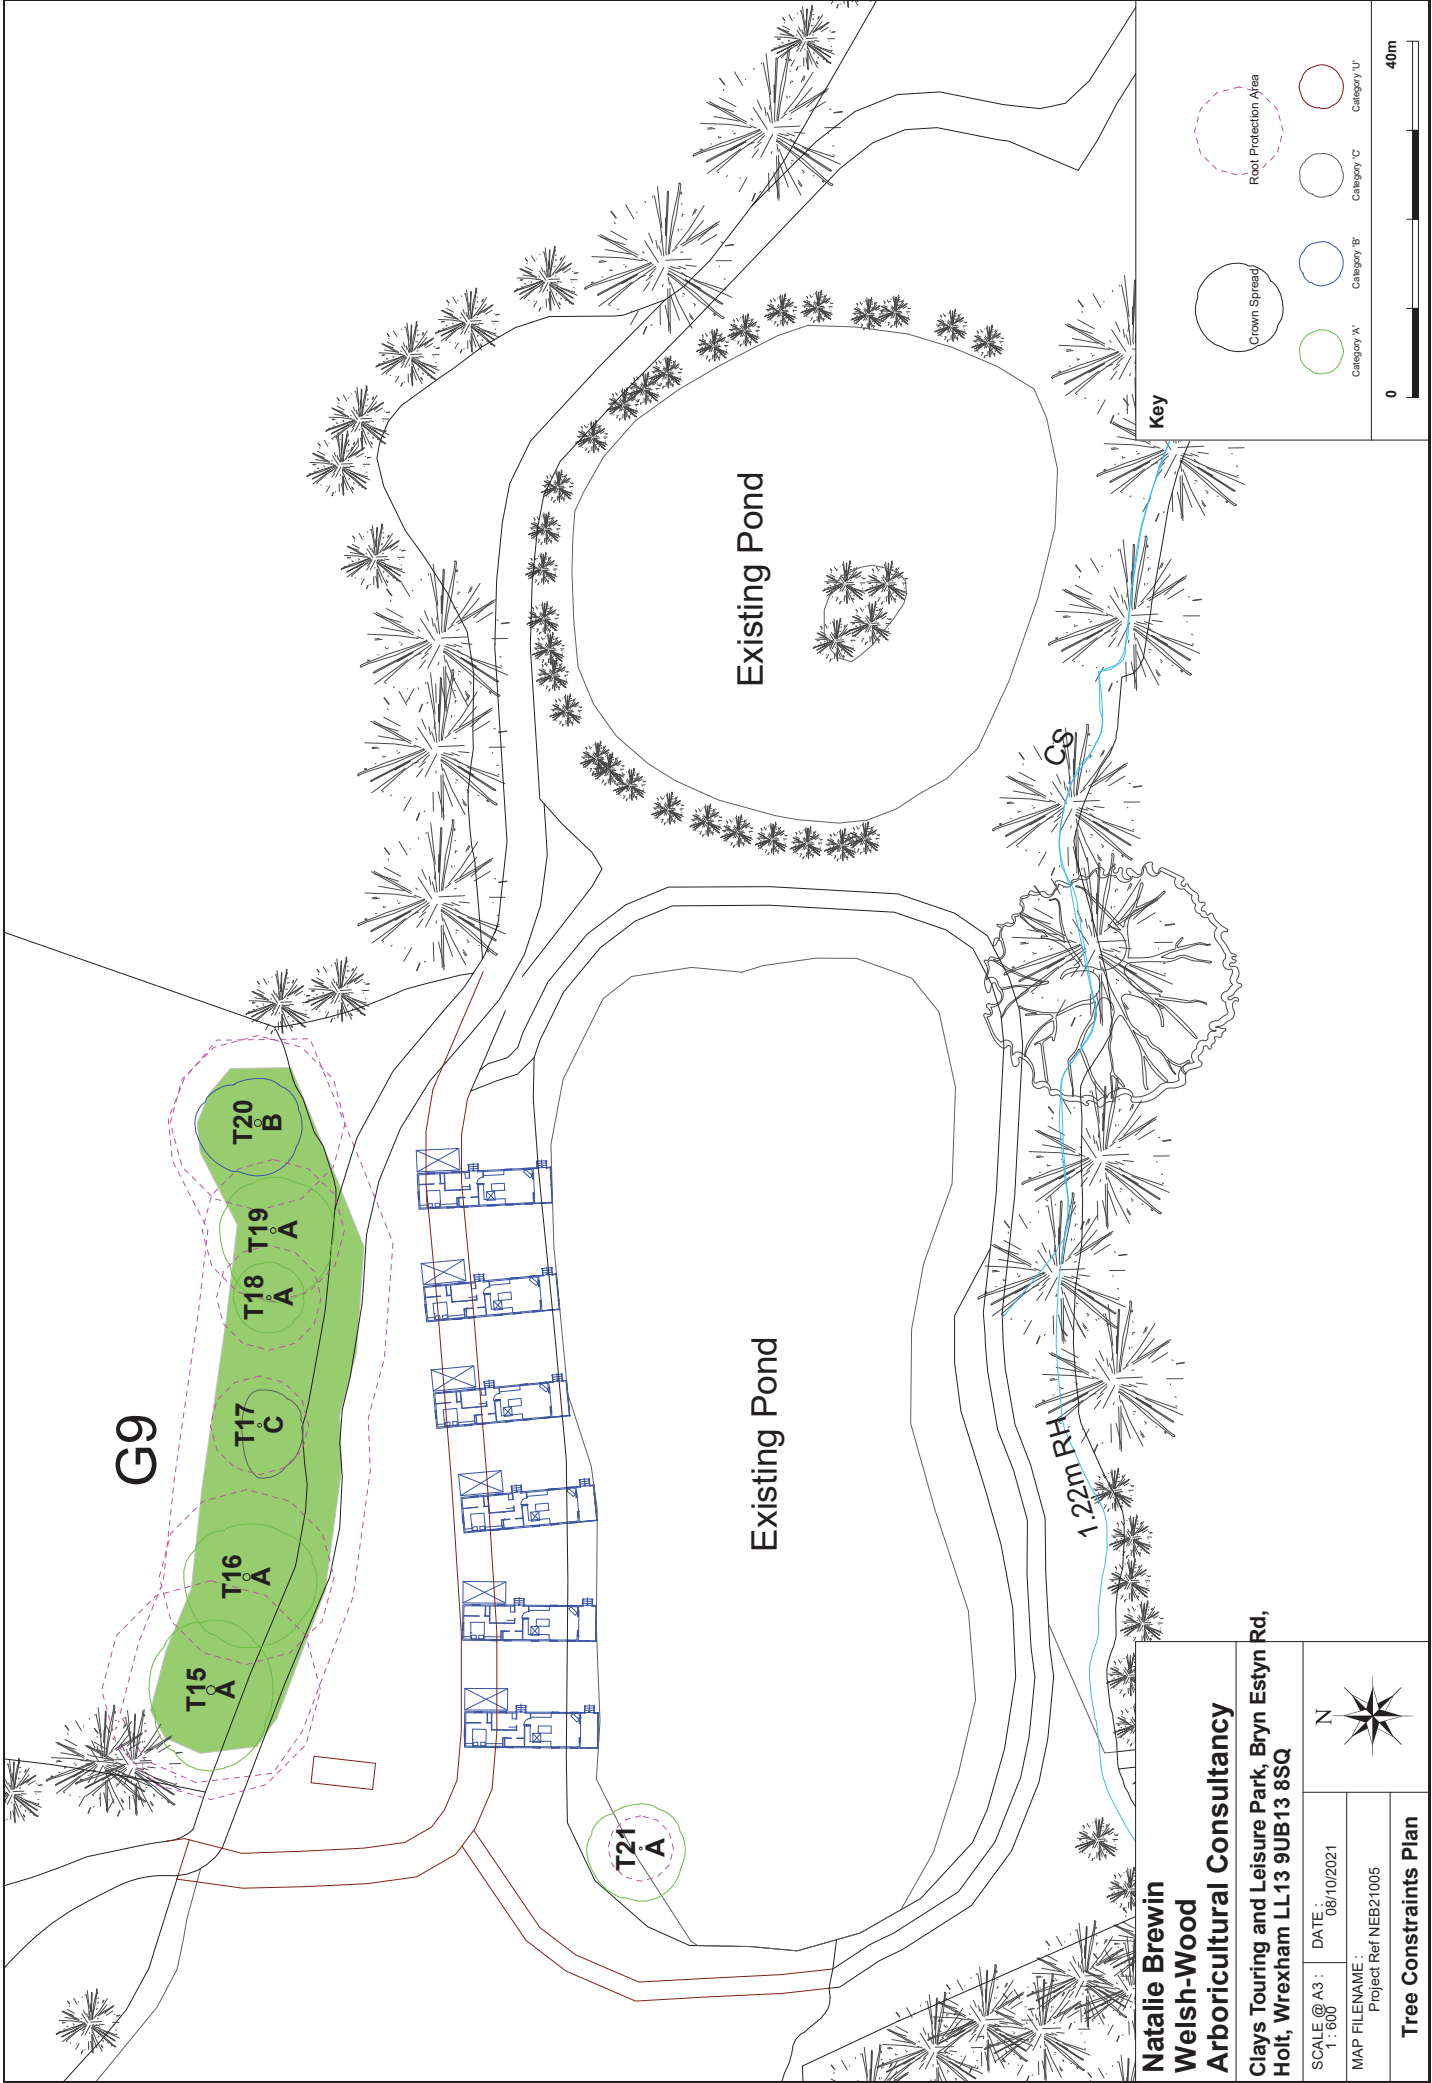
| MAP FILENAME :<br>Project Ref NEB21005 | | <b>Tree Constraints Plan</b> |

3.8.4.1 TCP 2.3 indicates a conflict between the new proposed access road and the line of oak trees however, the design plan has been amended to address this conflict as is shown in Appendix 3. The new design plan will be overlaid on the relevant TCP on request to confirm that the conflict has been removed.

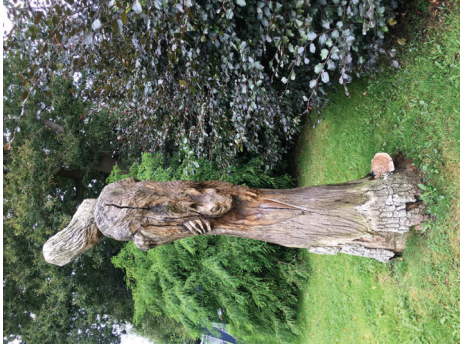
- 3.3.2 There are two decay pathogens on site noted on the stump of a historically felled oak located inside the main gate and close to T1. The fruiting bodies of these pathogens were somewhat degraded but they are thought to be Beefsteak Fungus (*Fistulina hepatica*) and one of the Ganoderma species. It should be noted that both decay pathogens can result in the stem or root failure in host trees. As such every precaution should be taken to minimise the likelihood of infection to a live tree on site.

- 3.5.3 As noted in 3.3.2 decay pathogens are present on site, Beefsteak Fungus and Ganoderma spp. They are both parasitic fungus that live on the live wood within a tree and have the potential to cause significant failure of part or all of a tree. No indications of infection to live trees from these pathogens were noted during survey however, it should be considered for all future condition tree assessments made on site.

P2 – Stump with pathogen fruiting body

- 3.3.3 Fungus spread via spores released from their fruiting bodies, which is the mushroom or bracket part of the fungus that we see. Entry into new hosts usually occurs via wounds to the tree or tree roots. As such every care should be taken to avoid unnecessary wounding and minimise root disturbance.

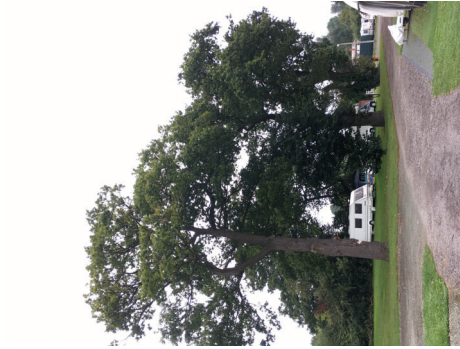
- 3.3.1 T1 – T5 are oak species all semi mature or mature in age that predate the current land usage. They are for the most of a fair condition although there are symptoms associated with soil compaction as would be expected. (See TCP 2.1)

- 3.5.1 Physiological condition relates to the health of the trees surveyed.
- 3.5.2 Several of the oak trees on site are displaying symptoms of soil compaction in the form of deadwood and epicormic growth. Soil compaction is a significant issue for trees and hinders root growth and function. This is not an unexpected issue given the site usage however should be noted given the potential hazards for visitors to the site. (LONSDALE 1999)

P3 – Line of oaks (T1, T5, T6, T7)

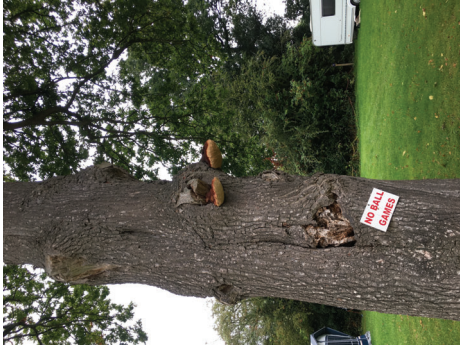
- 3.5.4 One live tree, T7, was identified with the decay pathogen Shaggy Bracket (*Inonotus hispidus*). This decay pathogen is not commonly found on oaks, however, can have catastrophic effects on ash resulting in stem failure. The pathogen as identified on the main stem around an area of wounding with dysfunctional tissue visible. Management options including decay detection, reduction and removal were discussed with the site owners during survey so that they may make a decision most appropriate for the tree and its location within the touring camping area.

| Tree ID | Common Name | Botanical Name | Height (m) | Calc. / Actual Stem Dia. (mm) | Spread (m) | | | | Height (m) & Orientation of First Significant Branch | Avg. Canopy Height (m) | Life Stage | General Observations | Preliminary Recommendations | Estimated Remaining Contribution (Years) | B55837: 2005 Category | RPA Radius (m) | RPA m² |
|---|---|---|---|---|---|---|---|---|---|---|---|---|---|---|---|---|---|
| 7 | English oak | <i>Quercus robur</i> | 17 | 790 | 8 | 5 | 7 | 7 | N5 | 3 | SM | Inonotus hispidus on main stem at pruning wound at 3m. Multiple stem wounds and decay evident, extent epicormics. | Further investigation required - discussed with site owner. | 10+ | C1 | 9.5 | 282 |

P4 – T7 Inonotus brackets

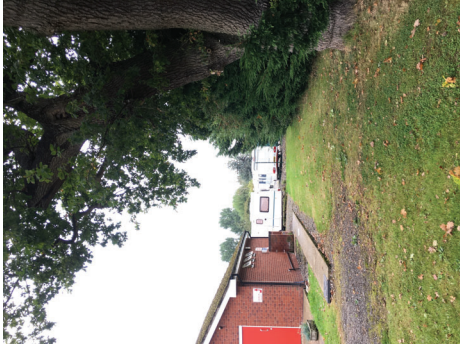
| Tree ID | Common Name | Botanical Name | Height (m) | Calc. / Actual Stem Dia. (mm) | Spread (m) | | | | Height (m) & Orientation of First Significant Branch | Avg. Canopy Height (m) | Life Stage | General Observations | Preliminary Recommendations | Estimated Remaining Contribution (Years) | BS5837: 2005 Category | RPA Radius (m) | RPA m² |
|---|---|---|---|---|---|---|---|---|---|---|---|---|---|---|---|---|---|
| 2 | English oak | <i>Quercus robur</i> | 13 | 1210 | 7 | 7 | 8 | 6 | N3 | 2 | M | Fibre buckling at 0.5-1.5m, hazard beam in crown. Previous crown reduction. | No work required. | 20+ | B1 | 14.5 | 662 |

P6 – G3 hedge and T2 oak

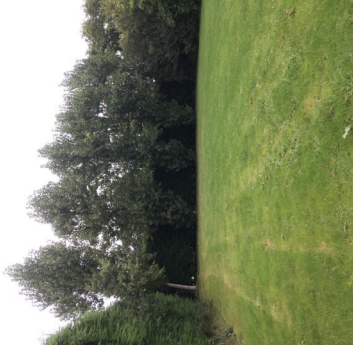
- 3.3.4 T8 – T13 are semi mature hybrid poplars situated around what is currently the tent field. Several of them have been subject to significant crown reductions as part of their ongoing management. This is discussed further in section 3.4. (See TCP 2.2)

- 3.4.1 Structural condition relates to the form of the trees, in particular specimens that have developed as multi stemmed from the base or may have developed poor branch structure that renders them susceptible to failure in the future.
- 3.4.2 As noted in 3.3.4 several of the poplar trees have been subject to crown reductions or topping as part of their ongoing management. It must be noted that this type of

management necessitates cyclical pruning. As the re-growth matures it eventually exceeds its optimum size and becomes susceptible to failure.

P8 – Tent field showing topped Poplars
