**Tree Condition Report  
Arboricultural Impact Assessment  
Method Statement and Tree Protection Plan**

**Land at Halghton New Mill,**

**On behalf of Bleazard and Galletta  
For  
Mr P Taylor**

**01.02.2022**

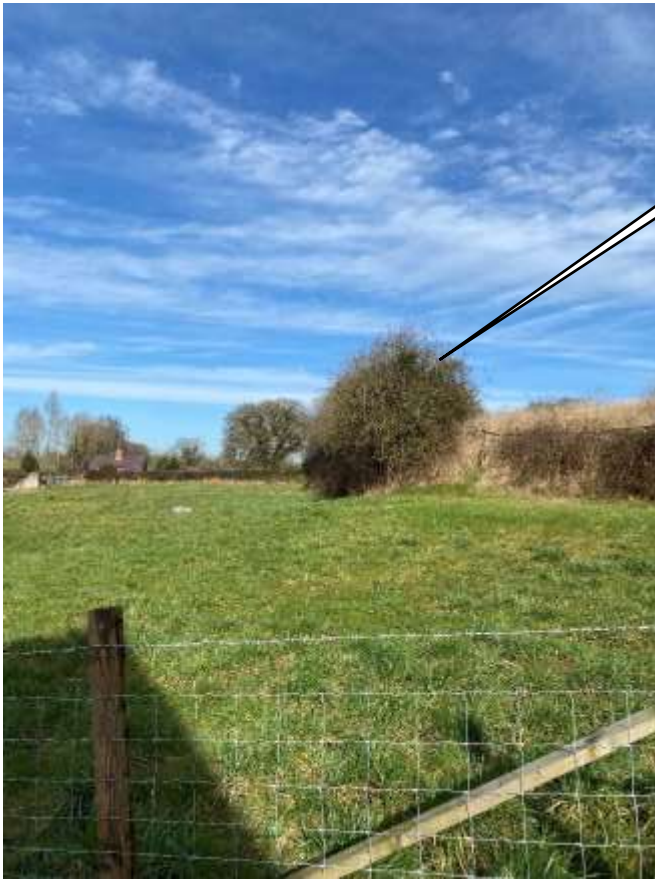
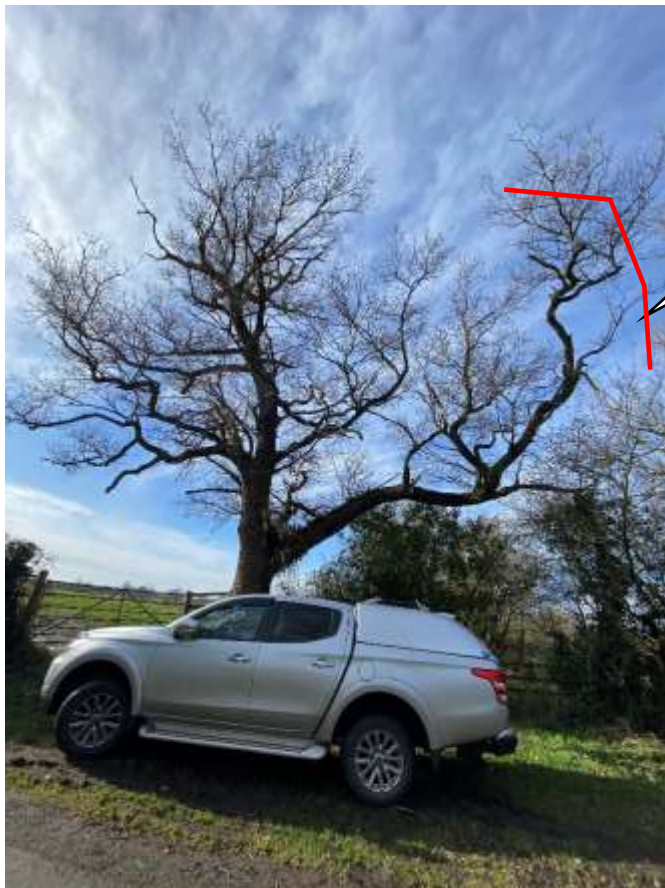
T3- indicative pruning  
position

| <p><b>Tree Condition:</b><br/> <b>Root:</b> no soil movement.<br/> <b>Stem:</b> decay in base of stem and cavity.<br/> <b>Crown:</b> major deadwood overhanging proposed driveway. Hazard beam crack in 1<sup>st</sup> order limb over proposed driveway.<br/> <b>Tree Quality Assessment:</b> Ref.BS5837 (2012) 4.5.1 <b>Category B2:</b> 'trees present in numbers, usually growing as groups or woodlands, such that they attract a higher collective rating'.<br/> <b>Water Demand NHBC 4.2-B:</b> high<br/> <b>Root Protection Area RPA:</b> for tree of 68cm diameter at 1.5m <math>(0.68 \times 12) = 8.2\text{m}</math>.<br/> Total RPA required at current stage of growth = 211m<sup>2</sup><br/> <b>Arboricultural Impact Assessment AIA:</b></p> <ul style="list-style-type: none"> <li>• The proposed driveway will fall within the RPA of T3.</li> <li>• The existing field entrance will be used for the access.</li> <li>• No alteration of soil levels is permitted within the RPA</li> </ul> <p><b>Method Statement: for the construction of the proposed driveway</b></p> <ul style="list-style-type: none"> <li>• Install section of Heras fence barrier positioned as indicated on the tree protection plan. Specification as recommended in BS5837 (2012) fig.3 appended</li> <li>• The CCS should be designed by an engineer to carry the maximum anticipated loading for site construction traffic and then for future use.</li> <li>• The CCS must be constructed before vehicles cross the RPA using the 'rolling out' system of installation. This will need to be the first phase of the construction to provide access to the field.</li> <li>• The permeable surface on top of the CCS within the RPA should be protected with a temporary sacrificial surface laid over a geotextile separator to ensure permeability is retained (i.e. intersections should not become blocked by the passage of construction vehicles).</li> <li>• No excavation for haunching is permitted on side of the CCS closest to the tree/s within the RPA. The CCS edge must be supported e.g. by above-ground retaining boards/blocks secured with road pins to minimise damage to the lateral roots.</li> <li>• Ramping onto the pavement will need to be located within the RPA of T3. Excavation for the ramping will be done by hand to avoid severing major roots (greater than 25mm diameter).</li> <li>• The ramping onto the road within the RPA will be created 5.6m from the stem. The ramping will need to be done under arb-supervision, to avoid severing major roots (greater than 25mm diameter).</li> <li>• The British standard only permits the removal of the turf layer, the mineral soil has to remain undisturbed. The existing field access is level is lower than the road, so no alteration of soil levels are proposed within the RPA</li> <li>• End reduction of the lowest limb on the north side of the crown by 1.5m, to reduce loading on weakened limb. This 1<sup>st</sup> order limb has a cavity within the limb, as a result of an old hazard beam crack, which doesn't have appeared to have successfully stabilised. It is possible that there is active decay within the wound site. Limb is overhanging the proposed driveway. See photo detail in Appendix for indicative pruning position.</li> </ul> | |

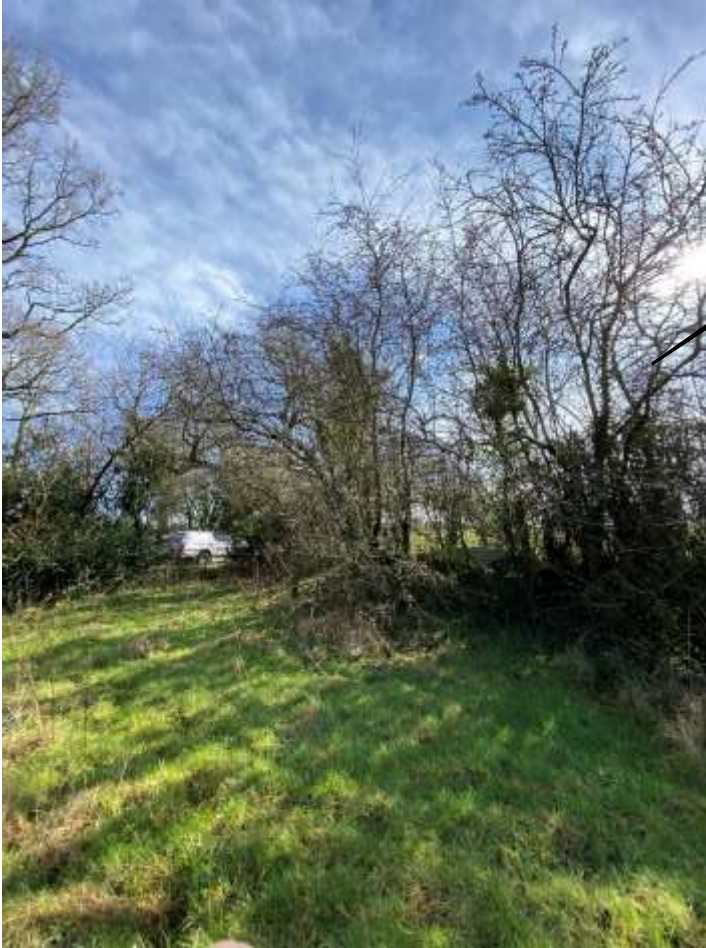
H2

| <p><b>Tree Condition:</b><br/> <b>Root:</b> no soil movement.<br/> <b>Stem:</b> multiple stems.<br/> <b>Crown:</b> No evidence of recent breakouts or significant dieback. Lapsed hedge with collapsed crowns in places.<br/> <b>Tree Quality Assessment:</b> Ref.BS5837 (2012) 4.5.1 <b>Category B2:</b> 'trees present in numbers, usually growing as groups or woodlands, such that they attract a higher collective rating'.<br/> <b>Water Demand NHBC 4.2-B:</b> High<br/> <b>Root Protection Area RPA:</b> for tree of 20cm diameter at 1.5m <math>(0.20 \times 12) = 2.4\text{m}</math>.<br/> Total RPA required at current stage of growth = <math>18\text{m}^2</math><br/> <b>Arboricultural Impact Assessment AIA:</b> <ul style="list-style-type: none"> <li>The proposed access driveway falls outside the RPA of the majority of H2. There is a 5m section of the drive to the east, which falls within the RPA of H2</li> <li>No trench excavation is permitted within the RPA of T8</li> <li>No alteration of soil levels is permitted within the RPA</li> </ul> <b>Method Statement: construction of proposed driveway</b> <ul style="list-style-type: none"> <li>Install section of Heras fence barrier positioned as indicated on the tree protection plan. Specification as recommended in BS5837 (2012) fig.3 appended</li> <li>The CCS should be designed by an engineer to carry the maximum anticipated loading for site construction traffic and then for future use.</li> <li>The CCS must be constructed before vehicles cross the RPA using the 'rolling out' system of installation. This will need to be the first phase of the construction to provide access to the field.</li> <li>The permeable surface on top of the CCS within the RPA should be protected with a temporary sacrificial surface laid over a geotextile separator to ensure permeability is retained (i.e. intersections should not become blocked by the passage of construction vehicles).</li> <li>No excavation for haunching is permitted on side of the CCS closest to the tree/s within the RPA. The CCS edge must be supported e.g. by above-ground retaining boards/blocks secured with road pins to minimise damage to the lateral roots.</li> <li>Ramping onto the existing road is located outside the RPA of H2</li> <li>The British standard only permits the removal of the turf layer, the mineral soil has to remain undisturbed. The existing field access is level is lower than the road, so no alteration of soil levels are proposed within the RPA</li> <li>End reduction of foliage overhanging the proposed driveway by approximately 1m. this will then be retained as a managed hedgerow.</li> </ul> </p> | |

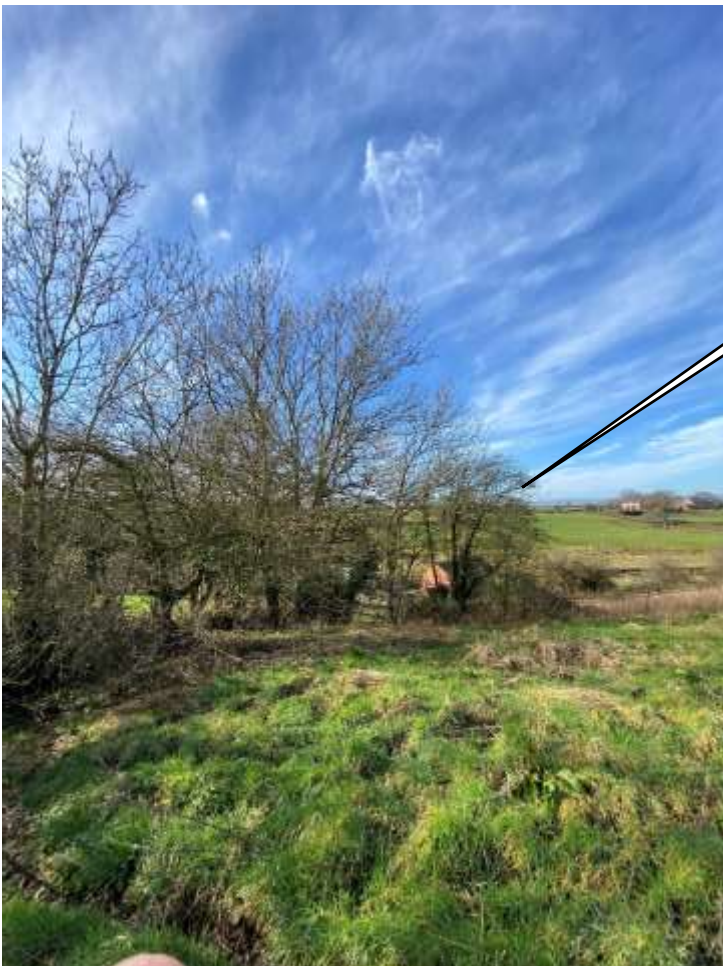
G1

| <b>Tree Condition:</b><br><b>Root:</b> no soil movement.<br><b>Stem:</b> no significant defects.<br><b>Crown:</b> No evidence of recent breakouts or significant dieback. will need reducing over the proposed driveway for clearance.<br><b>Tree Quality Assessment:</b> Ref.BS5837 (2012) 4.5.1 <b>Category B2:</b> 'trees present in numbers, usually growing as groups or woodlands, such that they attract a higher collective rating'.<br><b>Water Demand NHBC 4.2-B:</b> High<br><b>Root Protection Area RPA:</b> for tree of 25cm diameters at 1.5m $(0.25 \times 12) = 3\text{m}$ .<br>Total RPA required at current stage of growth = $28\text{m}^2$<br><b>Arboricultural Impact Assessment AIA:</b> <ul style="list-style-type: none"> <li>The proposed access driveway falls outside the RPA of G1</li> <li>No trench excavation is permitted within the RPA</li> <li>No alteration of soil levels is permitted within the RPA</li> </ul> <b>Method Statement: for the construction of the proposed driveway</b> <ul style="list-style-type: none"> <li>Install section of Heras fence barrier positioned as indicated on the tree protection plan. Specification as recommended in BS5837 (2012) fig.3 appended</li> </ul> | |

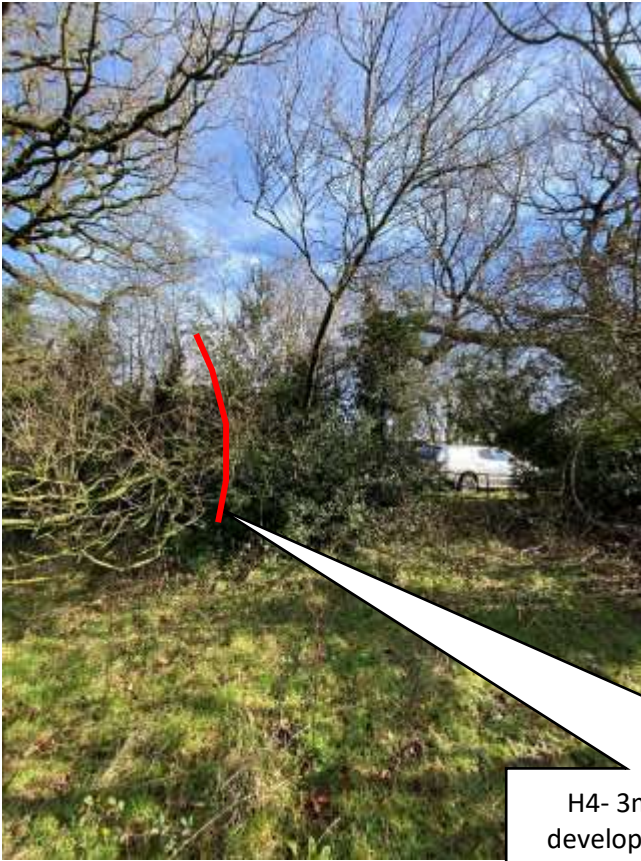
| <p><b>Tree Condition:</b><br/> <b>Root:</b> no soil movement.<br/> <b>Stem:</b> multiple stems.<br/> <b>Crown:</b> No evidence of recent breakouts or significant dieback. Lapsed hedge with collapsed crowns in places.<br/> <b>Tree Quality Assessment:</b> Ref.BS5837 (2012) 4.5.1 <b>Category B2:</b> 'trees present in numbers, usually growing as groups or woodlands, such that they attract a higher collective rating'.<br/> <b>Water Demand NHBC 4.2-B:</b> High<br/> <b>Root Protection Area RPA:</b> for tree of 20cm diameter at 1.5m <math>(0.20 \times 12) = 2.4\text{m}</math>.<br/> Total RPA required at current stage of growth = <math>18\text{m}^2</math><br/> <b>Arboricultural Impact Assessment AIA:</b> <ul style="list-style-type: none"> <li>The proposed access driveway falls within the RPA of H4</li> <li>No trench excavation is permitted within the RPA</li> <li>No alteration of soil levels is permitted within the RPA</li> </ul> <b>Method Statement: for the construction of the proposed driveway</b> <ul style="list-style-type: none"> <li>Install section of Heras fence barrier positioned as indicated on the tree protection plan. Specification as recommended in BS5837 (2012) fig.3 appended</li> <li>3m section of the south end of H4 proposed for removal by the developer, to improve visibility and create visibility splay.</li> </ul> </p> | |

H4- 3m section of H3 proposed for removal by the developer, in order to create visibility splay for access and driveway
