**PROPOSED RESIDENTIAL DEVELOPMENT  
WOODLANDS FARM, DODDS LANE  
GWERSYLLT, WREXHAM  
FOR  
WALES & WEST HOUSING ASSOCIATION**

**APRIL 2015**

**GEO-ENVIRONMENTAL INVESTIGATION REPORT  
14155/GEIR**

**ROBERT E FRY & ASSOCIATES LTD.**  
45, Bridgeman Terrace  
Wigan, WN1 1TT

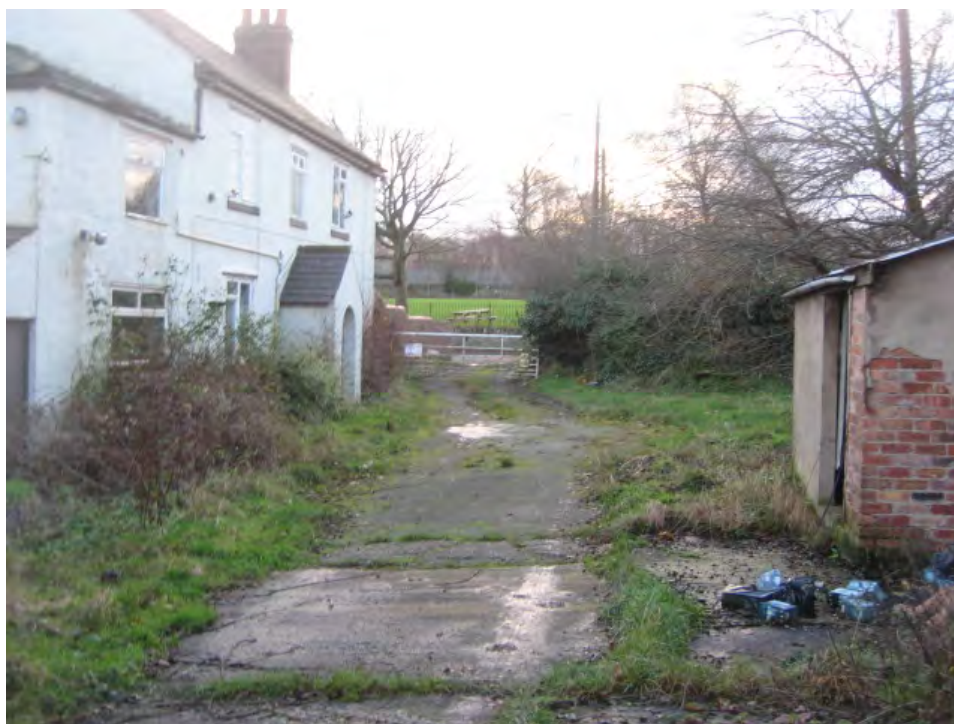
Photo 1 –General view south west of the farm building and the access from Dodds Lane

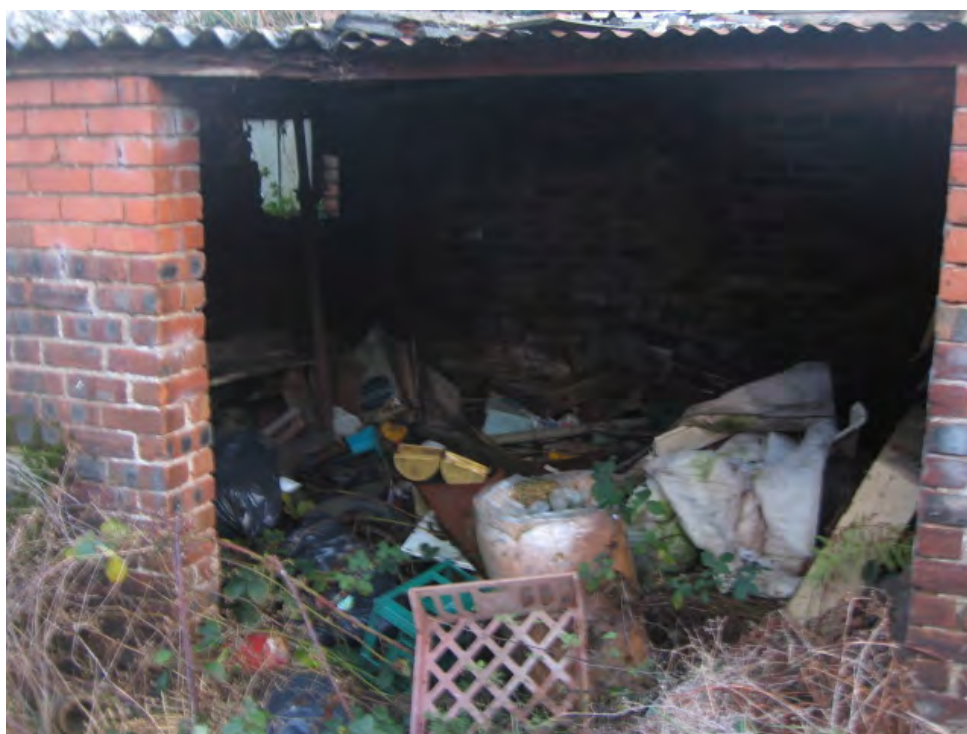
Photo 2 – View of contents of farm buildings with general waste

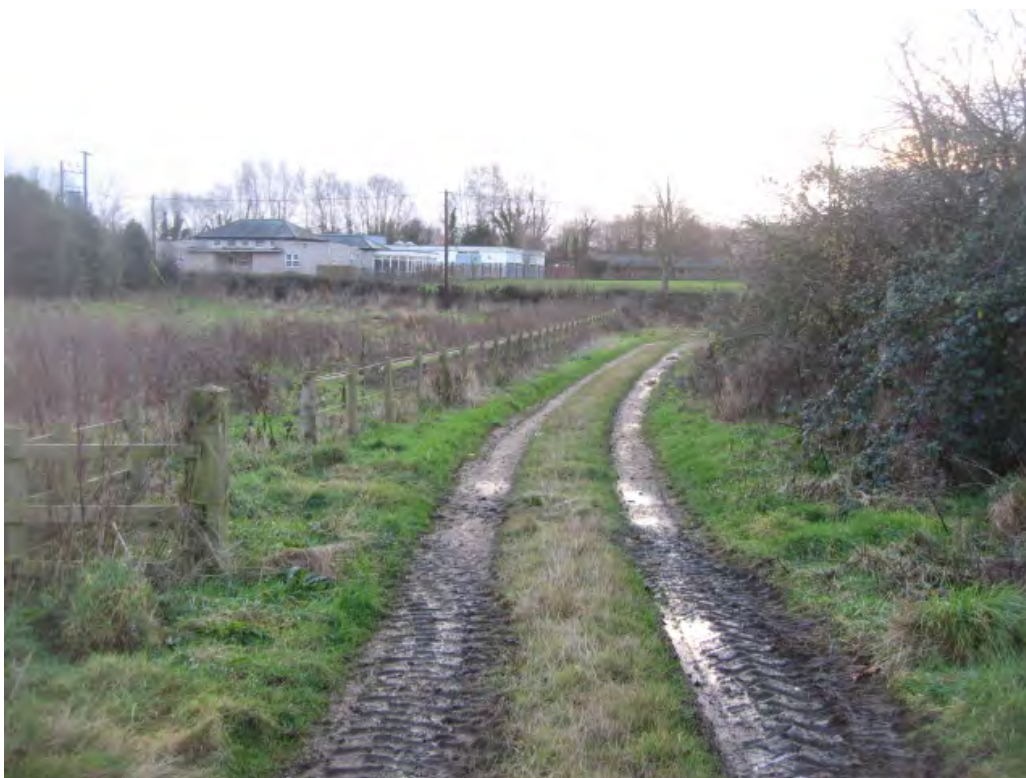
Photo 3 – View south along the access track leading to the front yard of Woodlands Farm

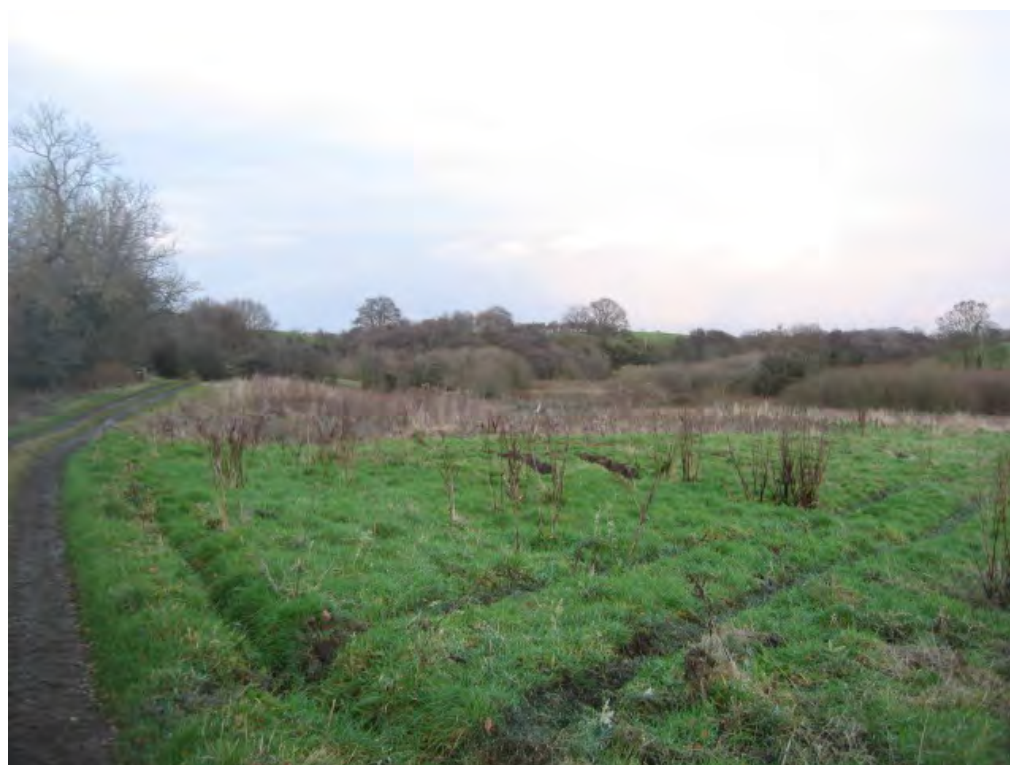
Photo 4 – General view north with the access road present to the left

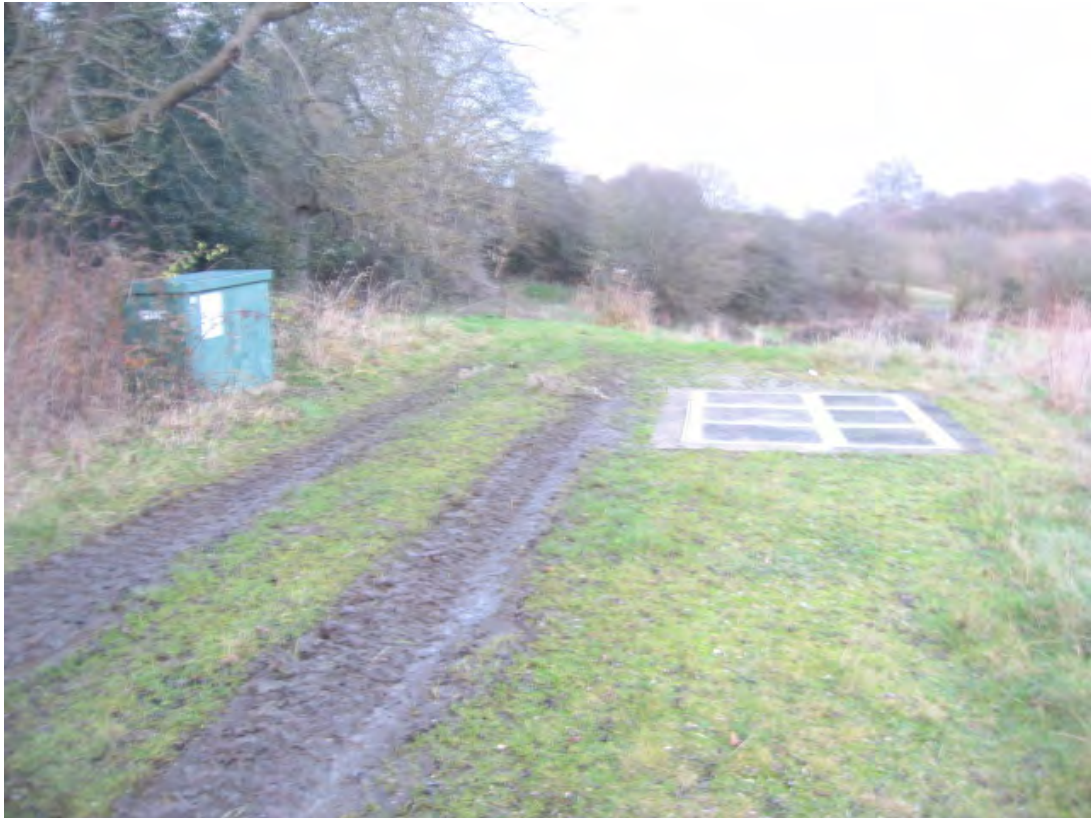
Photo 5 – Underground tanks relating Welsh Water

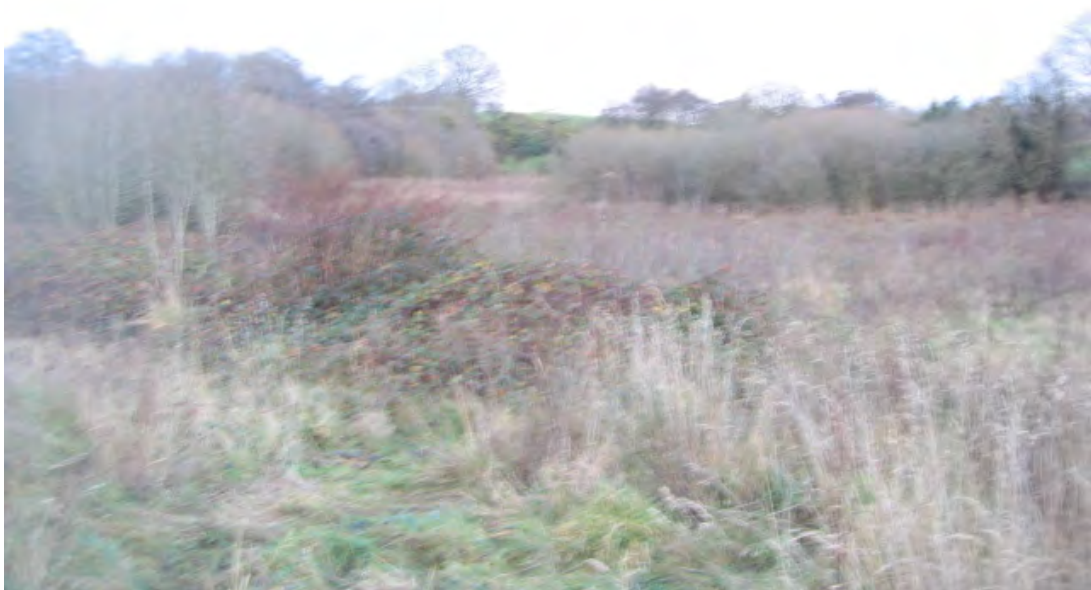
Photo 6 – General view north east of the marsh area

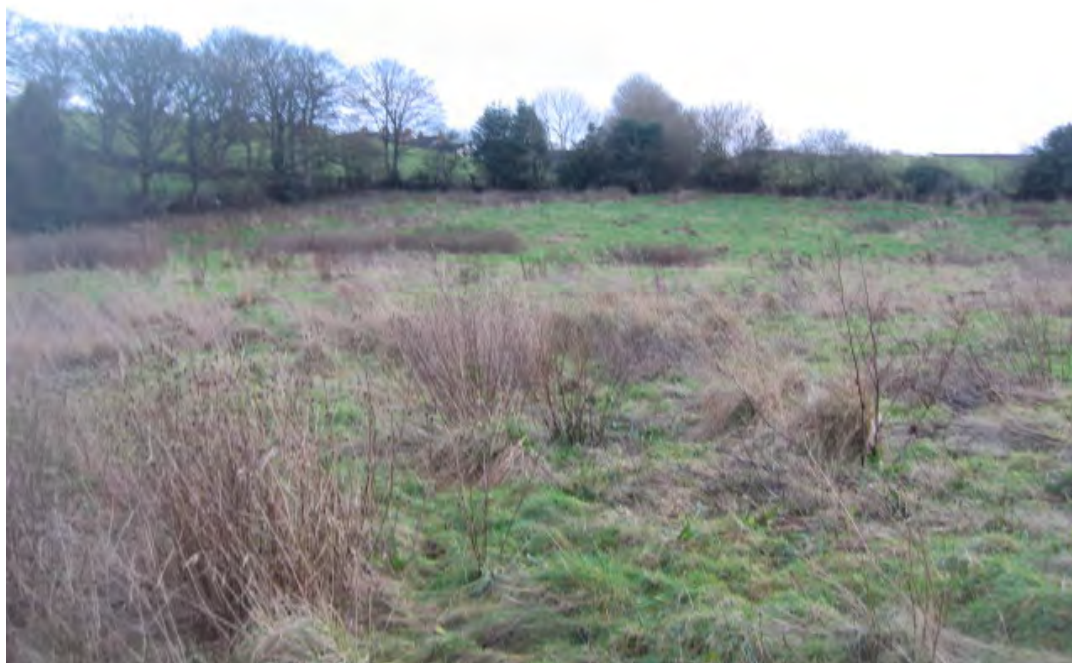
Photo 7– General view south east

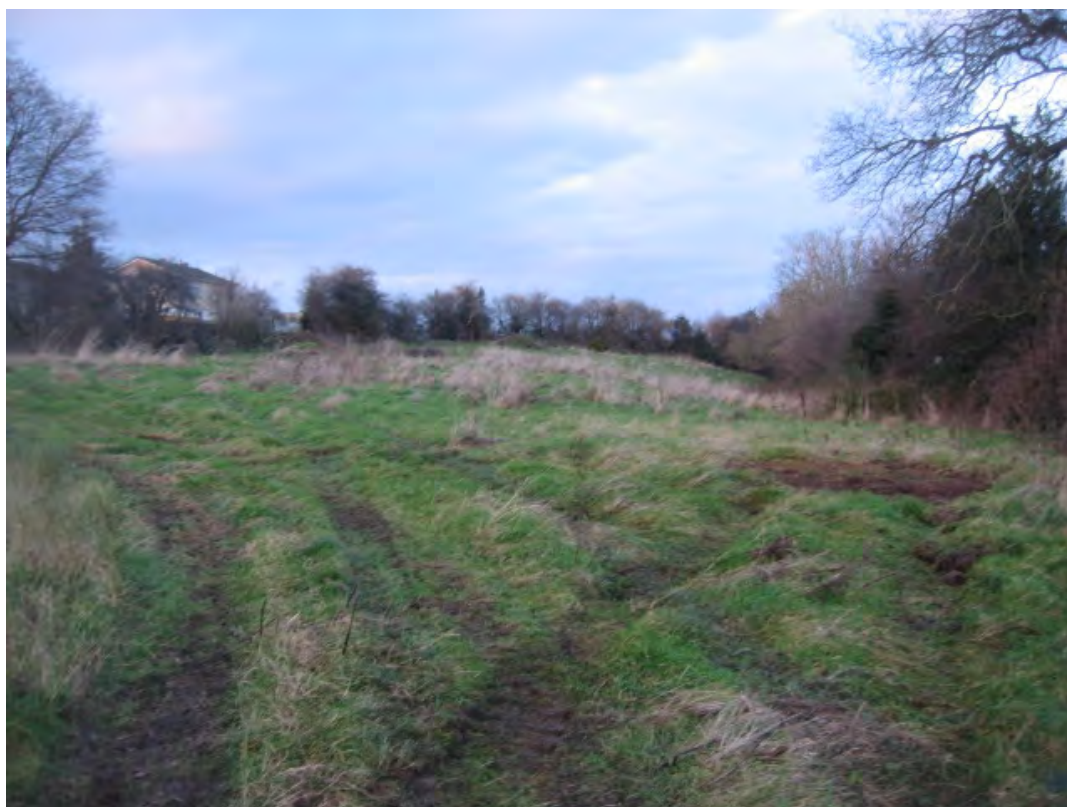
Photo 8– View north within the most westerly parchment of land

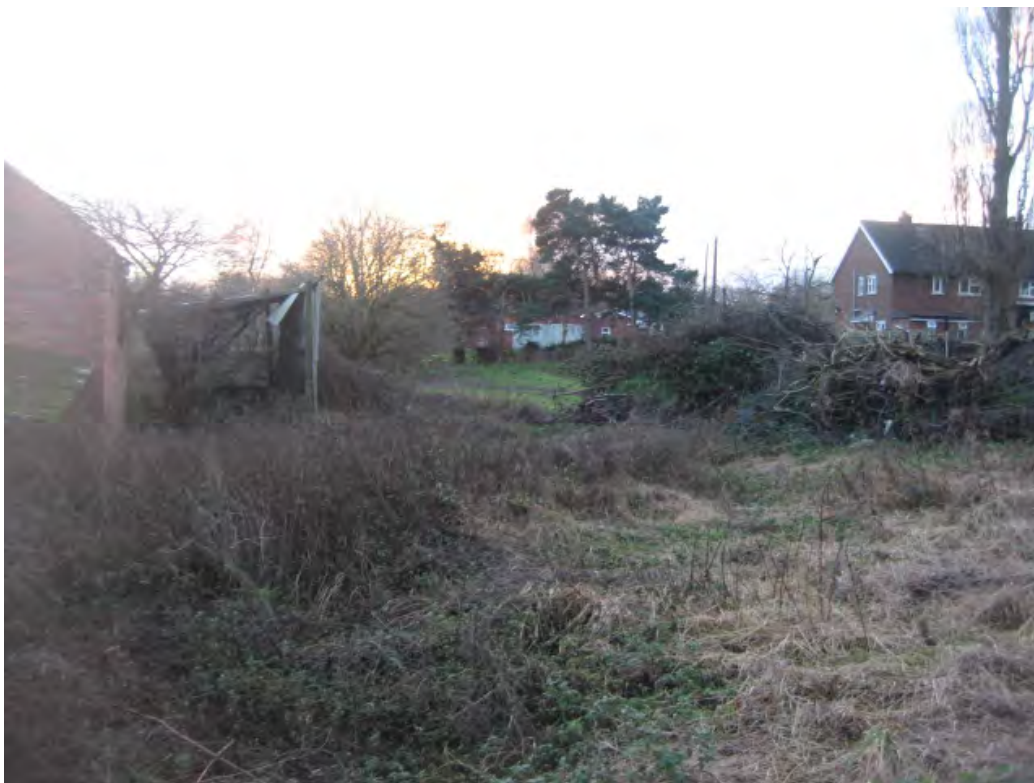
Photo 9 – General view south west within the most westerly parchment of land

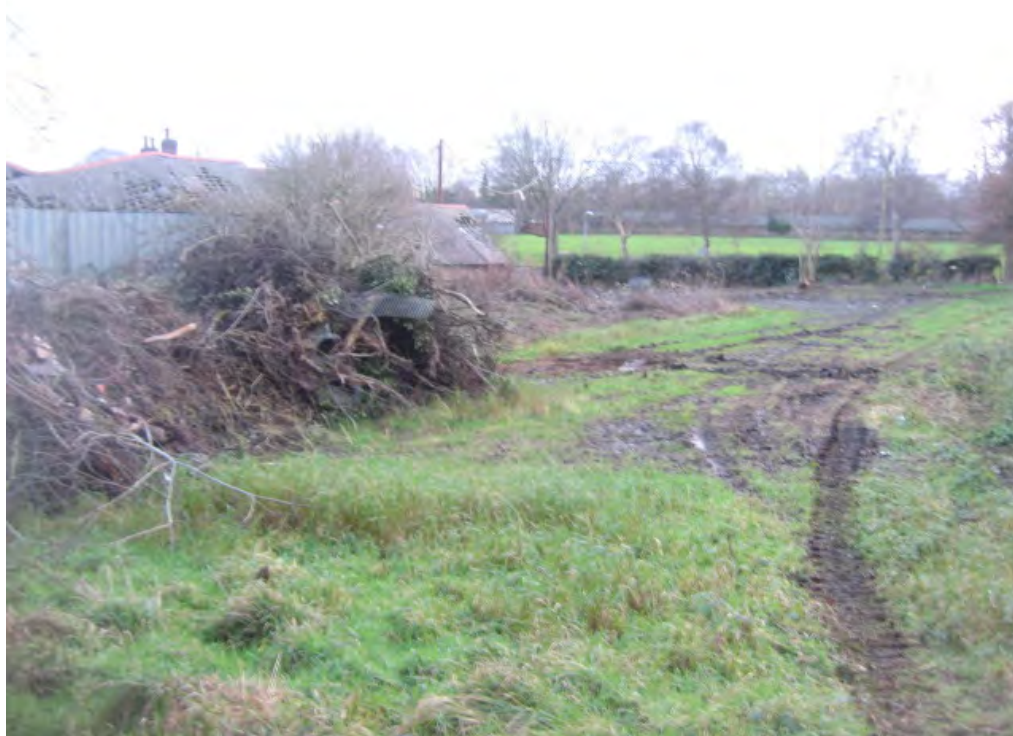
Photo 10 – View south of the large stockpiles of vegetation and general waste present with Woodlands Farm located in the rear of the picture
