**RE: P/2021/0238 – Discharge of Condition 8 (Contamination) of Planning Permission P/2018/0675**

**Gas Membrane Repair Process**

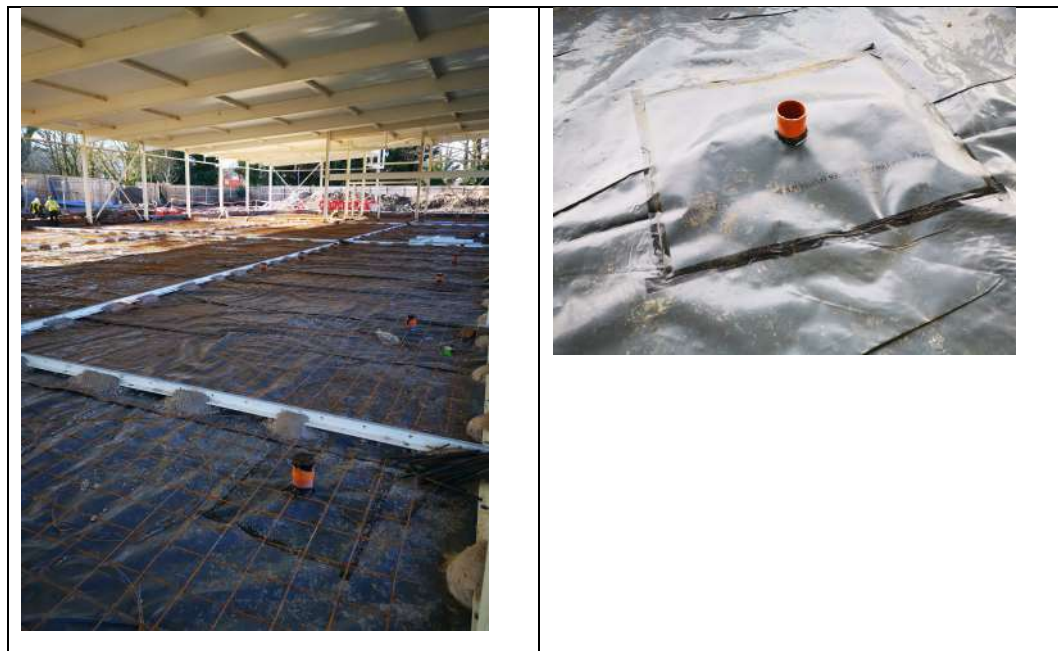
Braithwaites have provided the photos below to illustrate the condition of the membrane prior to casting of the floor slab:
