## Welsh-Wood

Tree Condition Survey (Hazard Assessment)

12/14 Applewood Close,  
Wrexham  
LL13 7GU

Ref: NEB 20002

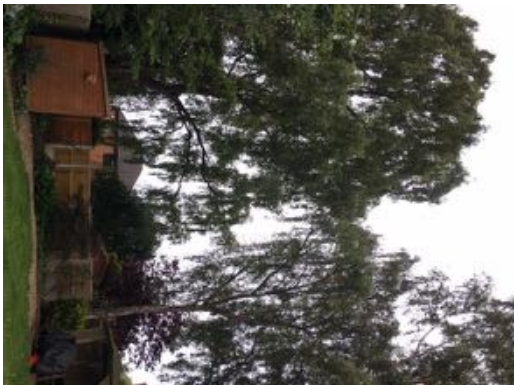
T1 & T2

| Tree ID | Botanical Name | Common Name | Height (m) | DBH (cm) | Age Class | Condition Category | Comments | Management Prescriptions | Priority |
|---|---|---|---|---|---|---|---|---|---|
| 1 | <i>Betula pubescens</i> | Silver birch | 13 | 59 | M | Good | Two primary co-dominant stems at 2m. Vigorous crown. Ivy on stem severed and now dead. | No works required. | N/A |
| 2 | <i>Betula pubescens</i> | Silver birch | 11 | 25 | SM | Fair | Asymmetrical form due to adjacent tree cover and suppressed form. Limited dieback and deadwood (1 - 2 branches). Pruning wound decay at 2m, appears superficial. | No works required. | N/A |

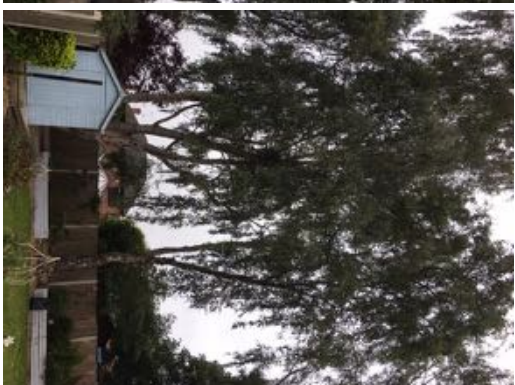
T3 & T4

| Tree ID | Botanical Name | Common Name | Height (m) | DBH (cm) | Age Class | Condition Category | Comments | Management Prescriptions | Priority |
|---|---|---|---|---|---|---|---|---|---|
| 3 | <i>Betula pubescens</i> | Silver birch | 14 | ave 35 | M | Fair | Multi stemmed at 1m (3 stems). Self braced primary limb. Pruning wounds and decay at 1.0m and 1.5m. Pruning stubs in crown. | No works required. | N/A |
| 4 | <i>Betula pubescens</i> | Silver birch | 12 | 38 | SM | Poor | Damaged buttress with some decay. Decayed wood and bark and suspected Kretzschmaria deusta bracket. Pruning wound at 1.5m with advanced decay and pseudosclerotial plating. Dieback and deadwood throughout crown. | Remove to ground level. Remove all arisings from site. | H |

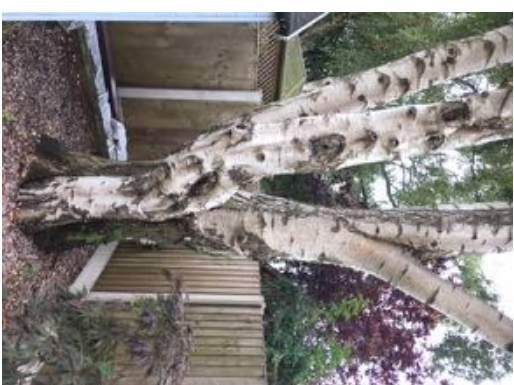
- 3.3.1 Structural condition relates to the form of the trees, in particular a specimen that has developed as multi stemmed from the base or may have developed poor branch structure that renders it susceptible to failure in the future.
- 3.3.2 No significant structural defects were noted however, T3 has self-bracing branches. Self-bracing branches occur when the path of two or more branches meet and they begin to grow together or coalesce. No remedial action to address this is deemed necessary.
- 3.3.3 T5 was originally multi stemmed at the base however two stems have subsequently been removed.

T3 Stem

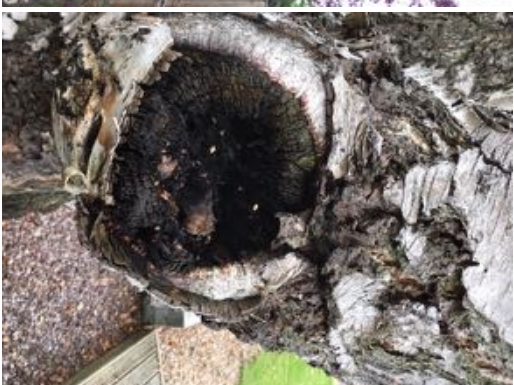
- 3.4.1 Physiological condition relates to the health of the tree surveyed.
- 3.4.2 T3 has two pruning wounds between 1.0-1.5m with decay visible. The extent is unknown but not deemed as a significant defect at this time.
- 3.4.3 T4 has buttress wounding with advanced decay and necrotic bark. *Kretzschmaria deusta*, an aggressive root and stem rotting fungus, is also present. *Kretzschmaria*

T3 Pruning Wound

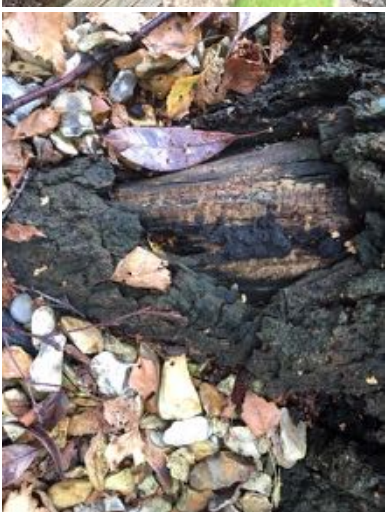
deusta is particularly discrete and appears as small black crusted areas which are the fruiting body of the fungus itself.

- 3.4.5 Decay pathogens in trees degrade live wood and can result in branch or tree failure. Kretzschmaria deusta is associated with root and stem rot. It causes what is known as a soft rot, which preferentially degrades the cellulose in wood, the component that facilitates flexibility. As such the resultant fracture of the stem is brittle and may be sudden. As a result T4 has been scheduled for removal. (LONSDALE 1999)

T4 Buttress decay & pathogen

- 3.5.1 The removal of T4 has been recommended under a \*five day notice provided to the Local Planning Authority with regard the Tree Preservation Order. It is also recommended that consideration is given to the removal of T5.
- 3.5.2 No other remedial action has been specified at this time.
- 3.5.3 \*Given the presence of Tree Preservation Orders it is necessary to either make a supported application for any proposed tree works, or give 5 days' notice of the intent to carry out works to a dead or dangerous tree. This notice must be given in writing and it is likely that the Arboricultural Officer will complete a site visit to confirm that the proposed works are justified under the 5 days' notice and can proceed.

- 4.1.1 On receipt of permission from the Local Planning Authority the tree works should be completed by an appropriately qualified and insured arboricultural contractor, following the specification provided in this report.
- 4.1.2 It is also important that the contractor sanitises their equipment appropriately on completion of the works to prevent spread of the identified pathogen.

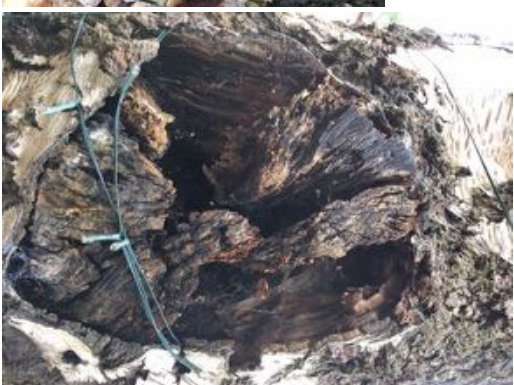
- 3.4.4 In addition a pruning wound with advanced decay and pseudoschlerotial plating was noted on T4 at 1.5m. Pseudoschlerotial plating is a sign of infection from a decay pathogen.

T4 Pruning wound & advanced decay

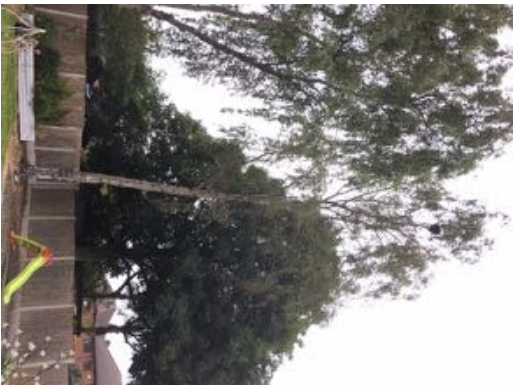
| Tree ID | Botanical Name | Common Name | Height (m) | DBH (cm) | Age Class | Condition Category | Comments | Management Prescriptions | Priority |
|---|---|---|---|---|---|---|---|---|---|
| 5 | <i>Betula pubescens</i> | Silver birch | 12 | 38 | SM | Poor | Originally multi stemmed at base (3 stems) 2 stems removed. Decay at basal pruning wounds evident, extent unknown, staining noted. Suppressed form due to adjacent tree. Thin crown, dieback and deadwood through approximately 30% of the tree. Pruning wounds and stubs in crown. Nest in situ. | No works required. (Consider for long term removal and replacement) | N/A |

- 4.2.1 It is recommended that the remaining trees are inspected again in 2 years from the date of this report and the inspection record updated accordingly.
- 4.2.2 However it would be prudent to inspect T5 in 1 year from the date of this report, given its condition and historical wounding relevant to the on-site pathogen if it is retained.
- 4.2.3 All inspections should be carried out by a qualified and competent arboricultural consultant who must be made aware of the details of this survey.
- 4.2.4 If any significant changes to the trees appearance is noted in the meantime the advice of an arboricultural consultant should be sort. This includes any significant changes to the immediate and adjacent environment the tree is situated in such as any ground disturbance.

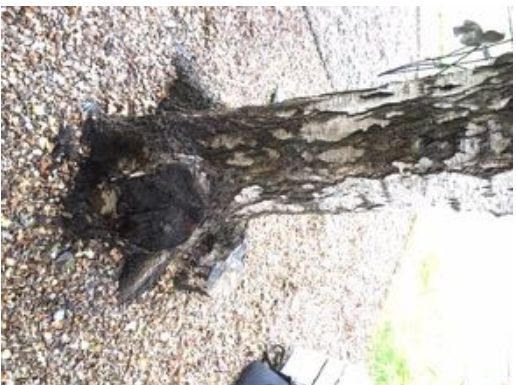
T5 Stem base

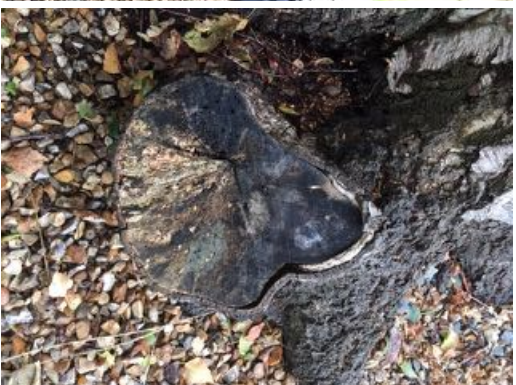
- 3.4.6 T5 has two large pruning wounds at the base as a result of the historic removal of two main stems. Both are decayed and appear stained however the extent of the decay is unknown. The crown of the tree is suppressed and in decline with die back and deadwood throughout. It is deemed premature to recommend the removal of this tree at this time; however consideration should be given to its long term removal and replacement due to its condition and the presence of the decay pathogen on site.

T5 Pruning wound 1

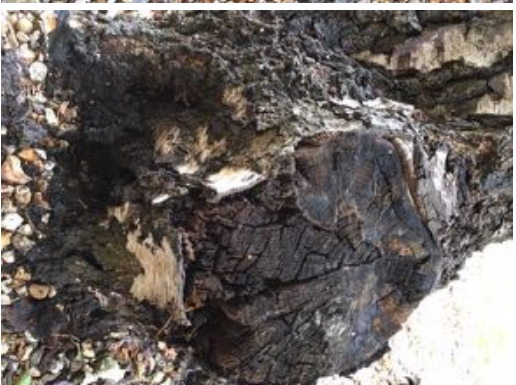
T5 Pruning wound 2
