**TY MAWR**

**Pontfadog, Wrexham, LL20 7AS**

### **Structural Condition Survey of Existing Barn**

**SR01**

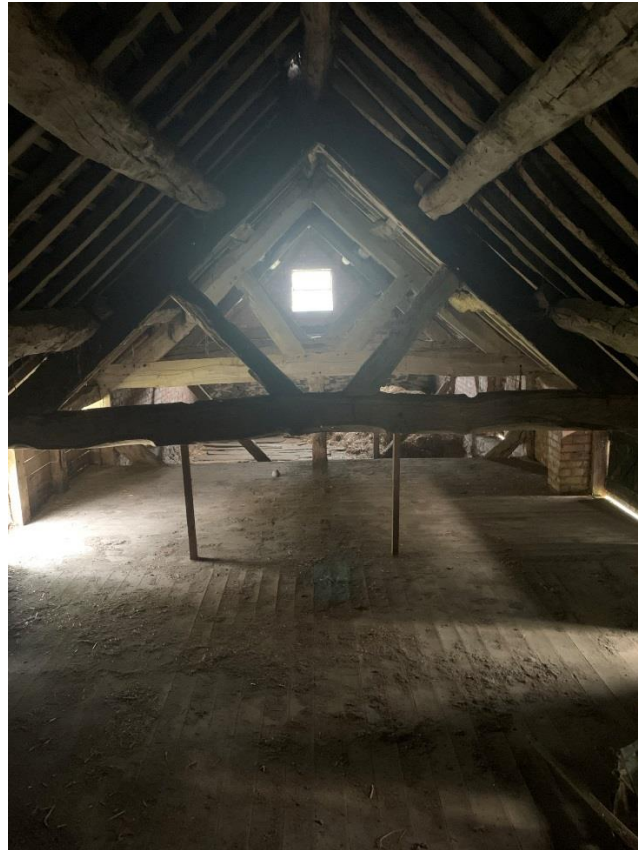
**PHOTOGRAPH 1**

- 2.2 The primary construction of the roof structure comprises a series of timber trusses supported on external brickwork flank walls – **Photograph 1**. The timber purlins supporting the secondary pitched roof rafters are supported by the main trusses. The roof is moderately pitched.

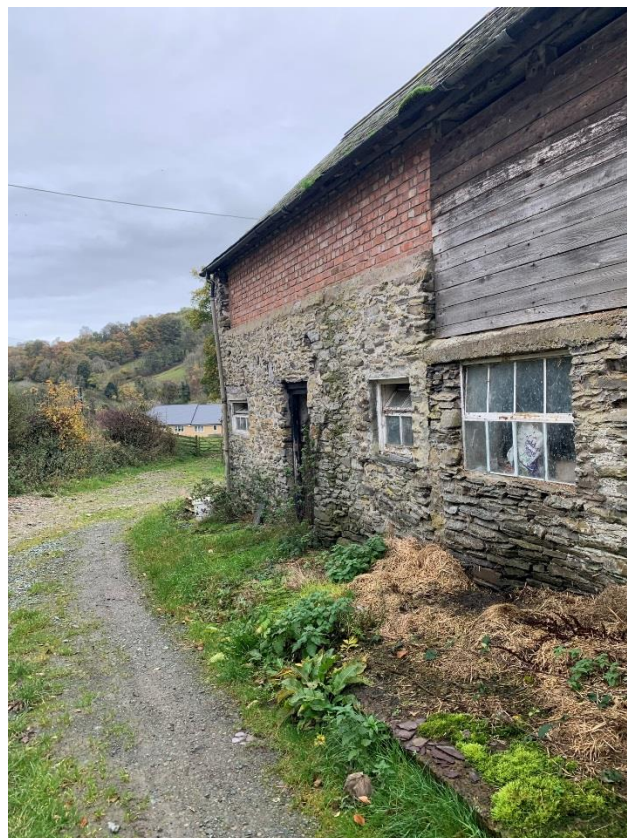
**PHOTOGRAPH 2**

- 2.3 The primary external walls/ cladding generally comprises brickwork masonry with stonework rendered, and patches of top coursing brickwork, timber cladding, and concrete blockwork in certain locations – **Photograph 2**. The internal partition walls appeared to be in brickwork masonry. On the South end gable wall, a lean-to structure had been identified.

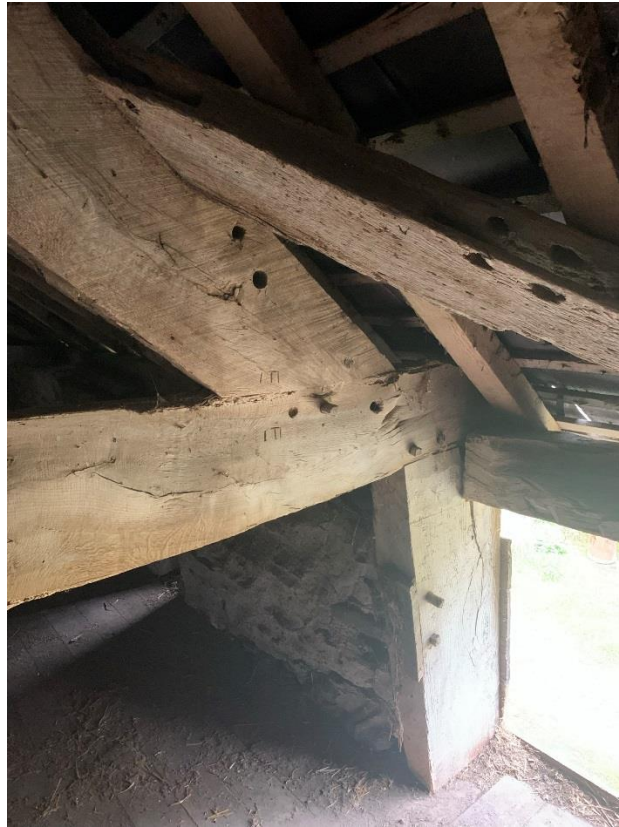
**PHOTOGRAPH 3**

- 2.4 The stability of the building in minor axis appeared to be contributing through a combination of the timber trusses with flank wall masonry buttresses, diagonal braced shoring, and the internal masonry partitioning shear walls – **Photograph 3**.

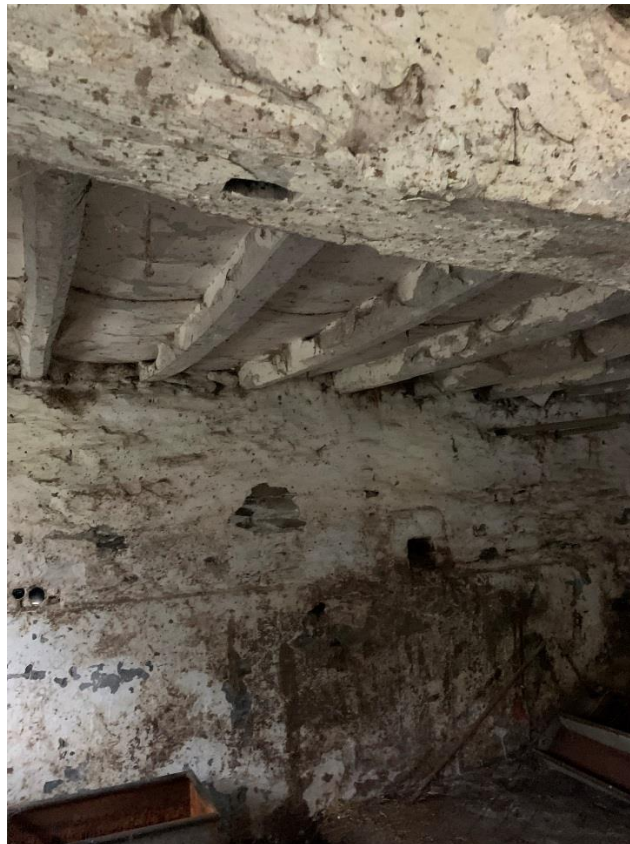
**PHOTOGRAPH 4**

- 2.8 The mezzanine floors appeared to have had been built within the bottom chord zone of the roof trusses. The structural condition of the floor appeared significantly weak and deflection of the floor joists was detected. The condition of some of the mezzanine floor joists above the Milk Parlour appeared rather weak – **Photograph 4**.

- 3.2 The high and low level mezzanine structures must be strengthened by adding intermediate floor joists. Replace all damaged timbers with new C24 grade joists.

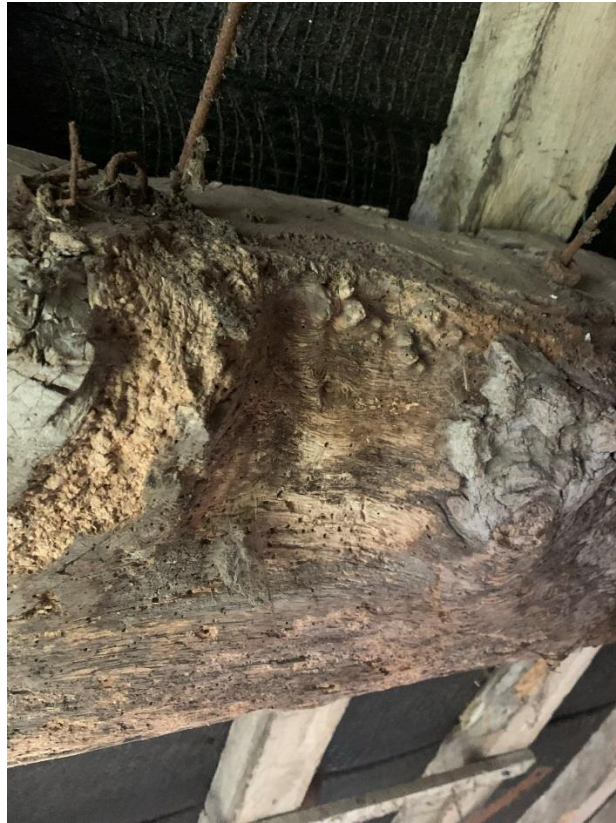
**PHOTOGRAPH 5**

- 2.9 Severe degradation of timber purlins and some truss members including diagonal axial members were identified – **Photographs 5 & 6**. This would most likely be due to exposure to extreme humidity and weathering causing the timbers to decay with time.

- 3.3 The decayed timber purlins appeared to have lost structural strength and must be replaced by new C24 grade timbers – subject to structural calcs.

- 3.4 The decayed diagonal truss timber members and vertical prop appeared to have lost structural strength and must be replaced by new C24 grade timbers – subject to structural calcs.

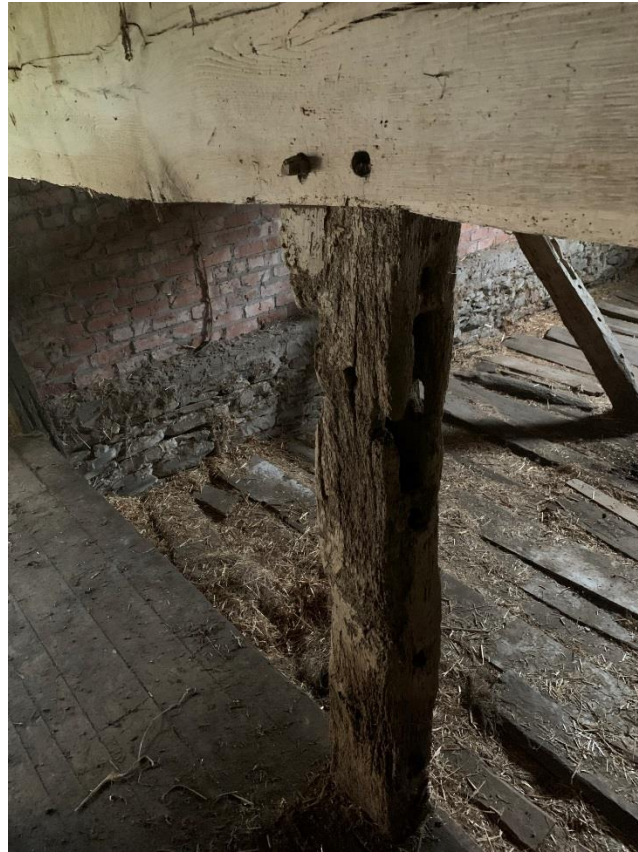
**PHOTOGRAPH 7**

- 2.10 Severe degradation of the timber post propping the third truss had been identified. The timber section appeared fully decayed – **Photograph 7**.

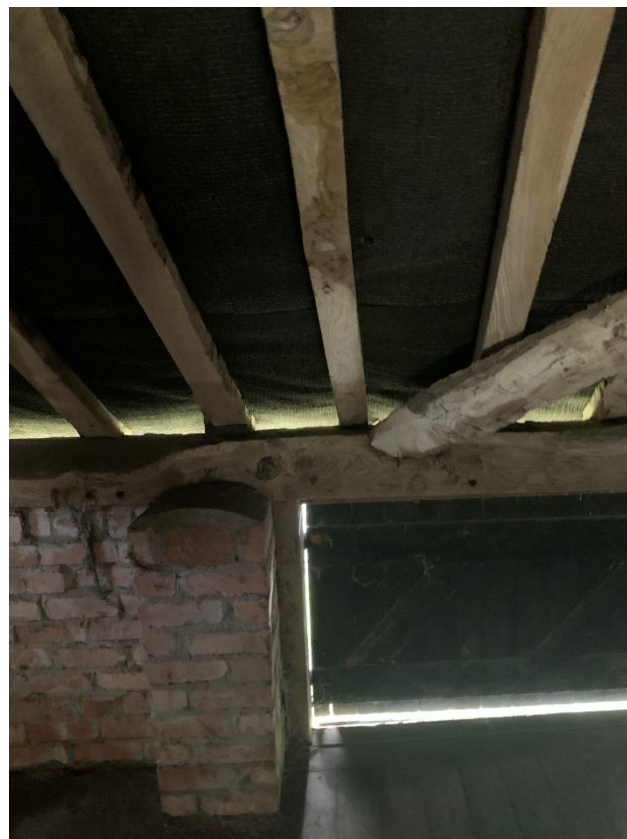
**PHOTOGRAPH 8**

- 2.11 Some of the masonry buttresses did not appear to be fully bonded to the flank walls – this would potentially cause structural instability due to the walls being partially restrained – **Photograph 8.**

- 3.5 All masonry buttresses must be tied back to the masonry flank walls using wall starters and masonry ties to ensure full bonding is achieved for re-establishment of structural stability.

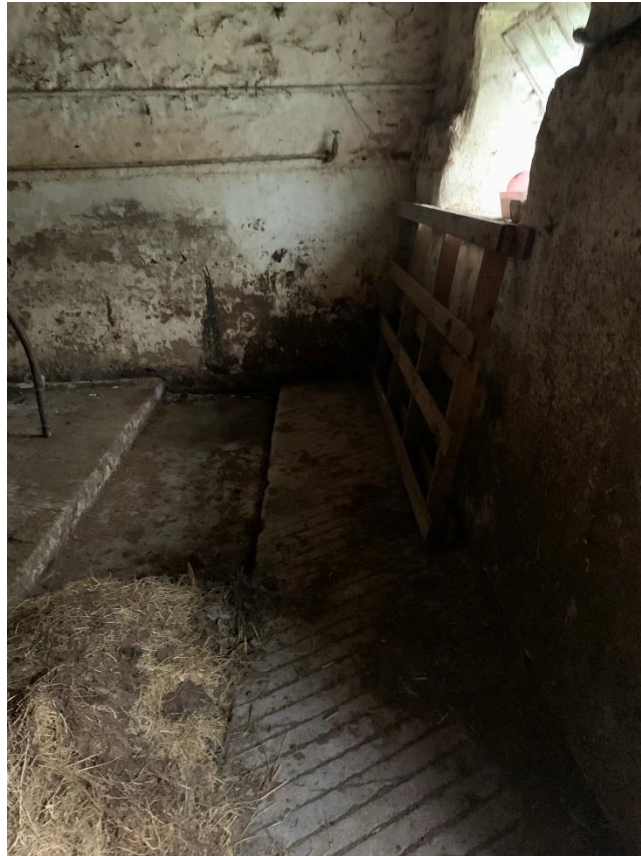
**PHOTOGRAPH 9**

- 2.12 The ground floor construction appeared to be in stonework/ concrete tiled flooring – subgrade underneath the flooring is unknown. The flooring was found to be uneven and in significantly poor state, and in varying levels between Storage room and Milking Parlour – **Photograph 9.**

- 3.6 The existing ground floor construction does not appear to comply with the latest building regulations for the proposed scheme and must be re-built in accordance with the mandatory specification subject to structural design.

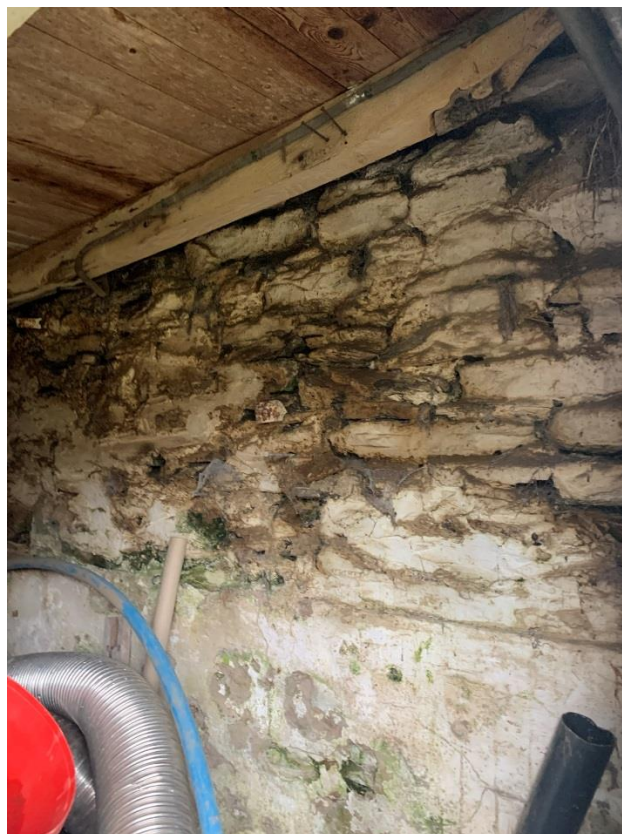
**PHOTOGRAPH 10**

- 2.14 Significant weathering damage to the internal masonry walls and inside face of external walls. Significant hair line cracks of magnitude up to 1mm were found on the internal masonry walls. They appear to be due to embrittlement as a result of age deterioration and are ‘non-structural’ – **Photograph 10.**

- 3.8 All the internal and external masonry walls that have been damaged due to weathering must be thoroughly cleaned using specialist masonry treatment method and re-plaster as necessary.

- 3.10 All 'non-structural' cracks in masonry can be repaired using proprietary sealant method.
- 3.11 The leaning flank wall and outward displacement may have been the result of a potential movement occurred in the property. Further investigation is recommended. Any displaced masonry should be repointed and repaired as necessary, but not until the movement issue is resolved.

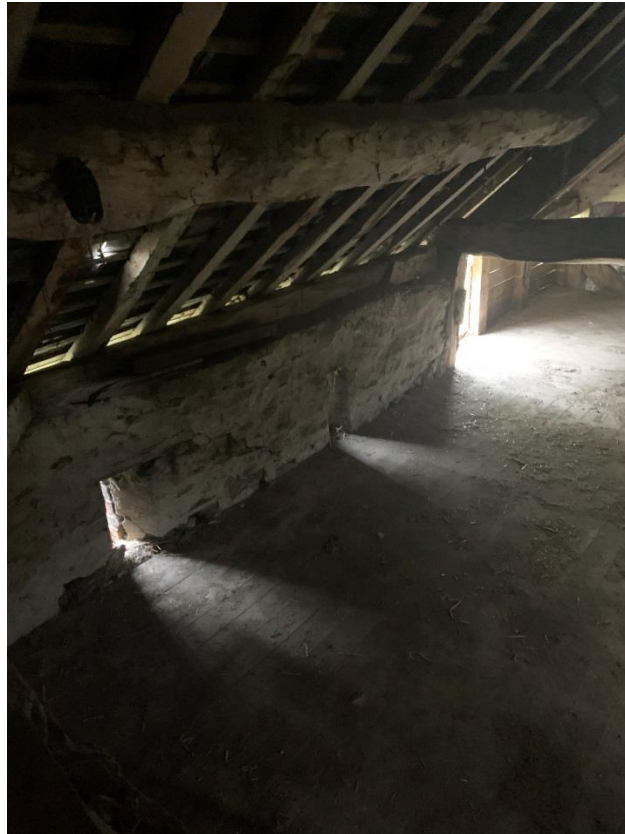
**PHOTOGRAPH 11**

- 2.15 A diagonal ‘Fine’ shear crack circa 3mm was observed along the brick mortar coursing adjacent to the flank wall window which appeared to be due to a possible structural movement – **Photograph 11.**

- 3.9 All structural cracks associated with the inside face of the flank walls should be repaired using bed joint reinforcement and appropriate Helifix method – refer to section 2.0 for identification of structural cracks.

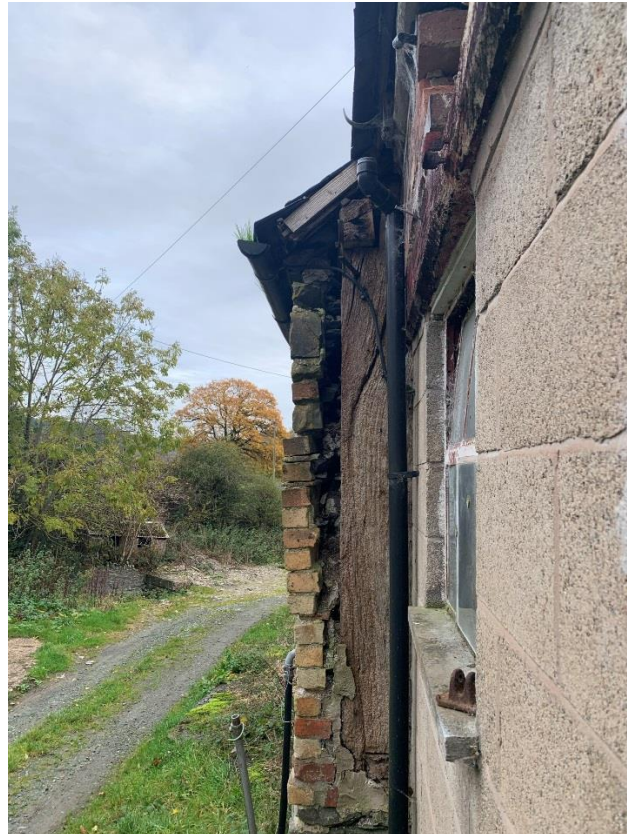
**PHOTOGRAPH 12**

- 2.17 The flank wall adjacent to the Storage room door opening appeared to be leaning outward. The wall appeared out of plumb, which would possibly be due to a structural movement – **Photograph 12.**

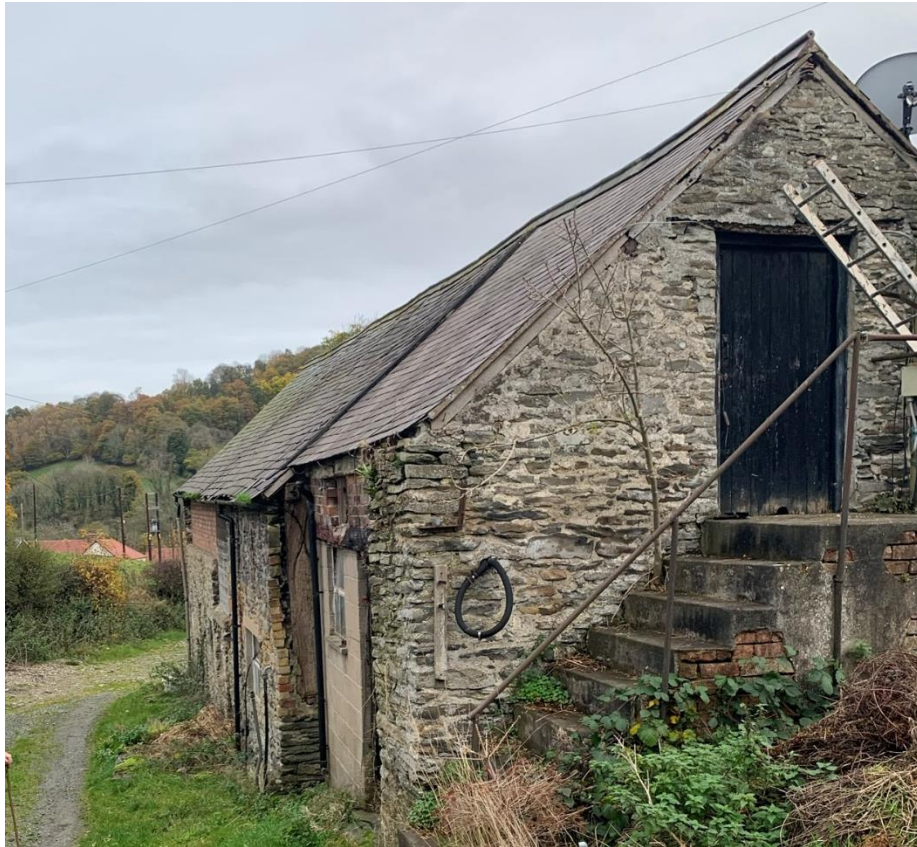
**PHOTOGRAPH 13**

- 2.18 Extensive shear cracks of magnitude up to 8mm at the eaves of the North Gable wall and at the corner of the door opening was observed resulting in the dislocation of stonework, which appeared to be due to potential structural movement – **Photograph 13.**

- 3.13 The extensive structural damage at the corner of the North gable wall appeared to have compromised the structural integrity of the building due to rotational movement, and a robust repair works need to be carried out.

- 3.12 With regard to the structural cracks mentioned in 2.16 & 2.18, a trail pit investigation is recommended to verify if there has been any ground movement and establish the extent/ nature of a possible subsidence. A robust structural engineering solution such as 'underpinning' or strengthening of foundation is recommended as necessary. The movement is possibly be ongoing and in our opinion would unlikely to progress significantly in the foreseeable future failing to recognise the cause.

- 3.14 Regarding 3.12, it is further recommended that careful repointing and re-building of masonry brickwork/ stonework is carried out with new mortar bed. Moreover, Helifix masonry repair solution (in accordance with their recommendation) should be adopted to repair the cracks on the external walls. This however should not be done until the substructure is fully secured in case there has been a settlement in the ground.

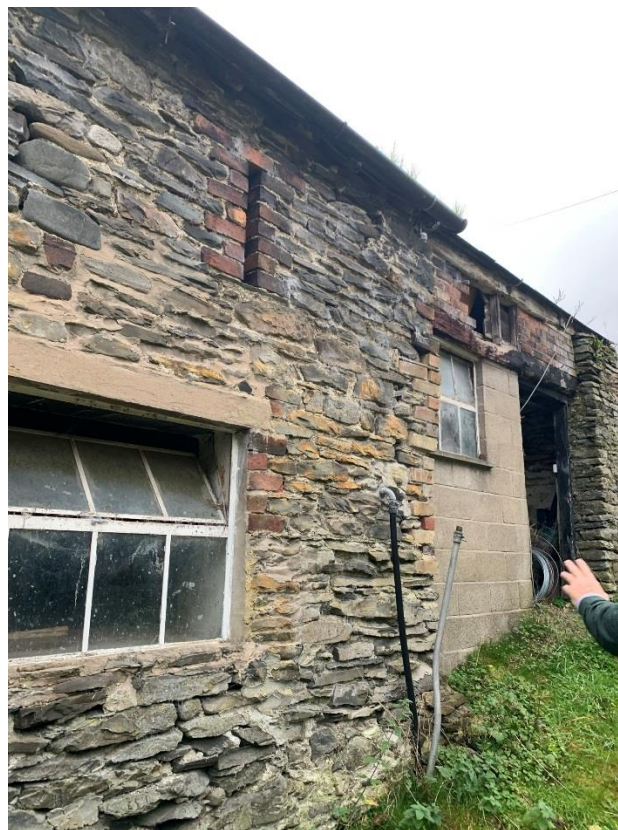
**PHOTOGRAPH 14**

- 2.19 Significant deterioration of timber lintel above the Storage room door opening was observed – **Photograph 14.**

- 3.7 The rotten timber lintel on the flank wall has clearly lost its structural integrity and must be replaced by a new C24 timber or steel/ specialist lintel subject to calcs.
