**Project:** 21\_5837\_07\_40  
**Site:** Croesnewydd Road, Wrexham, LL13 7TD  
**Client:** Michael Alderson

| Document Title: | Tree Survey & Arboricultural Impact Assessment |
| Project Title: | Croesnewydd Road, Wrexham, LL13 7TD |

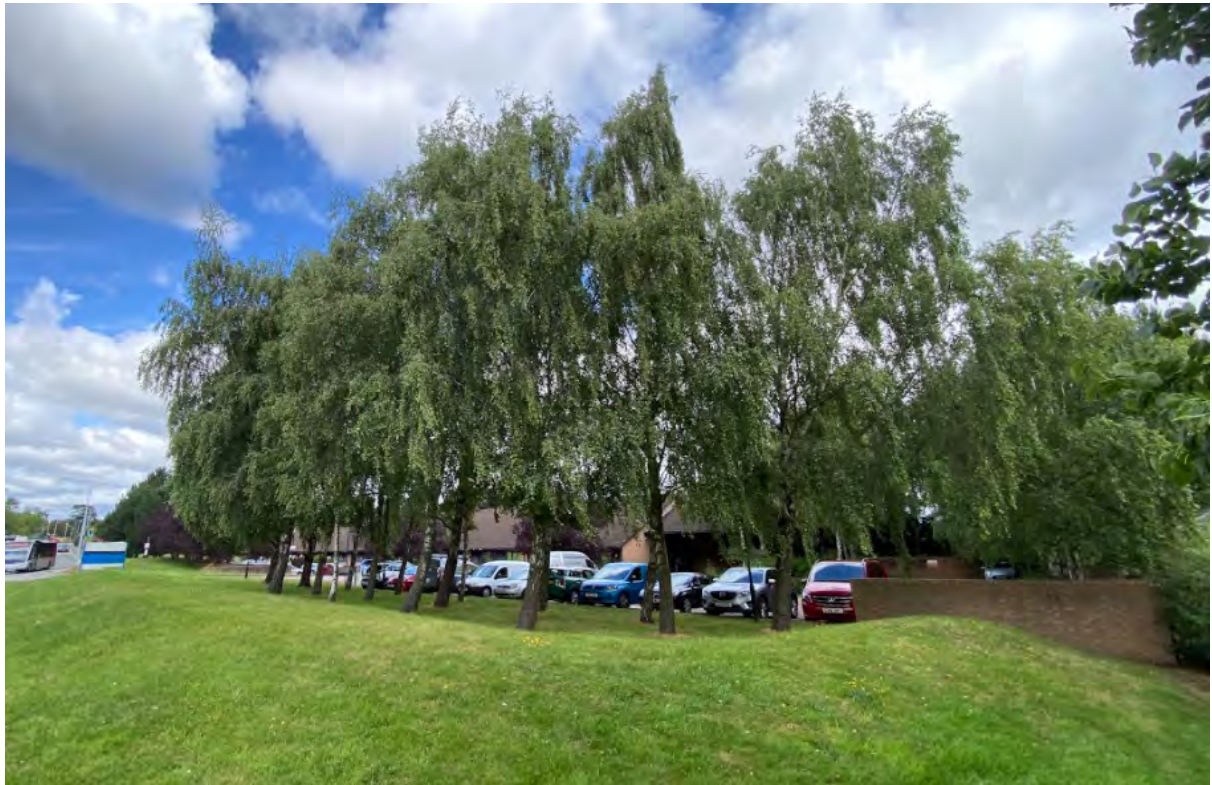
The construction of substations 1 & 2 will require the removal of six Category A trees, as the footprint of the proposed buildings are in direct conflict with the trees. The proposals have been amended to include some alterations to parking and turning areas, which will involve the removal of two further trees.

*Photographic plate showing Category A trees in the proposed location of Substations 1 & 2.*
