**Mulsford Farm, Malpas SY14 7LP – Structural Condition Report**

## **STRUCTURAL CONDITION REPORT FOR THE**

### **PROPOSED BARN CONVERSION PROJECT**

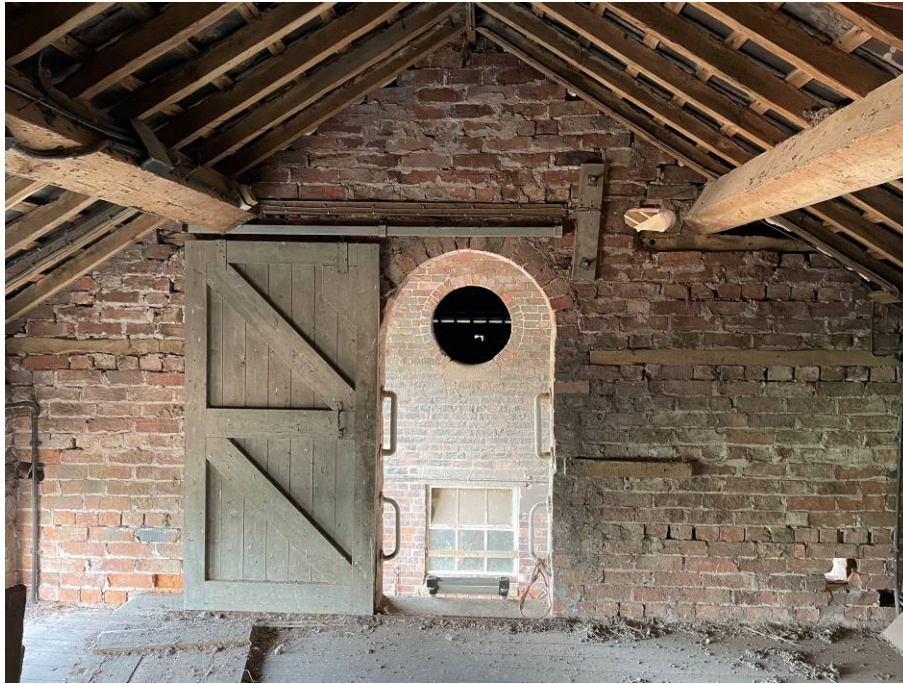
The existing duo pitch roof construction comprises of traditional slate roof tiles supported by soft timber rafters supported by a single oak purlin on each pitch. The oak purlins span between loadbearing masonry walls at the north end of the barn and oak trusses at the south end of the barn.

Refer to the attached Photographs P.03 to P.08 in Appendix A.

The roof timbers appear to be in good condition given the age of the property and in a reasonable state of repair. In general there were no signs of any prolonged moisture issues or visual evidence of wet or dry rot to the roof structure.

The roof to the north end of the barn does not have any roofing membrane below the slate tiles, however on the south end of the barn there is a roof membrane present although its condition is unknown.

4. The adequacy of the existing roof structure should, at the appropriate time, be verified to confirm that it complies with current building regulations.
