## Appendix C Reconnaissance Photographs

### C1 Millrace and Floodplain

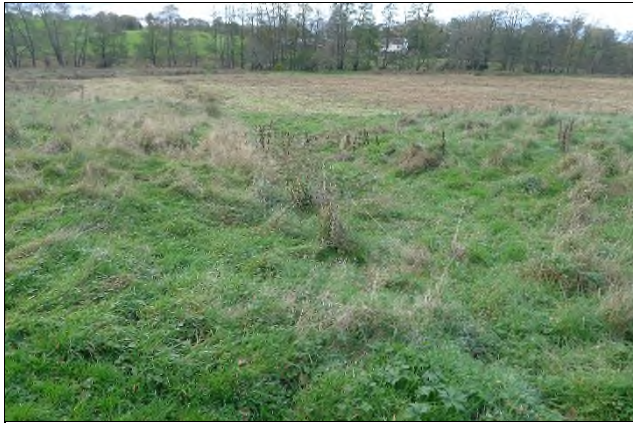
C7 and C8 Note: Breakthrough drainage lines are points where the old millrace bund has been eroded and allows local runoff during intense storms to flow into the floodplain and feed ponding and saturation of areas of marshy grassland.

**C7.** Breakthrough drainage line feeding marshy area.

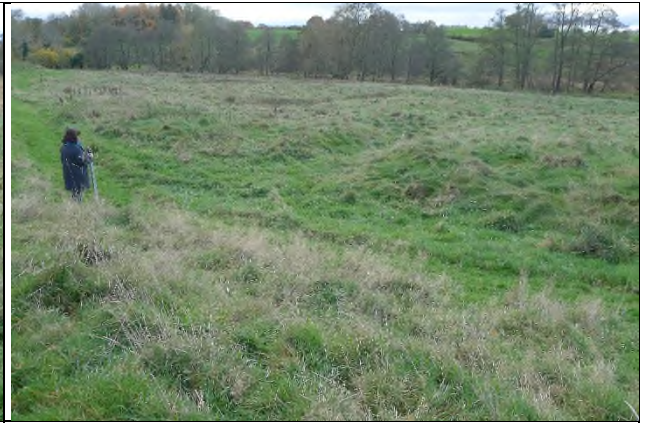
**C8.** Second breakthrough drainage line.

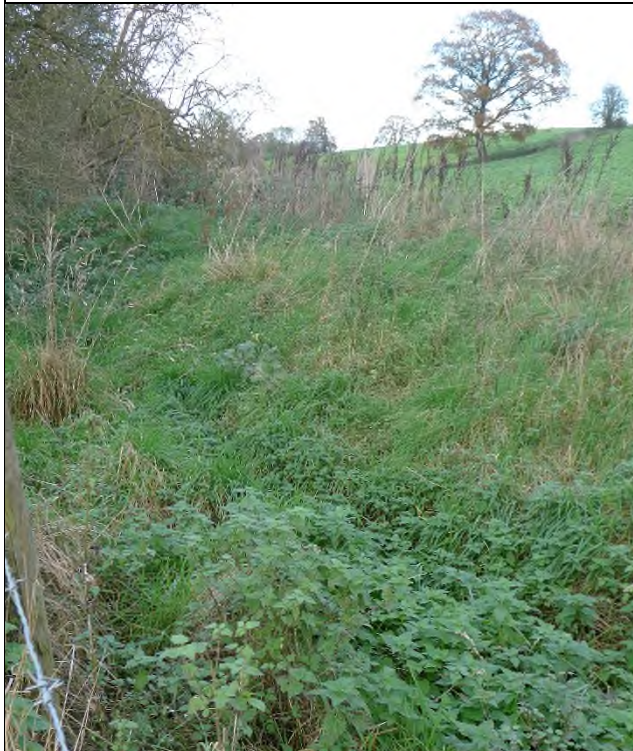
**C9.** Vegetated millrace on other side of property fence, and catchment hillside with mangel wurzel.

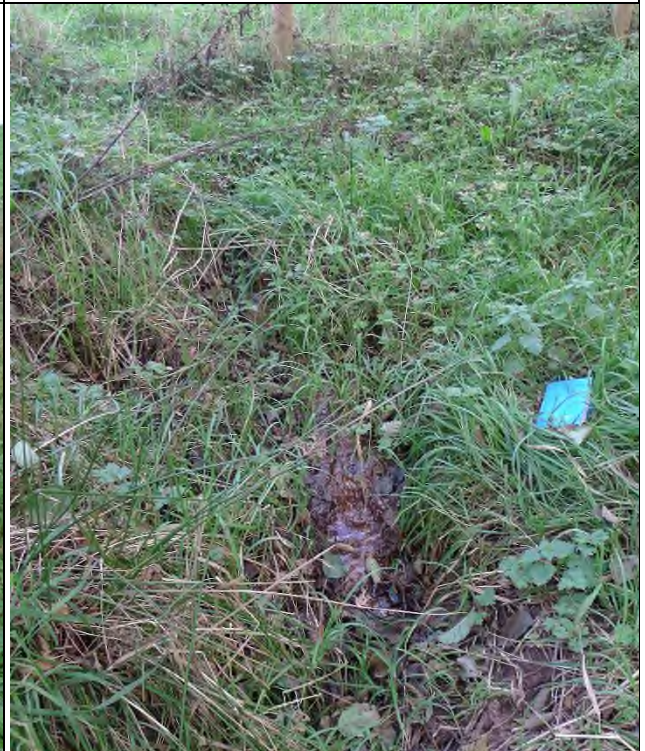
**C10.** Seepage line in bank of Emral Brook, 1 m below adjacent floodplain level.

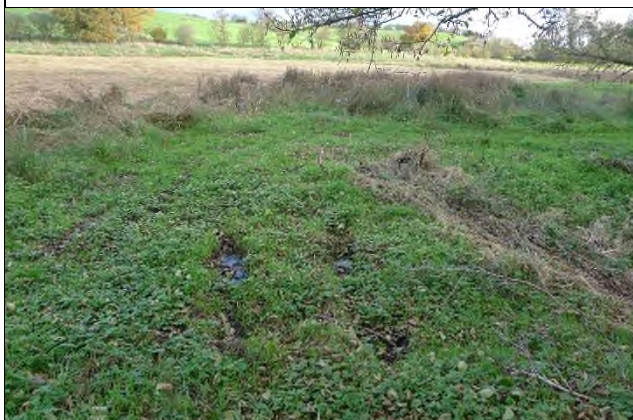
**C11.** Top end of recent otter run into marshy area, 100 m downstream of footbridge.

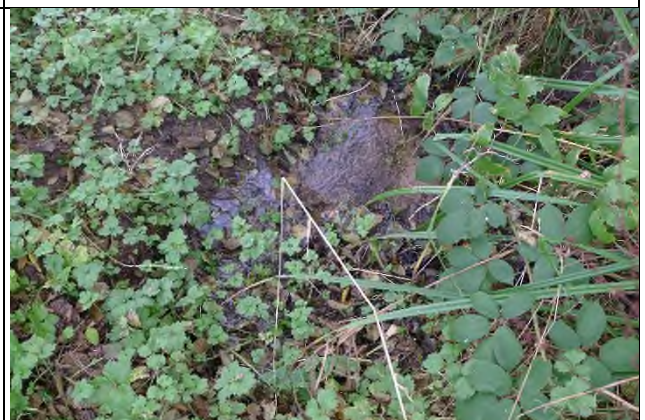
**C12.** Spring near end of old millpond overflow channel, flowing at 2-3 l/s at time of survey.

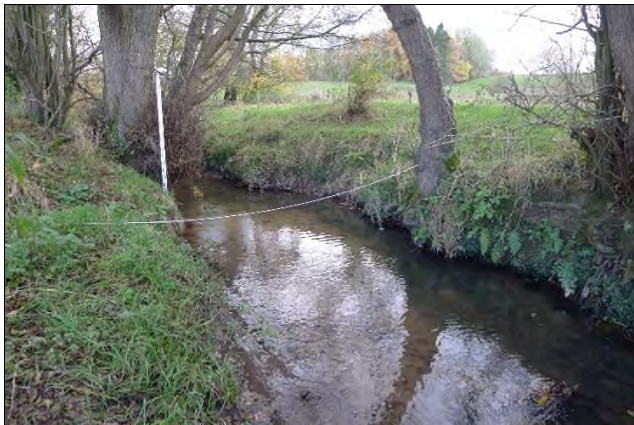
**C13.** Emral Brook at property south boundary.

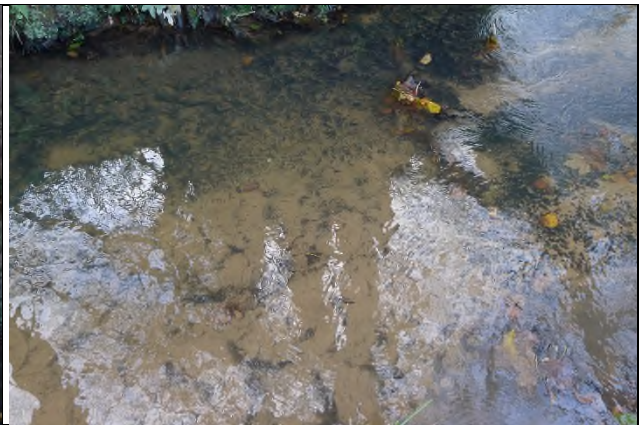
**C14.** Hard, sandy stream bed with stones.

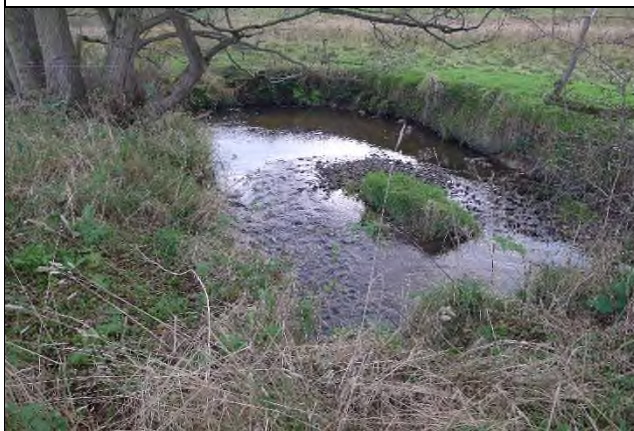
**C15.** Riffles and island formation 160 m downstream of property south boundary, with bank scour pool.

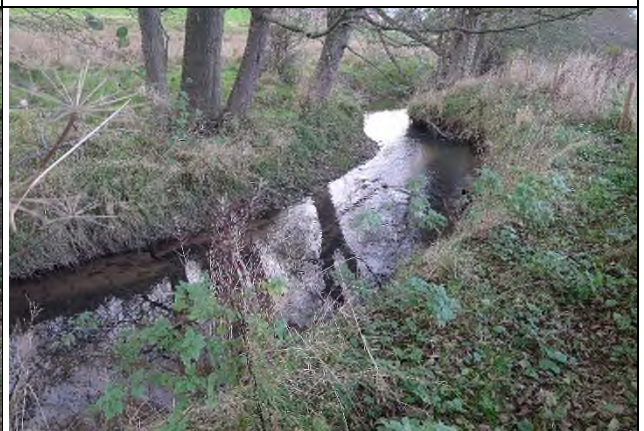
**C16.** Clean meandering reach 200 m downstream of property south boundary.

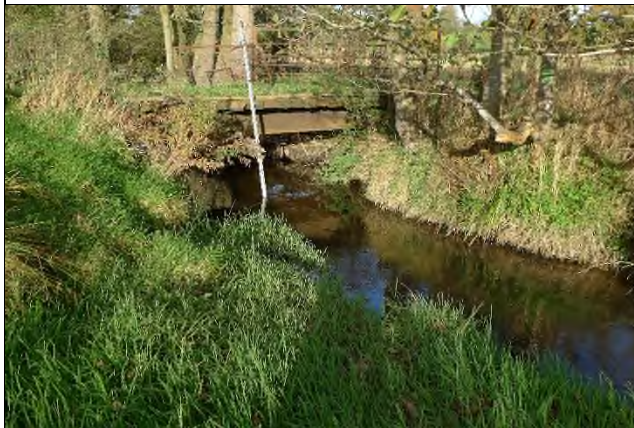
**C17.** Flow gauging point 2, upstream side of footbridge [view looking downstream].

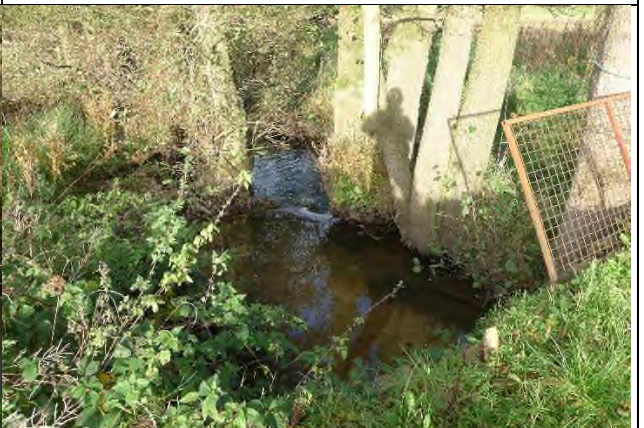
**C18.** Trees blocking stream downstream of footbridge.

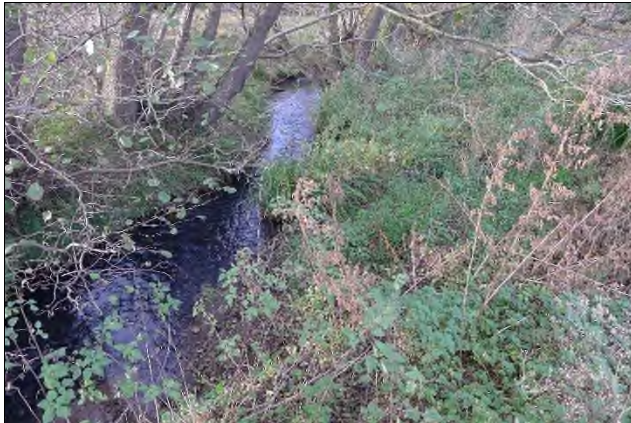
**C19.** Emral Brook and Inlet from old millrace overflow channel, fed by spring

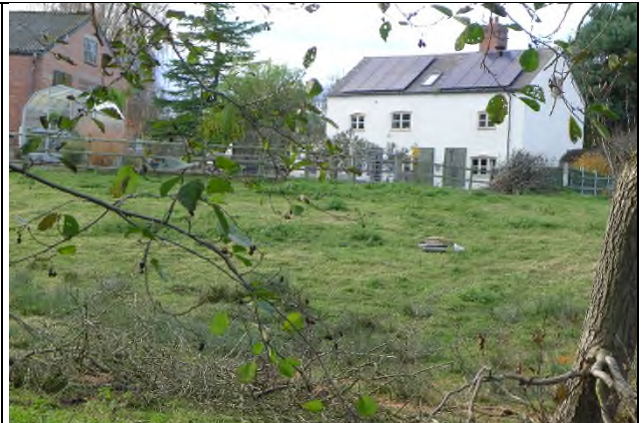
**C20.** Lion Lane Farm and well at edge of floodplain [Left margin of Emral Brook in the foreground].

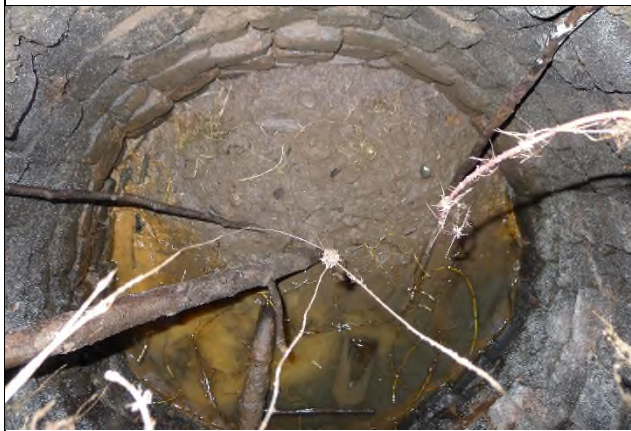
**C21.** Interior of well at Lion Lane Farm [full of earth, with small patch of water to one side].

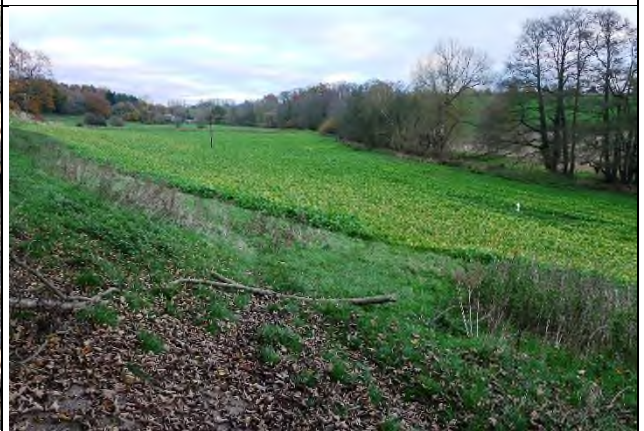
**C22.** Floodplain south of Llanerch Panna, with white marker at site of old well.

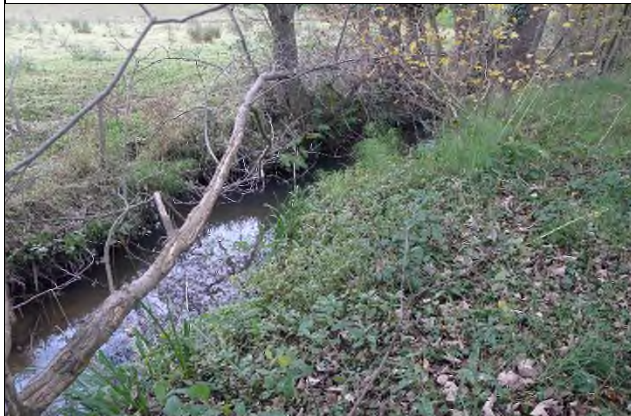
**C23.** Narrowing of stream channel at site of old millrace diversion weir [view downstream].

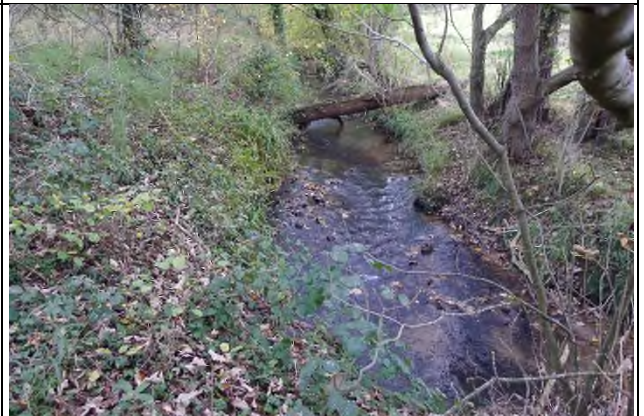
**C24.** Wider stream channel upstream of site of old millrace diversion weir [view upstream]
