# **Arboricultural Constraints Appraisal**

in Relation to Proposed Construction of Four Sub-Stations at

**Net World Sports, Bryn Lane,  
Wrexham, Denbighshire, LL13 9UT**

**Title:**  
**TREE CONSTRAINTS PLAN**  
In Relation to Proposed Construction of Four Sub-Stations

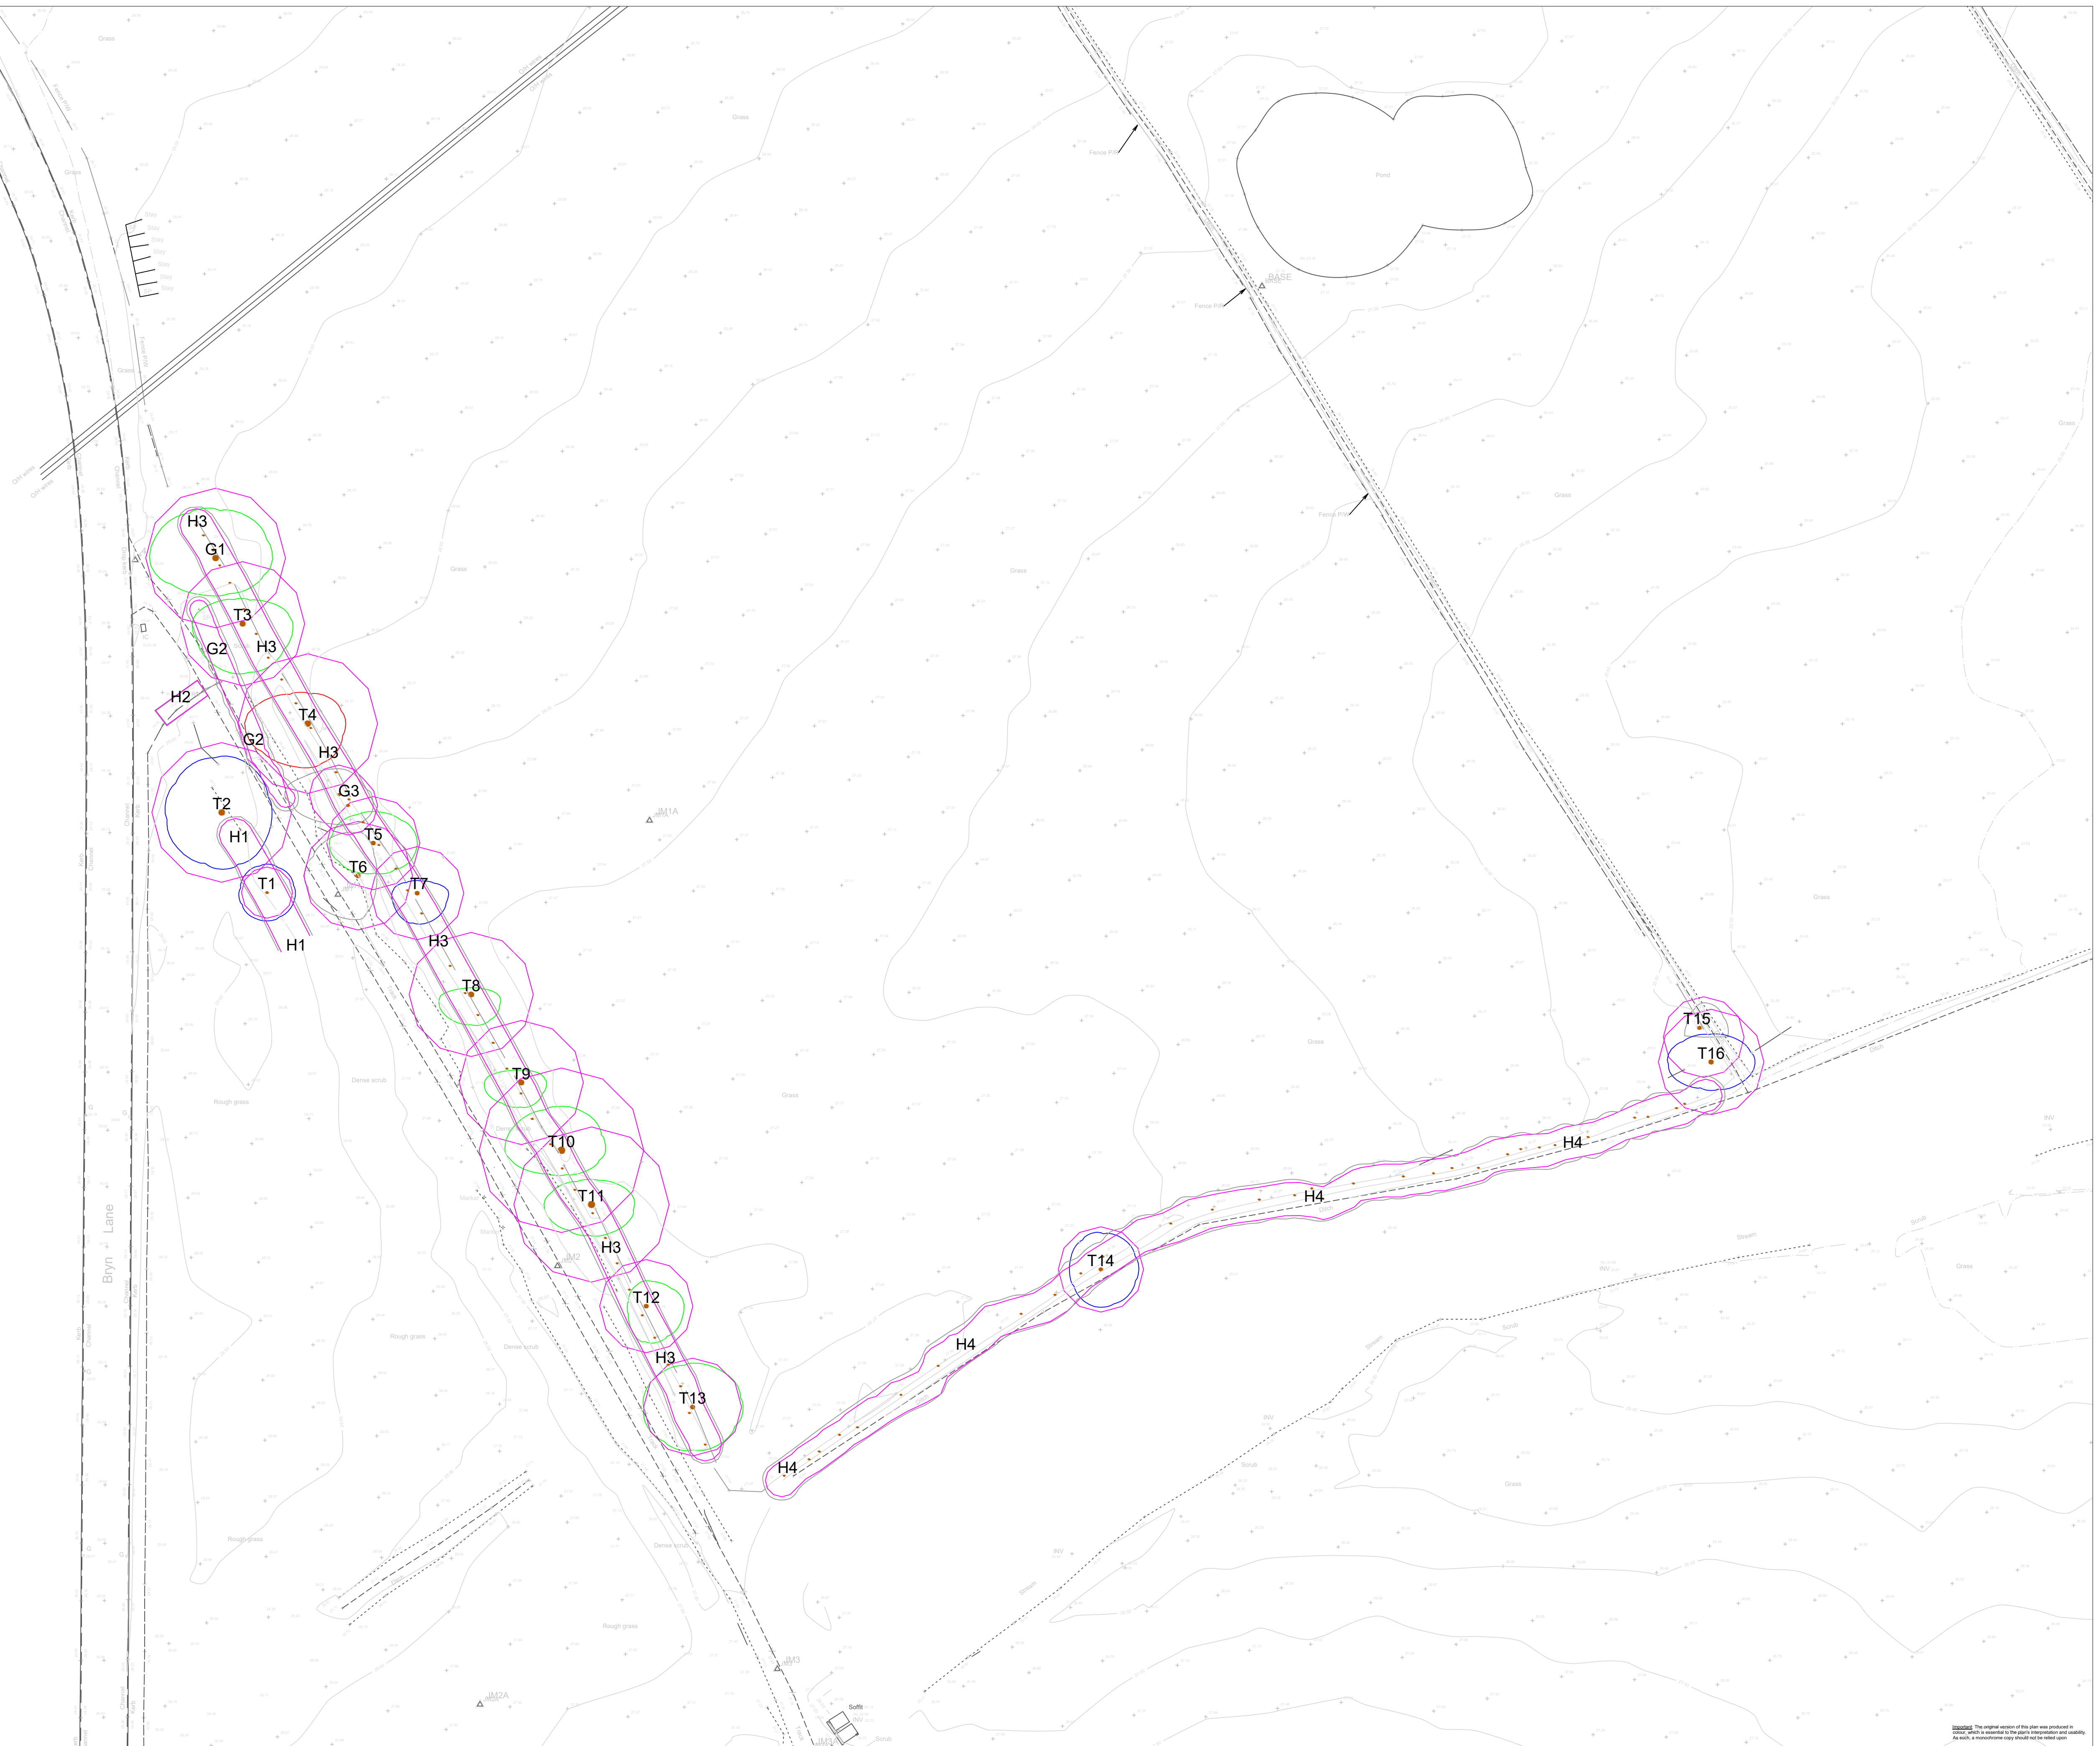
Note: The locations of trees T1, T3, T15 and T16 and group G2 and hedges H1, H2 and H3 were not included on the topographical survey plan provided, and were subsequently added to the information at the time of the survey using GPS and, where possible, measured from existing site features. As such, the locations of these trees and the locations and extents of these groups and hedges cannot therefore be considered to be entirely accurate.
