**STRUCTURAL REPORT**  
**ON**

**BLAENAU UCHAF , FRONCYSYLLTE , LLANGOLLEN,**  
**LL20 7RY**

**ALPHA – CHARTERED SURVEYORS**  
**FIELDS FARM, HORTON**  
**WEM, SHROPSHIRE**  
**SY4 5ND**  
**TEL 01939 234849**  
**[www.alphacharteredsurveyors.co.uk](http://www.alphacharteredsurveyors.co.uk)**

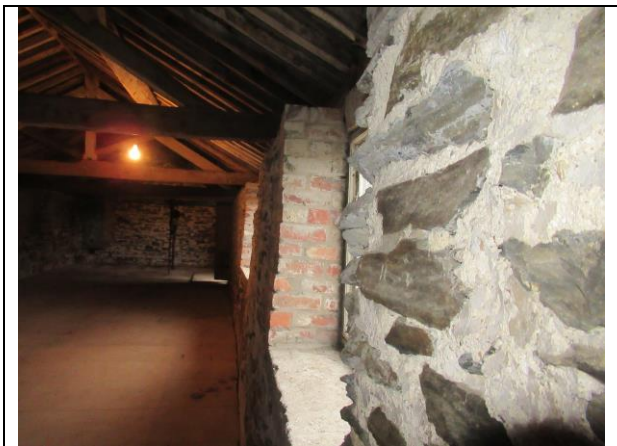
There is evidence of slight bowing to the front elevation (west). The bowing and distortion was considered to be slight, given the age and type of property, and no recent or significant movement was noted at the time of our inspection. During conversion providing adequate support and connection of the roof to the walls will be necessary.

| Slight bowing to wall. | Interior. |

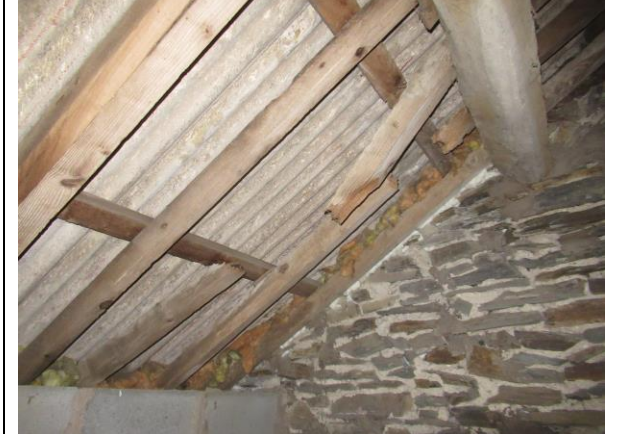
The roof covering will require renewal in conjunction with conversion. The roof structure is currently adequate for the current covering. Slight deterioration and isolated damage to the rafters has occurred but this was not considered structurally significant.

| Example of minor rafter damage. | Example of slight stone damage. |

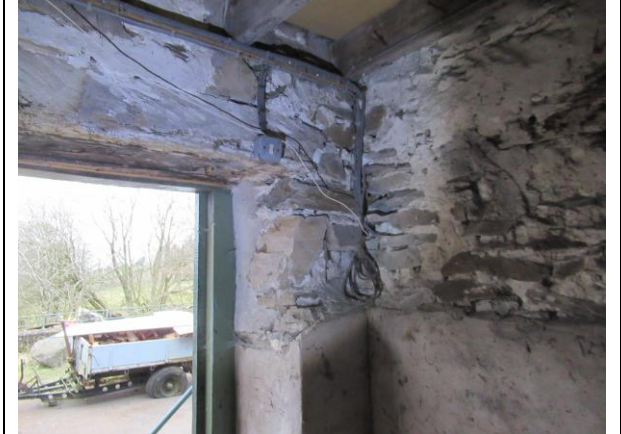
Internally there are very localised areas of the stonework which has become damaged and deteriorated but this is very minor and was not considered structurally significant.

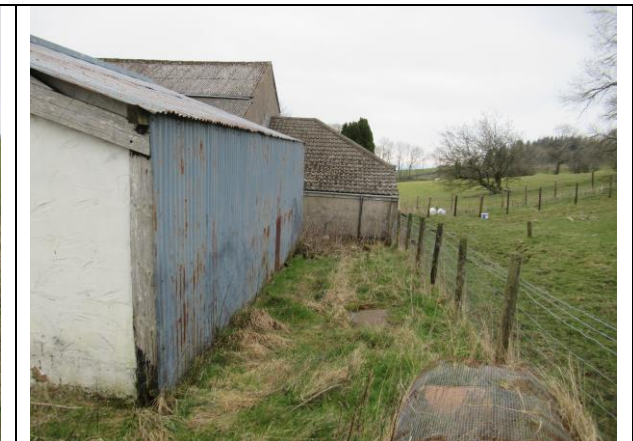
| Garage to East. | Rear wall clad with steel sheets. |

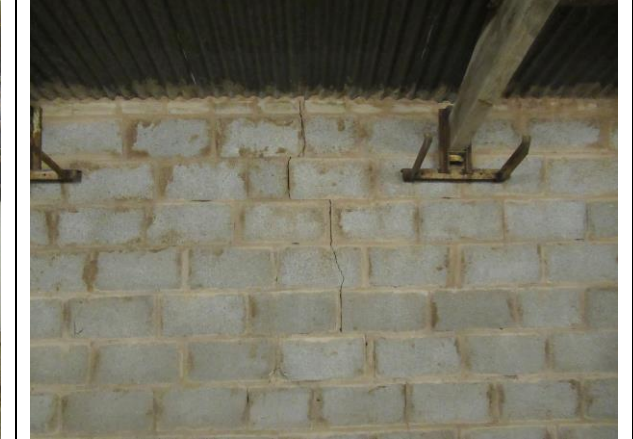
There is slight bowing, distortion and cracking to the north elevation of this building. This north section of this garage is a basic extension to the original structure. The north wall will require improvement or rebuilding.

| Internal view. | Crack to rear wall. |
