REF: 2520/PB/RepLet/mjs

25<sup>th</sup> May 2021

## **HILLCROFT, PENTRE BYCHAN: MINING INVESTIGATION**

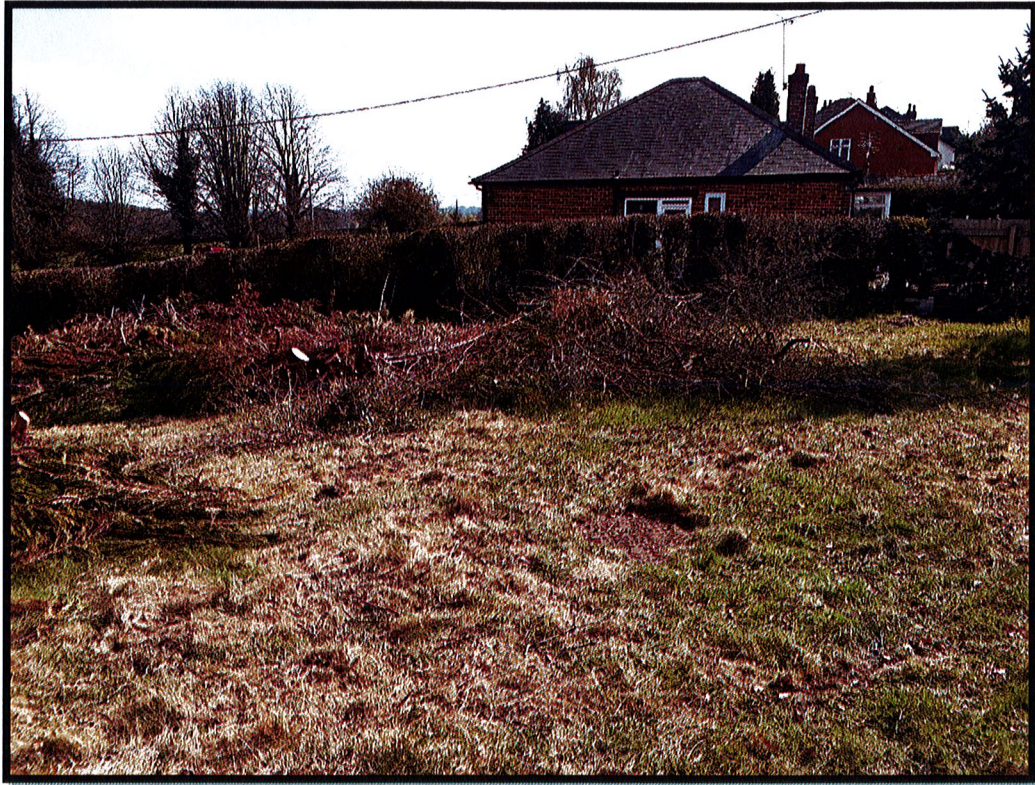
The location of the shaft was determined by a man hole cover on site, which was lifted and photographs taken, see below:

**Photograph 1: Showing manhole cover above shaft**

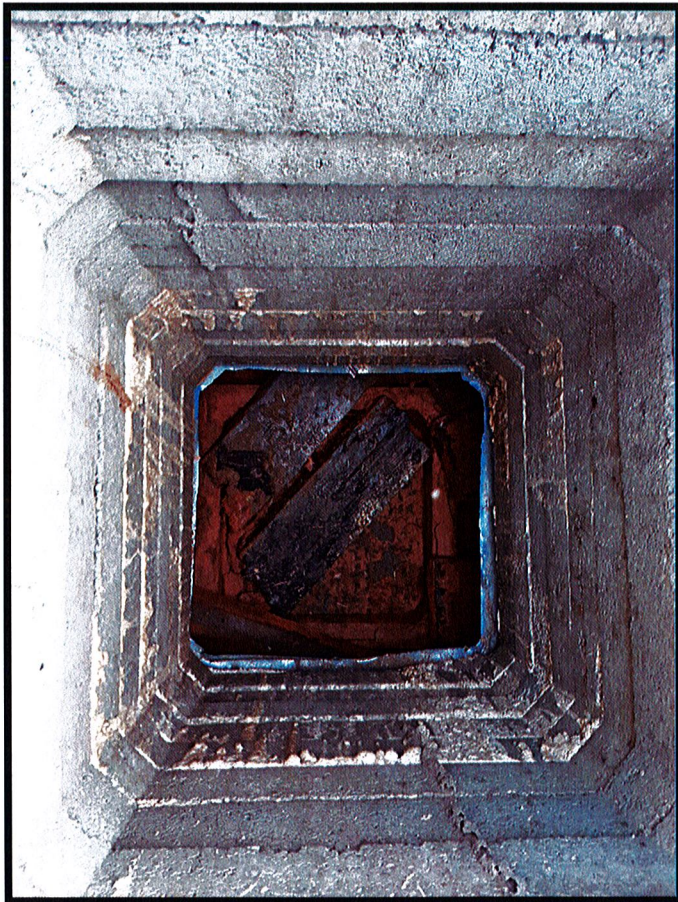
**Photograph 2: Looking down shaft manhole, dipped at 2.20m**

The previous desk study and site investigations have proved the shaft in the western section of the site to have been capped with a 6m by 6m diameter concrete cap, with an inspection chamber, see Photograph 2. However, the shaft cap has not been founded at rock head, with the dynamic probes adjacent to the shaft reaching refusal at a depth of around 11m.

There is therefore the possibility that the shaft backfill could settle with time, leaving a void beneath the shaft cap. However, the shaft will almost certainly have a brick/masonry liner to below rock head, as the ground conditions at depth comprise water bearing sand and gravel.

Therefore, if the shaft backfill settles it is unlikely to affect the site and the shaft cap will be supported off the liner. In any case, the manhole left above the shaft is a typical detail for such shafts, which haven't been drilled and grouted (CIRIA Report C758D, 2019), which allows the backfill to be monitored and topped up if required.

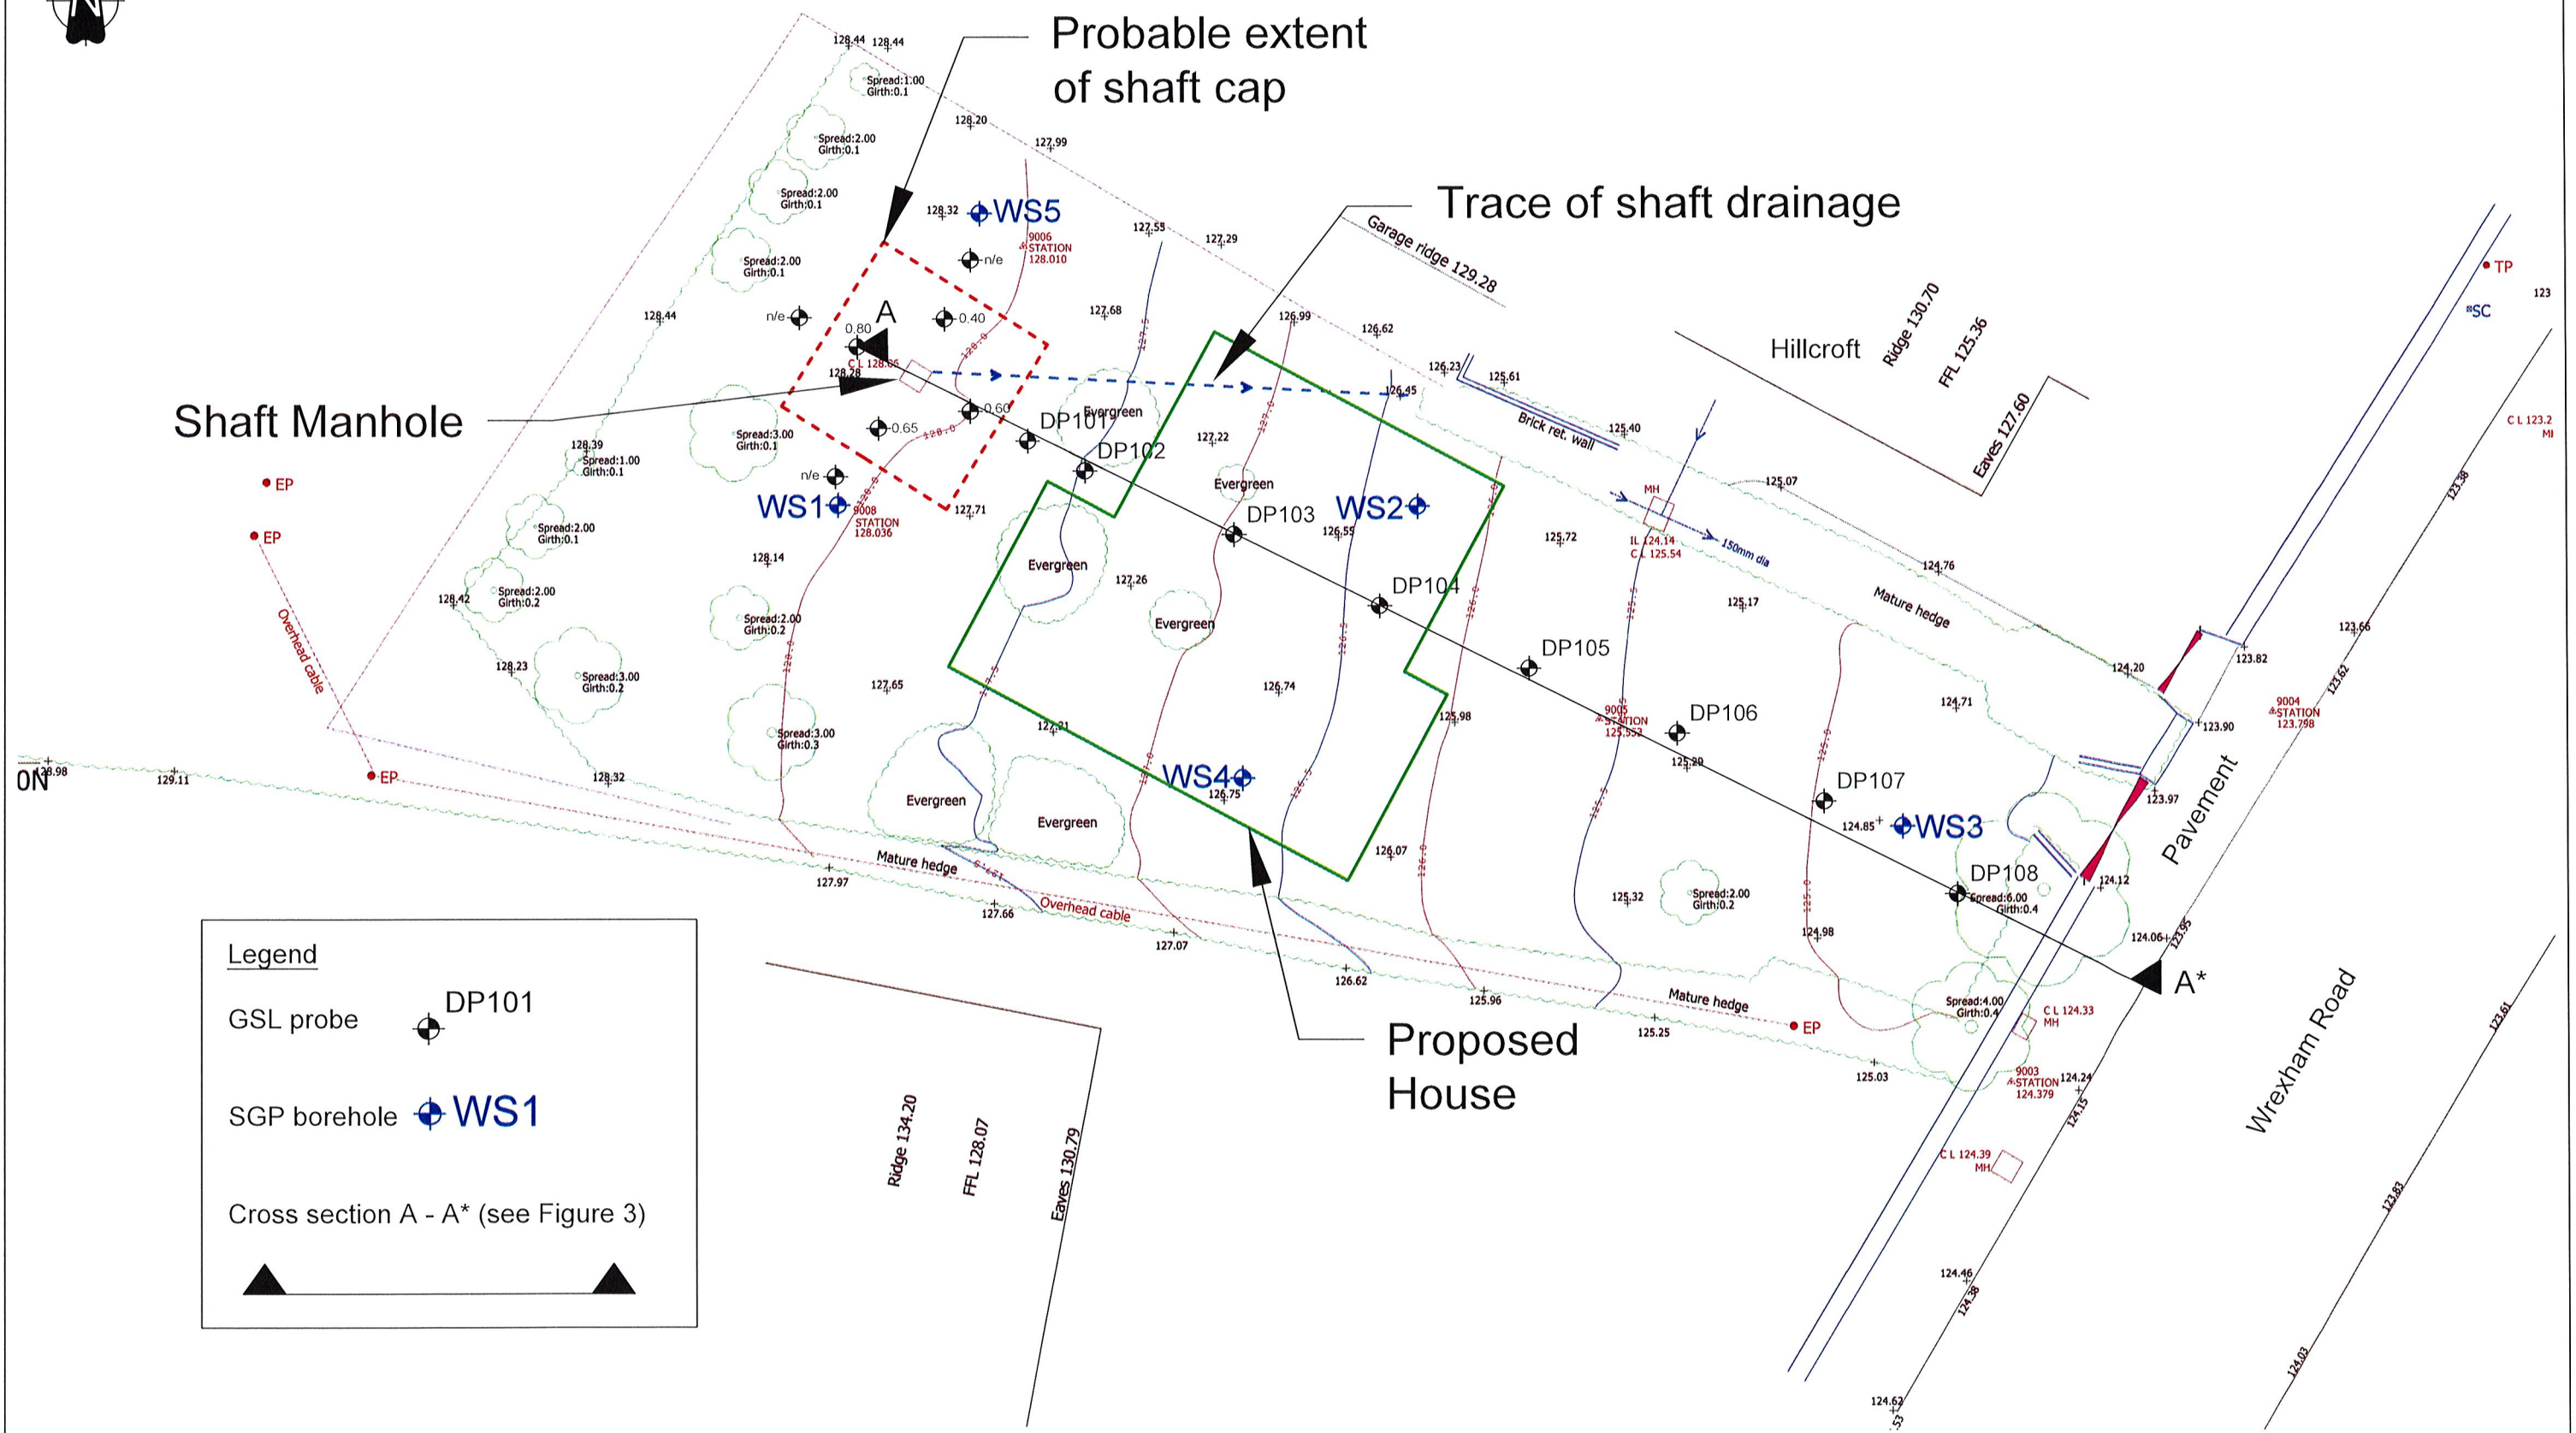
FIGURE 2

In this case, such an envelope would comprise the proposed house location, which is currently shown 2m away from the edge of the cap, and therefore only 3.5m away from the shaft itself, see Figure 2.

Site Layout &  
Exploratory Hole  
Location Plan

In conclusion, the location of the house in relation to the shaft requires piled foundations, however, if the house location was moved closer to Wrexham Road, then the foundation option could probably be changed to a raft foundation, designed to span potential voids of 3m and cantilever 1.5m at its edge.

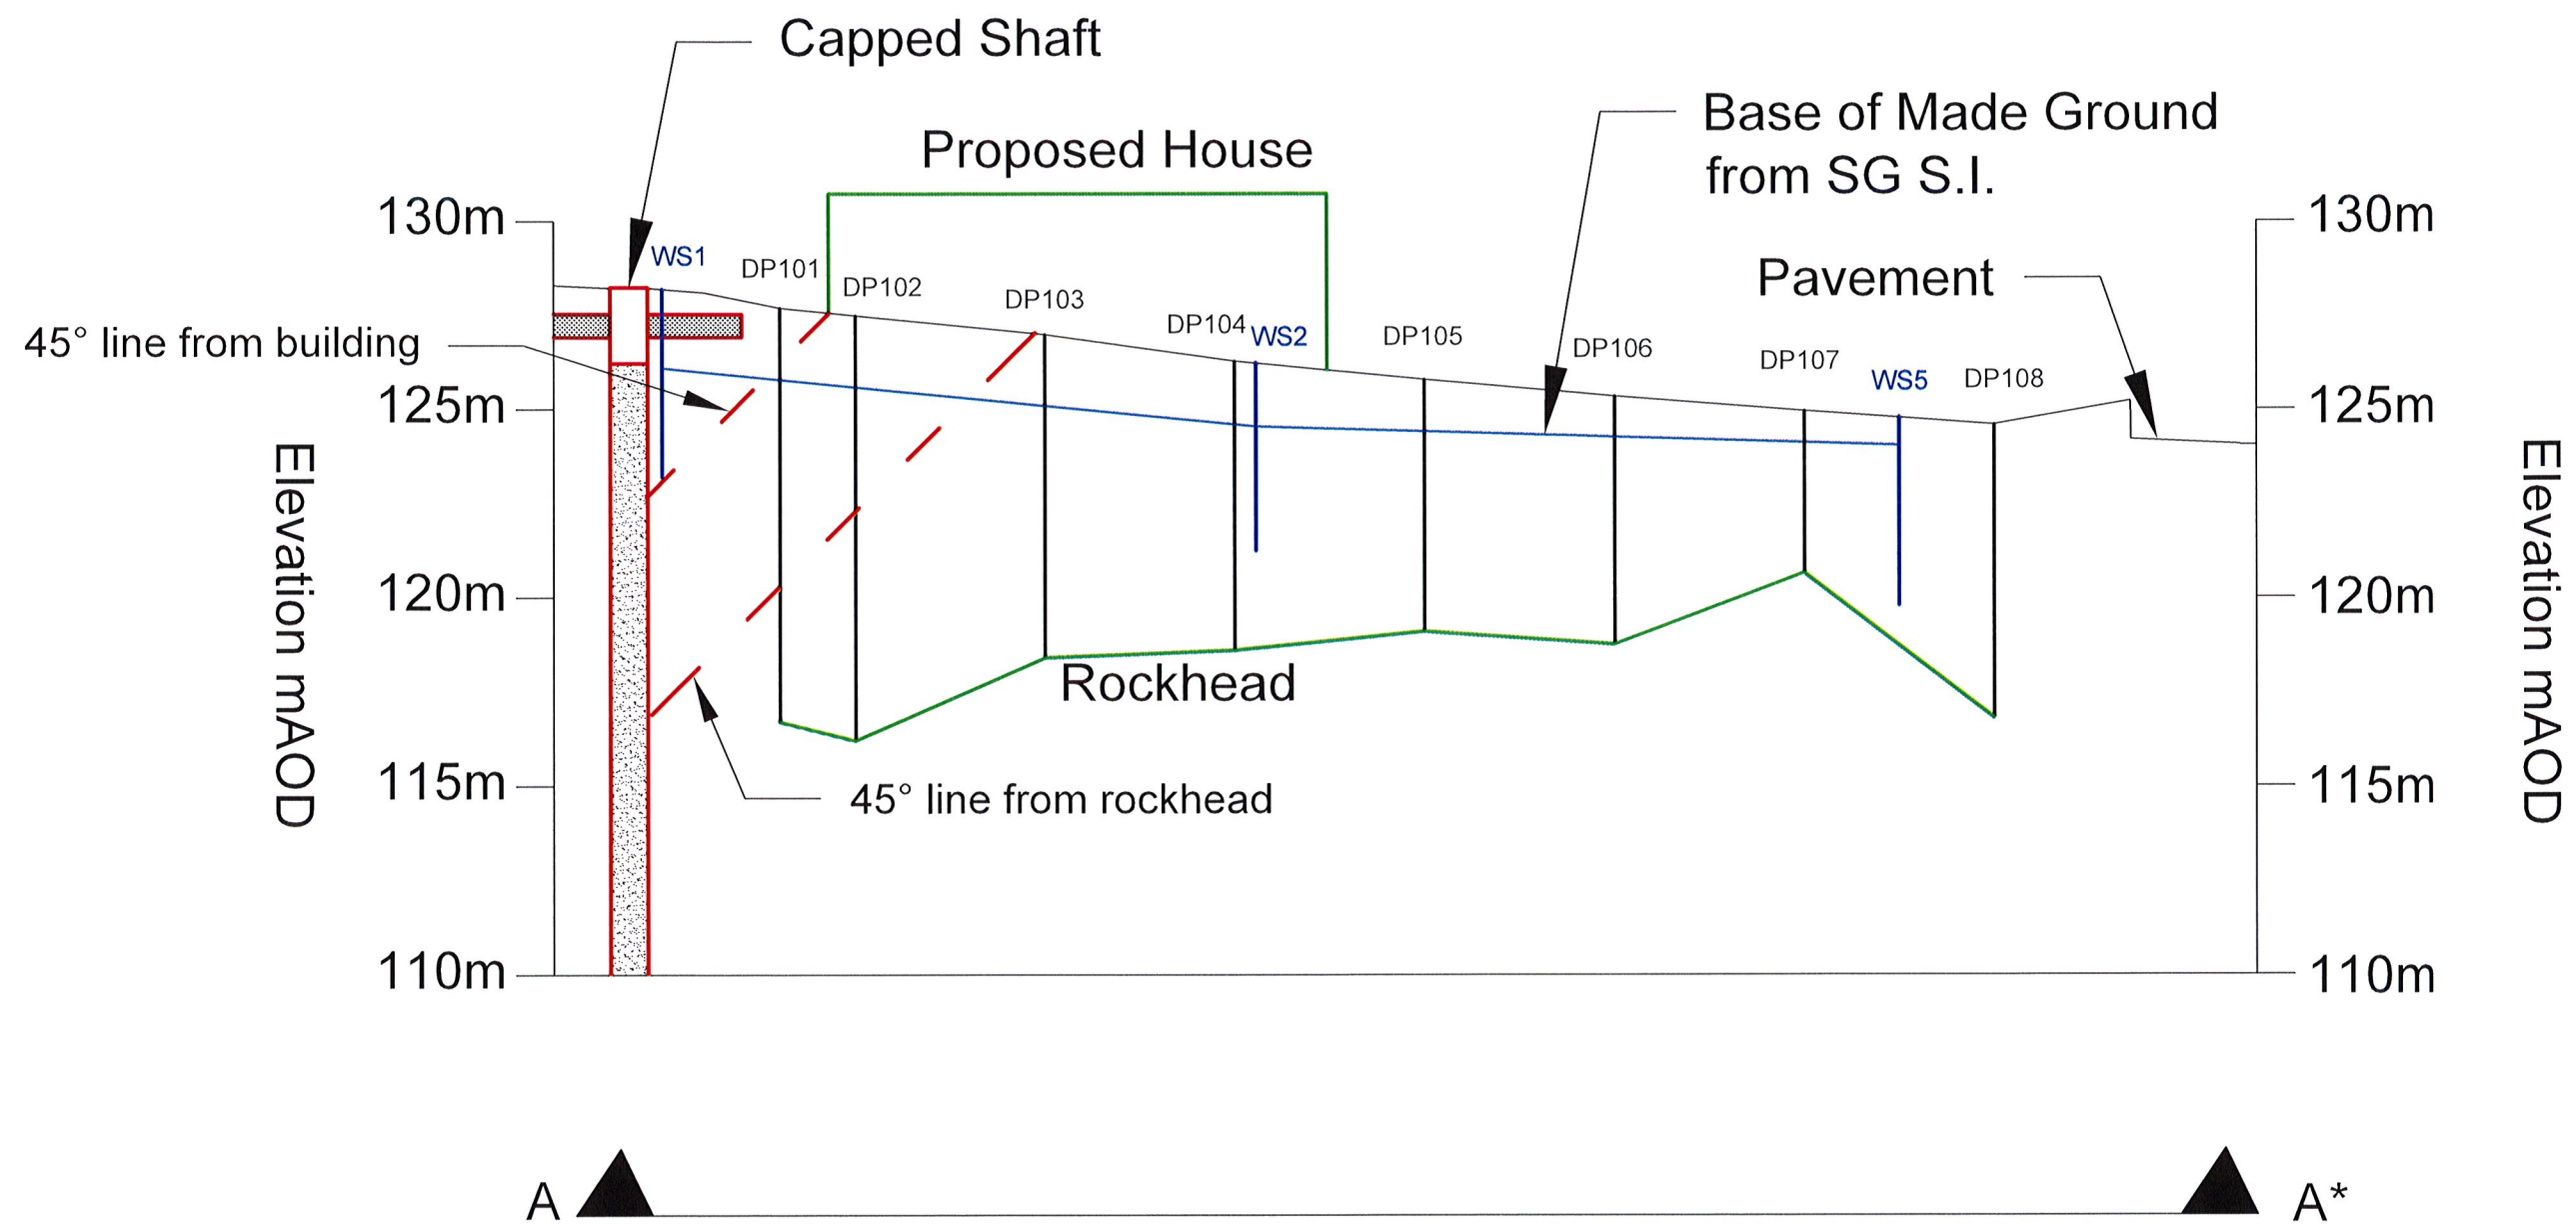
FIGURE 3

A cross section of the site has been produced, showing the indicative bedrock profile, and depth of shaft cap, proven by the dynamic probing, see Figure 3. In addition, the shaft cap is shown in relation to the proposed development location.

Whilst such piles would probably get the required working loads before reaching bedrock, the proximity to the shaft means that taking a 45° line from rockhead the piles would still need to be taken to bedrock, see Figure 3.

Cross Section  
A - A\*

To satisfy the Coal Authority any foundation solution will have to avoid surcharging the top of the shaft cap. This would mean that piled foundations would be required taken down to the underlying bedrock at depths of around 11.0m, reinforced concrete ground beams would then be required to span between the piles.

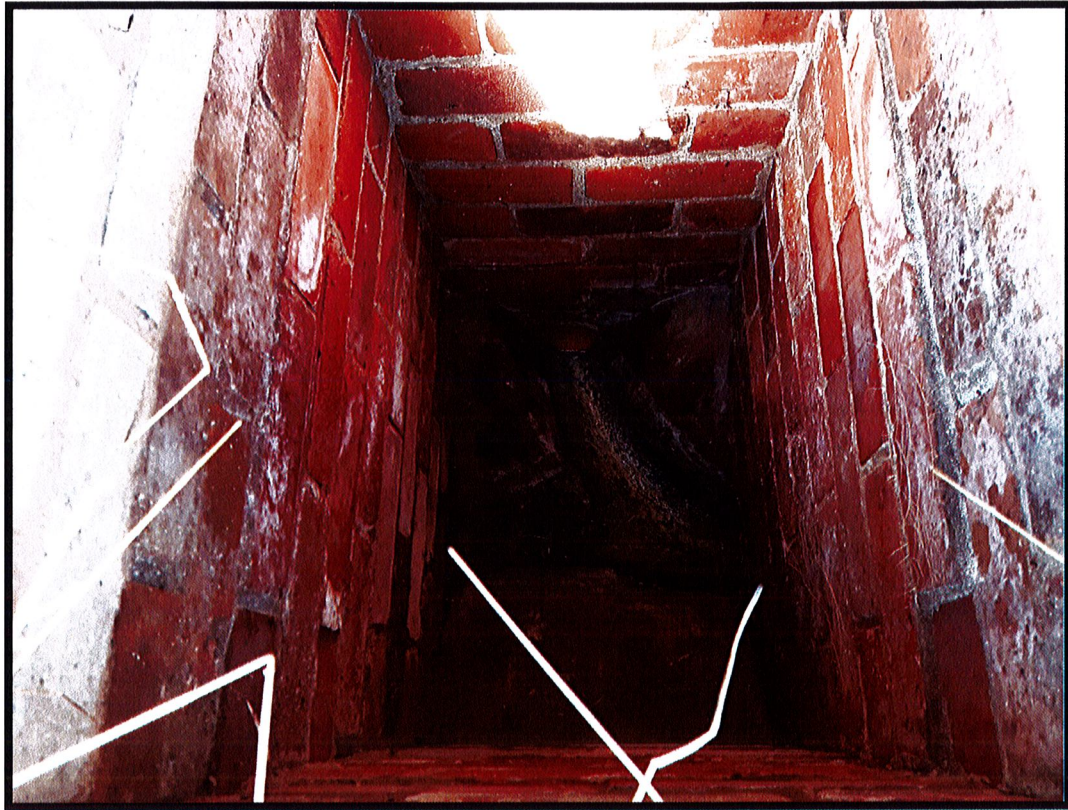
**Photograph 3. Manhole chamber for shaft drainage.**

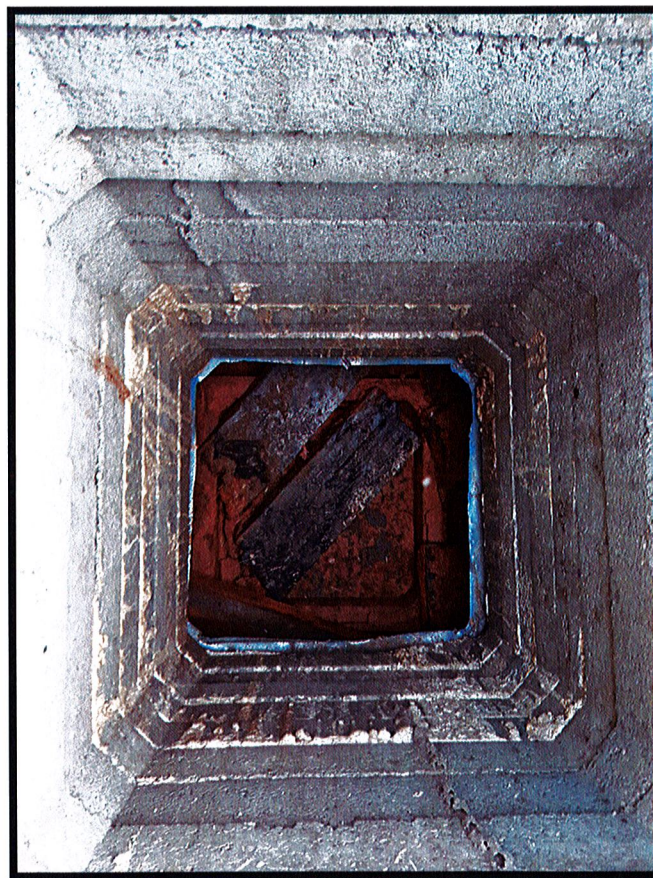
**Photograph 4. Shaft inspection chamber (2.00m deep).**
