19<sup>th</sup> May 2021

**RE: SPECIFIC DEFECT REPORT: STRUCTURAL REPORT ON BARN AT  
MIDDLEWOOD FARM.**

## STRUCTURAL REPORT ON BARN AT MIDDLEWOOD FARM.

Barn at,  
Middlewood Farm,  
Sarn Road,  
Threapwood,  
SY14 7AW.

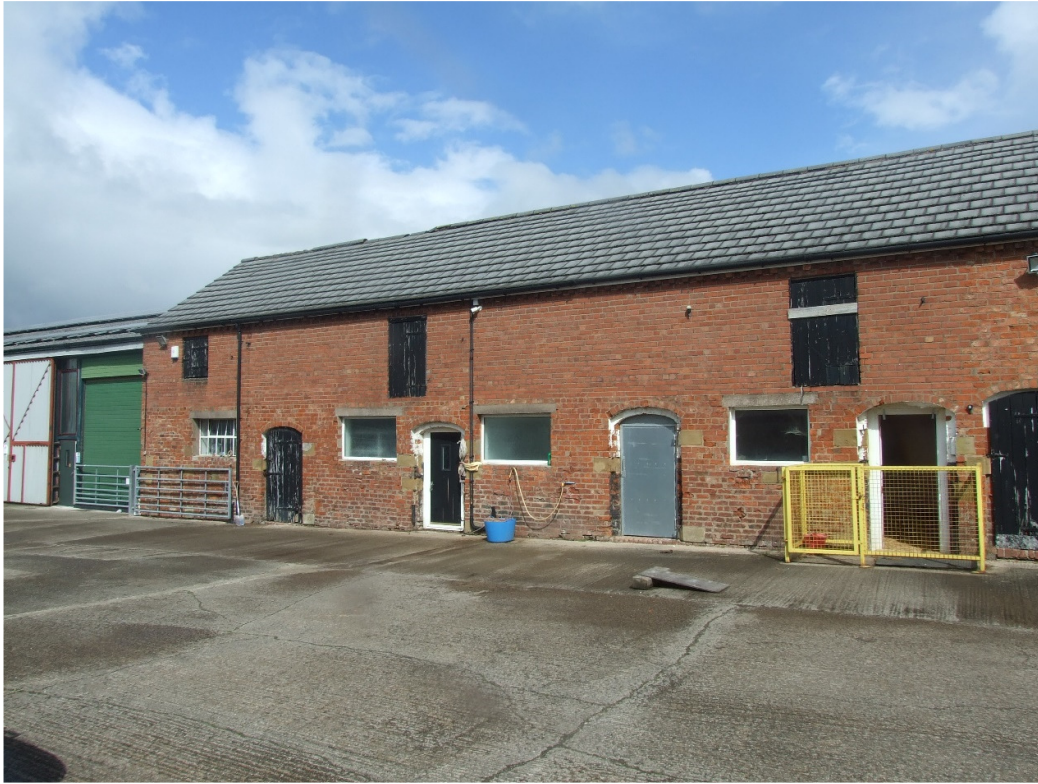
Courtyard elevation.

- E.2.1 COURTYARD ELEVATION: The elevation is 330mm to ground floor and 225mm to first floor with concrete lintels being provided

- E.2.2 The pointing was weathered in places to the elevation and a small amount of spalling was noted.
- E.2.3 Impact damage was noted to the far left of the elevation. This took the form of minor cracking and some new bricks have been added at the location of the damage.

- F.1.2 FRONT ELEVATION: No major issues, normal thermal upgrade required internally and some aesthetic repair externally.
- F.1.3 LEFT ELEVATION: No major issues, normal thermal upgrade required internally. Some aesthetic rebuilding due to impact damage and cracking. (Past repair noted)
- F.2 NEW INTERNAL WALLS: The new walls will be constructed off a new engineered designed inner raft/slab. This will have the effect of removing all loads off the existing external envelope.
- F.2.1 The new roof and floor loads will be supported of inner block walls constructed of the new raft. The existing foundations/walls can also be supported on the raft with 20mm reinforcement bars drilled in at 400mm centres set within the raft's reinforcement

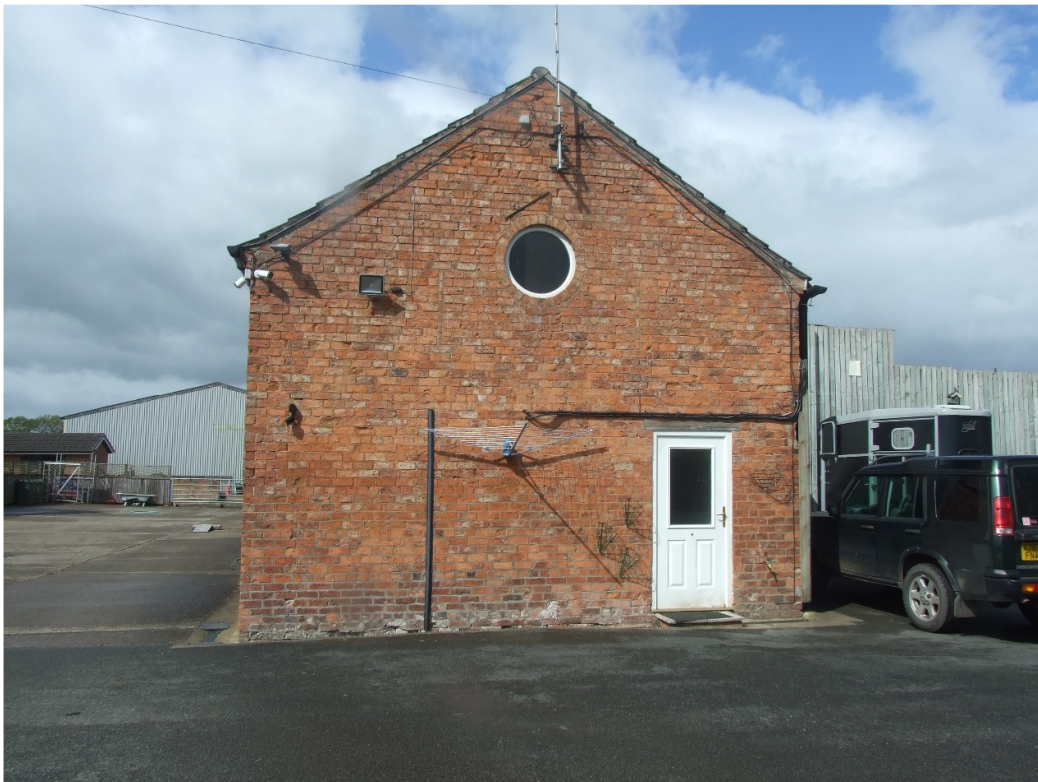
Right elevation

- E.2.6 RIGHT GABLE ELEVATION: This gable was again noted to be 330mm and 225mm and was of English garden wall bond, minor spalling but no major defects.

- F.1 EXISTING WALLS:
  - RIGHT ELEVATION: No major issues, normal thermal upgrade required internally and some aesthetic repair externally.
- F.1.1 REAR ELEVATION: No major issues, normal thermal upgrade required internally and some aesthetic repair externally. Adjacent barn to be removed.

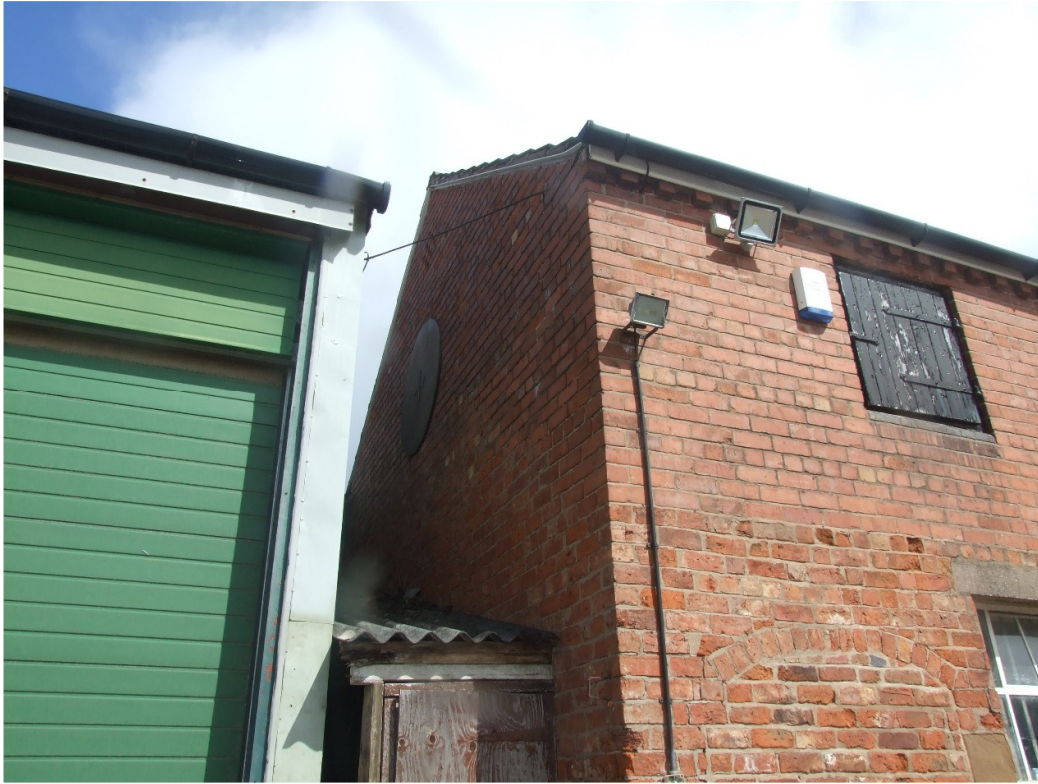
Left elevation.

- E.2.4 LEFT GABLE ELEVATION: This gable was partially concealed by the adjacent barn but when checked no major issues noted. The damage to front elevation was also noted to the right corner of the elevation.

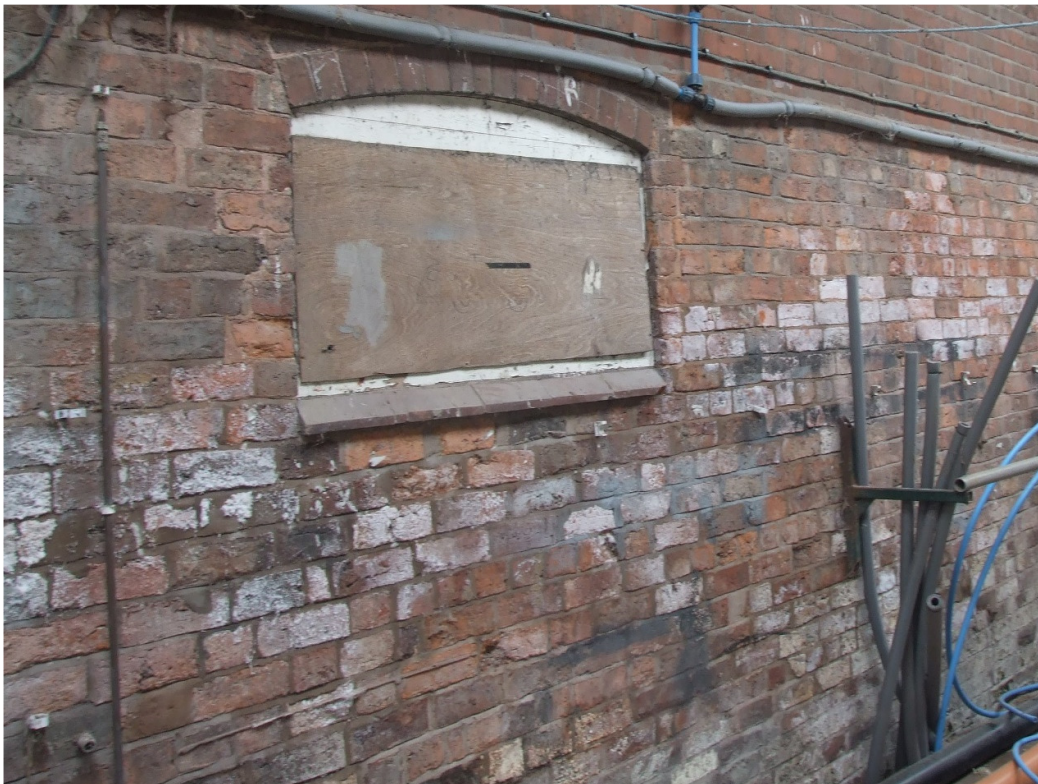
Rear elevation within adjacent barn.

- E.2.5 REAR ELEVATION: The rear elevation is concealed within an adjacent barn that is to be removed. When inspected there was no signs of movement, cracking or bowing.

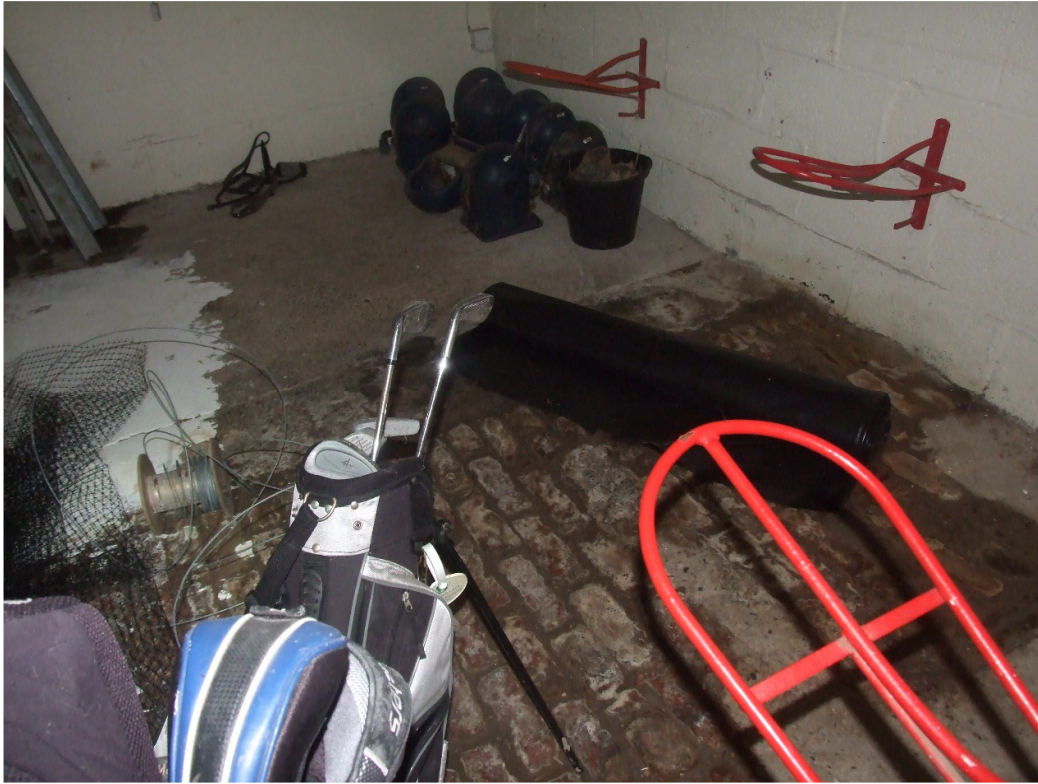
- E.2.7 All walls will need to be upgraded thermally internally to meet current thermal standards.
- E.3 GROUND FLOOR: This floor was of concrete and brick. The floor was uneven and would require to be excavated and reinstated in any conversion to comply with thermal requirements.

Brick and concrete ground floor

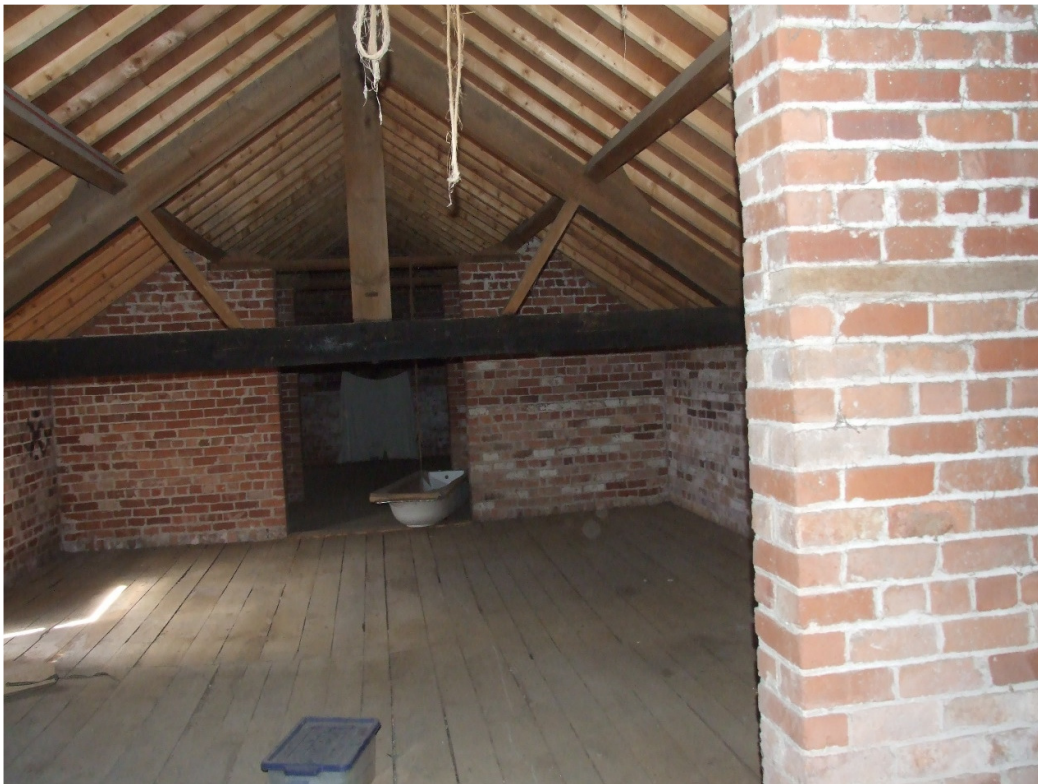
- E.3.1 FIRST FLOOR: The first floor is of suspended timber and has been affected by some rot and woodworm. This floor again would need to be removed and reinstated to comply with current loading, sound proofing and fire rating requirements.

First floor timber floor and truss.

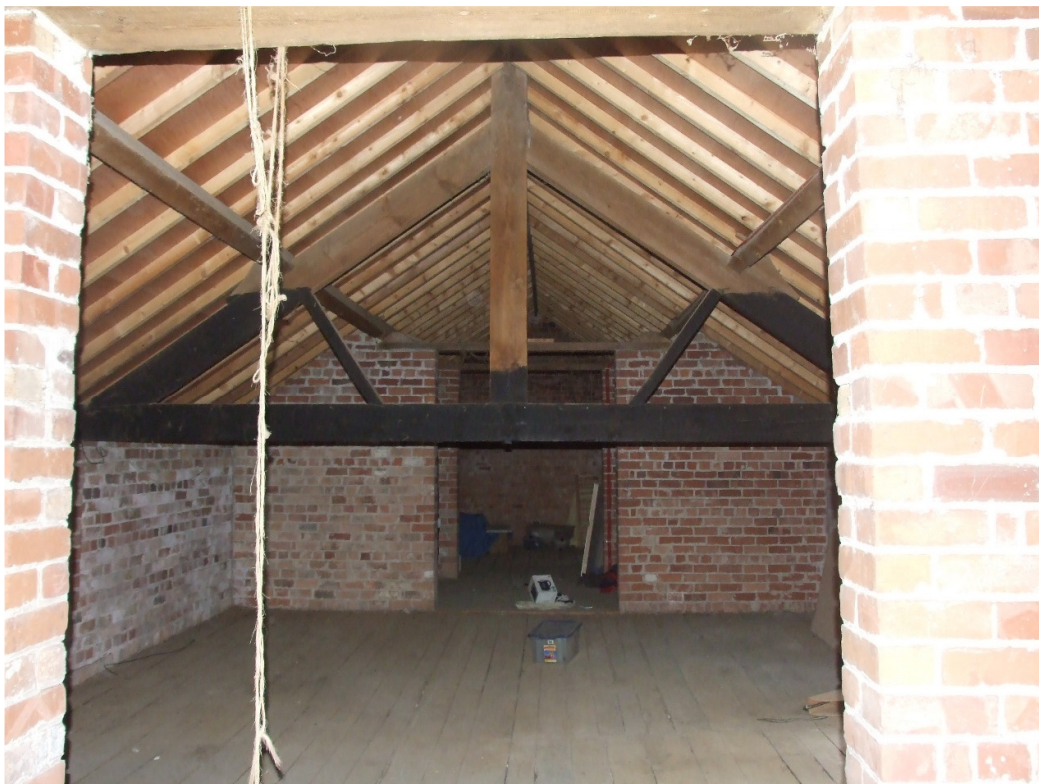
- E.1.2 The purlins are supported on gable ends and inner king post trusses.  
The trusses are in a fair condition.  
The original purlins can also be reused when treated and cleaned.

First floor internal, showing truss and walls along with rafters, purlins and sarking board.

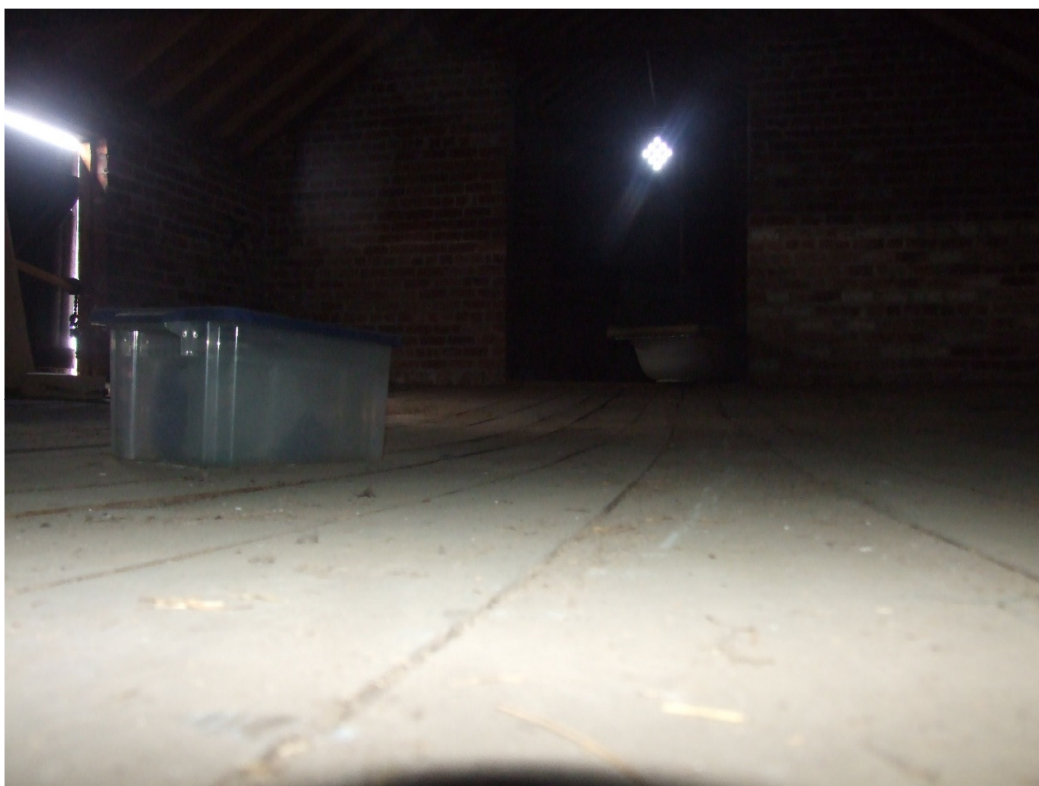
Slight sag in floor; joists and floor boards to be upgraded to comply with building regulations.

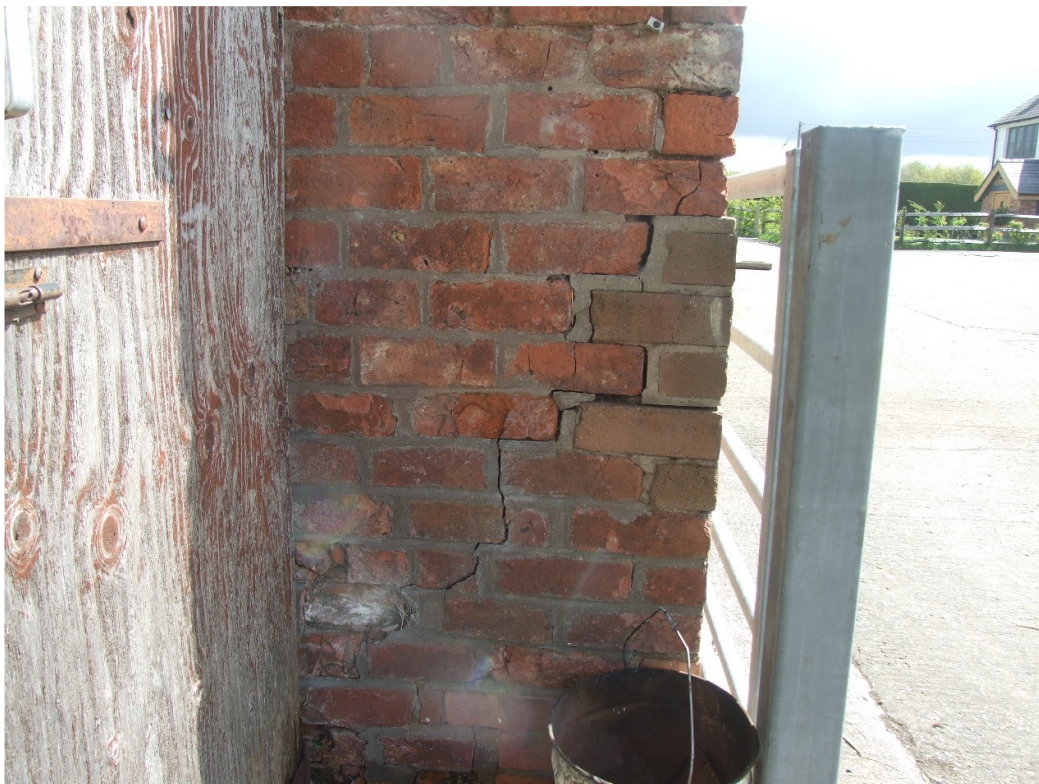
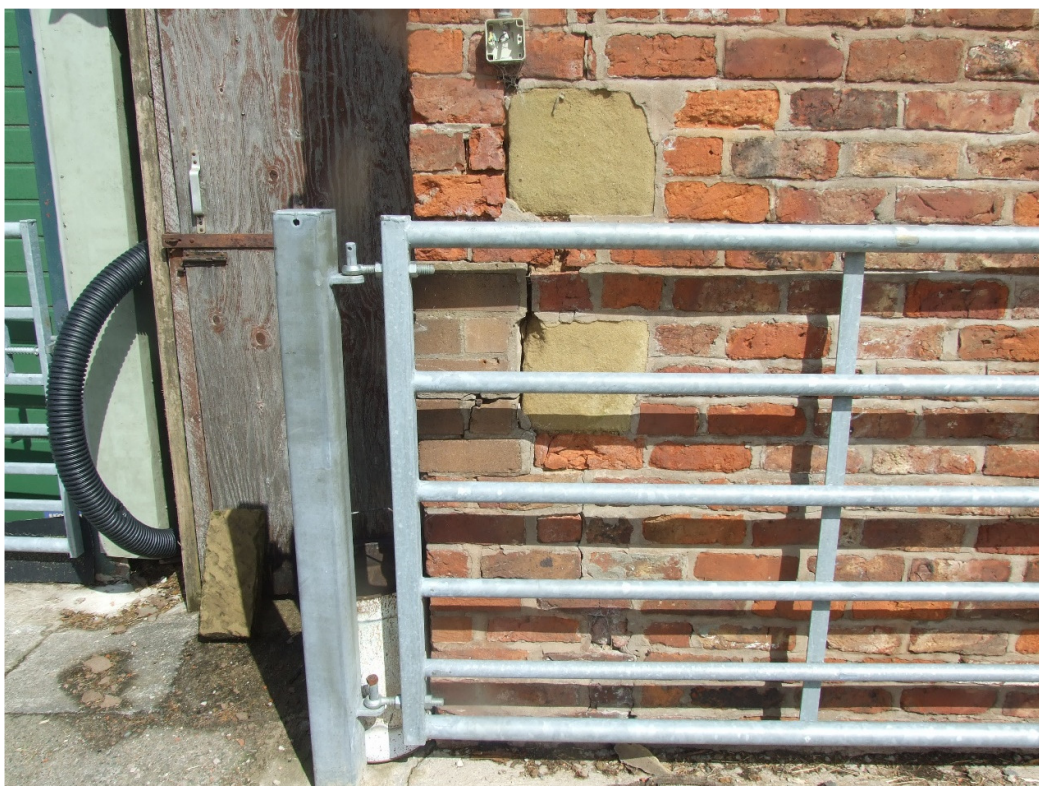
Minor damage to courtyard and left corner.
