# 8 Dispensary Row

## Heritage Impact Assessment and Design Access Statement

Rev A - January 2022

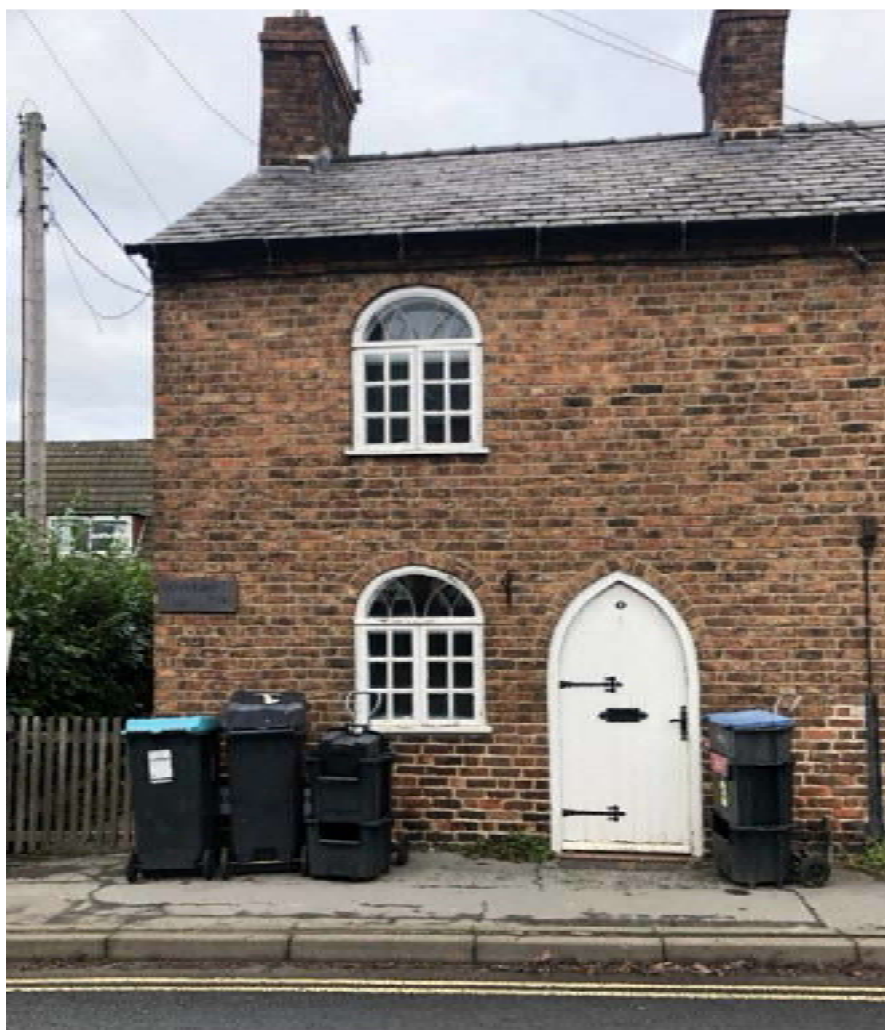
2

Front elevation

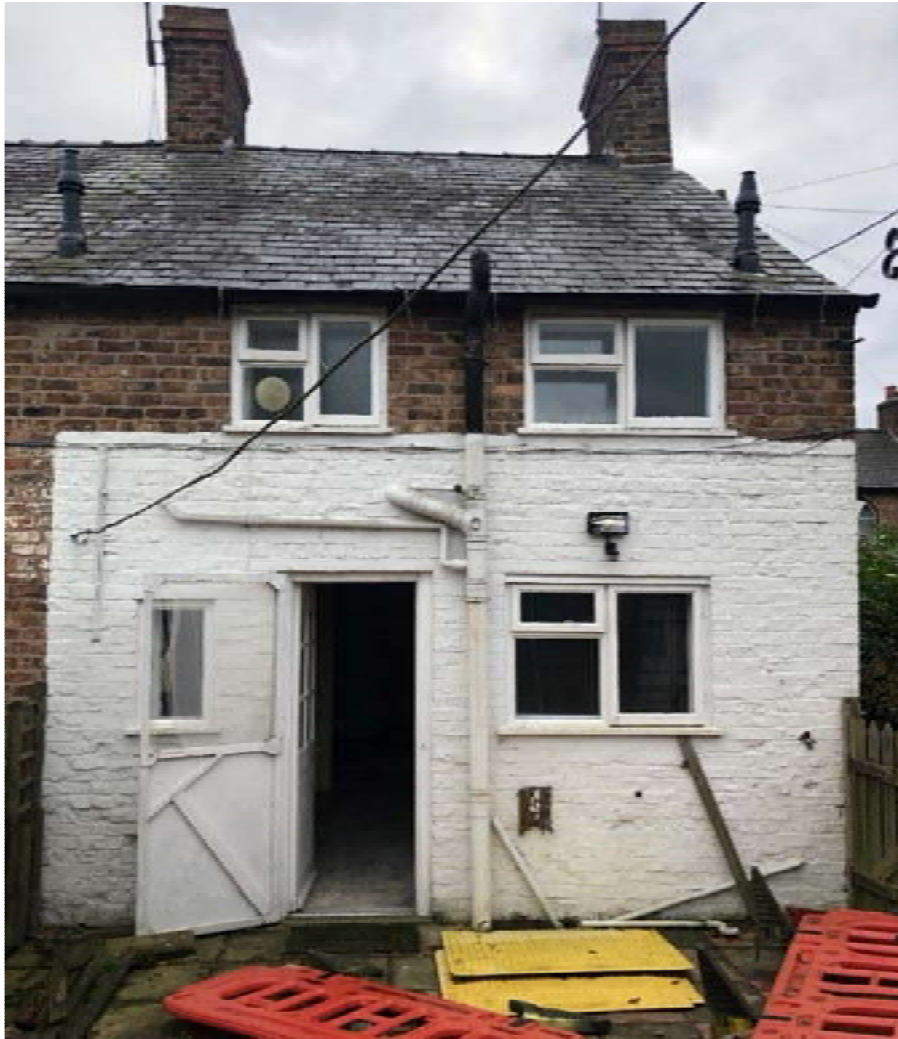
3

Rear Elevation

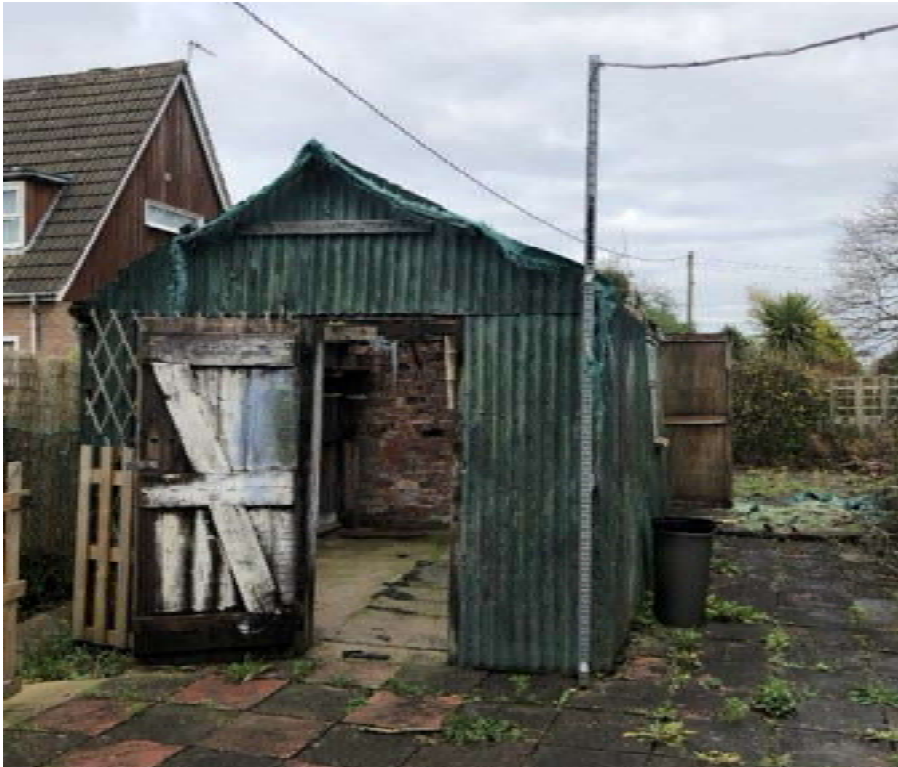
4

Outbuilding

The outbuilding's roof has recently been removed as it was suspected to have contained asbestos. A timber frame structure remains, clad in corrugated iron and the floor is poured concrete. To the rear of the outbuilding, a brick gable wall separates it from a smaller lean-to style storage building, which is of painted timber sheeting, a bituminous felt roof, and a mix of concrete flagstones and quarry-tiles.

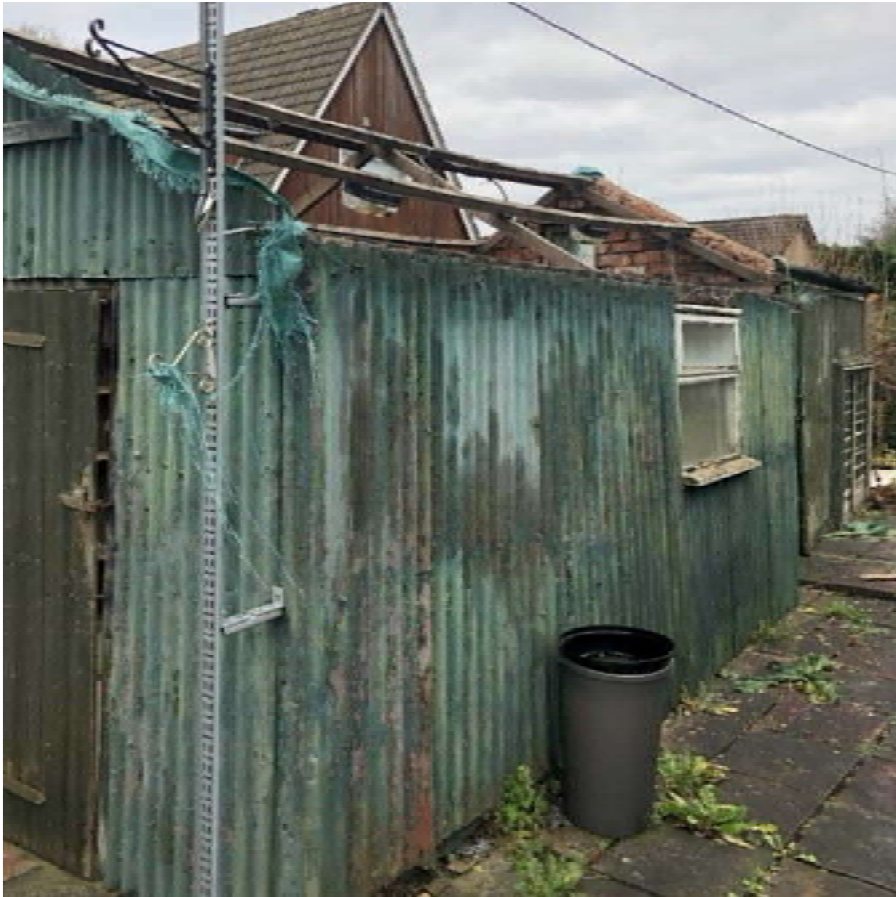
5

Outbuilding side

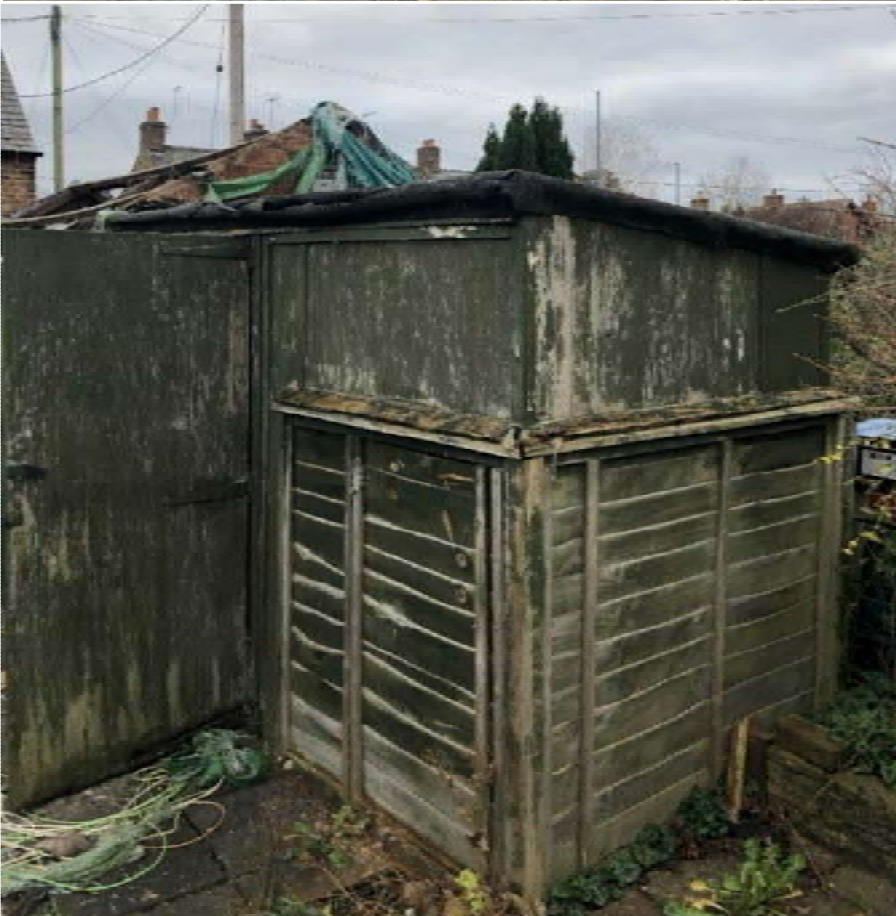
6

Rear of outbuilding

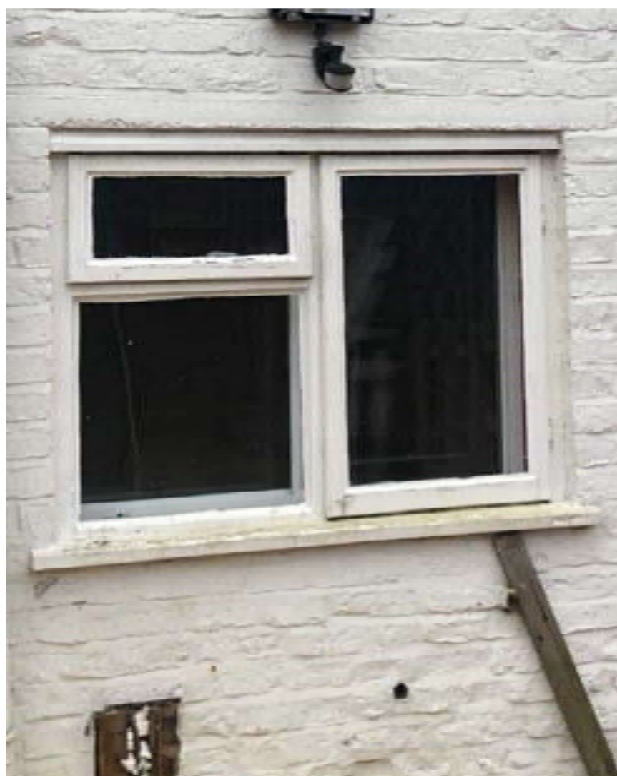
The existing single glazed timber framed windows to the rear of the property (see image 1 and 2 below) are proposed to be replaced with double glazed timber framed or uPVC windows, of the same or very similar size, style, and finish/appearance. The new windows will improve the thermal performance of the building, and the retention of the size/style of the windows will ensure overall visual impact will be extremely minor or negligible. Please refer to the Existing and Proposed Elevations and 3D Visuals submitted with this application.

Image 1: Existing ground floor window

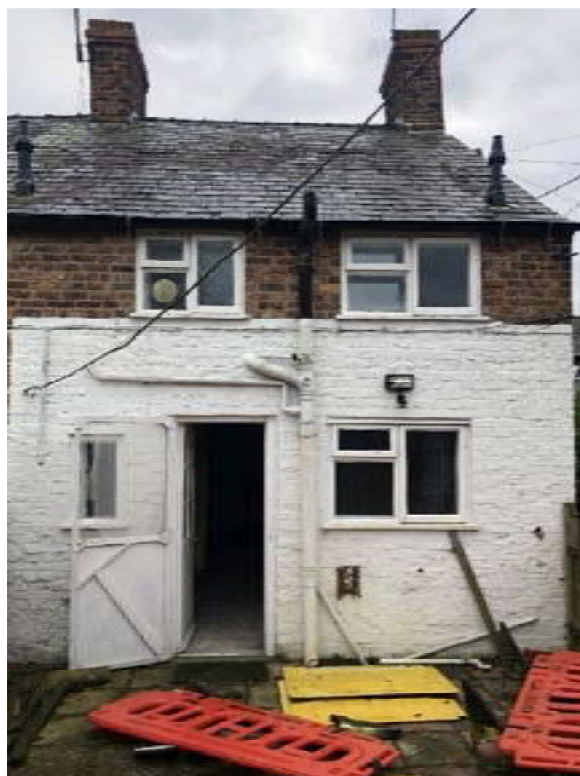
Image 2: Rear elevation

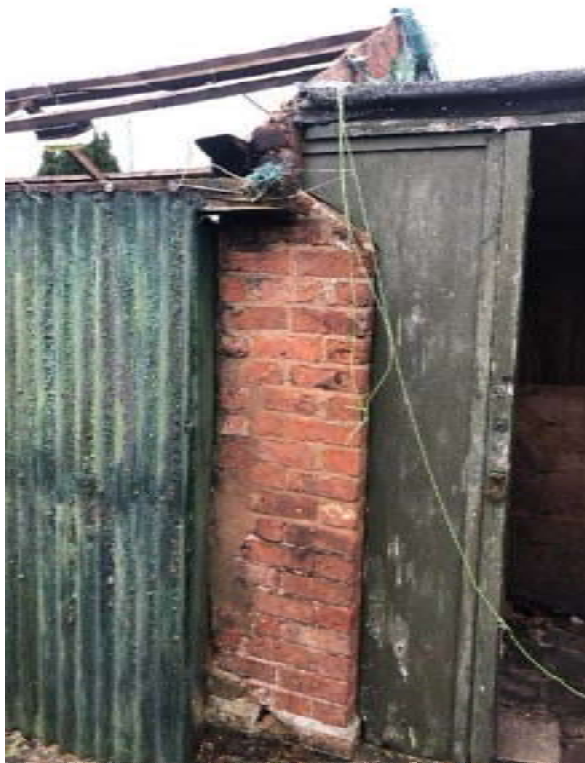
The outbuildings appear to have been constructed after the cottages, at least in part, due to the gable brick type mostly being of different composition, size and colour to the dwelling (see Figures 4, 5 below and 6, 7 overleaf). Corrugated iron sheets the weathering of the timber and iron cladding, along with the use of quarry-tiled threshold suggests their construction is not recent.

It is likely that the outbuildings were slightly later editions (possibly re-built, or built using re-purposed materials), and the current condition of the outbuildings is generally poor. The gable wall shows signs of subsidence/movement where cracks have appeared, which would need also addressing.

Figure 4: brick of outbuildings gable wall

- **Outbuilding brick dimensions: 215mm x 100mm x 65mm**
- **Dwelling brick dimensions: 230mm x 110mm x 70mm**

1. The wall is constructed from 9" brickwork with a 4" thick apex above. The apex incorporates a window.
2. Severe cracking 10-15mm wide is apparent at both ends of the wall with downwards runs in the bed joints at each end clearly apparent. The pattern of defects is indicative of significant settlement at each end of the wall.

3. The wall has been rebuilt or amended on several occasions in the past with different colours and qualities of brickwork used. The original brickwork shows evidence of widespread spalling to faces which is prevalent in brickwork of this age.

4. The additional inspection has confirmed my previous observations with regard to the condition of the wall. In order to ensure that the wall remains stable in the long term following removal of the timber framed sheds, extensive repairs will be required including partial reconstruction, underpinning and stitching. The costs involved in stabilising the wall will be significant and need to be set against the fact that this is a short length of wall which has no context. Therefore, I would reiterate my opinion that the wall should be demolished.

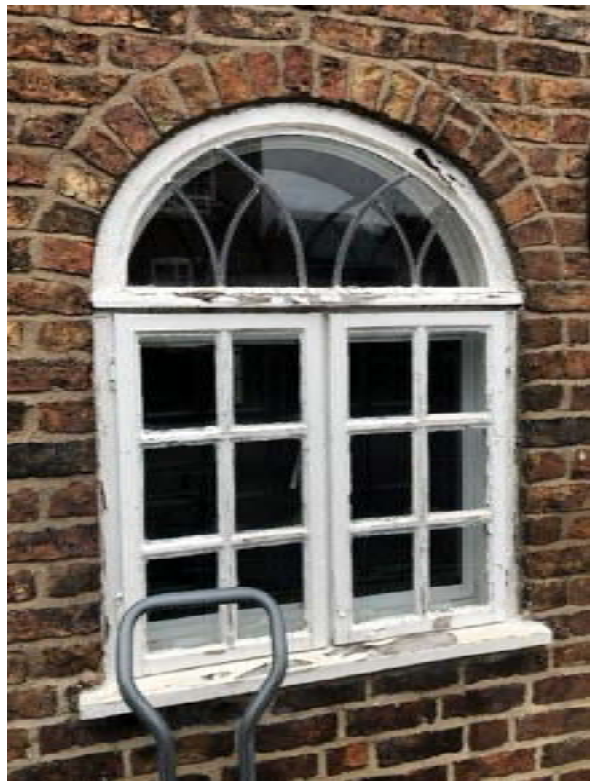
Figure 5: Bricks of no.8 Dispensary Row dwelling

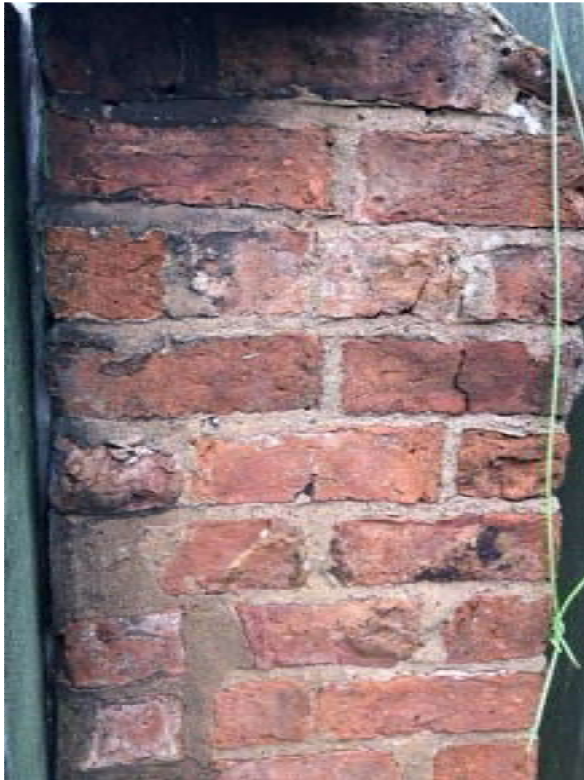
Figure 6: brick of outbuildings gable wall

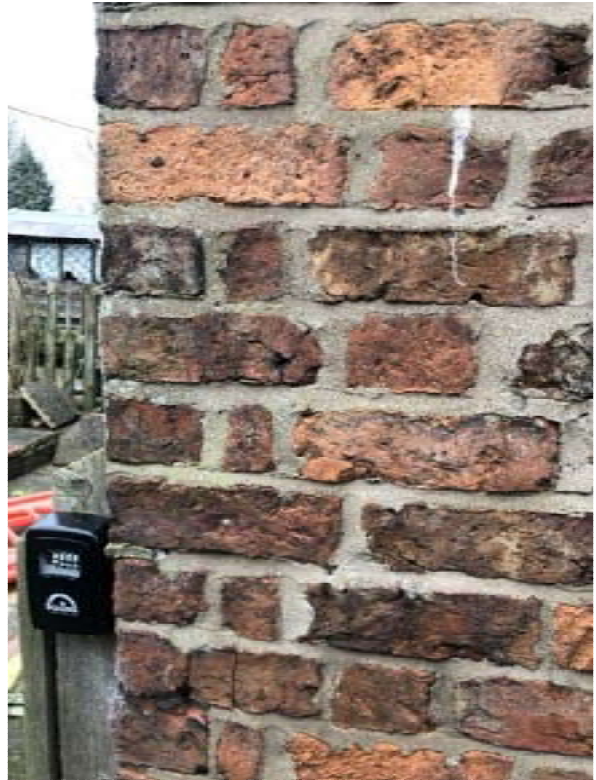
Figure 7: Bricks of no.8 Dispensary Row dwelling

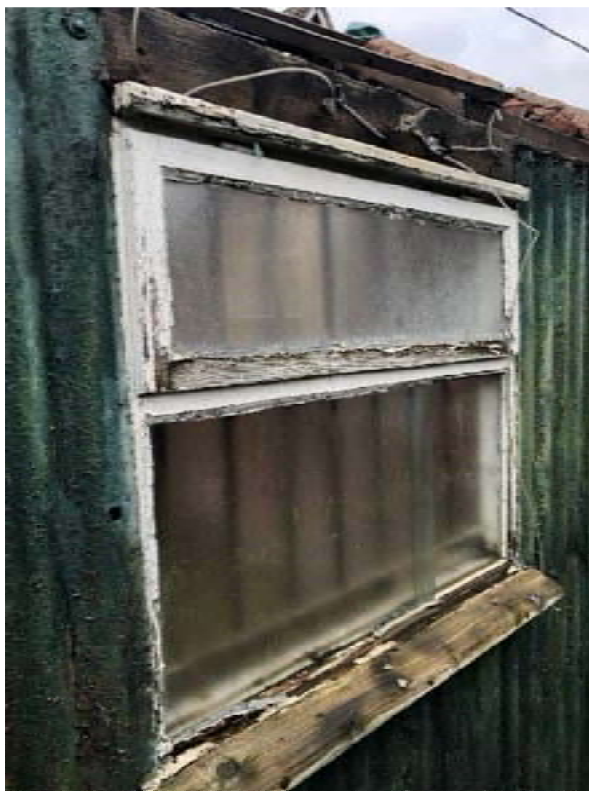
Window to outbuilding with iron bars behind

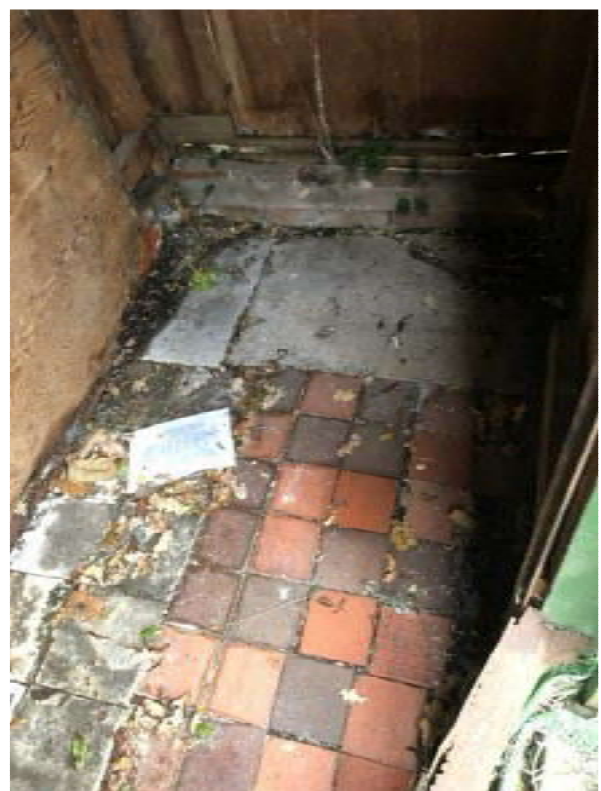
Quarry-tiles to floor of smaller outbuilding
