# Bunkers Hill Cottages, Bersham, Wrexham

## Structural Appraisal Report

November 2021

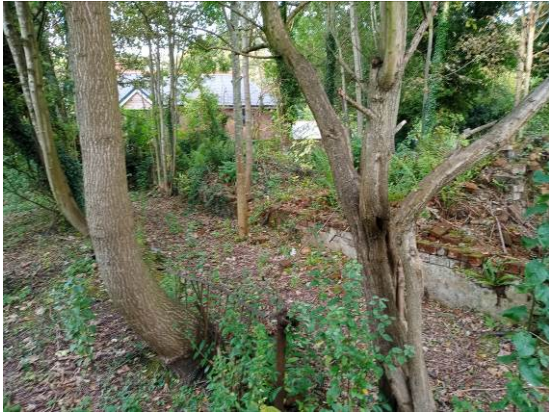
The elevations where visible comprise brickwork to full height with areas of render finishes in isolated locations (see Photos 1 and 2).

The overall condition of the elevations is considered to be very poor.

Photo 1 – Front Elevation.

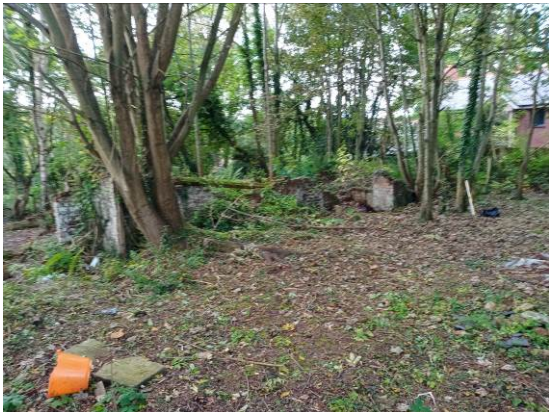
Photo 2 – Rear Elevation.

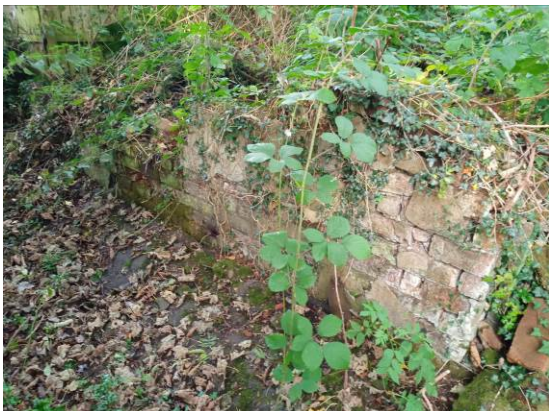
Evidence of severe mortar deterioration is apparent throughout along with erosion of brick units, some of which have disintegrated (see Photo 3). The mortar is lime based and has become friable and weak due to exposure to the generally damp atmosphere generated by the overhanging vegetation. Brickwork of this age is quite weak and susceptible to damp penetration and spalling. Degradation to the units is prevalent throughout to varying degrees. However, where render finishes are provided, a significant number of the brick units have burst and broken apart.

Photo 3 – Typical condition of external wall.

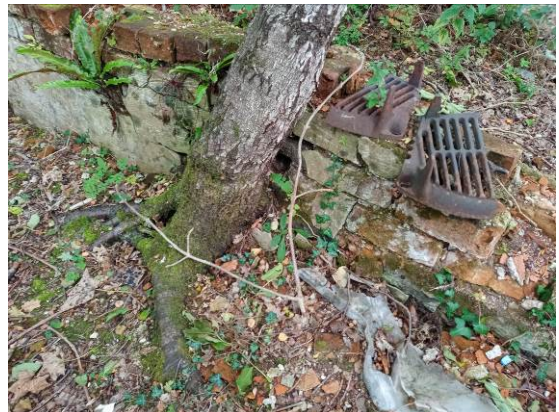
Several saplings and mature trees are growing very close to or immediately adjacent to the elevations. In several areas the growth has caused disturbance to the brickwork (see Photo 4). It is also apparent that this may have also affected the foundations, though this was not proven at the time of inspection.

Photo 4 – Tree growing close to/within the external wall.

- Remove stumps and rebuild sections of wall and foundations disturbed by vegetation.
- Rebuild external and internal walls and chimney stacks using retained brickwork augmented by recycled brickwork of similar appearance. All brickwork shall be laid in a traditional lime mortar formed out of hydraulic lime mixed with sand, aggregate and water as required. Exact constituents shall be agreed with the Conservation Officer.

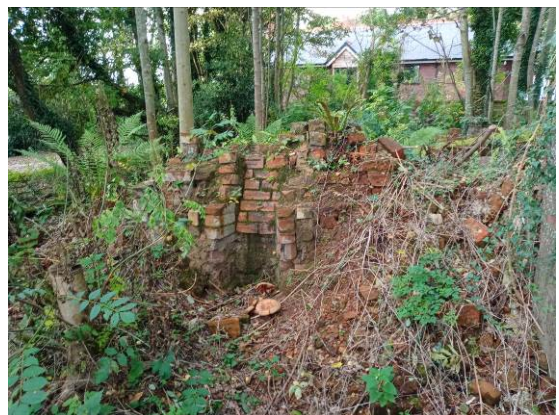
The internal chimney stacks are partially collapsed whilst the stacks to the end elevations would appear to have collapsed completely (see Photo 5). Significant quantities of brick debris are apparent internally which would confirm that the stacks have collapsed over time and not been demolished in a controlled manner. The condition of the debris is variable with some intact units visible. Internal walls show evidence of separation indicative of weather penetration and vegetation growth (see Photo 6).

Photo 5 – Typical view of chimney

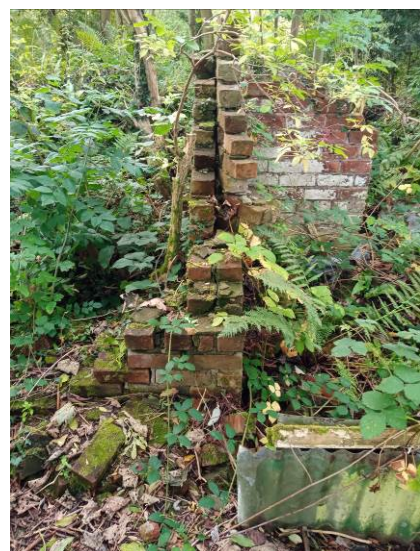
Photo 6 – Separation of solid brick wall.
