## GEOINVESTIGATE LIMITED

### Coal Mining Risk Assessment (CMRA)

| LOCATION | Acrefair Sports & Social Club, Bethania Road,<br>Wrexham, Acrefair LL14 3TR |
| ISSUE DATE | 5 October 2021 |

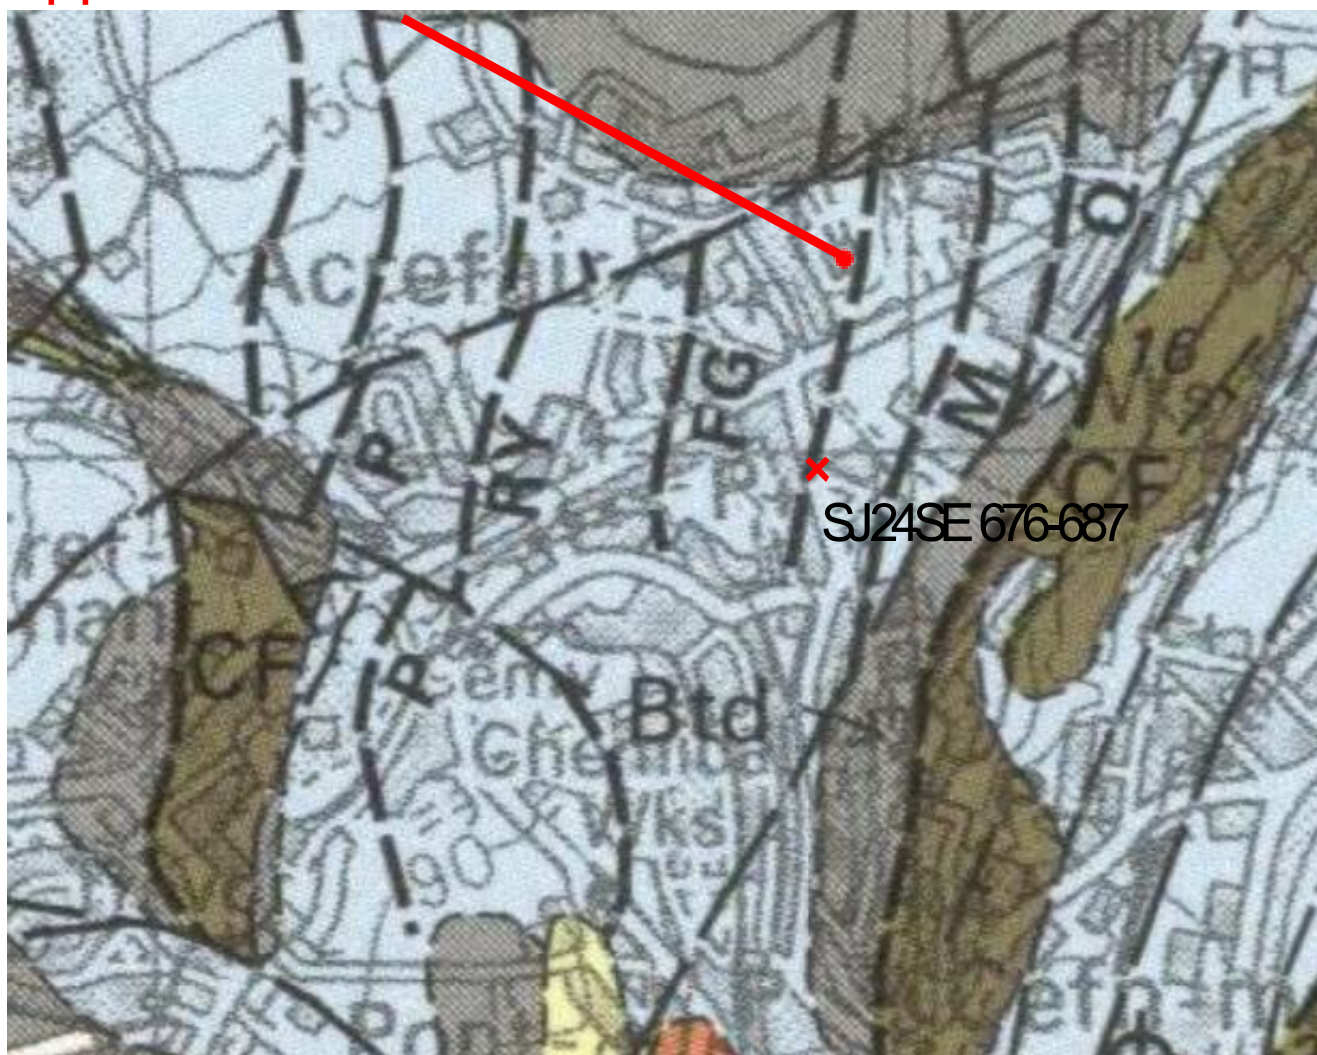
## EXTRACTS OF BGS GEOLOGY MAP

The location of the site is shown on the extract of BGS solid geology map presented in Appendix D. The tentative elevation of the site relative to the vertical geology column is shown below the map. The drift/soil horizon above the solid geology bedrock is not shown on the column.

The geology map indicates that drift/soil cover is Devensian Till (Diamicton) of unknown thickness at this locality.

The BGS geology map indicates the site is underlain by bedrock of Pennine Lower Coal Measures Formation comprising mudstone, siltstone, and sandstone with coal seams.

According to the geology map the site falls between outcrop of the M and FG (Fireclay Group) seams and may be immediately underlain by an unnamed coal seam occurring between the two. Consequently, the development may be underlain by workings of Fireclay Coal at 48m depth with possibly a further unnamed shallower coal seam above this.

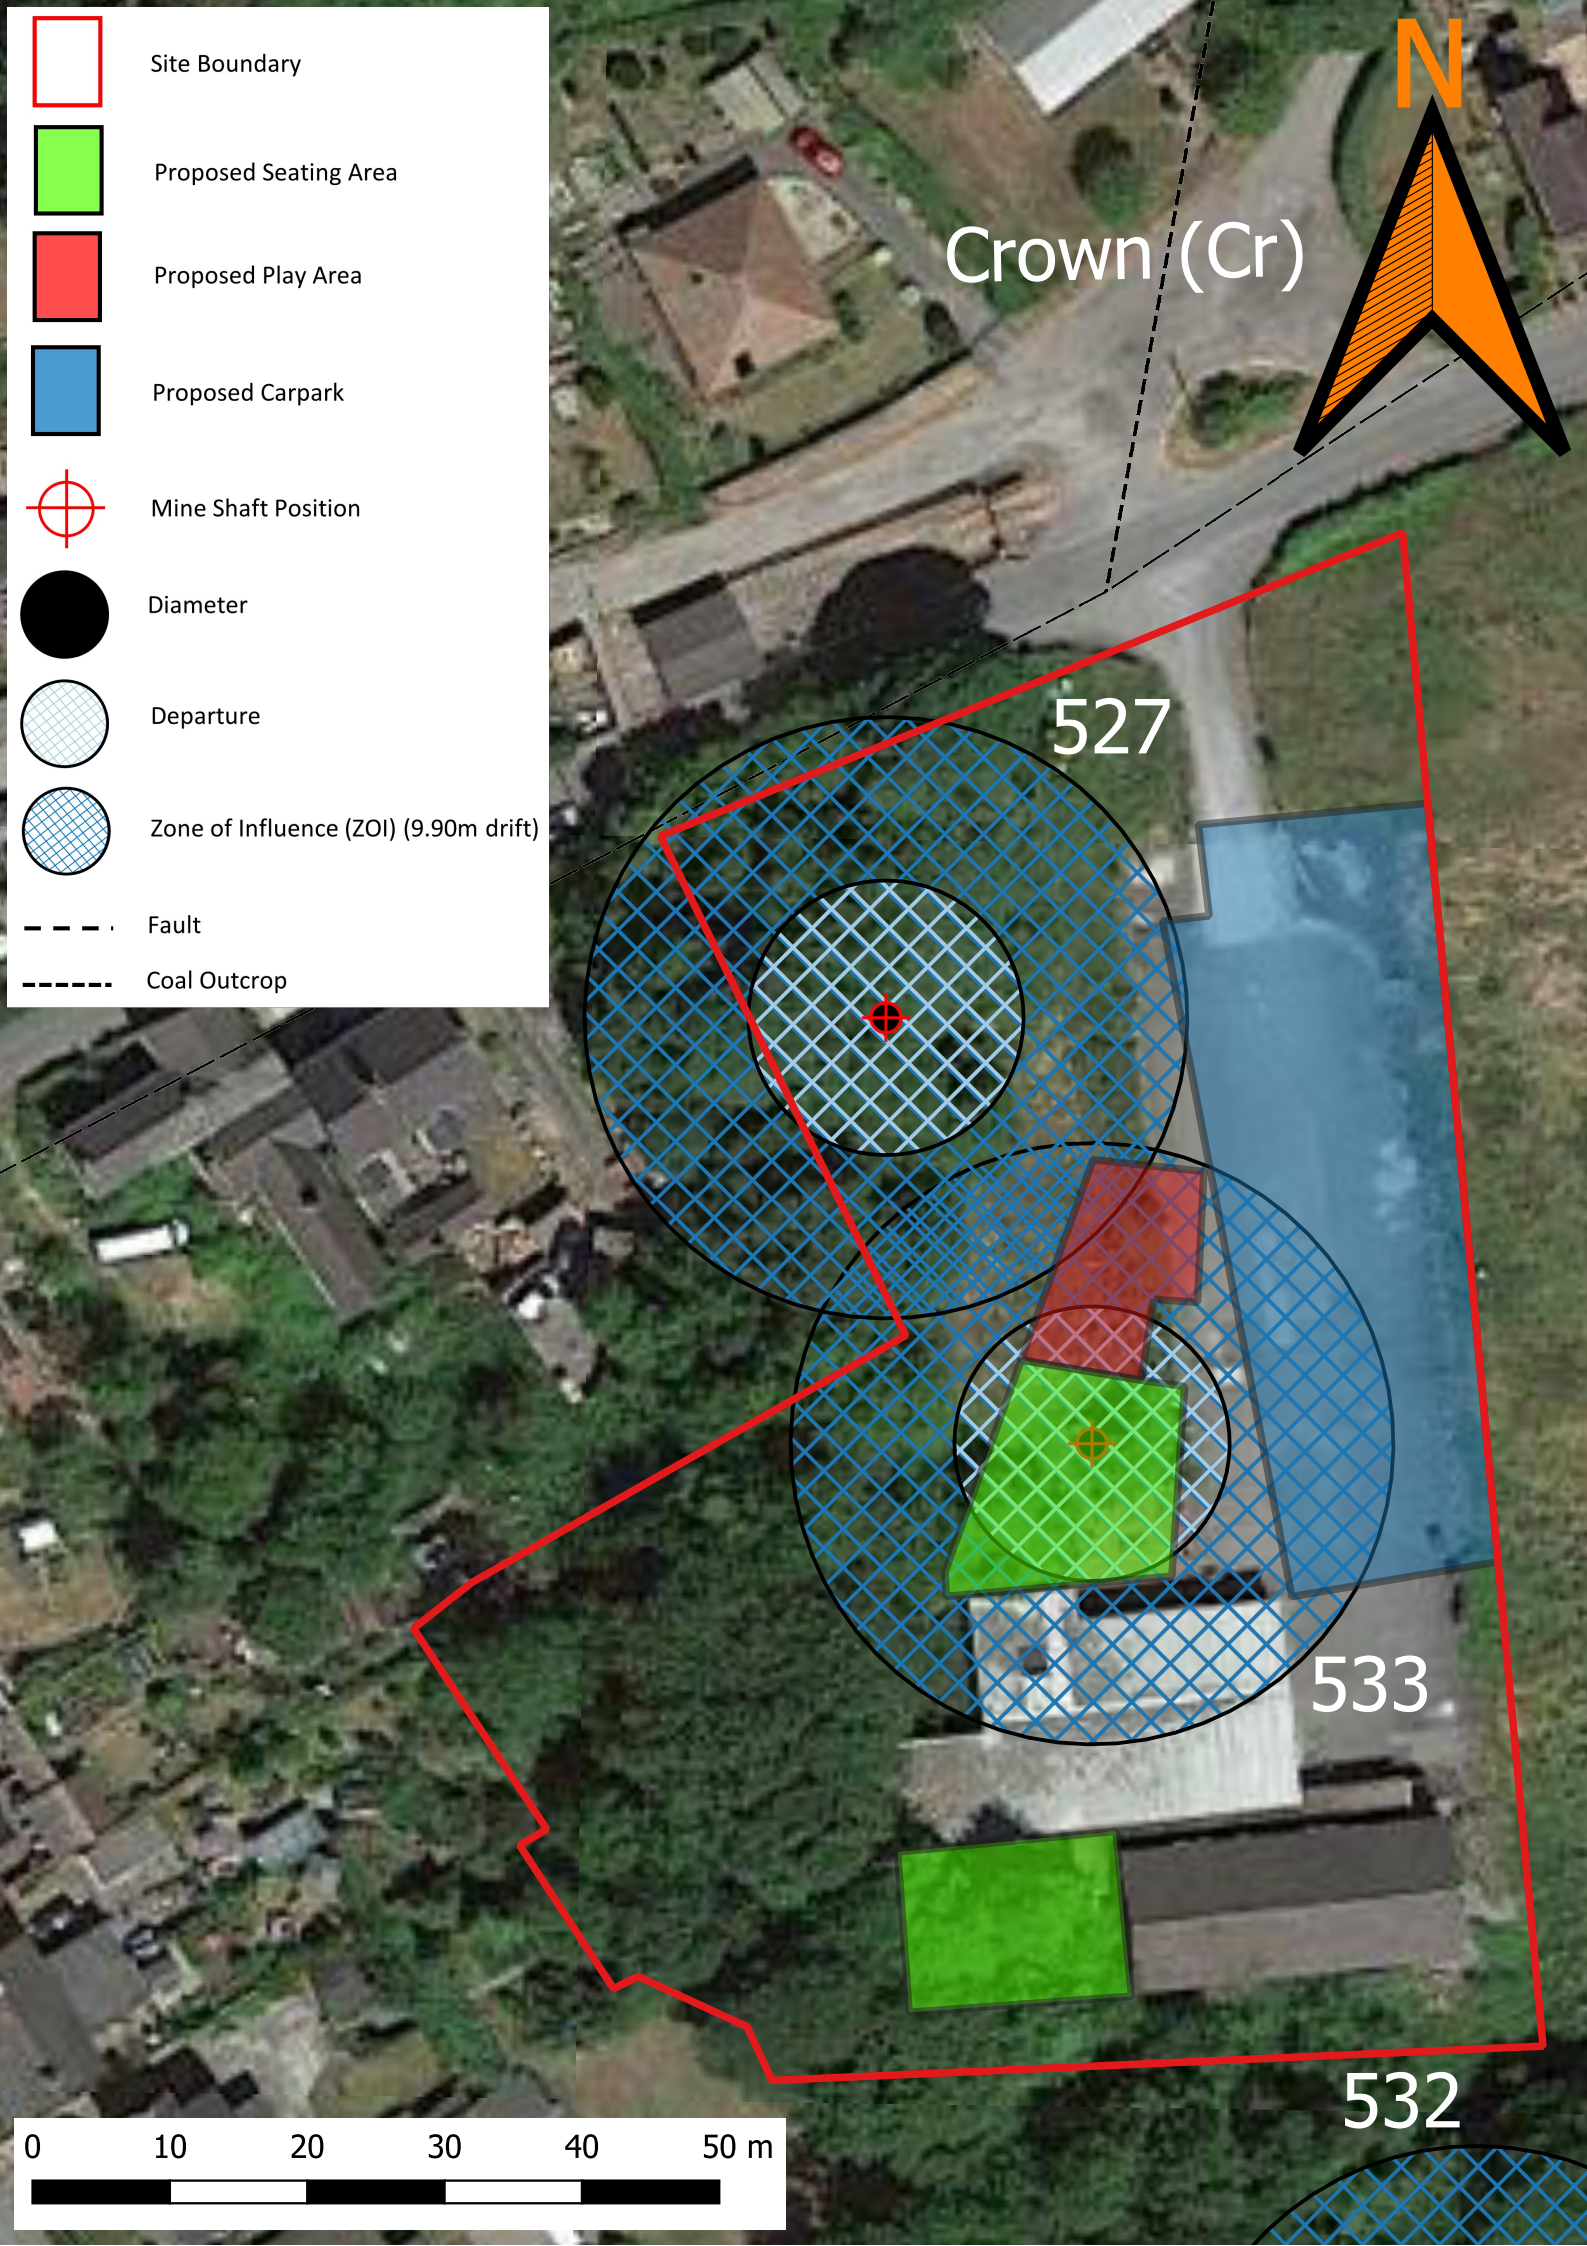
APPENDIX F  
MINE ENTRY ZOI

The departure zone of shaft 533 clips the edge of the existing carpark but not the new slightly remodelled carpark.

The departure zone of 527 lies at the northern end of the site and its departure zone does not encroach upon the carpark or the Playground. Consequently, in our opinion 533 has a more critical bearing on the development than 527.

Therefore, the outer ZOI for mine entries 527 & 533 are the same namely radii of 21.90m from each shaft centre plot.

The 10m departure zones and the ZOIs for these mine entries are shown in Appendix F. Both ZOIs and the departure zone of 533 encroach upon the 'Playground' while the ZOI of 533 impacts a large area of carpark, whereas the impact of 527 on the carpark is negligible.

While according to the Coal Authority mine shaft ground instability is an infrequent occurrence and low/very risk it is our opinion mitigation is required with regard to safeguarding the 'Playground' and the adjacent Seating Area' from mine shaft hazard posed by shaft 533 located within the property. In this respect (subject to approval of the CA) it is our opinion that preferably both facilities should be relocated outside the departure zones and ZOIs of 533 and shaft 527 as well.

However, given the possible site constraints the 'Seating Area' may perhaps (subject to CA approval) be in the departure zone of shaft 533, providing it is safeguarded with anchored geo-grid or alternatively it may be moved wholly outside it into the outer ZOI of 533.

Because the Playground is likely to be more controversial, in our opinion, it may need to be moved wholly outside the departure zone of 533 and located in its outer ZOI and similarly protected with an anchored geo-grid covering.
