# Asbestos Demolition Survey

The Moreton Inn  
Ruabon Road  
Johnstown  
Ruabon  
Wrexham  
LL14 6PU

Sentinel Environmental Consultancy Ltd  
Unit 17 Gwenfro  
Technology Park  
Wrexham  
LL13 7YP

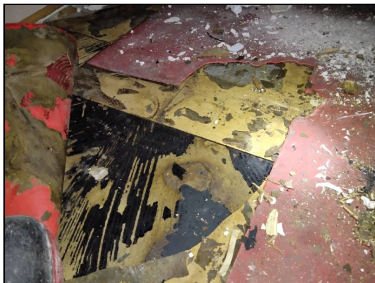
| | 2 Feb 2022 to 3 Feb 2022 | Luke Jones | Demolition Survey | Ground Floor | Chrysotile (1) |
| | AC004872 (S) | Reinforced Composite (1) | Completely Sealed (0) | Low Damage (1) | Occasionally likely to be disturbed |

| Recommended action | Remove | | | | |

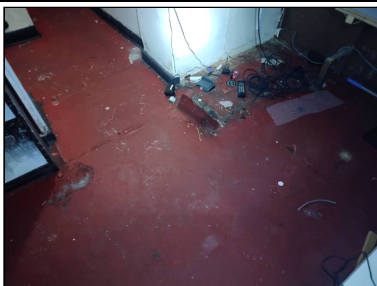
| | Survey Date: | Lead Surveyor | Survey Type | Floor | Analysis |
|---|---|---|---|---|---|
| | 2 Feb 2022 to 3 Feb 2022 | Luke Jones | Demolition Survey | Ground Floor | Chrysotile (1) |
| | AC004874 (S) | Reinforced Composite (1) | Completely Sealed (0) | Low Damage (1) | Occasionally likely to be disturbed |
| Surveyor comments | adhesive present to tile and floor, located to bar entrance | | | | |

| | Survey Date: | Lead Surveyor | Survey Type | Floor | Analysis |
|---|---|---|---|---|---|
| Recommended action | Remove | | | | |

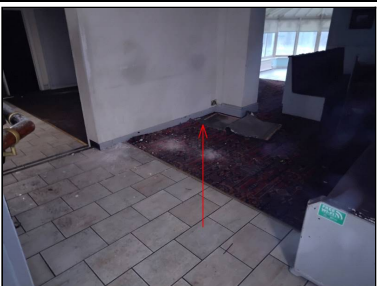
| | Survey Date: | Lead Surveyor | Survey Type | Floor | Analysis |
|---|---|---|---|---|---|
| | 2 Feb 2022 to 3 Feb 2022 | Luke Jones | Demolition Survey | Ground Floor | Chrysotile (1) |
| | AC004876 (S) | Reinforced Composite (1) | Completely Sealed (0) | Low Damage (1) | Occasionally likely to be disturbed |
| Surveyor comments | adhesive present to tile & floor, located to perimeter of central dividing wall | | | | |

| | Survey Date: | Lead Surveyor | Survey Type | Floor | Analysis |
|---|---|---|---|---|---|
| Recommended action | Remove | | | | |

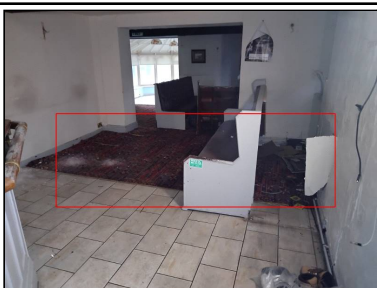
| | Survey Date: | Lead Surveyor | Survey Type | Floor | Analysis |
|---|---|---|---|---|---|
| | 2 Feb 2022 to 3 Feb 2022 | Luke Jones | Demolition Survey | Ground Floor | Chrysotile (1) |

| | Survey Date: | Lead Surveyor | Survey Type | Floor | Analysis |
|---|---|---|---|---|---|
| Recommended action | Remove | | | | |

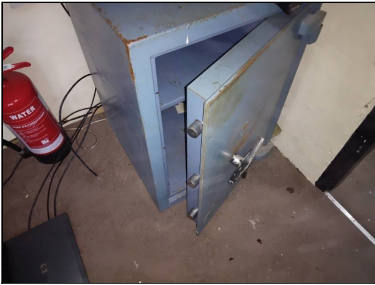
| Surveyor comments | | no access within, presumed to be present | | | |

| Recommended action | | Inspection Required | | | |

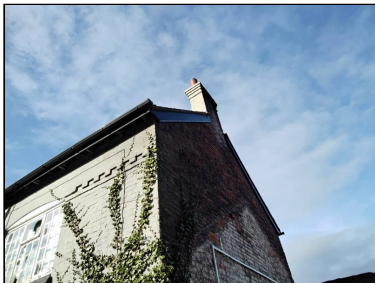
| | 2 Feb 2022 to 3 Feb 2022 | Luke Jones | Demolition Survey | External | Chrysotile (1) |
| Surveyor comments | located to main building | | | | |

| Recommended action | Remove | | | | |

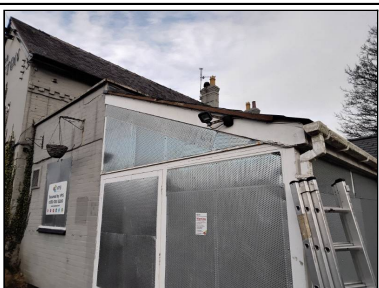
| | Survey Date: | Lead Surveyor | Survey Type | Floor | Analysis |
|---|---|---|---|---|---|
| | 2 Feb 2022 to 3 Feb 2022 | Luke Jones | Demolition Survey | External | Chrysotile (1) |
| Surveyor comments | located to conservatory | | | | |

| | Survey Date: | Lead Surveyor | Survey Type | Floor | Analysis |
|---|---|---|---|---|---|
| Recommended action | Remove | | | | |
