## **STRUCTURAL ENGINEER'S REPORT**

Holt Hill  
Green Street  
Wrexham  
LL13 9JF

21-6001-AC-01

10<sup>th</sup> June 2021

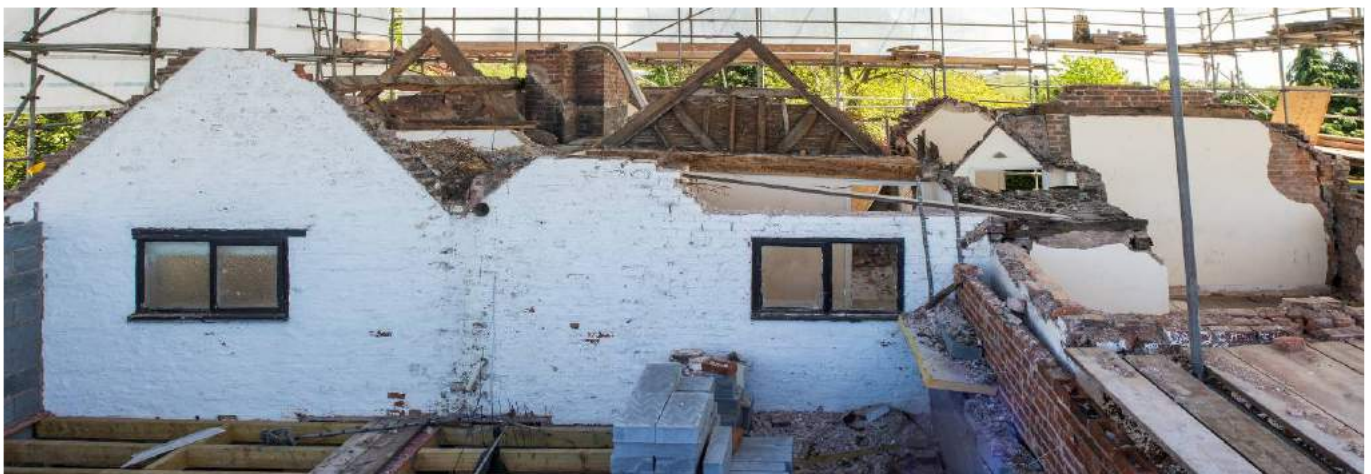
**Photograph 1:** View on west elevation (rear) of the property at the time of our visit.

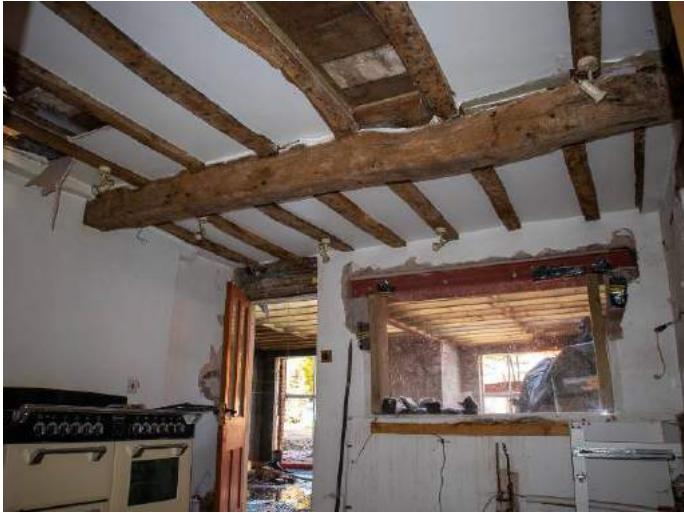
**Photograph B1:** (6734) View on the ceiling structure to the kitchen.

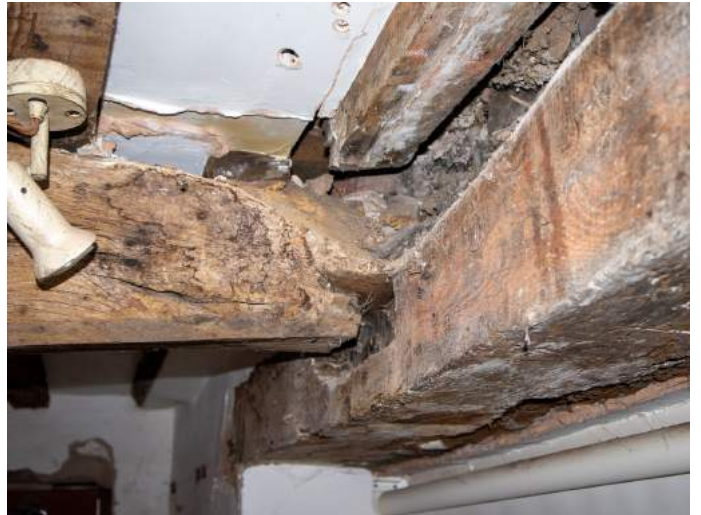
**Photograph B2:** (6724) Connection of the primary beam to the external wall cross beam within the kitchen. Note the splayed top face of the primary beam and notching in this beam and the cross beam.

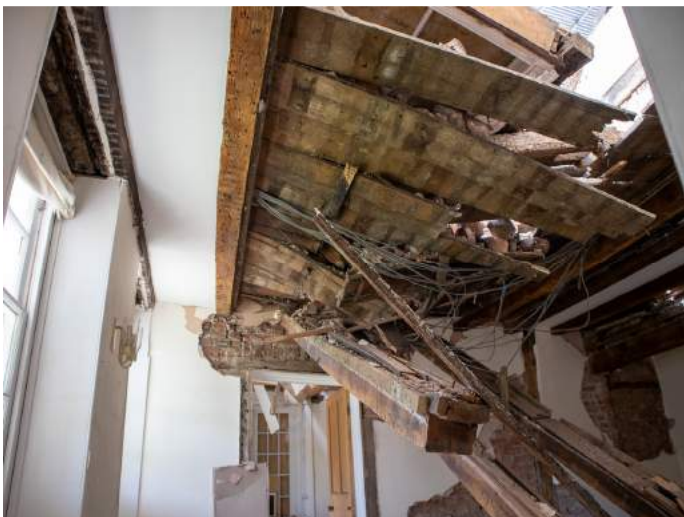
**Photograph B3:** (6736) View on the collapsed floor over the lounge. Note the twist on the joist but the end grain of the joists appears satisfactory. Also note the steep fall across the door head to the study.

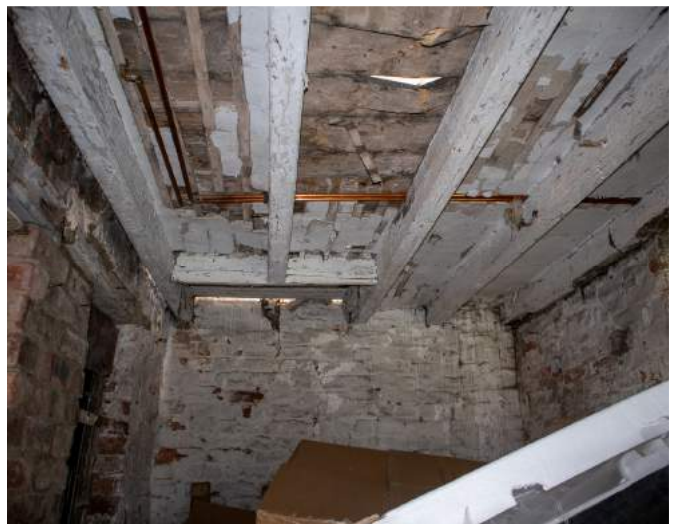
**Photograph B4:** (6749) Internal view of the first floor joists over the garage. Generally, the joists were in a satisfactory condition.

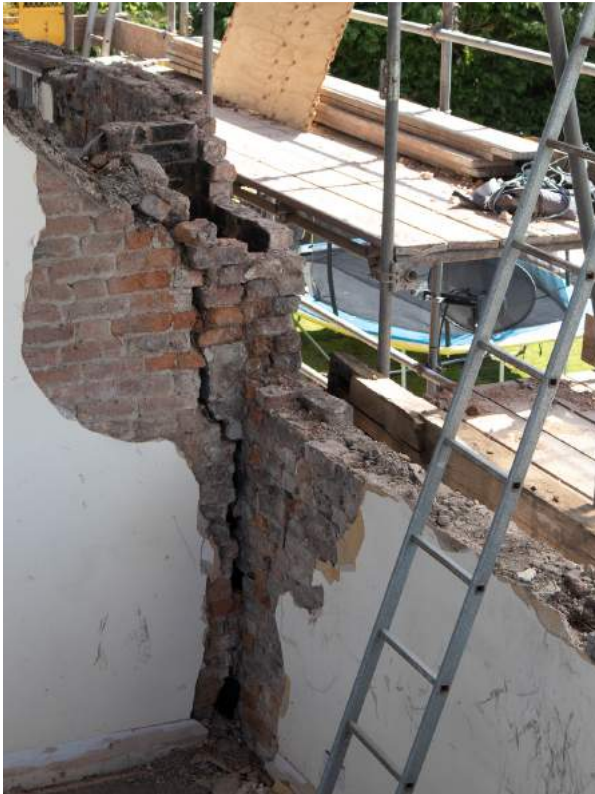
**Photograph B5** (6768) showing the wide vertical fracture at the junction of the chimney stack 2 with bedroom 4. . Local rebuilding and strengthening will be required.

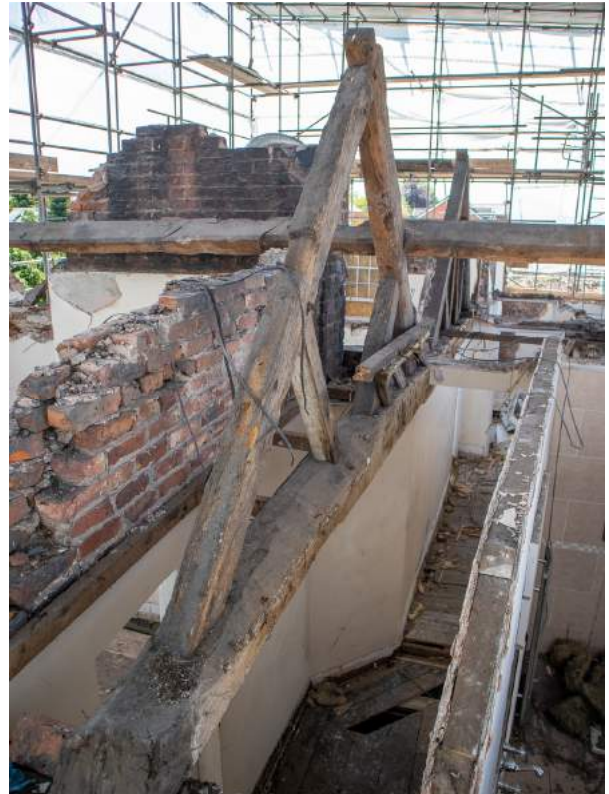
**Photograph B6:** (6772) View on truss 2 with Truss 1 in the distance. Note that the condition of the timber is generally satisfactory; the landing wall is solid bonded masonry and supports the overlapping purlins; the bathroom wall is stud construction running parallel with the truss.

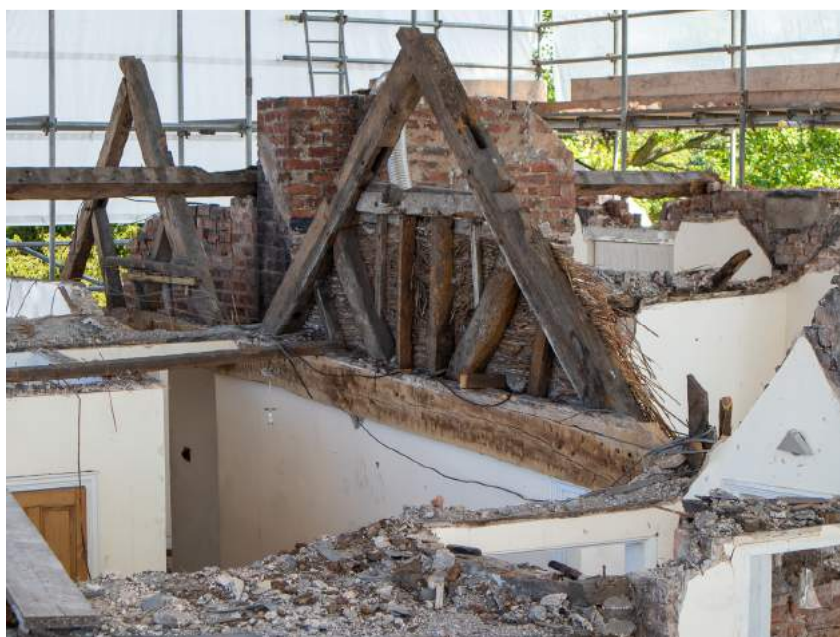
**Photograph B7:** (6790) Roof truss 1. This truss appears to have been modified. It essentially is the same truss profile as truss 2 but has the additional cross and vertical members to support the reeds for the plaster on bedroom 1.

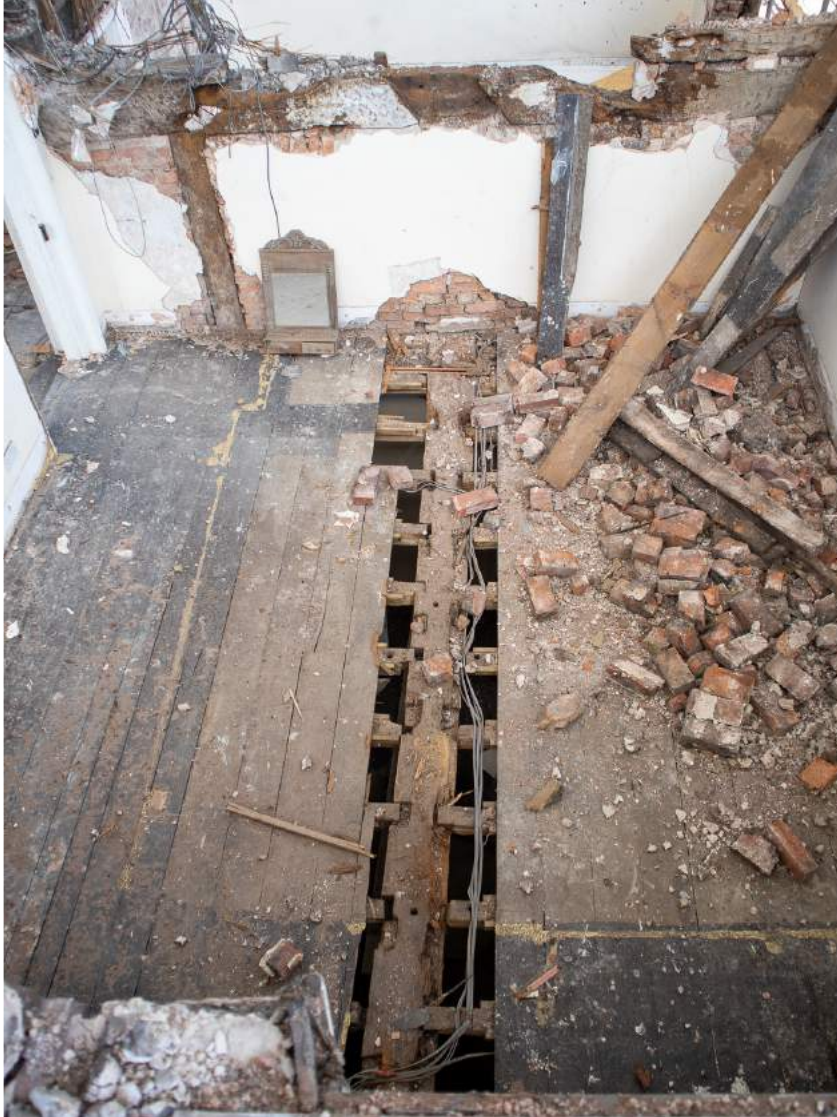
**Photograph B8:** (6784) view on the first floor beam over the study. Note that the joists have deep pockets and some appear to have little or no bearing. The floor joists in this room are generally wide and are probably original.

The timber structure on the far wall lies on a valley line and is in a poorer condition. The presence of brickwork infill makes this frame less critical so repair of decayed timber will be easier.
