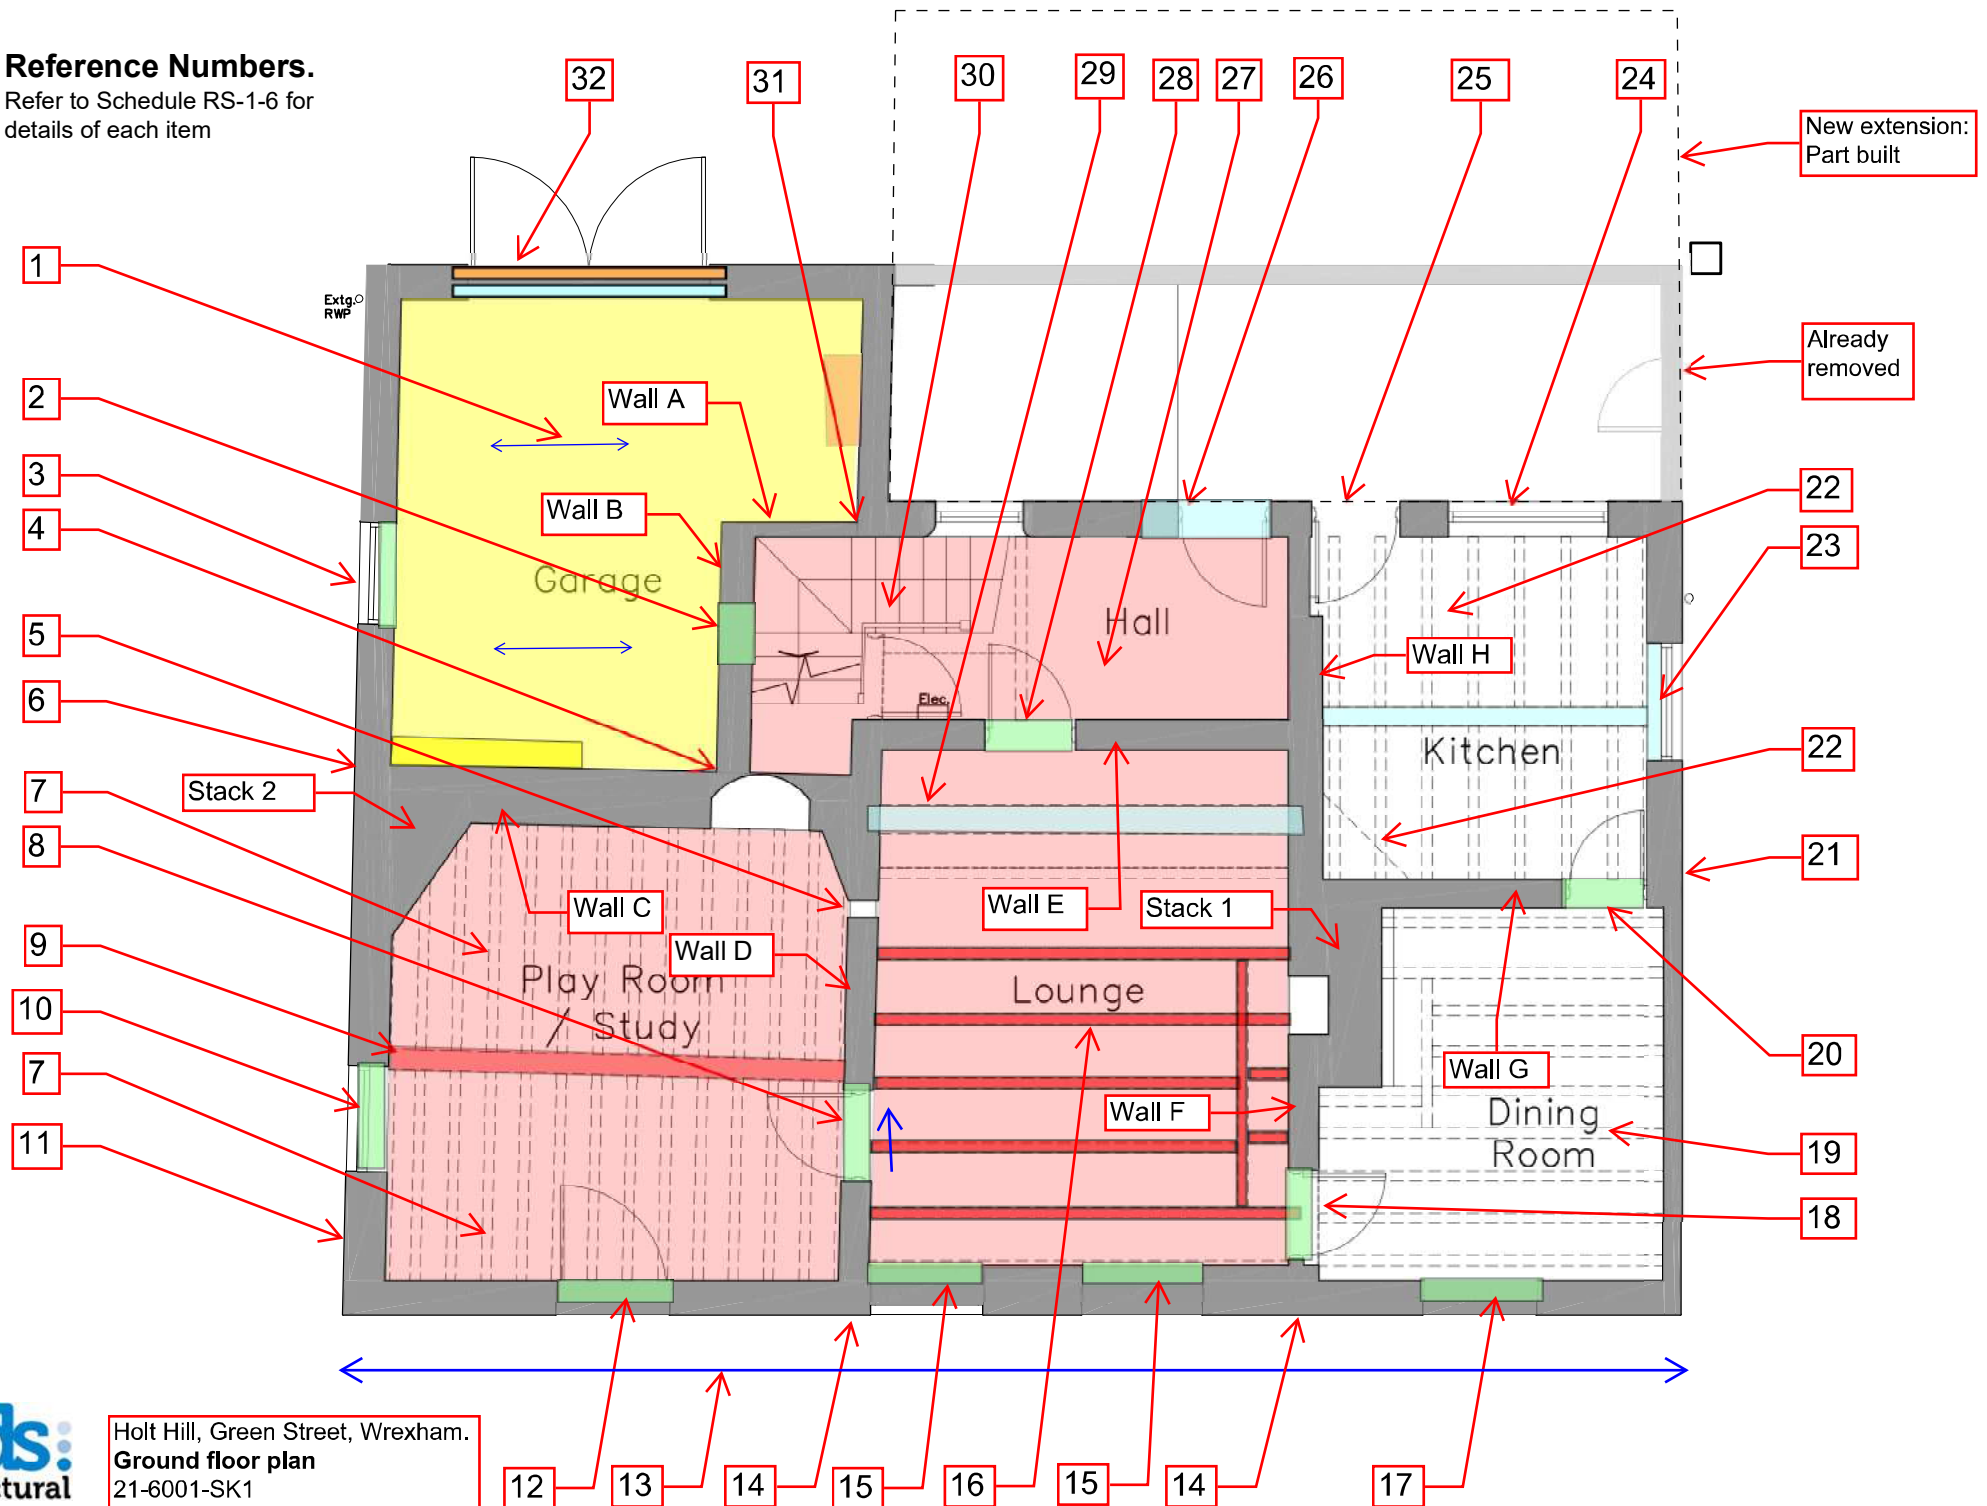
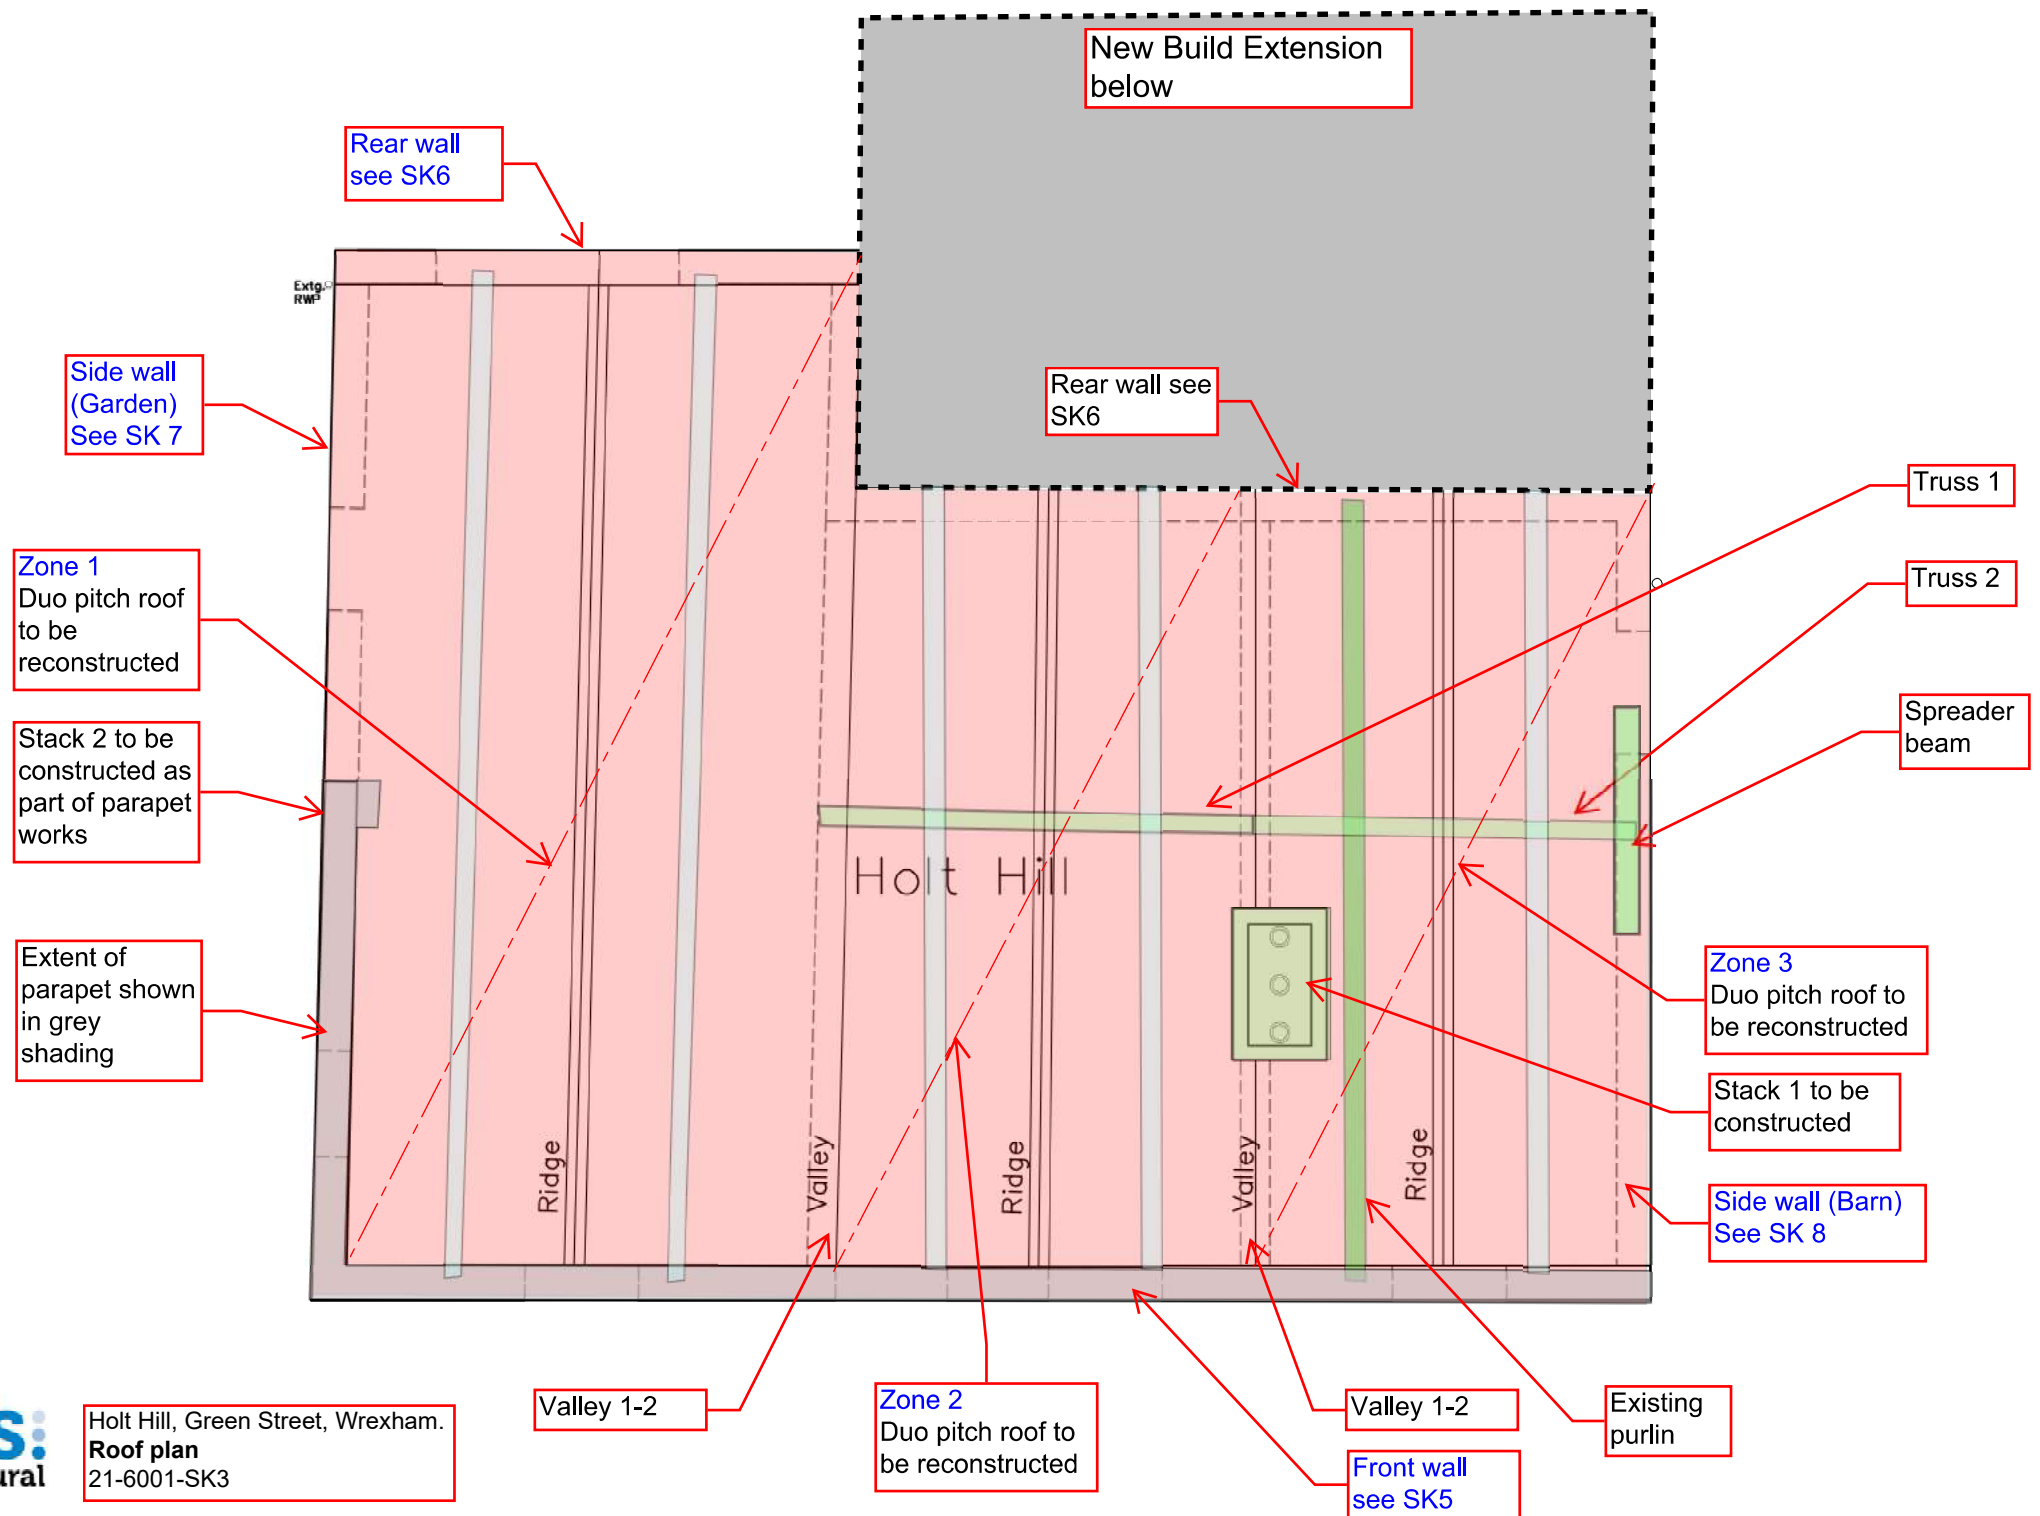
Cellar not safe to access  
so not inspected. Expect  
any timber beams or  
joists that are embedded  
into the external wall to  
need spliced repairs.

Assumed position of  
cellar on ground floor plan

Damp treatment by  
others

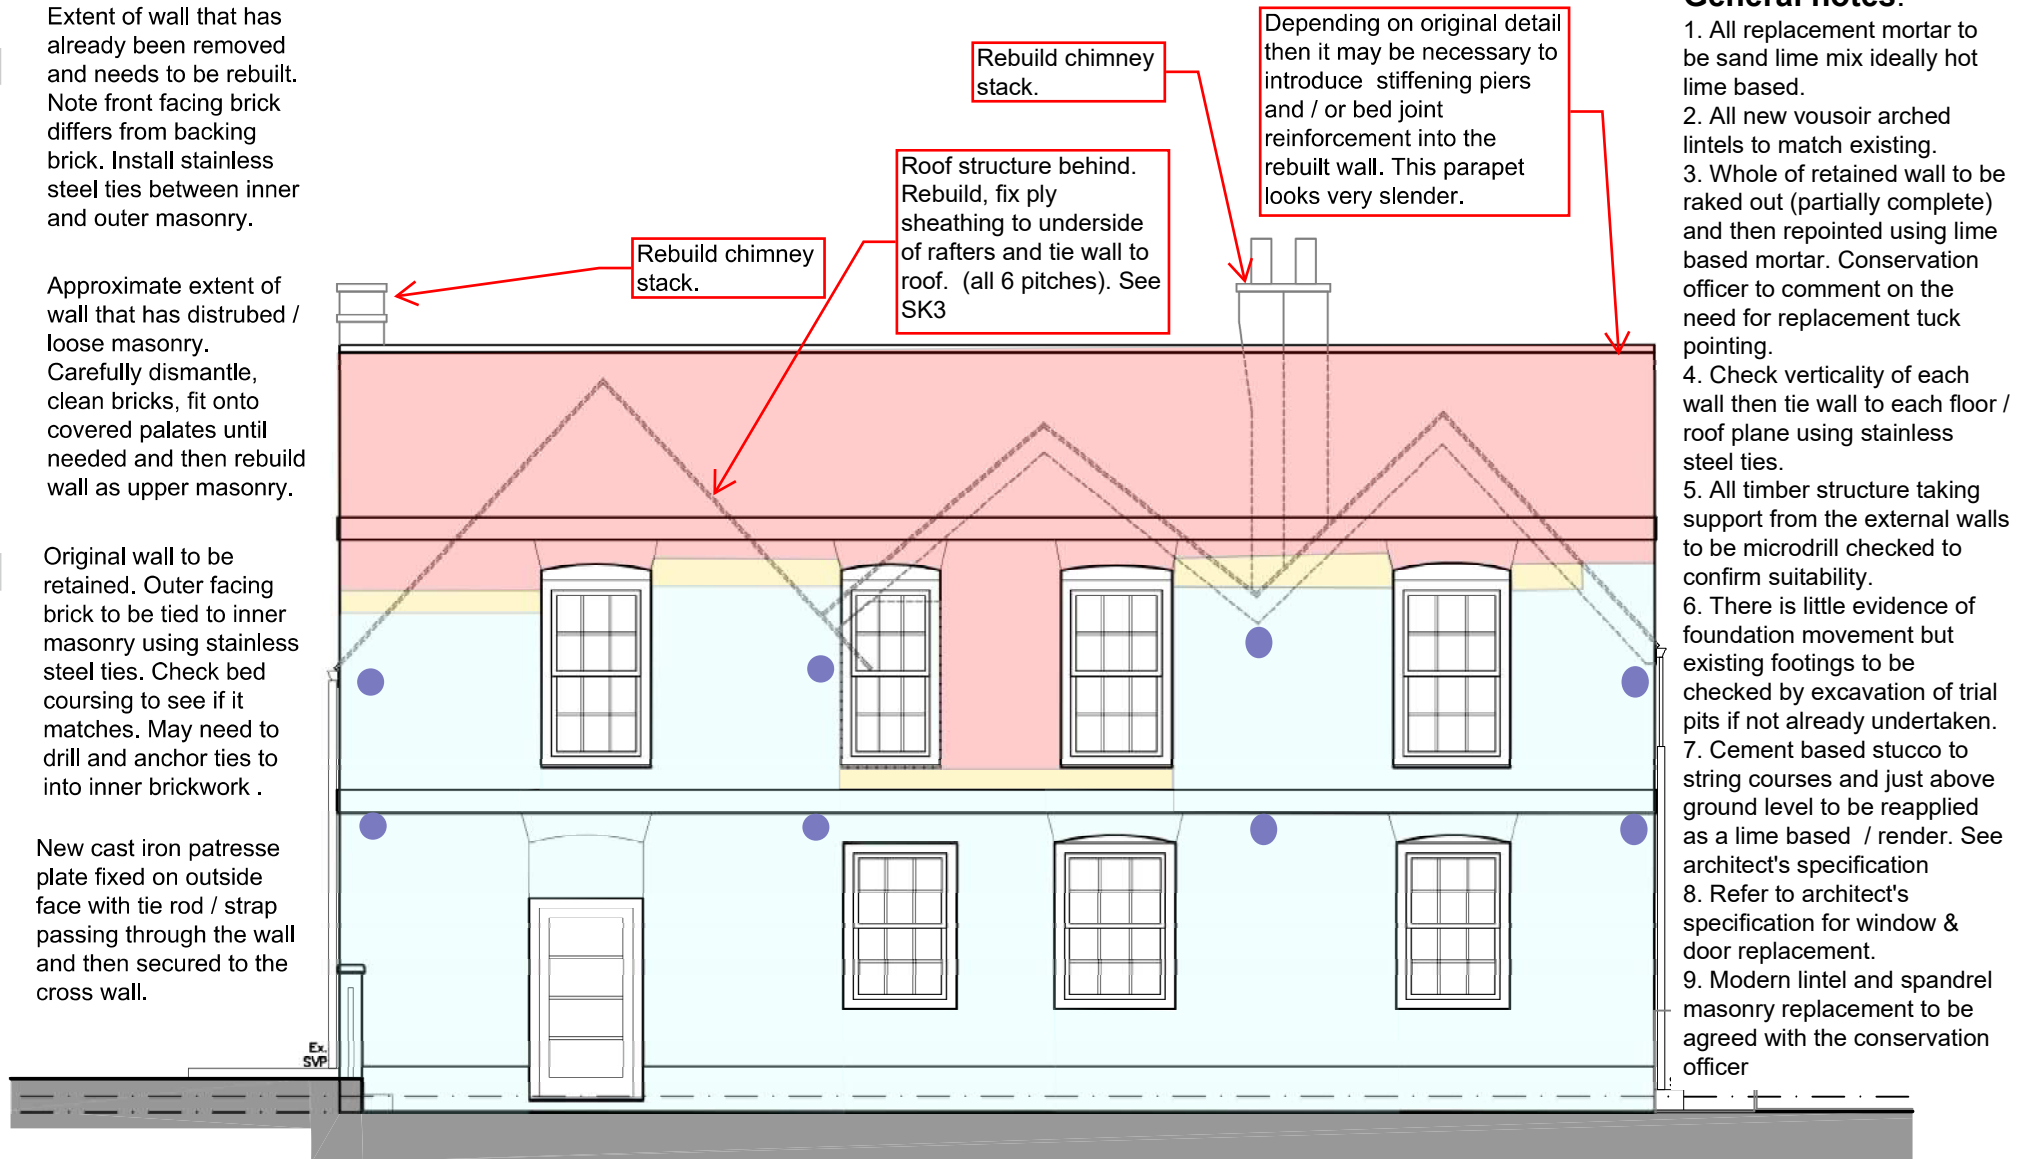
Extent of wall that has already been removed and needs to be rebuilt.

Approximate extent of wall that has disturbed / loose masonry. Carefully dismantle, clean bricks, fit onto covered palates until needed and then rebuild wall as upper masonry.

Original wall to be retained. Locally rake out loose mortar and repoint as necessary particularly in area of former RWPs.

Extent of wall that will be disturbed when the garage beam is replaced. Allow for replacement. Where stepped cracked masonry occur above this zone fix helibars in bed joints

New cast iron patresse plate fixed on outside face with tie rod / strap passing through the wall and then secured to the cross wall, floor or roof.

Rebuild chimney stack. Check existing section that has been retained to see if the mortar on the internal face of stack has perished. May need further masonry to be dismantled and rebuilt.

Roof structure behind. Rebuild and tie wall to roof. See SK3

Rebuild chimney stack. (See other stack)

Roof structure behind. Rebuild, fix ply sheathing to underside of rafters and tie wall to roof. (all 6 pitches). See SK3

Tie walls (3 No ) back to floor with restraint straps

Prop wall above and replace timber beam. Check inner beam and replace as necessary. Repair disturbed masonry over.

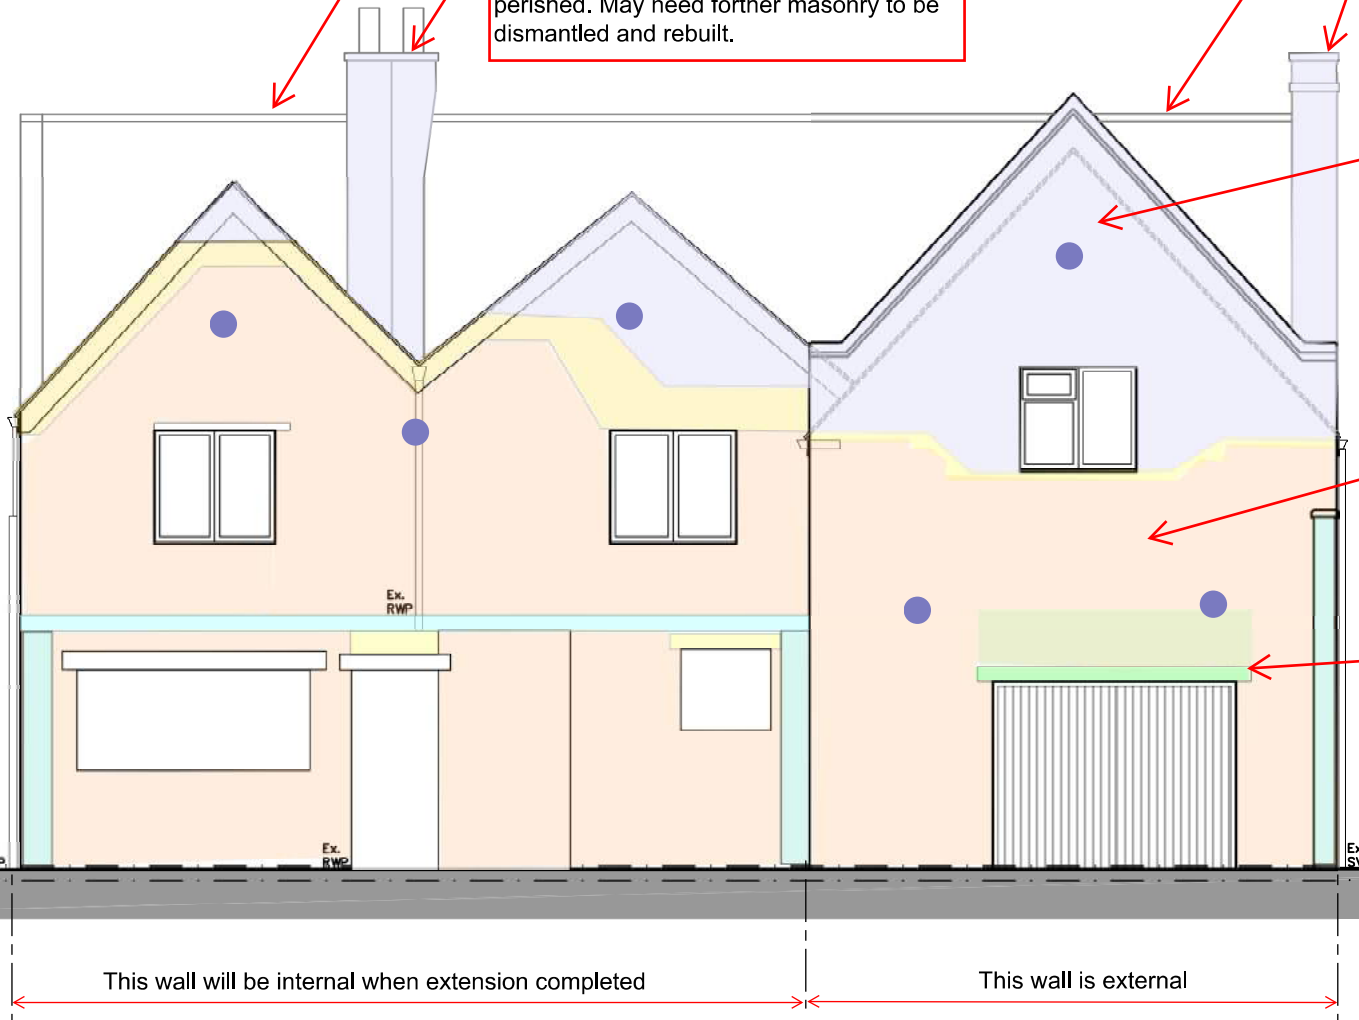
Extent of wall that has already been removed and needs to be rebuilt.

Approximate extent of wall that has disturbed / loose masonry. Carefully dismantle, clean bricks, fit onto covered palates until needed and then rebuild wall as upper masonry.

Original wall to be retained. Complete repointing with lime based mortar.

Inner face of wall has local damage. Allow for local rebuilding and fix Helibars in bedjoints and anchor into sound brickwork beyond.

Poor quality brickwork at joint of two wall types. Inner face not examined. Assume that the area shown has to be locally rebuilt. Install Helibars in the bedjoints across the damaged area into the adjacent brickwork.

Depending on original detail then it may be necessary to introduce stiffening piers and / or bed joint reinforcement into the rebuilt wall. This parapet looks very slender.

New cast iron patresse plate fixed on outside face with tie rod / strap passing through the wall and then secured to the cross wall.

Roof structure behind. Rebuild and tie wall to roof. See SK3

Chimney stack at end of parapet wall to be strengthened and incorporated into the wall.

Rebuild chimney stack. Check existing section that has been retained to see if the mortar on the internal face of stack has perished. May need further masonry to be dismantled and rebuilt.

Roof structure behind. Rebuild, fix ply sheathing to underside of rafters and tie wall to roof.

Tie wall back to roof with restraint straps

Tie wall to 1st Floor structure

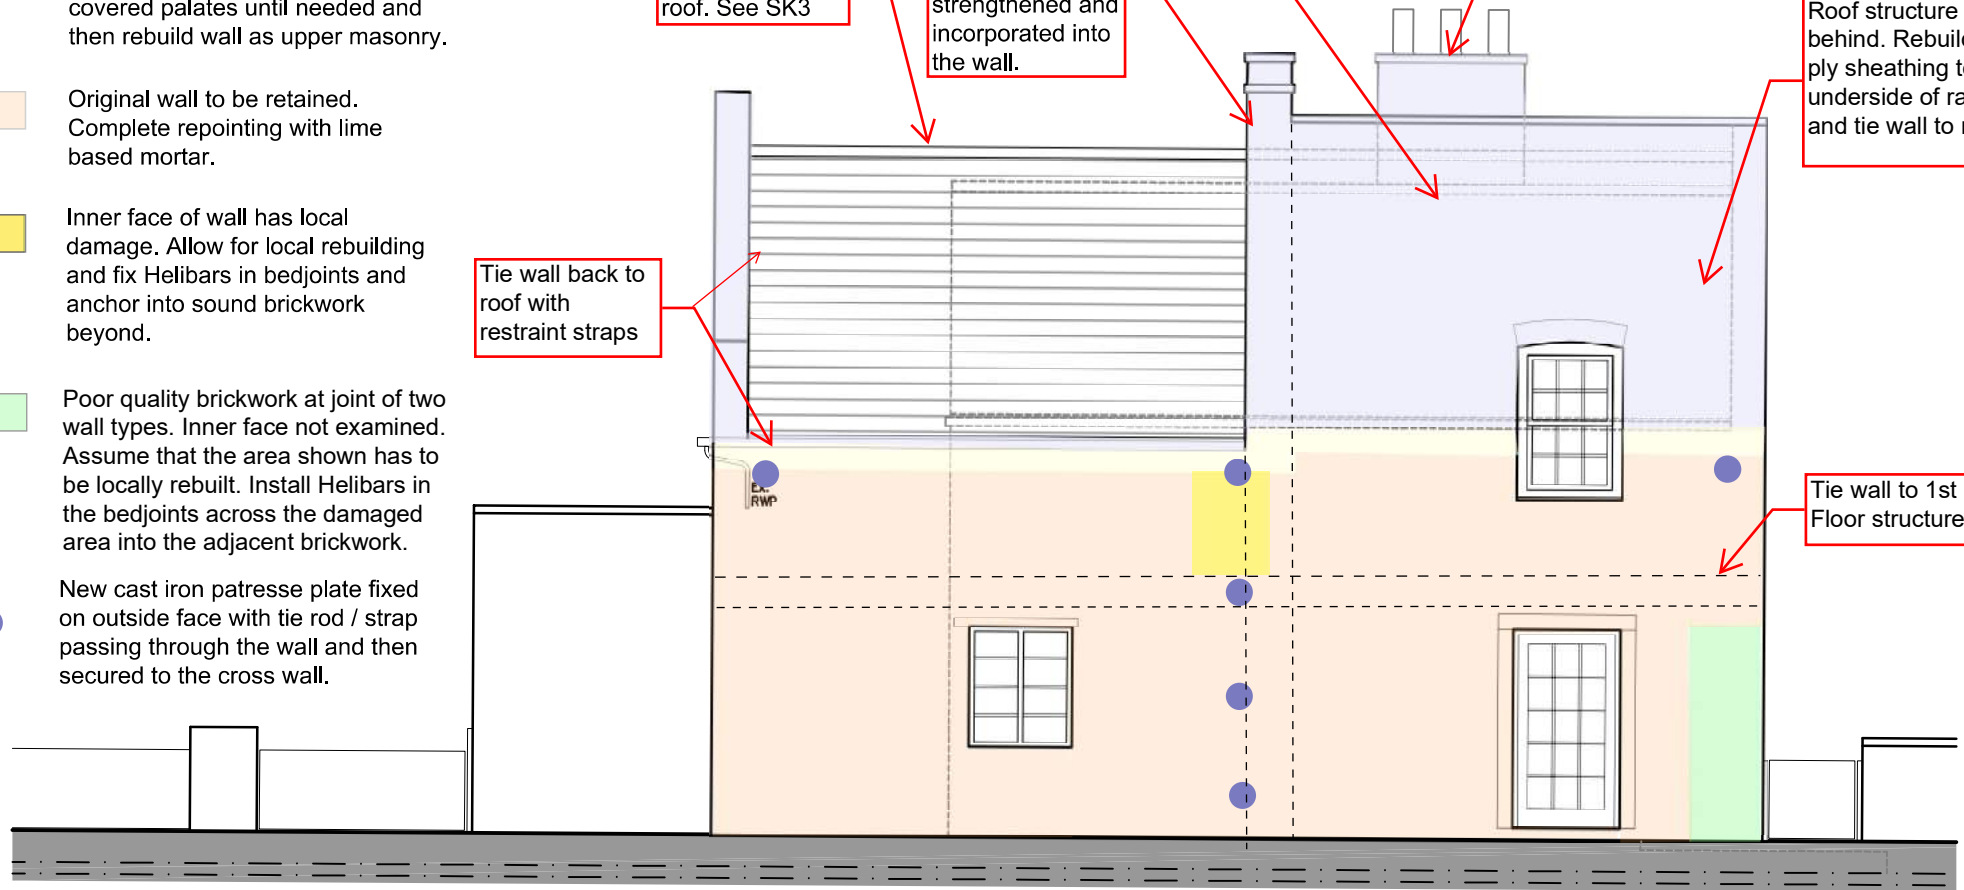
Depending on original detail then it may be necessary to introduce stiffening piers and / or bed joint reinforcement into the rebuilt wall. This parapet looks very slender.

This lintel needs reassessing and probably strengthening

Extent of wall that has already been removed and needs to be rebuilt.
-

Extent of wall that has already been removed and needs to be rebuilt. Note front facing brick differs from backing brick. Install stainless steel ties between inner and outer masonry.
-

Approximate extent of wall that has disturbed / loose masonry. Carefully dismantle, clean bricks, fit onto covered pallets until needed and then rebuild wall as upper masonry.
-

Original wall to be retained. Complete repointing with lime based mortar.
-

Rebuild chimney stack. Check existing section that has been retained to see if the mortar on the internal face of stack has perished. May need further masonry to be dismantled and rebuilt.

Roof structure behind. Rebuild, fix ply sheathing to underside of rafters and tie wall to roof.

Tie wall back to floor with restraint straps

New cast iron patresse plate fixed on outside face with tie rod / strap passing through the wall and then secured to the cross wall.
