**REPORT**

**ALTHREY WOODHOUSE  
OVERTON ROAD  
BANGOR ON DEE  
LL13 0DA**

**MR J & MRS C MINSHAW  
ALTHREY WOODHOUSE  
OVERTON ROAD  
BANGOR ON DEE  
LL13 0DA**

**Date of Inspection: 7<sup>th</sup> November 2019**

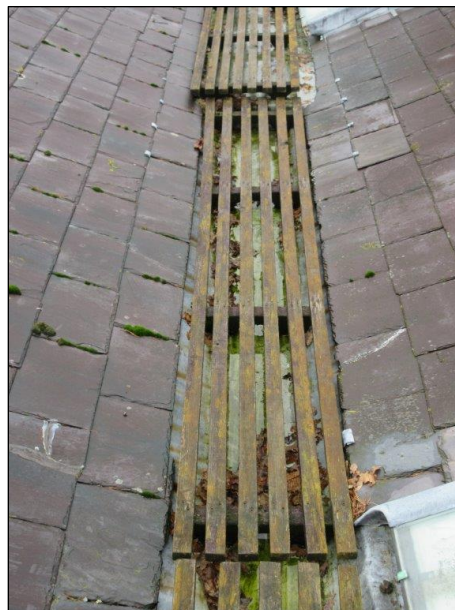
The valley gutter would of sufficient diameter to deal with the water discharge from the valley had it been correctly constructed.

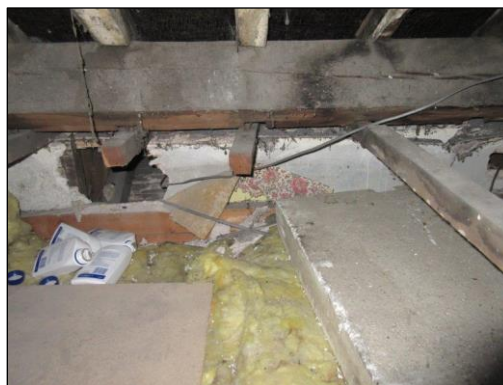
Rot has affected many of the roof timbers, some of the rafters have been replaced however there are several that have suffered from wet rot and there structural integrity will have been affected.

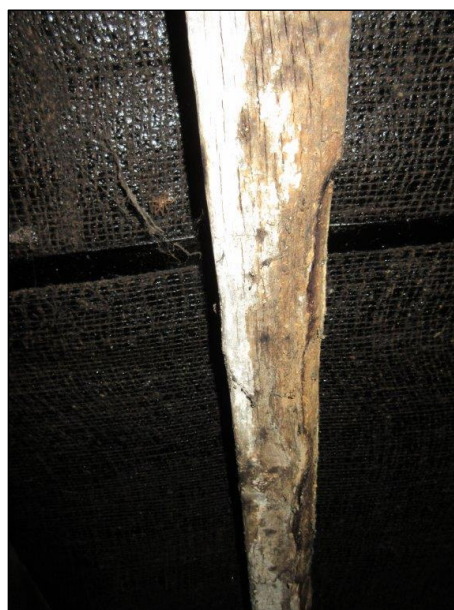
Similarly the ridge board has suffered with wet rot due to roof leaks.

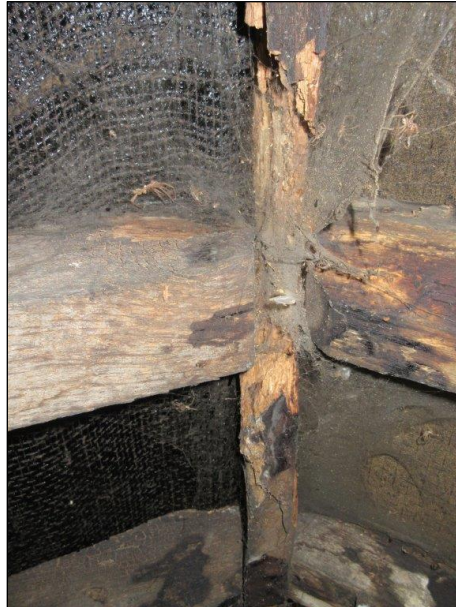
There is an infestation of wood boring beetle to the accessible roof space. Due to the give in the floorboards it is suspected that wood boring beetle is present and has damaged the boards although all floors were covered at the time of inspection.

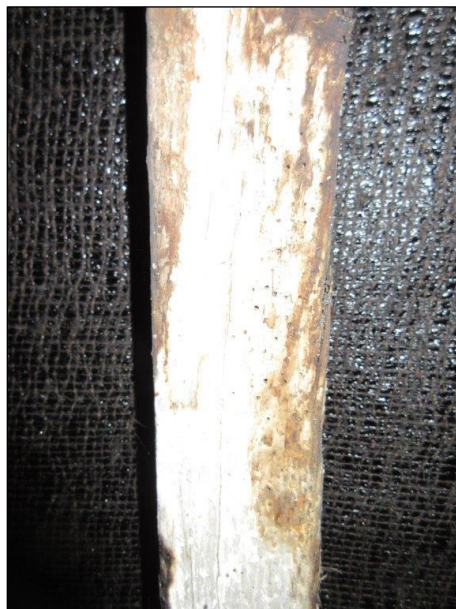
Timbers within the roof space which provides access to the roof are also suffering from wet rot.
