Pre-Development Site Survey

## Arboricultural Report

Centre 67  
Rhosddu Road, Wrexham  
LL11 2NW

Ref: NEB 19014 AIA & AMS Ver 1 (Demolition)

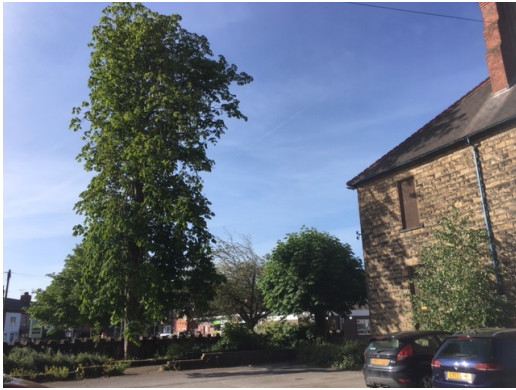
- 3.3.1 T1 is a prominent Horse chestnut at the front of the site that dominates the area. It is one of two trees remaining from a row that grew here originally. Two other trees have been removed historically and are regenerating from the stumps.
- 3.3.2 T2, also a Horse chestnut, has been subject to severe pruning in the form of a crown removal at approximately 2.5m. The justification for this is unknown however such action is usually taken when the structural integrity of a tree has been compromised.
- 3.3.3 Both T1 and T2 are contained within a grassed strip, bisected by a boundary wall, and restricted on either side by a footpath, parking area and highway.
- 3.3.4 T3 and T3 are both off site trees situated within the adjacent church yard and are typical for their species and setting.

| Tree ID | Common Name | Botanical Name | Height (m) | Calc. / Actual Stem Dia. (mm) | Spread (m) | | | | Height (m) & Orientation of First Significant Branch | Avg. Canopy Height (m) | Life Stage | General Observations | Preliminary Recommendations | Estimated Remaining Contribution (Years) | BS5837: 2005 Category | RPA Radius (m) | RPA m² |
|---|---|---|---|---|---|---|---|---|---|---|---|---|---|---|---|---|---|
| 1* | Horse chestnut | Aesculus hippocastanum | 17 | 590 | 5 | 2 | 4 | 3 | N2 | 1 | SM | Slight asymmetrical form to crown due to previous adjacent tree cover. Tree situated in retained bed consisting of a narrow grass strip. Stem epicormics and scale insect noted. Prominent tree. | No works required. | 20+ | B1 | 7.1 | 157 |

T1 & T2 – Horse chestnut

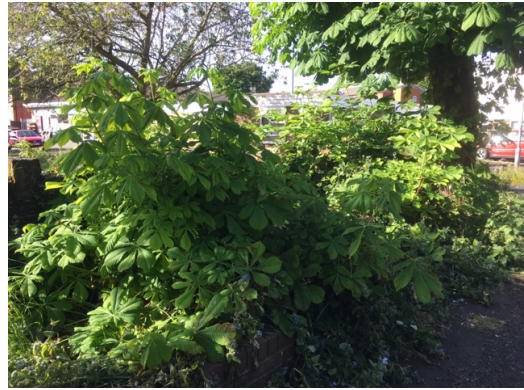
Stump re-growth between T1 and T2

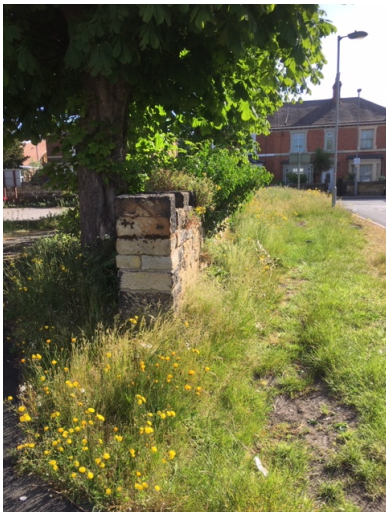
Wall bisecting grass strip

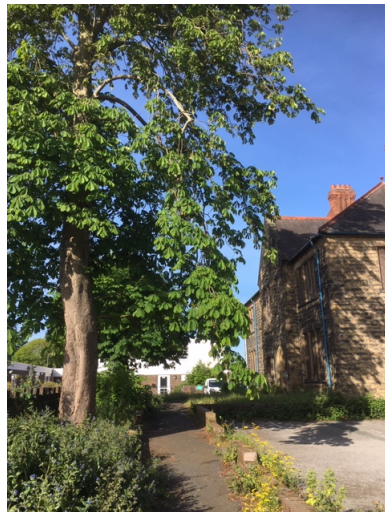
3.9.1 The tree canopy for T1 will likely extend outside of the tree protection fencing and therefore presents an above ground constraint to on-site operations, but not demolition. As such it may be prudent to extend the fencing in this portion of the site if possible to fully encompass the tree's canopy (see photograph titled – T1 and path at edge of grass strip).

T1 and path at edge of grass strip

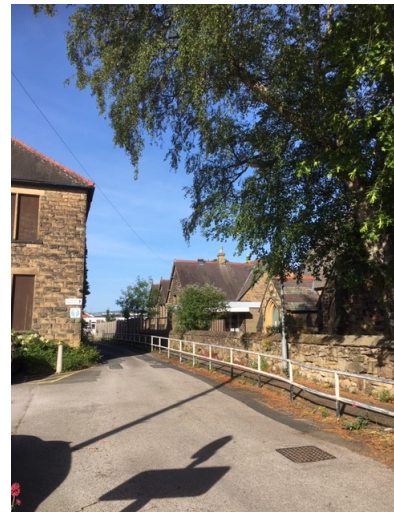
3.9.2 There is also the potential for heavy plant to make contact with tree canopies for the two off site trees T3 and T4. Their overall average canopy height is 2m and their spread

over the site is limited however this should be assessed prior to commencing works to ensure no damage occurs to the trees.

T3 and T4 overhang to site

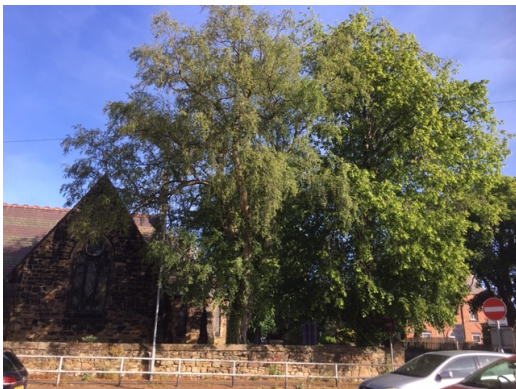
| Tree ID | Common Name | Botanical Name | Height (m) | Calc. / Actual Stem Dia. (mm) | Spread (m) | | | | Height (m) & Orientation of First Significant Branch | Avg. Canopy Height (m) | Life Stage | General Observations | Preliminary Recommendations | Estimated Remaining Contribution (Years) | BS5837: 2005 Category | RPA Radius (m) | RPA m² |
|---|---|---|---|---|---|---|---|---|---|---|---|---|---|---|---|---|---|
| 3 | Lime species | Tilia spp. | 14 | 520 | 5 | 6 | 5 | 4 | S2 | 2 | SM | Off site tree. Stem epicormics and scale insect. | No works required. | 20+ | B1 | 6.2 | 122 |
| 4 | Birch species | Betula spp. | 13 | 590 | 4 | 2 | 7 | 6 | S2 | 2 | M | Off site tree. Damaged surface roots. Stem base epicormics. Restricted visual assessment due to dense ivy. | No works required. | 10+ | C1 | 7.1 | 157 |

T3 and T4 in Church Yard

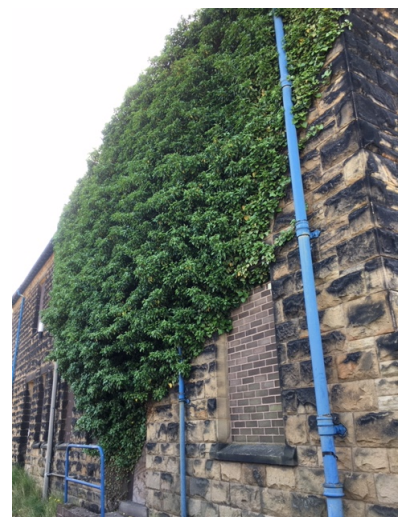
- 2.2.5 There is a mature ivy feature dominating the north west wall of the structure. It is understood that ecological surveys of the structure have been undertaken, nevertheless it must be noted that ivy supports a variety of wildlife, including nesting birds, and as such should be assessed immediately prior to demolition.

Mature ivy feature on structure
