# STRUKTURA

## Holt Hill Roof Inspection

**Version 1**

31/3/21

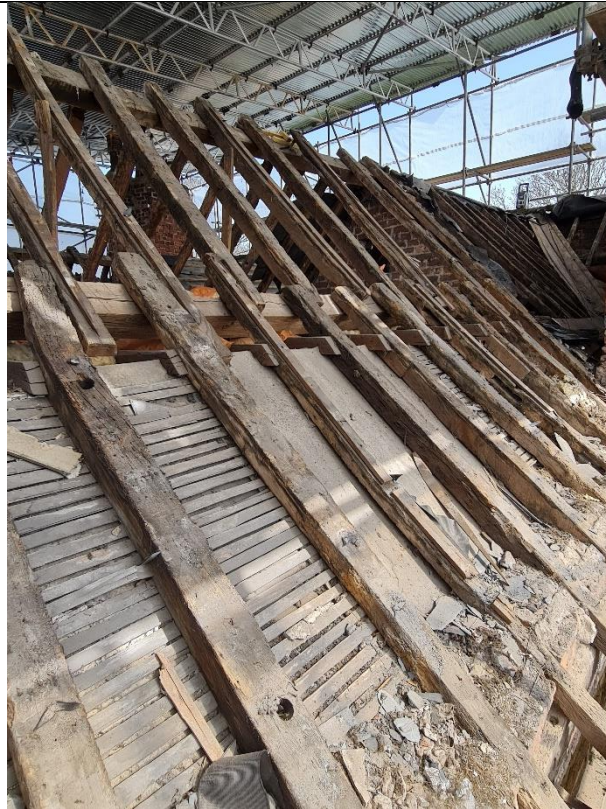
Roof View to front

Timber rafters have woodworm and severe loss of section. Cut outs in rafter section

We would recommend a new cut roof is installed, removing all roof timbers except the King Post truss to the Northern range which can be treated and replacing the old roof with a new cut roof with purlins and ridge constructed from Oak and new timber rafters. This new roof would be strapped back to the proposed re-constructed gables and gable parapet walls. Therefore re-instating the overall stability of the roof.

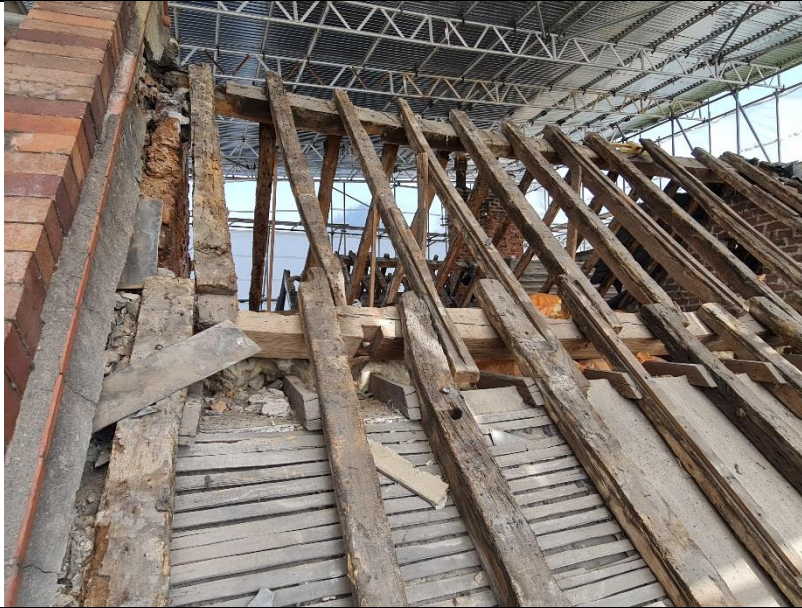
Roof View

Timber rafters have woodworm and severe loss of section

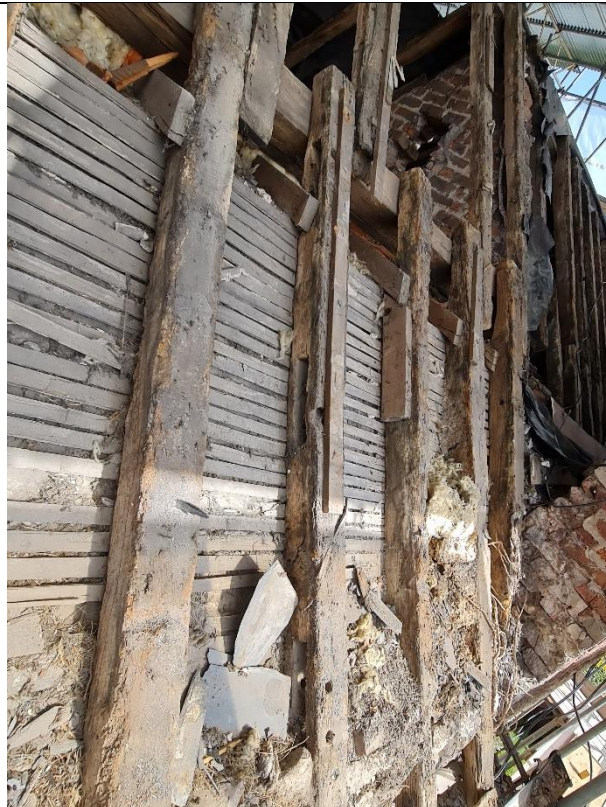
Rafter View

Cut outs from roof rafters. Rot to rafter ends

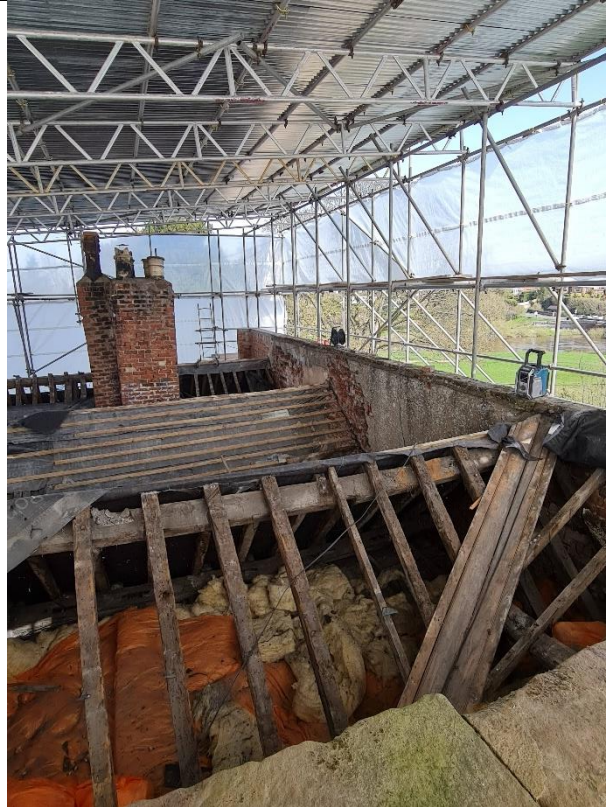
View of front Gable

Render removed from front gable, brickwork loose and not coursed correctly.

We would recommend that these walls are all taken down to window head level, this will allow the existing failed timber lintels over the first floor windows to be removed and new arch lintels installed and the whole gable rebuilt including the Southern Chimney stack.

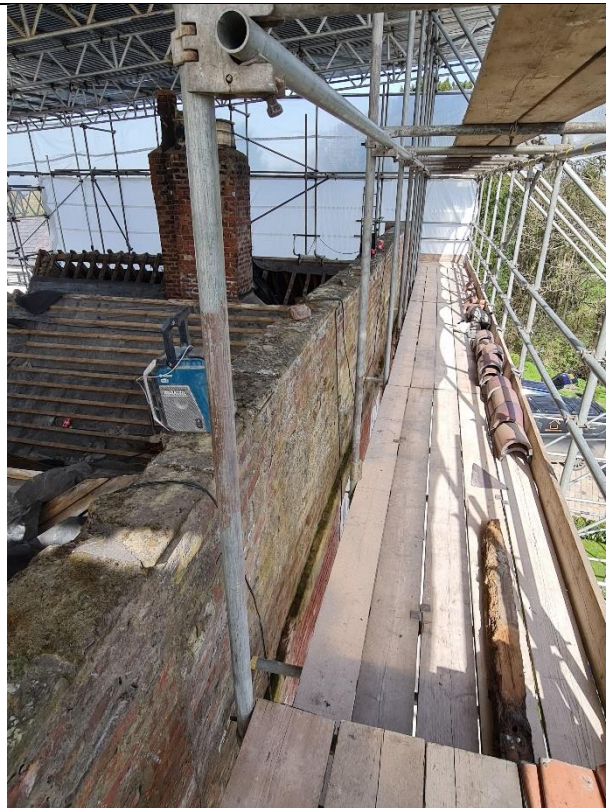
View of front Gable

Wall bowing

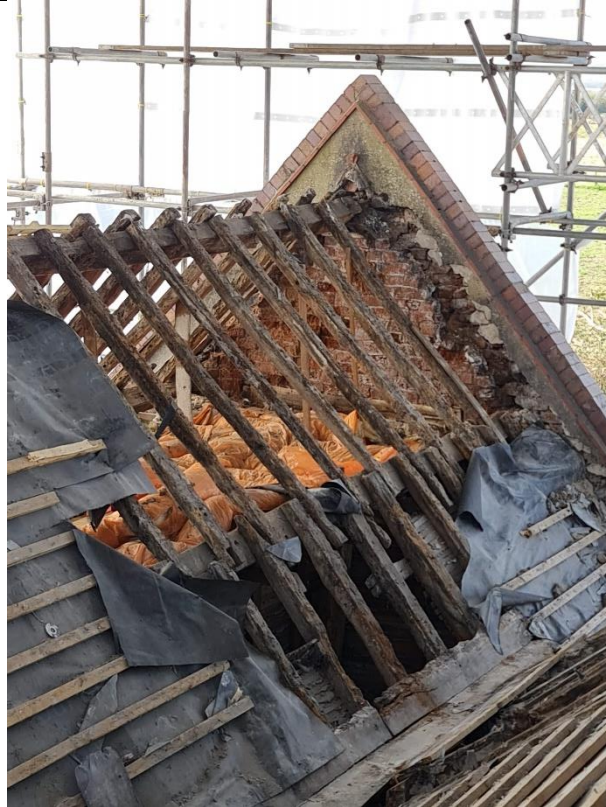
View of rear Gable

Loss of section to rafters

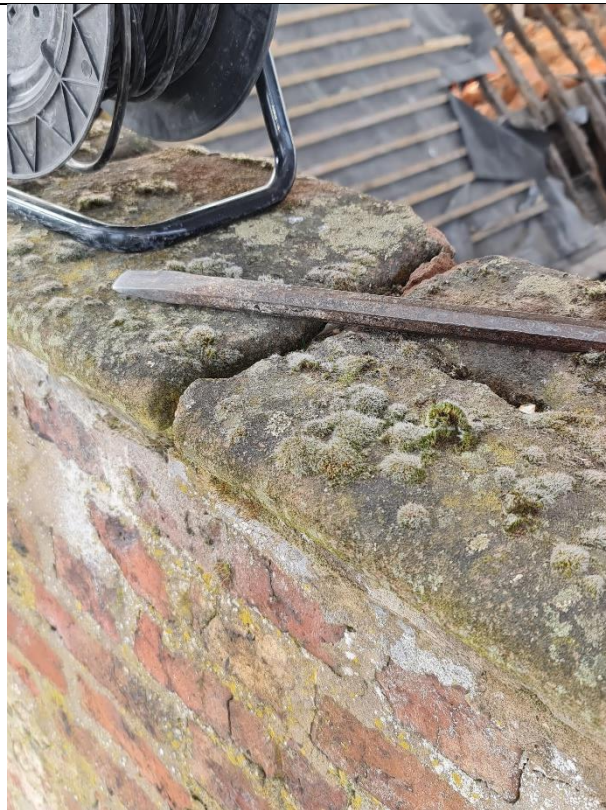
View of front coping

Coping stones loose and not fixed down

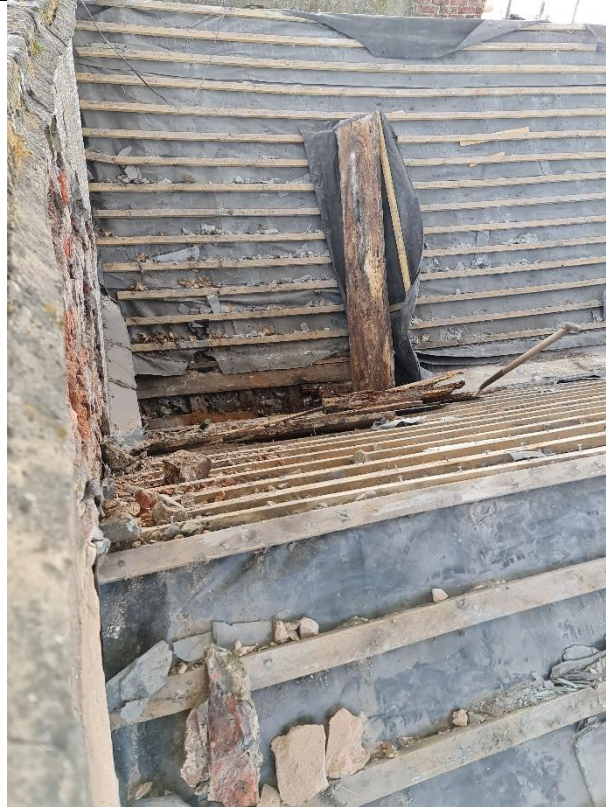
View of valley

Rot to valley gutter

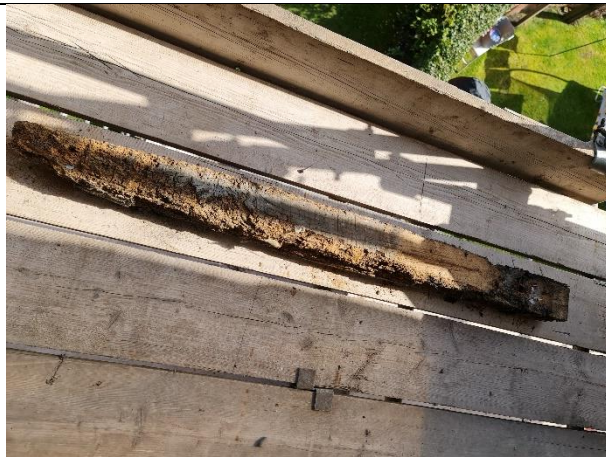
General

Rotten timber removed

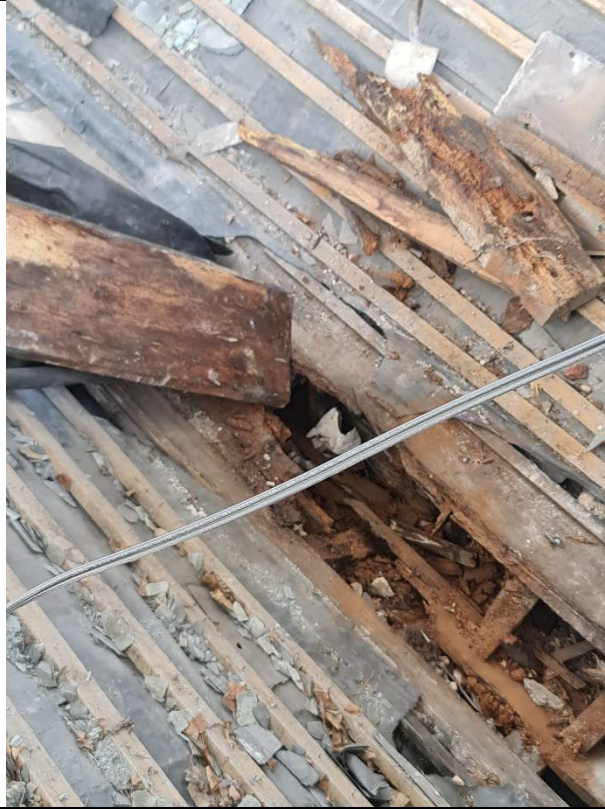
View of valley

Severe rot to valley

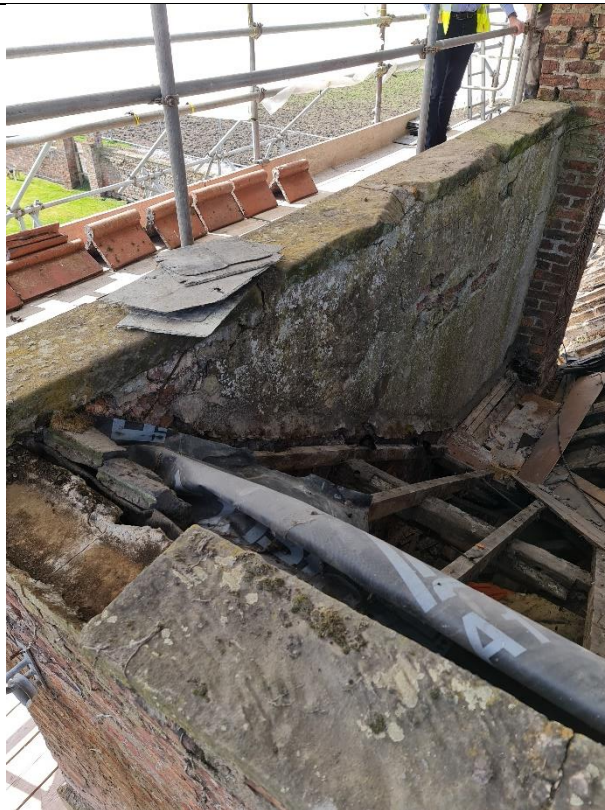
View of rear Gable

Wall bowing

The parapet gable wall and the rear gable walls, these are also in very poor condition, with excessive movement, The render has been removed and the internal face of the wall is not course and therefore provides limited structural stability. There has been a repair undertaken in the recent past to the North East corner which through anecdotal evidence collapsed which is solid and shows no sign of movement.

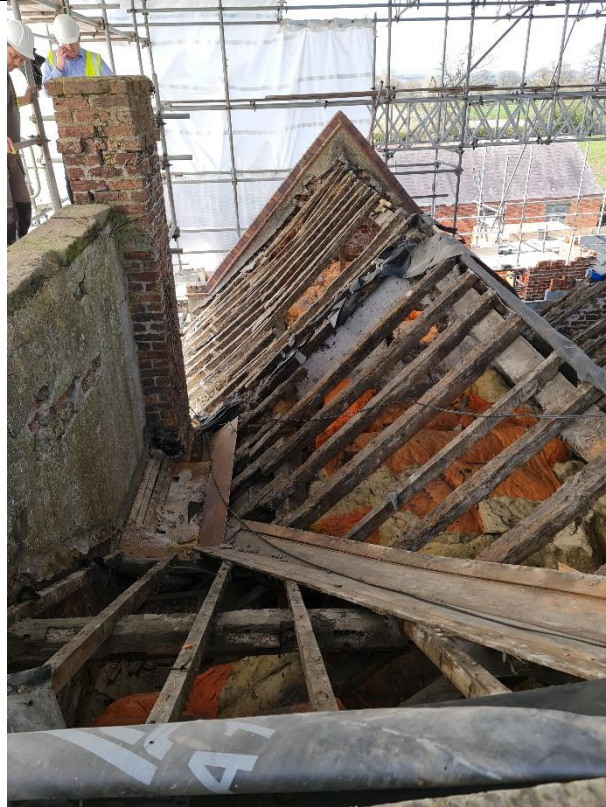
View of chimney

Chimney and parapet wall unstable and can be moved with light hand pressure.

With regards to the chimney to the southern elevation, this is in our opinion dangerous due to the excessive movement of the stack which can be moved by light hand pressure, under high wind loads we would consider this stack to be vulnerable to collapse and should therefore immediately be taken down to window head level and be re-built using existing bricks where possible. Once rebuilt we would recommend that a stay is installed to tie the stack to the newly re-constructed roof.

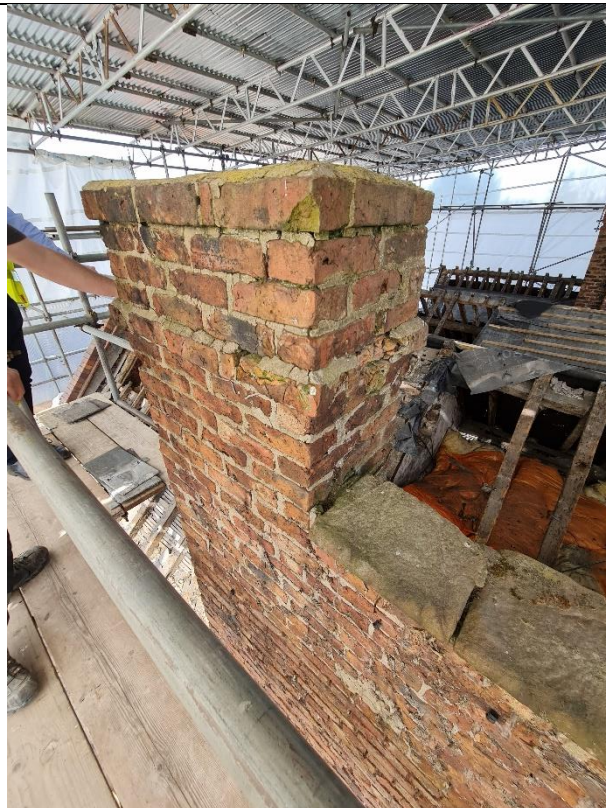
View of chimney

Dangerous chimney, can be moved with light hand pressure.

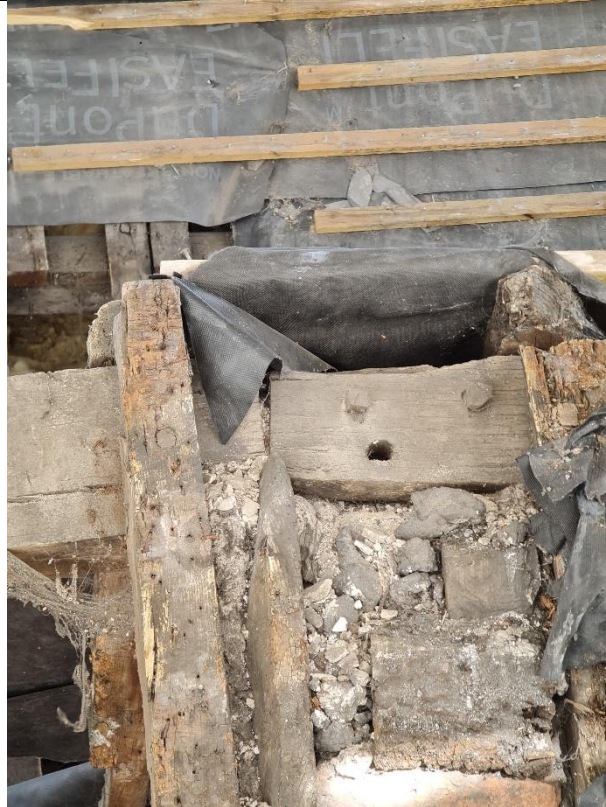
View of ridge connection

Ridge beam not supported

There are also serious defects with the detailing of the roof timbers with members such as ridge beams and purlins not being seated into the gable walls, therefore the roof as a whole is not stable.

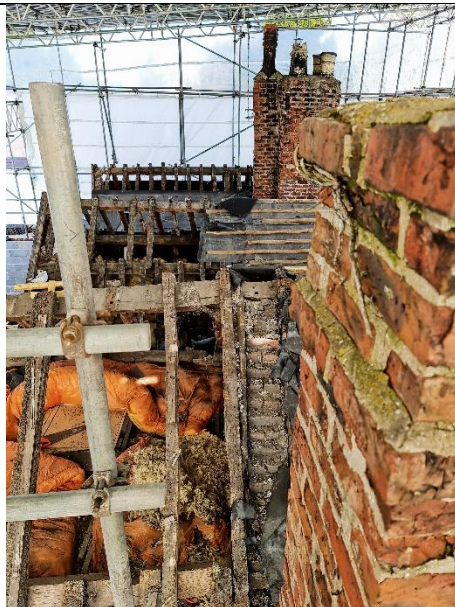
General View

Loss of timber to sections.

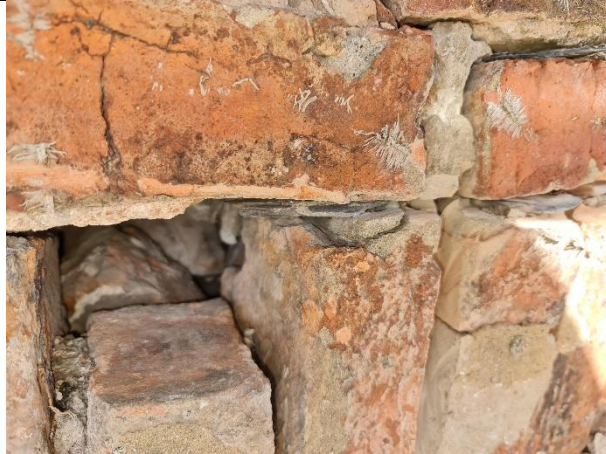
View of Lintel

Void through to timber lintel behind

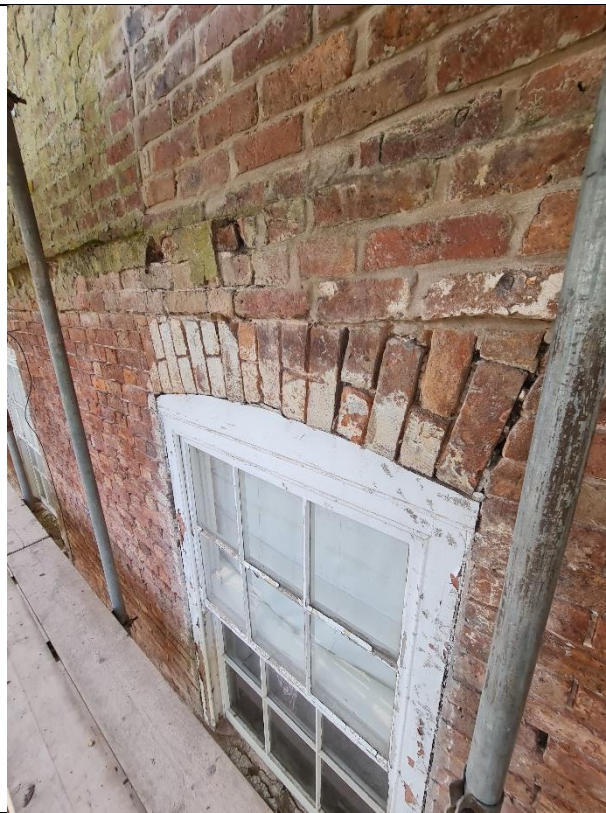
Lintel to front elevation

Lintel movement

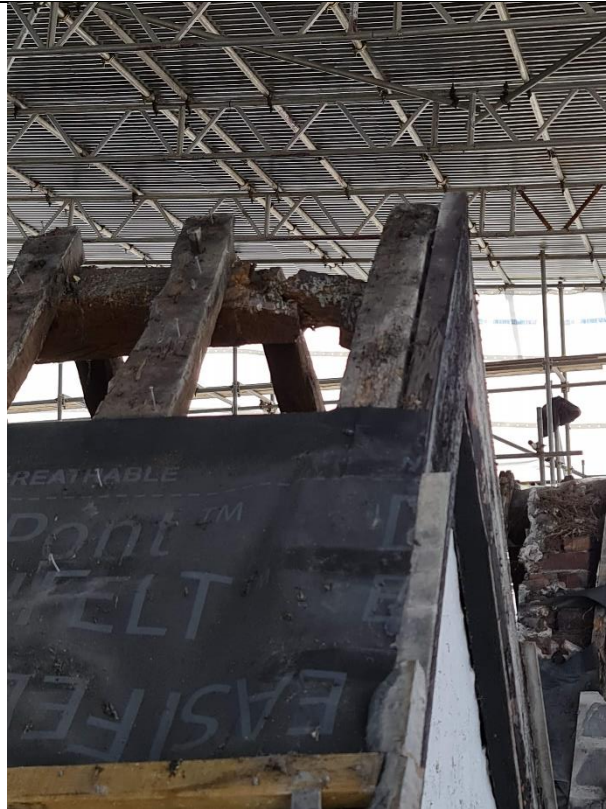
View of rear ridge beam

Failure of ridge beam
