Historic Building Recording at

# LOWER FARM BOWLING BANK

Planning App: P/2021/0604

Doc Ref: LP4028C-HBR-v1.1

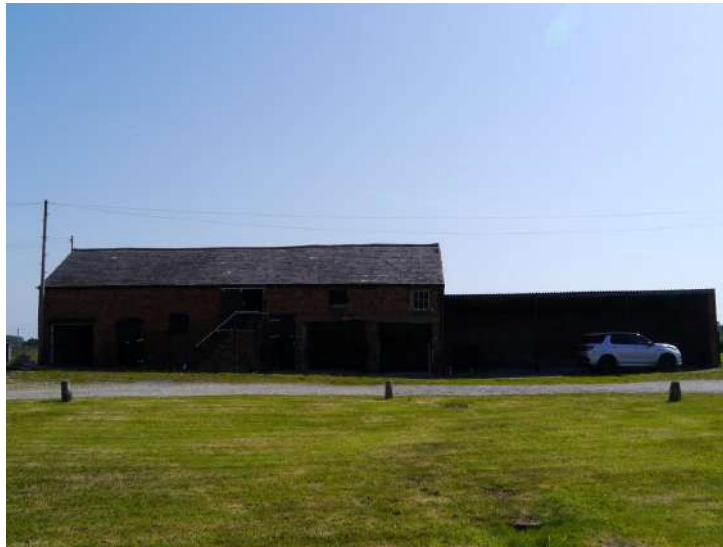
- 6.3.4. The south-west elevation functioned as the front facade and main access point into the building (PLATE 3). Protruding brick end top coursing decorated in dentil fashion, were featured below the slate roofline (PLATE 4).
- 6.3.5. Three wide barn doorways were evident along the south-west elevation. One located on the far north-west end of the facade, and two adjacent another

Plate 3 - South-west elevation

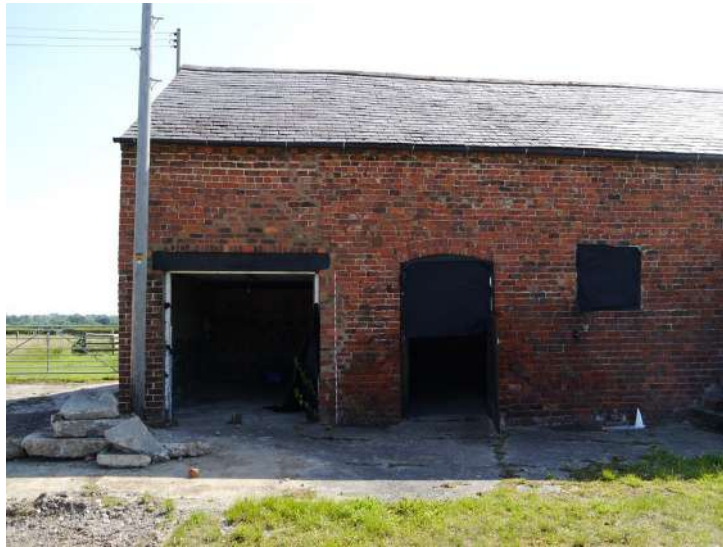
6.3.6. The north-west entranceway functioned as an access point into room B5, comprising of a timber frame, and solid timber beam lintel. There was a clear indication of restoration work to the surrounding fabric of the threshold, with an interruption to the brick bond arrangement which had been chased by a discolouration in mortar (PLATE 5). This may have potentially been the result of a later alteration phase to widen an original stable doorway.

Plate 5 - Room B5 threshold

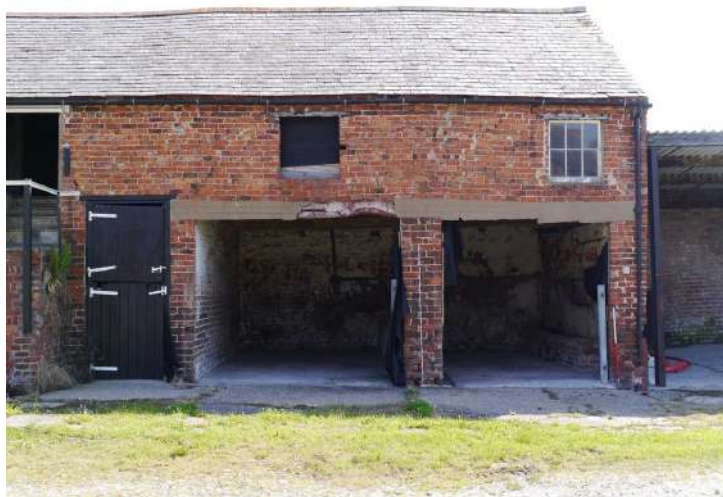
6.3.7. The two much wider entrance points situated on the far south-east elevation, comprised of solid timber beam lintels which were coated in etched plaster so to resemble a stretcher brickwork bond. B8 was marginally wider than the adjacent room B9 to the south-east (PLATE 6).

Plate 6 - Threshold of room B8 (left) and B9 (right)

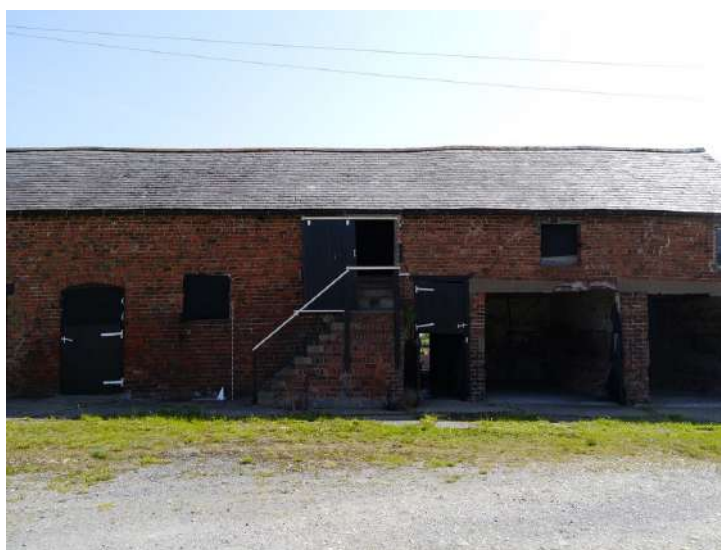
- 6.3.11. Situated south-east of the B6 window, a steep protruding outer staircase that ascended south-eastwardly to a narrow doorway located on the upper most elevation. Constructed from brick in typical english bond and large stone slabs, the feature functioned as an access route to the room F3 located on the first floor. The narrow and short sliding doorway entrance above the staircase was positioned directly below the roofline (PLATE 7).

Plate 7 - External staircase

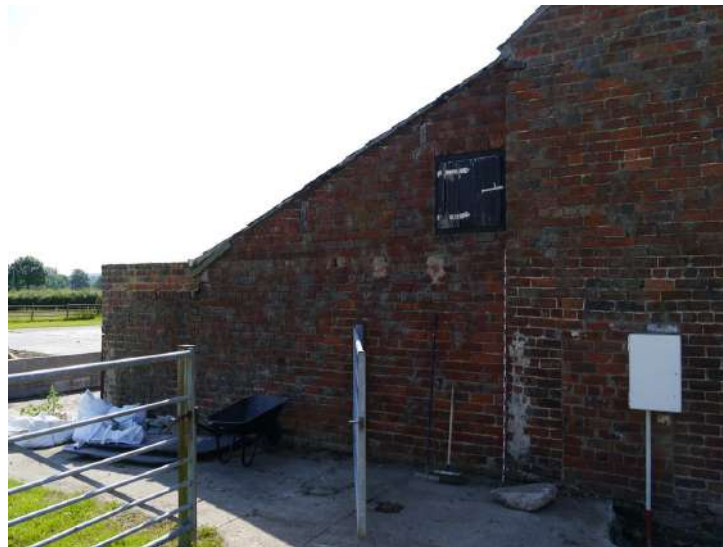
Plate 10 - Sealed feature

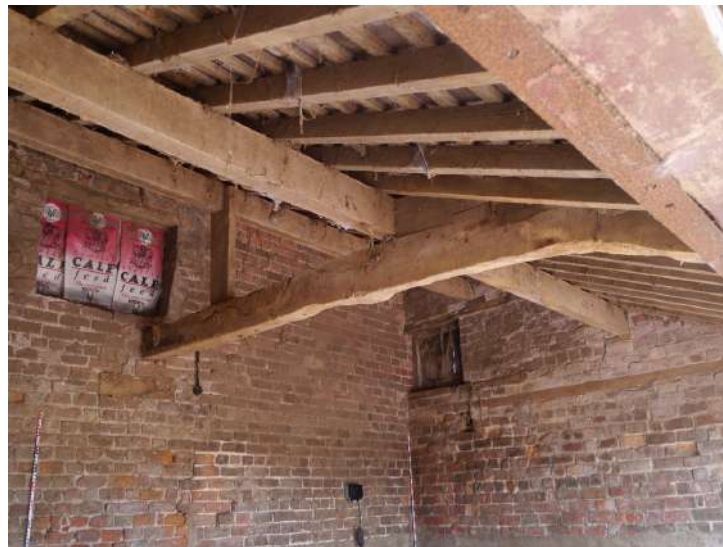
- 6.4.4. A small square pitching hole was positioned in the corner of the upper north-west wall, directly adjacent the south-west wall (PLATE 15). A horizontal timber blank lintel and sill was evident. Parallel to the opening on the south-east elevation wall was another pitching opening in similar dimension, complete with a horizontal timber blank lintel and sill fussed into the brick fabric, which would have created an opening into the adjacent Room 2. Features likely associated to an air ventilation system.

Plate 15 - Air ventilation window north-west wall room B1

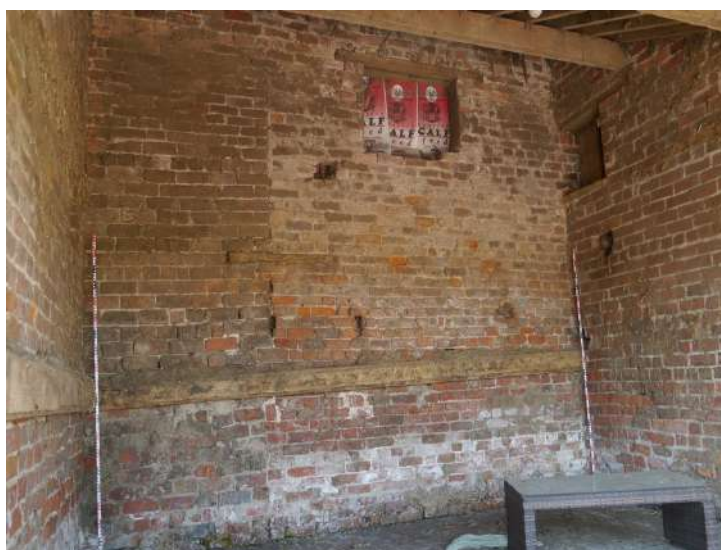
6.4.12. A reconstruction phase was evident as a clear vertical division score within the south-west brick fabric, distinguishable from the dissimilarity in brick colour and a break in bonding from the foundation to the roofline (PLATE 17). The later phase of brickwork extended from the centre of the wall to the north-west wall. Most likely associated to the similar feature seen in room B1 which would have probably been an original wide open Bay into room B6.

Plate 17 - South-west reconstruction wall room B2

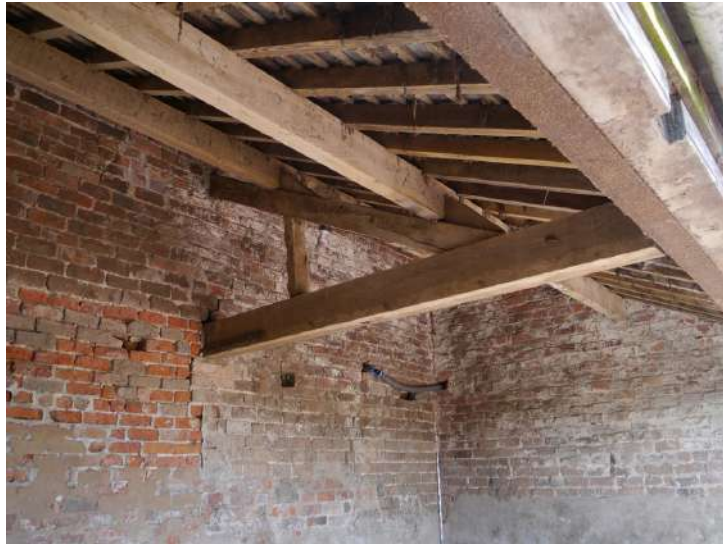
the north-west elevation wall (PLATE 21). Two purlins sat above the tie beam which were fused into the north-west and south-east walls. A series of common rafters rested above the purlins, extending in a declining fashion from the south-west wall to the steel joist of the north-west access point.

Plate 21 - Open roof with steel joist room B4

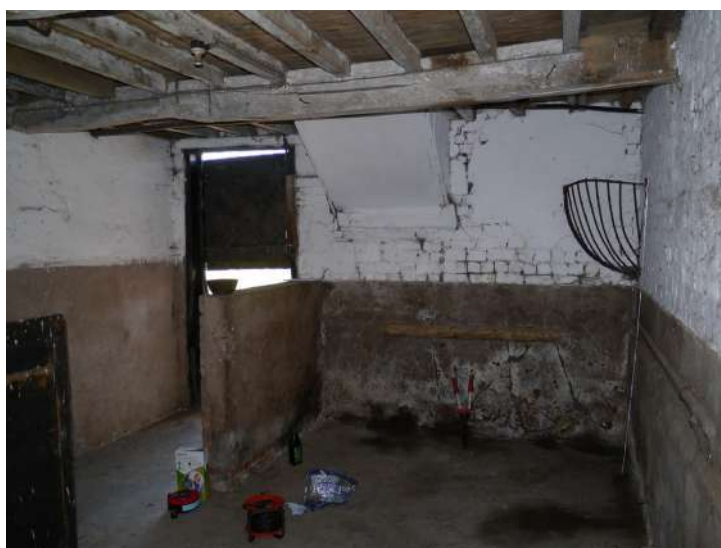
6.4.46. The outer staircase, positioned on the front facade, protruded marginally within room B7 along the south-west wall. (PLATE 28)

Plate 28 - Intruding staircase room B7

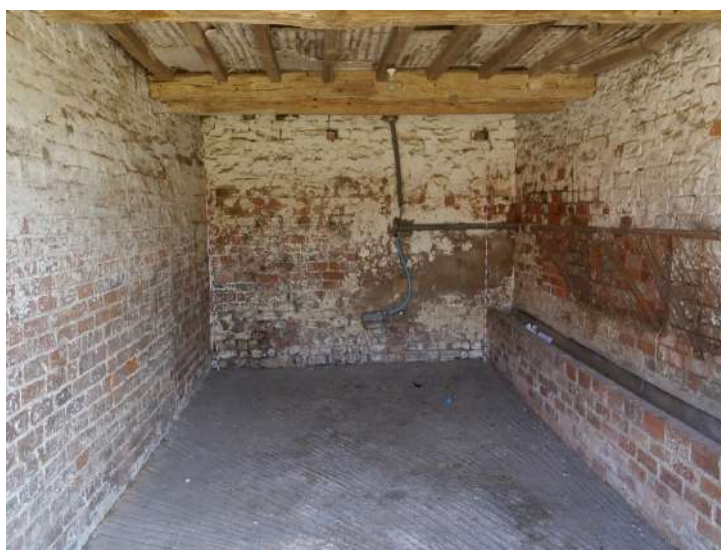
6.4.50. Room B8 was assessable via a large open doorway situated on the south-west elevation. The internal features consisted of english garden wall stretcher bond brick on the north-west, north-east, and south-east elevations. A residue of white paint was evident upon the brickwork, primarily surviving on the upper sphere of the foundations (PLATE 29).

Plate 29 - room B8

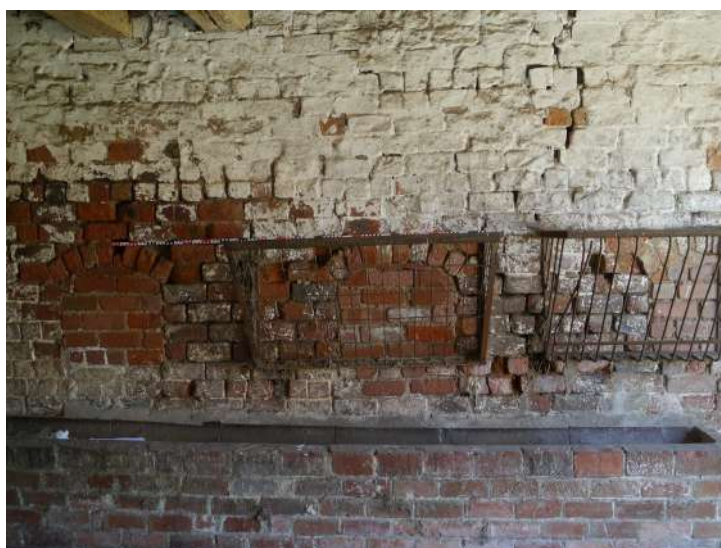
6.4.53. Three flat romanesque styled arched air ventilation windows were evident in a consecutive horizontal fashion along the centre of the south-east wall. Originally, the features would have formed an opening between room B8 and adjacent room B9, although, all three air ventilation windows were blocked in brick at a later phase (PLATE 30).

Plate 30 - Three sealed air ventilation features on the south-west wall in room B8

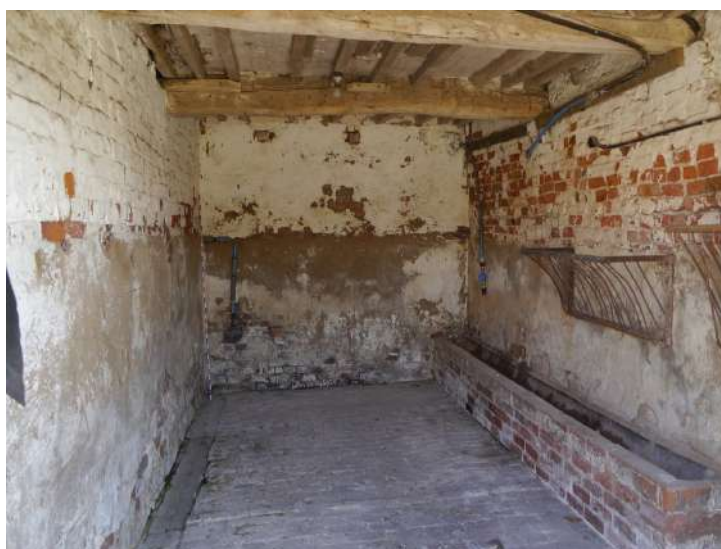
6.4.56. Room B9 fell marginally in breadth compared to room B8, but held similar internal features. The north-west, north-east, and south-east brick walls were fashioned in english garden wall bond. The lower brick surface was plastered in a layer of cement render, while the upper in white paint (PLATE 31).

Plate 31 - Room B9

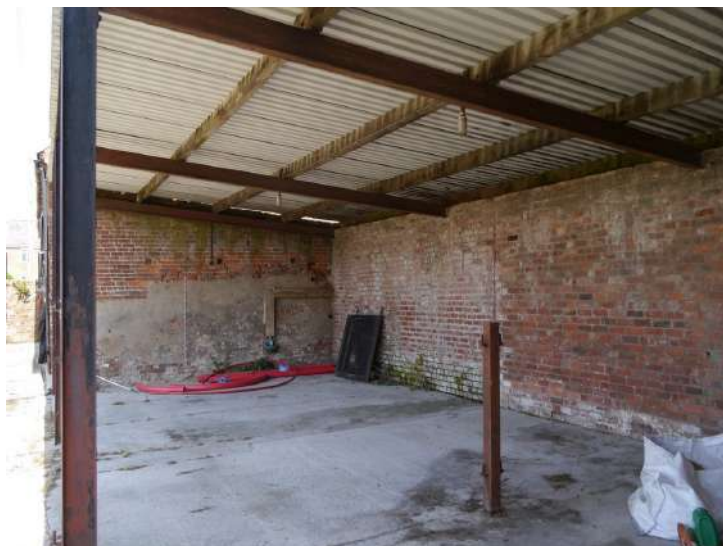
6.4.63. The floorspace consisted of modern concrete and utilised for storage during the time of survey (PLATE 33).

Plate 33 - Internal space room B10

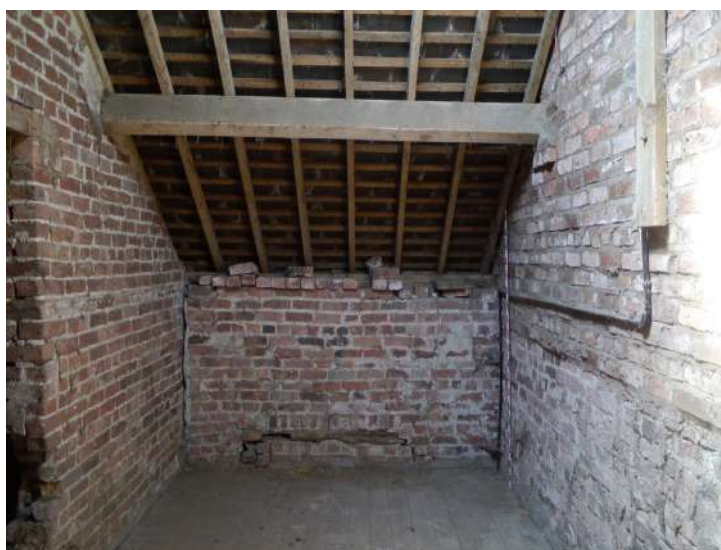
- 6.4.69. A series of headers were evident along the fourth lower course of the south-west wall, with a timber frame imbedded directly below (PLATE 36). Possibly the reminiscence of a lintel where a threshold once stood for access into room B5 below.

Plate 36 - South-west wall room F1

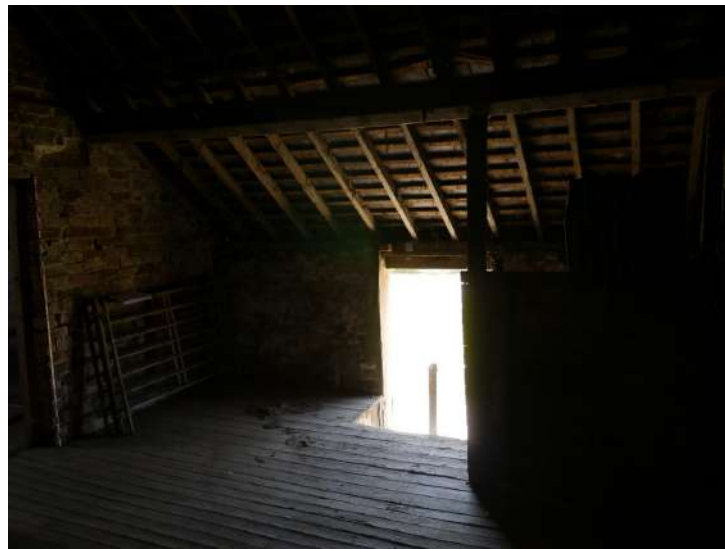
6.4.76. The short narrow threshold, positioned on the south-west elevation in room F3, functioned as the main and only access route into the first floor level from the external staircase (PLATE 39).

Plate 39 - Threshold south-west elevation room F3

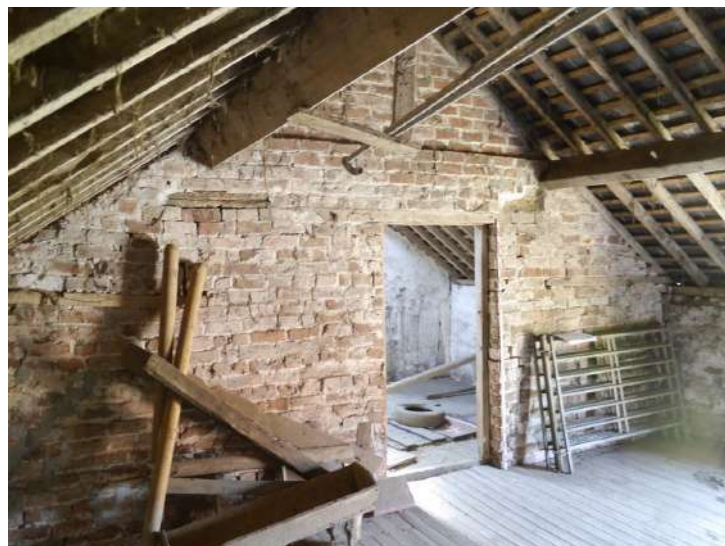
Plate 40 - South-east elevation room F3

6.4.77. Room F2 was assessable via a wide open threshold on the north-west elevation, and room F4 via a much narrower threshold on the south-east elevation (PLATE 40).

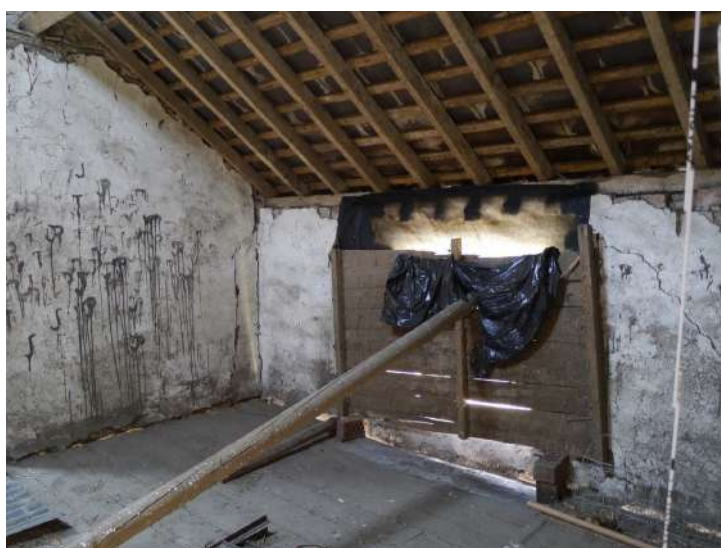
6.4.85. A small square window was positioned o the south-west wall (PLATE 42).

Plate 42 - Window feature room F4
