**FIR TREE HOUSE CLOY LANE OVERTON - OUTBUILDING**

As requested, we carried out a structural appraisal on the above mentioned outbuilding on Tuesday 4 August 2020.

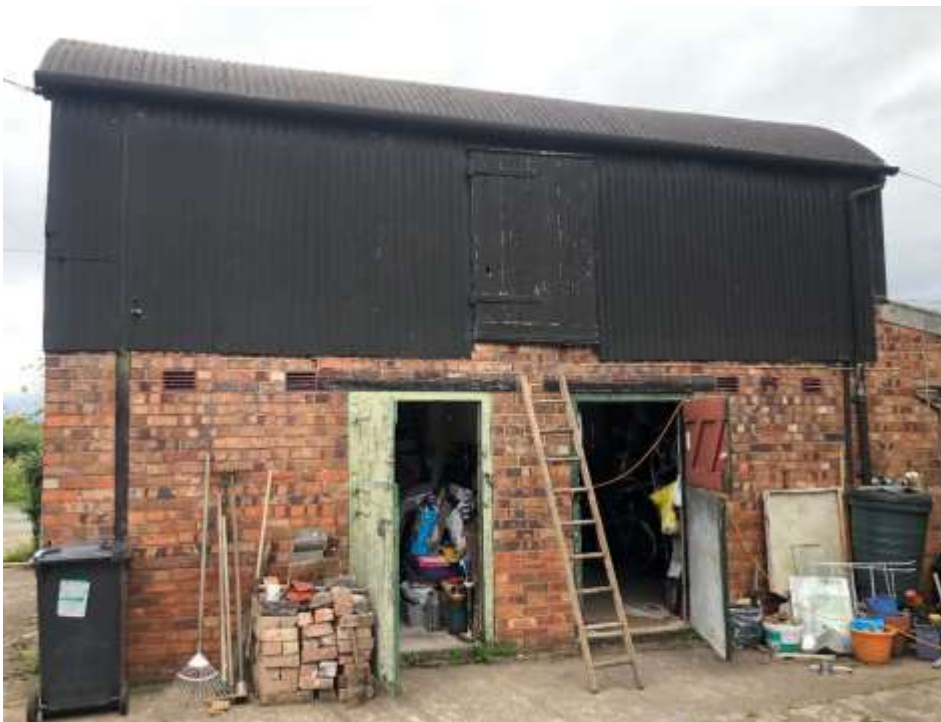
Photograph P1

The roof has a barrel vaulted, corrugated steel sheeted finish, see photograph P1.

The roof construction will need to be replaced for both the two storey building and the lean-to.

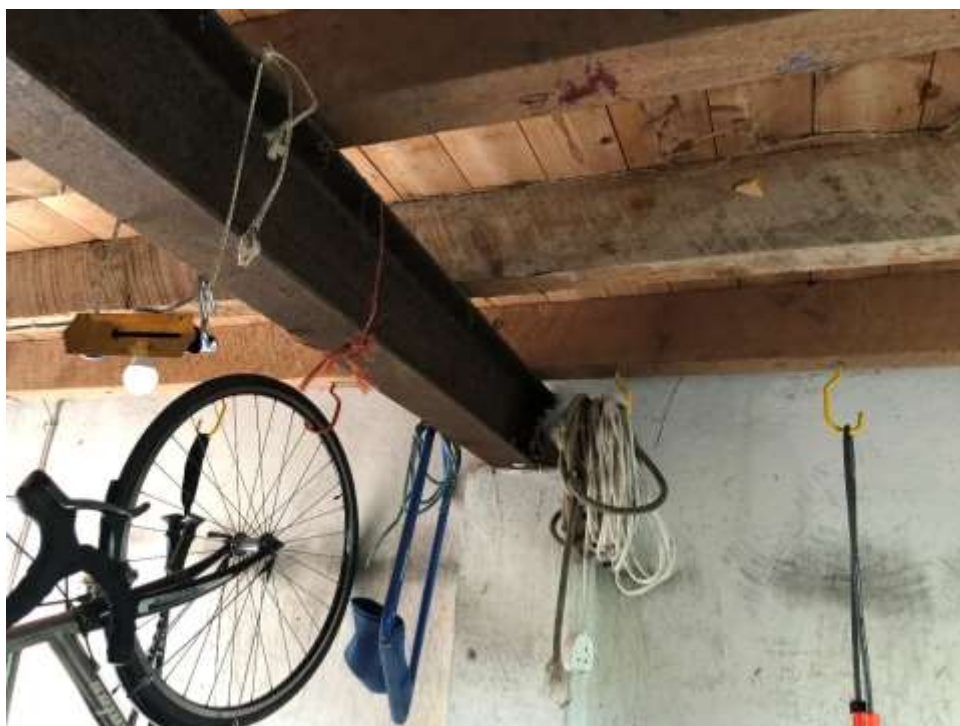
Photograph P2

The first floor joists appear to be in a reasonable condition commensurate with age along with the independent steel supporting members, see photograph P2. The floor is generally level.

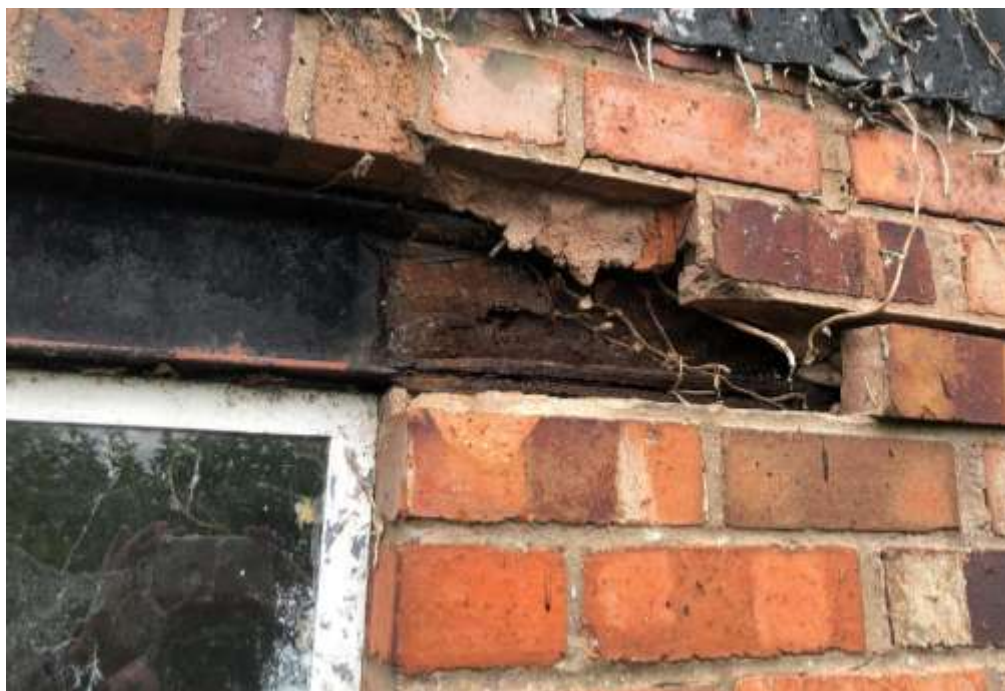
Photograph P3

**1.3** Externally the steel columns have steel tie members just below first floor level which are exposed externally and the brick walls are constructed above and below them. The exposed steel members have corroded badly and delamination has occurred in numerous locations, see photograph P3. The delamination of the steelwork has forced the brickwork to dislodge locally.

The steel framework would not be suitable for re-use in the proposed development for change of use, as the exposed steelwork has corroded badly in numerous locations. The steel frame should be removed from the structure and new loadbearing walls taken up to form the new upper wall construction. The brickwork will require bonding together when the existing steel columns are removed from the wall panels.
