**Site:** Holt Hill  
**Client:** C Eaton  
**Project Title:** Holt Hill  
**Document Title:** Building Inspection  
**Document Ref:** 19169  
**Report Status:** Issued for Information  
**Approval Project Director:** Karl Hill  
**Project Manager:** Yvonne Hogg  
**Struktura Limited:** Queens Chambers 5 John Dalton Street Manchester M2 6ET

## 1. Introduction

Struktura were requested by Mr C Eaton to attend site on Tuesday 27<sup>th</sup> April 2021 to inspect the property following works to reduce the wall height as recommended in the previous report dated 31<sup>st</sup> March 2021.

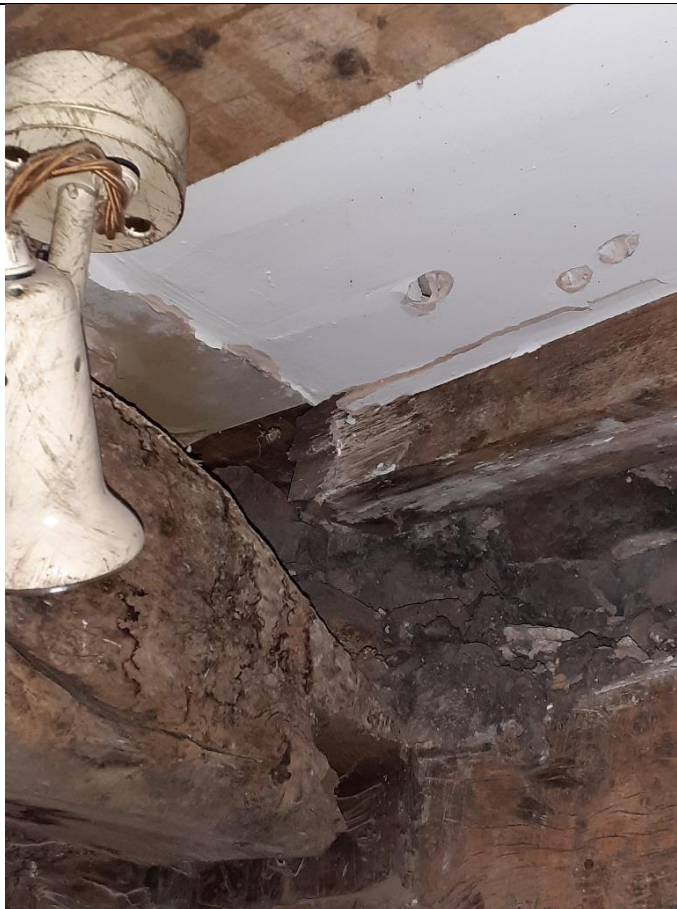
#### Kitchen

Primary beam badly affected by woodworm, inadequate bearing at lintel.

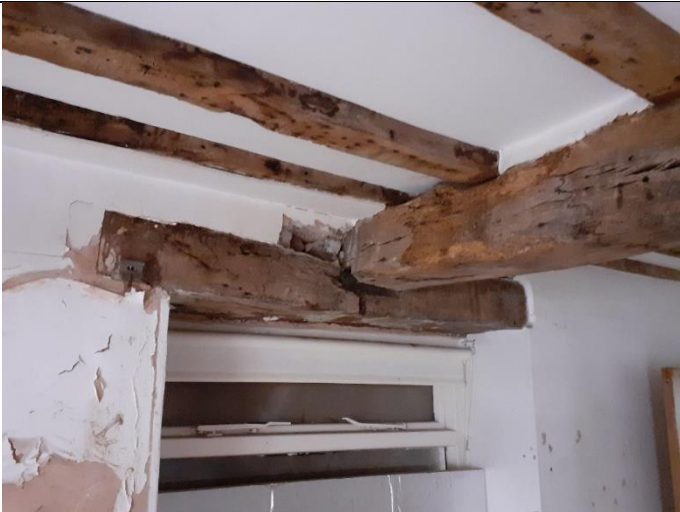
| | | lintel failed and badly affected by woodworm |

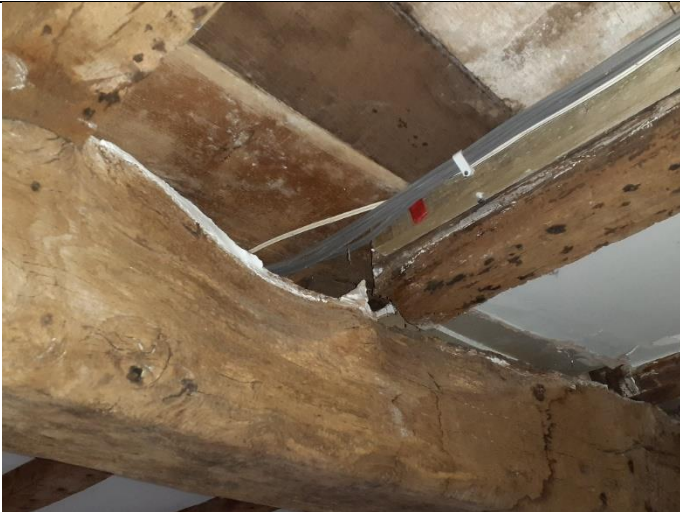
| | | 1 <sup>st</sup> floor joists badly affected by woodworm and have little or no bearing onto the primary beam. |

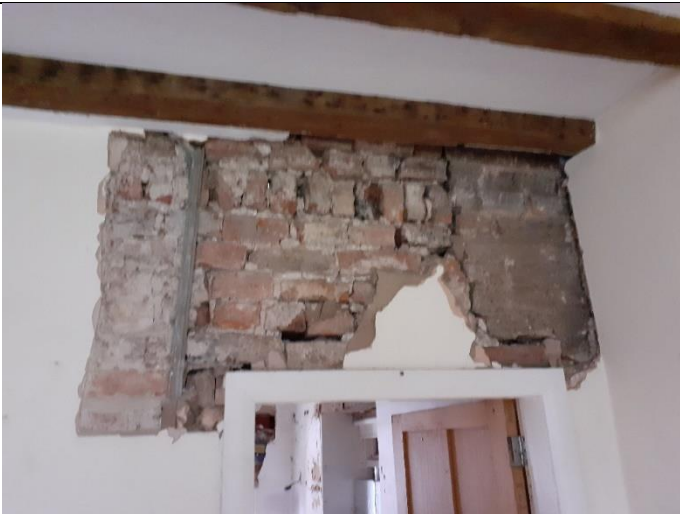
| Dining room | | No lintel over kitchen doorway, masonry not coursed, loose and unstable. |

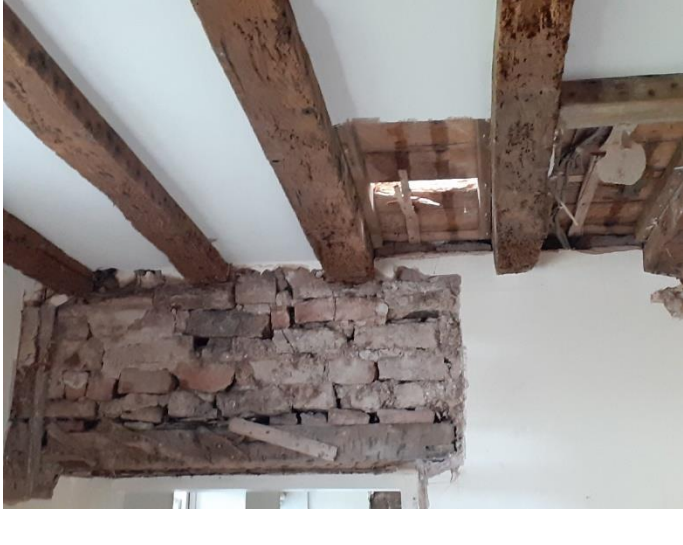
| | | <p>Timber lintel over lounge doorway, masonry not coursed, loose and unstable.</p> |

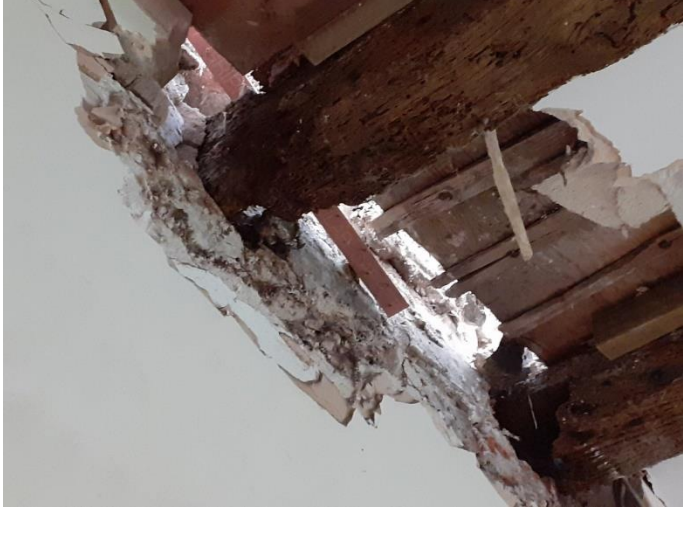
| | | <p>The majority of the 1<sup>st</sup> floor joists are badly affected by woodworm and rot. Significant loss of cross section and inadequate bearing at external wall.</p> |

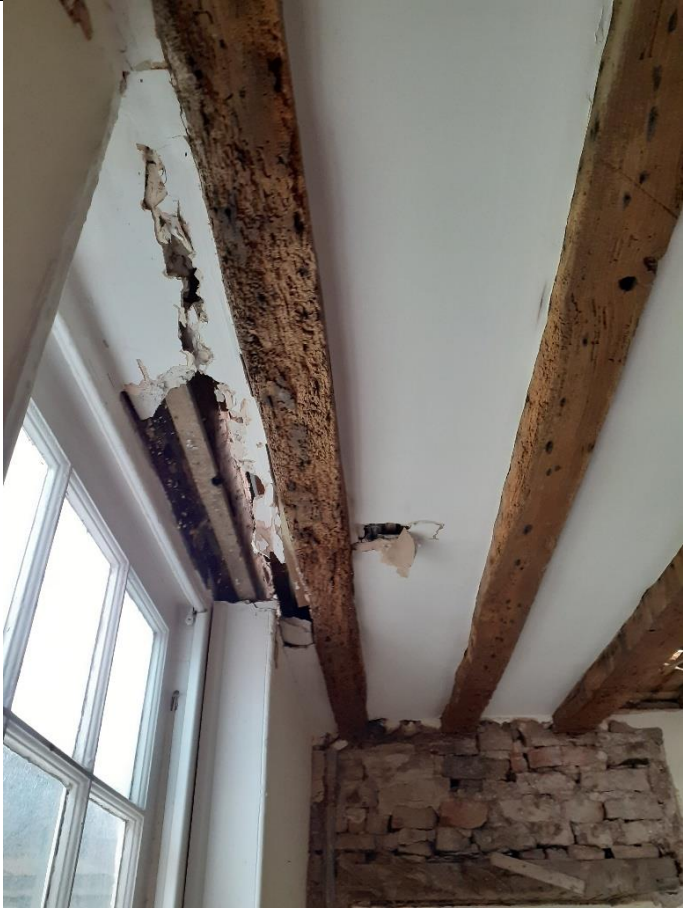
| | | <p>The majority of the 1<sup>st</sup> floor joists are badly affected by woodworm and rot. Significant loss of cross section and inadequate bearing at internal wall. Embedded timber lintel over front window is badly affected by rot and woodworm.</p> |

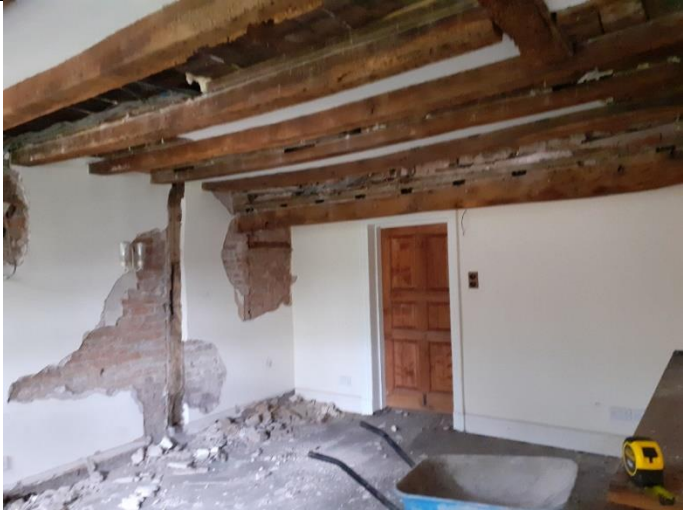
| Lounge | | <p>Beam and 1<sup>st</sup> floor joists are badly affected by woodworm and have significant loss of cross section. Beam carries 1<sup>st</sup> floor masonry wall.</p> |

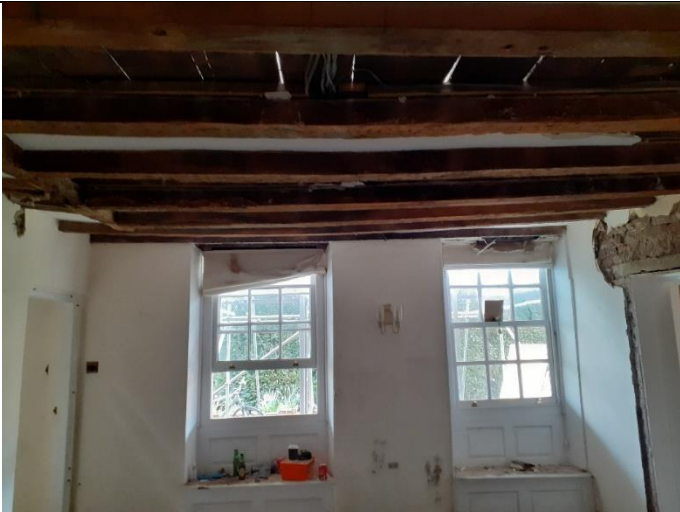
| | | Beam and floor joists sagging. |

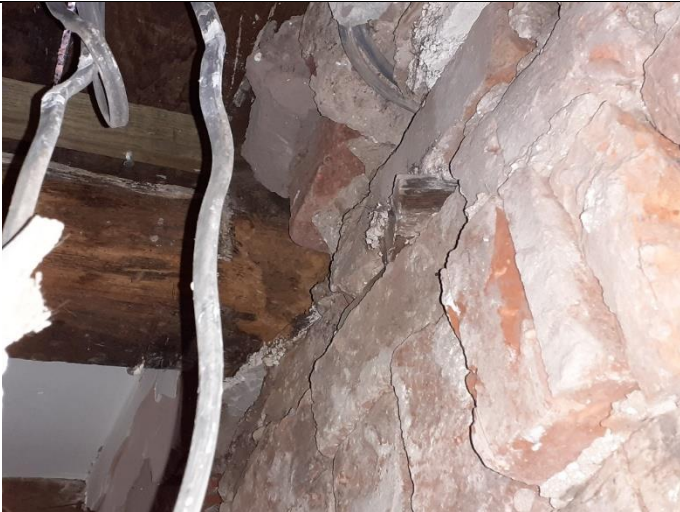
| | | 1 <sup>st</sup> floor joists have inadequate bearing. |

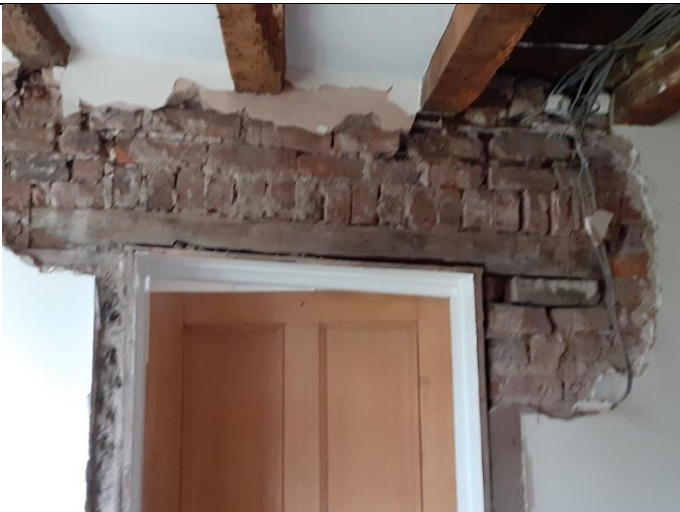
| | | Timber lintel over study doorway, masonry above loose and unstable. |

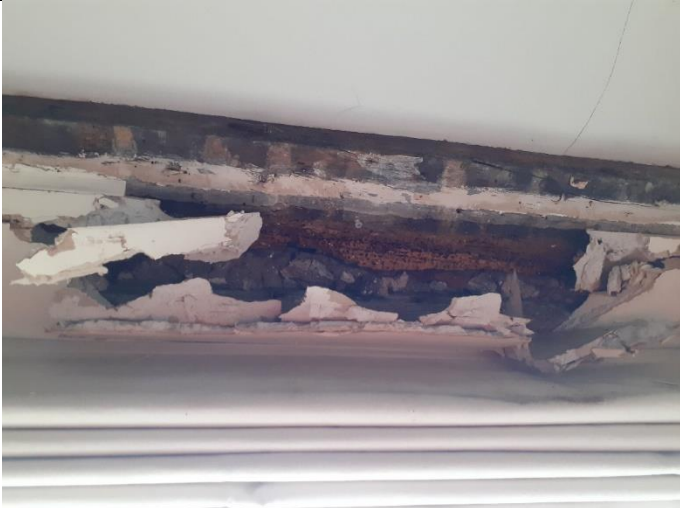
| | | Lintels over both front windows are badly affected by woodworm and rot and have significant loss of cross section. |

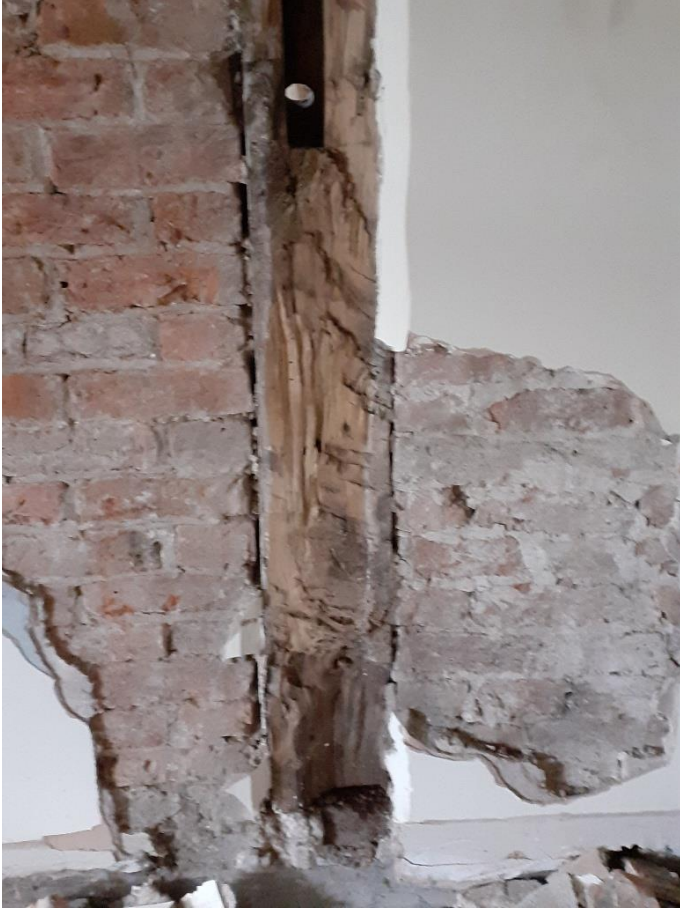
| | | Embedded timber column badly affected by rot and is not supported at the bottom. |

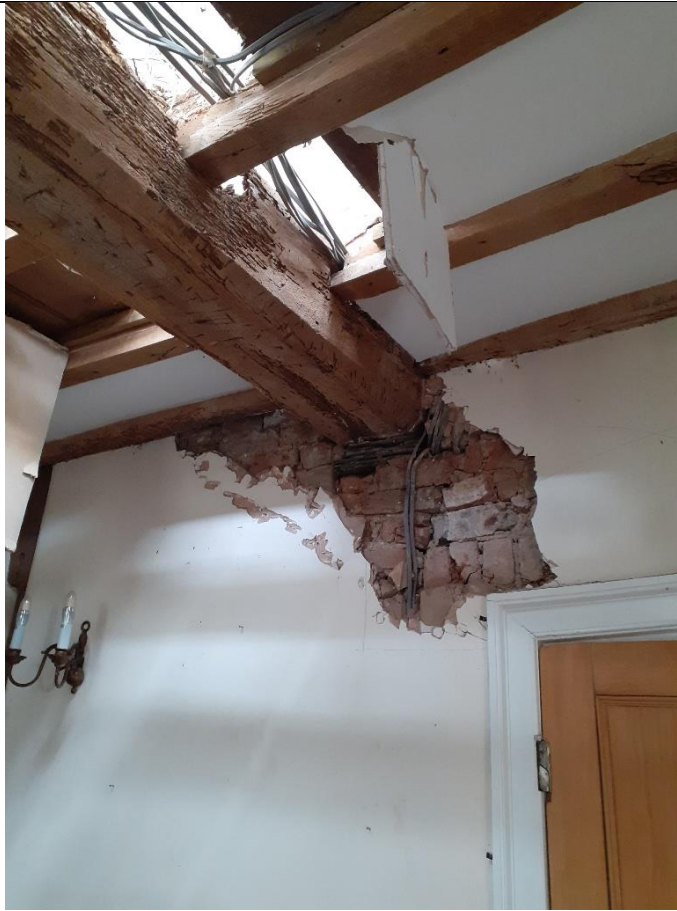
Primary beam badly affected by rot and woodworm with significant loss of cross section.

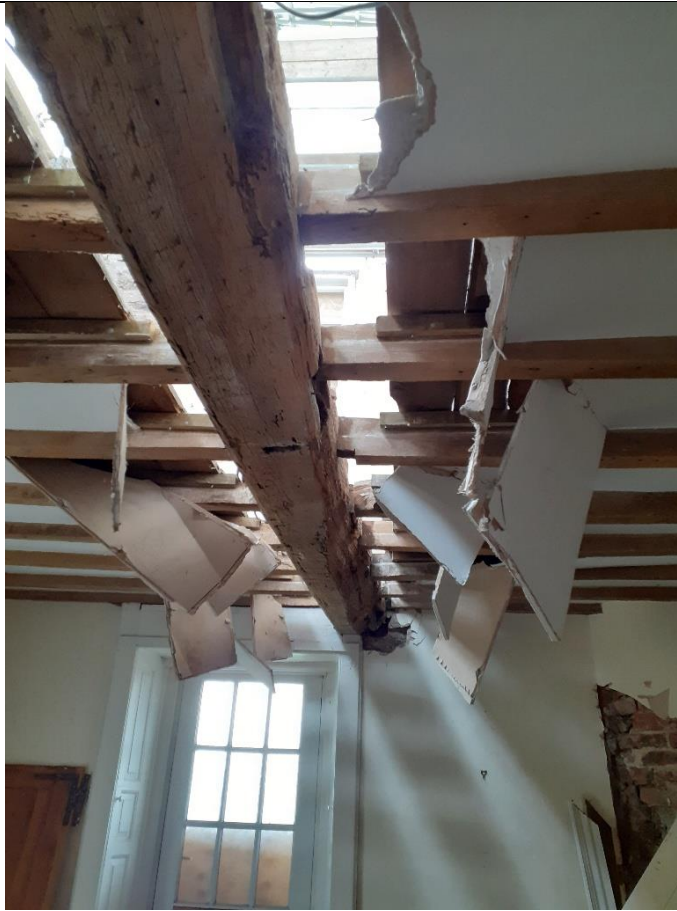
1<sup>st</sup> floor joists are badly affected by woodworm and have significant loss of cross section. Joists are notched at primary beam and have inadequate cross section at bearing.

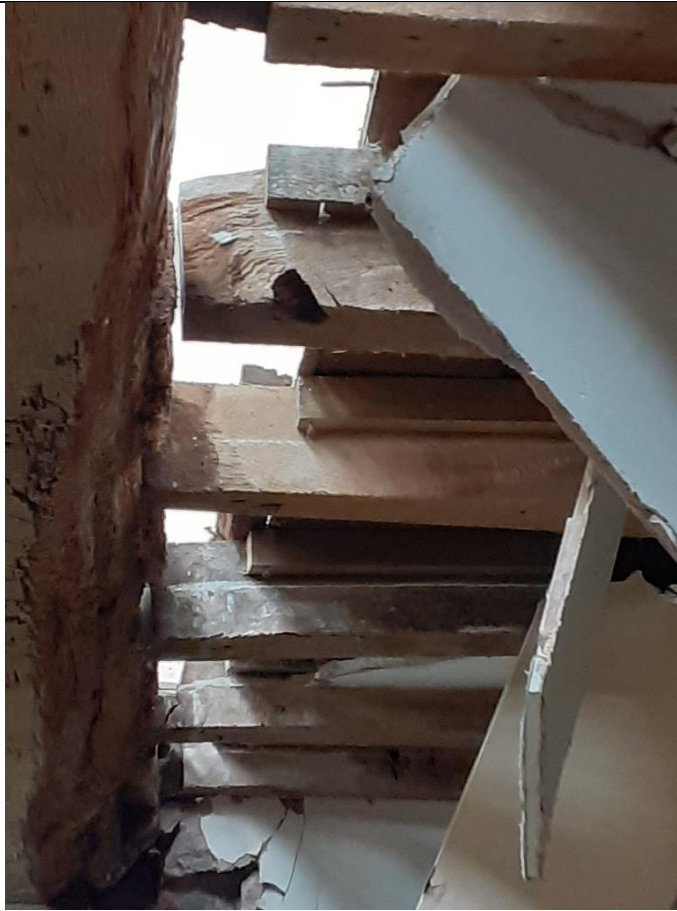
Some joists have no connection to the primary beam.

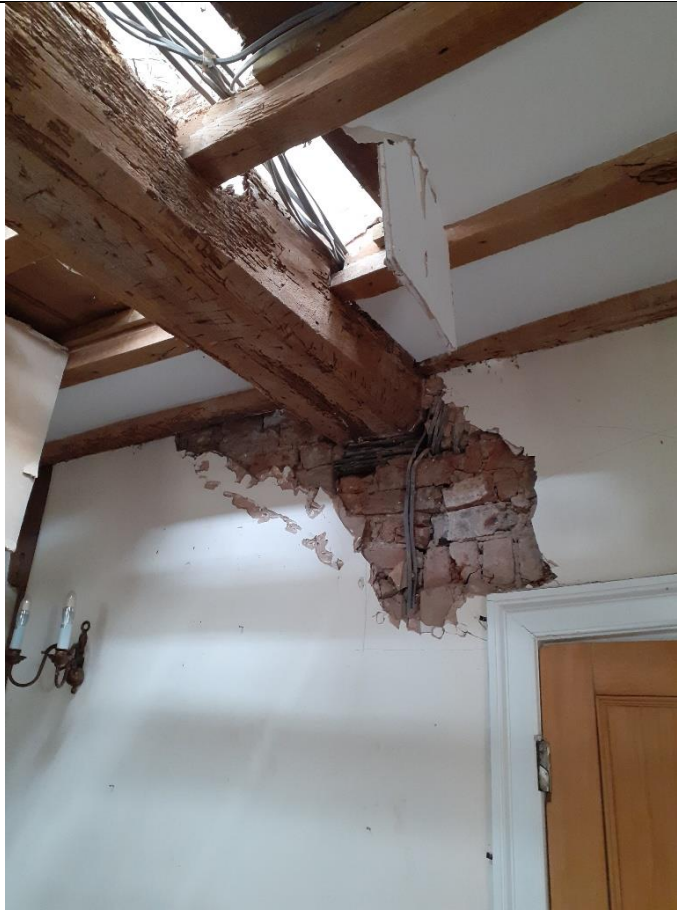
Internal wall  
masonry not  
coursed and  
in poor  
condition

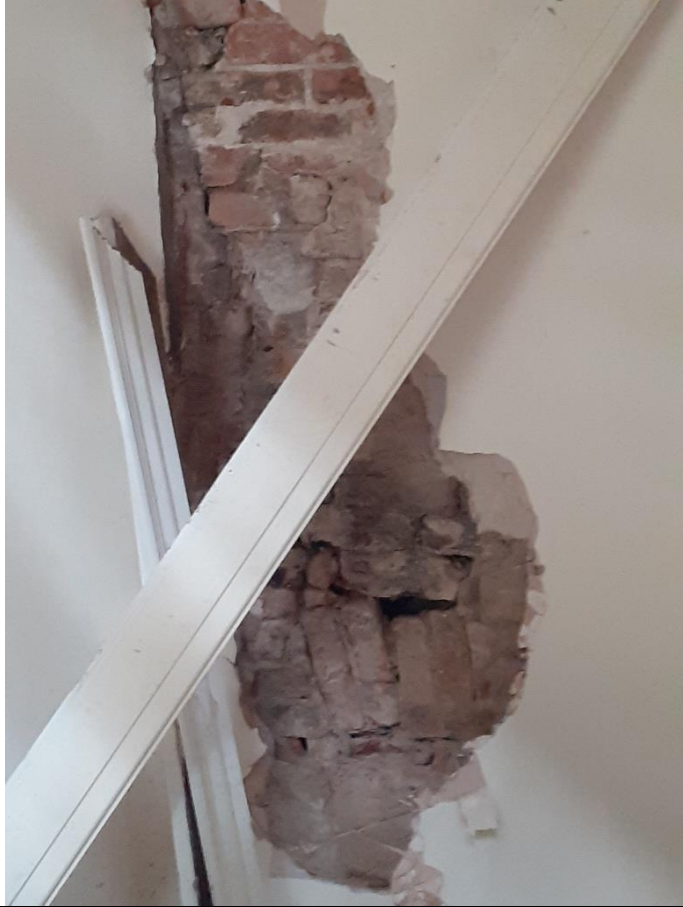
| | | <p>Masonry of corner chimney in poor condition and not connected to side wall</p> |

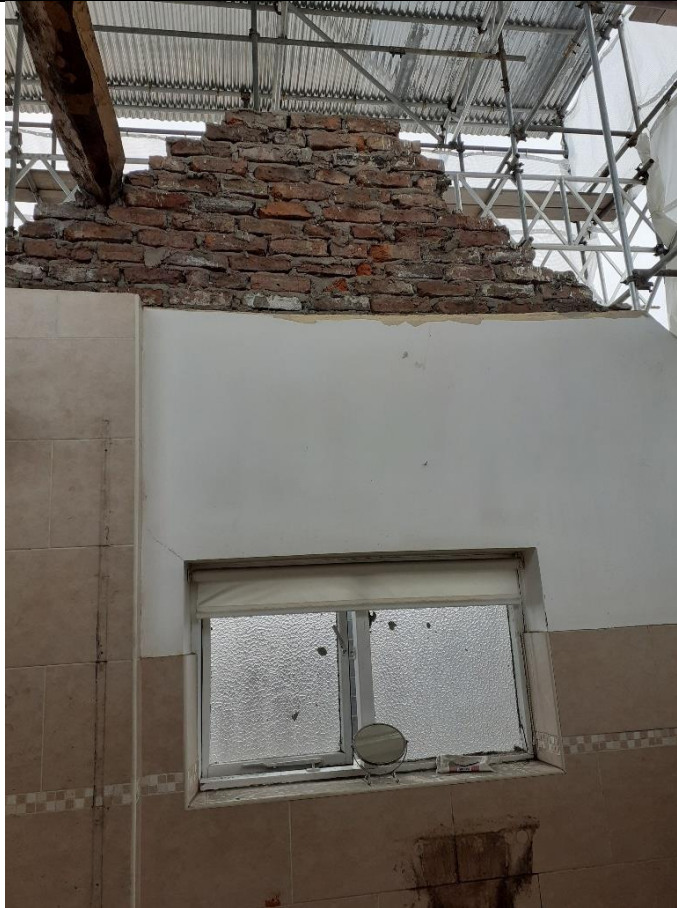
Original gable pike masonry unstable and out of plumb. No restraint from retained purlin.

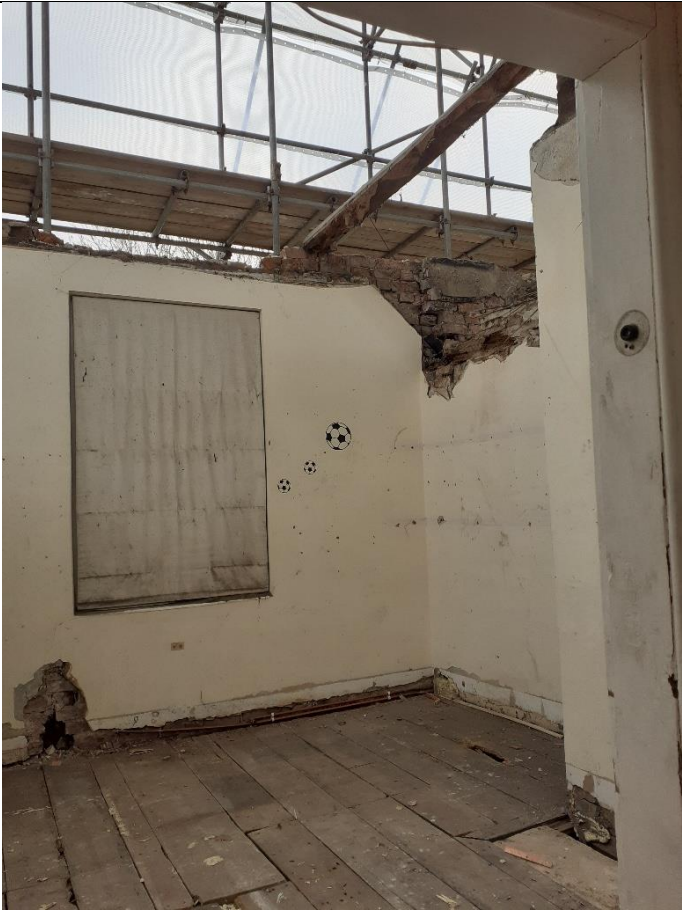
| <b>Bedroom 3</b> | | Floor boards affected by woodworm. No restraint to masonry from retained purlin |

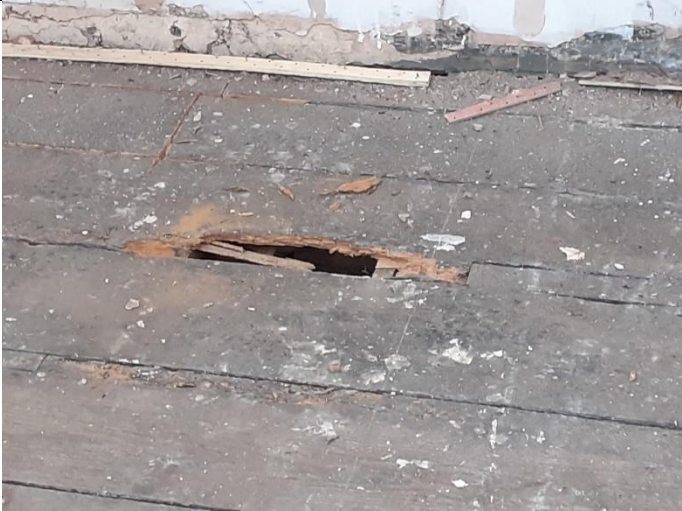
| | | Holes in floor boards from worm damage. |

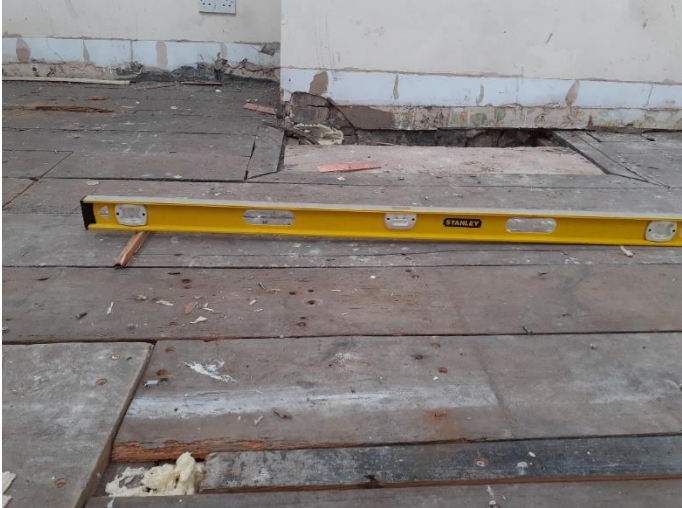
| | | <p>Floor sloping.</p> |

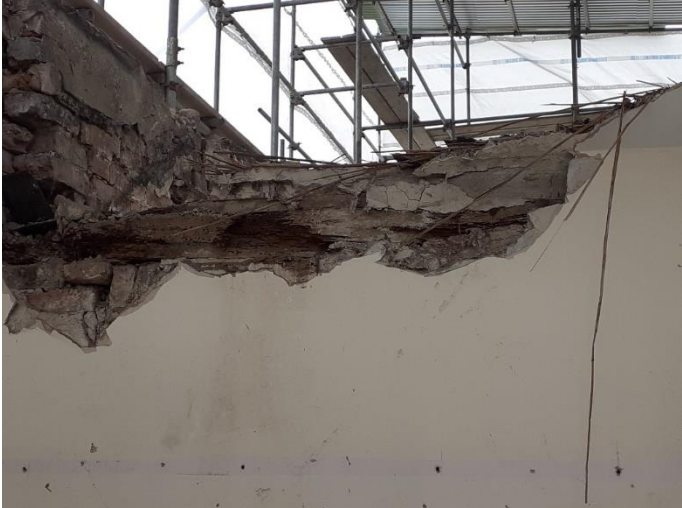
| | | <p>Embedded timber severely rotted and affected by woodworm. Significant loss of cross section</p> |

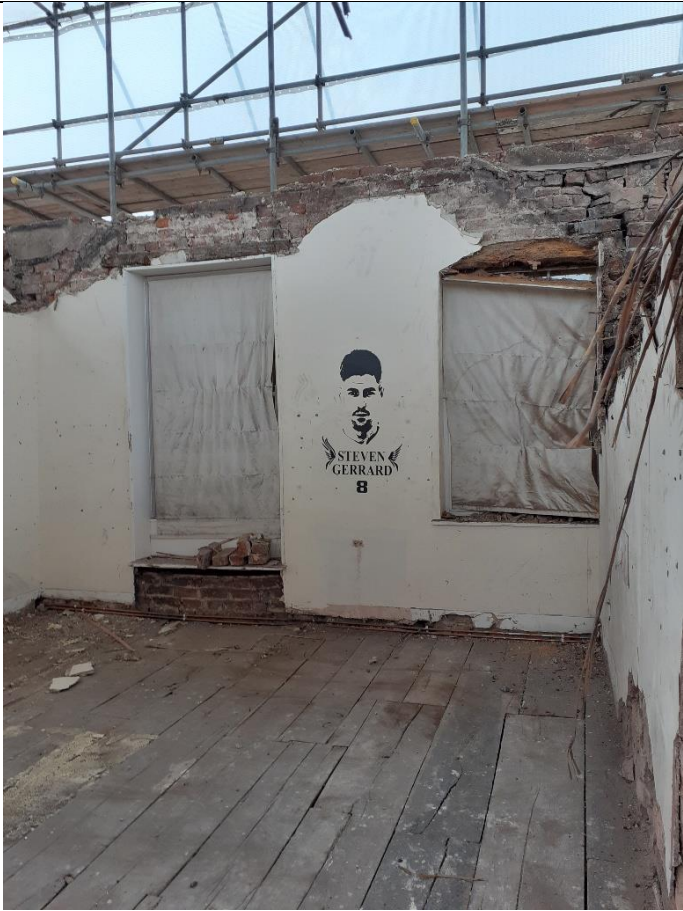
| <b>Bedroom 2</b> | | <p>Timber lintels over front windows badly affected by woodworm and rot, significant loss of cross section. Masonry of front wall loose and unstable.</p> |

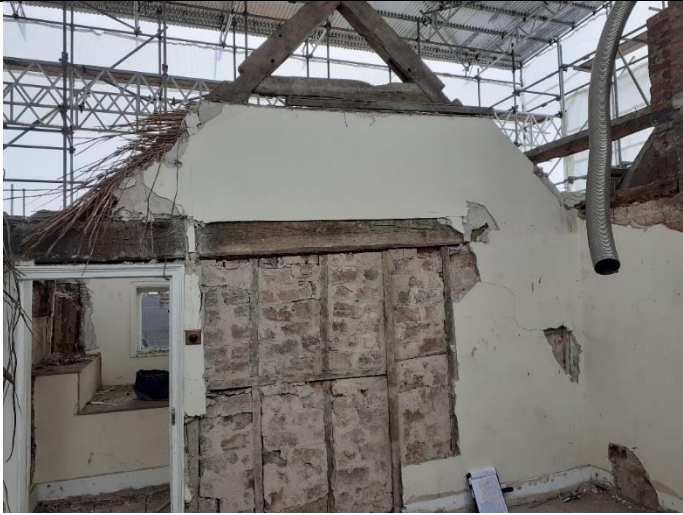
| | | <p>Internal wall is masonry filled timber frame</p> |

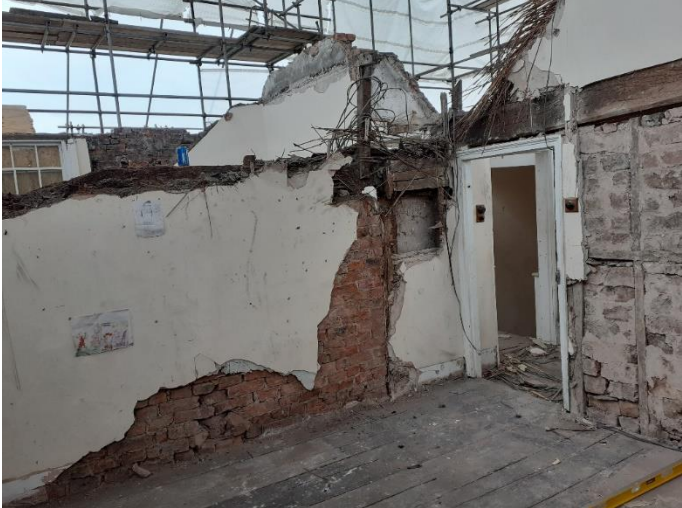
| | | <p>Embedded timber severely rotted and affected by woodworm. Significant loss of cross section</p> |

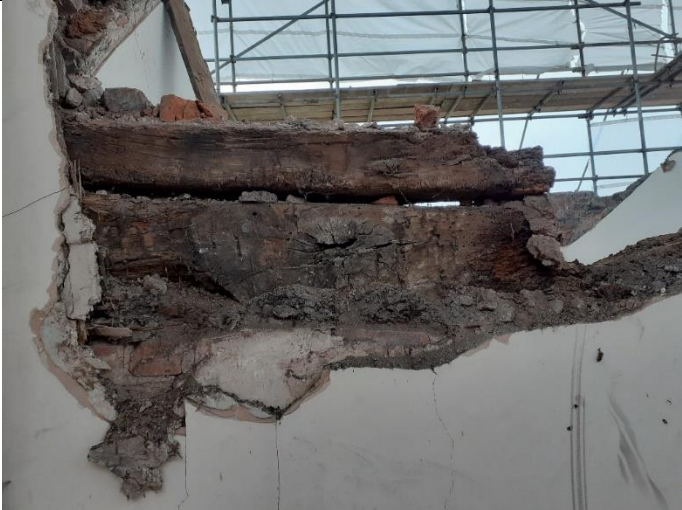
| | | <p>Embedded timber severely rotted and affected by woodworm. Significant loss of cross section</p> |

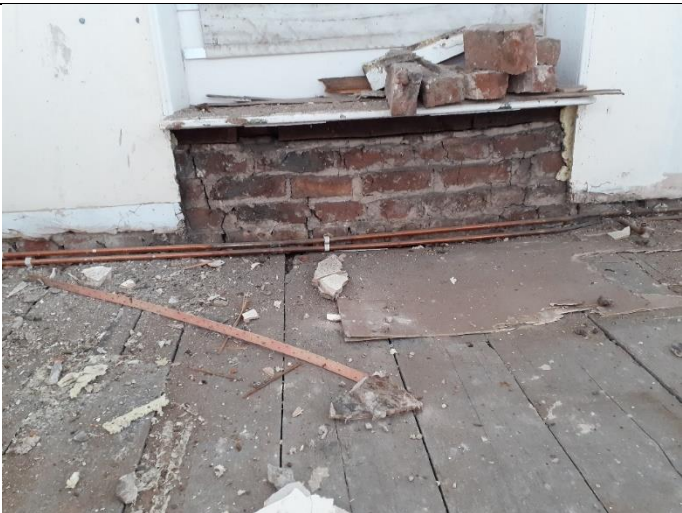
| | | <p>Front wall masonry below window is cracked, loose and unstable</p> |

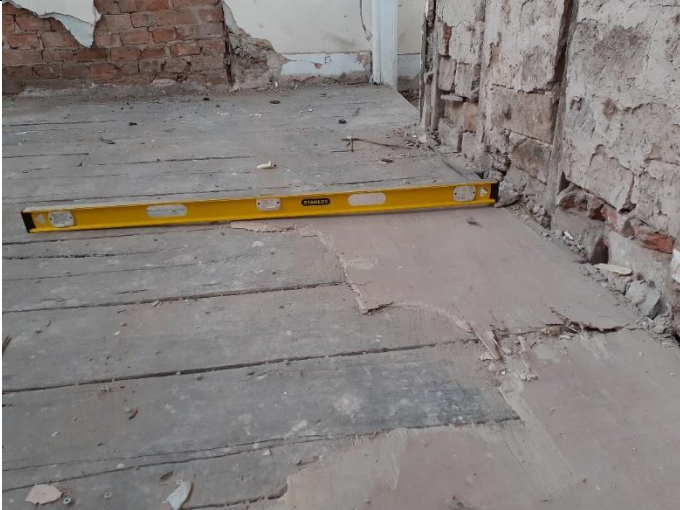
| | | Floor slopes towards middle |

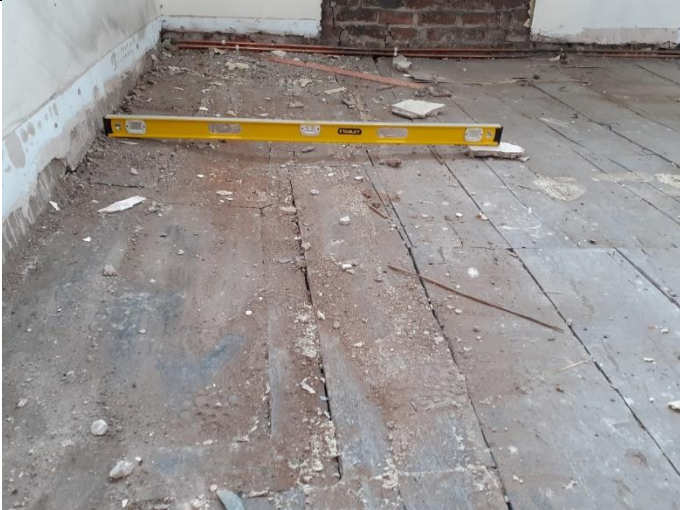
| | | Significant dish in floor |

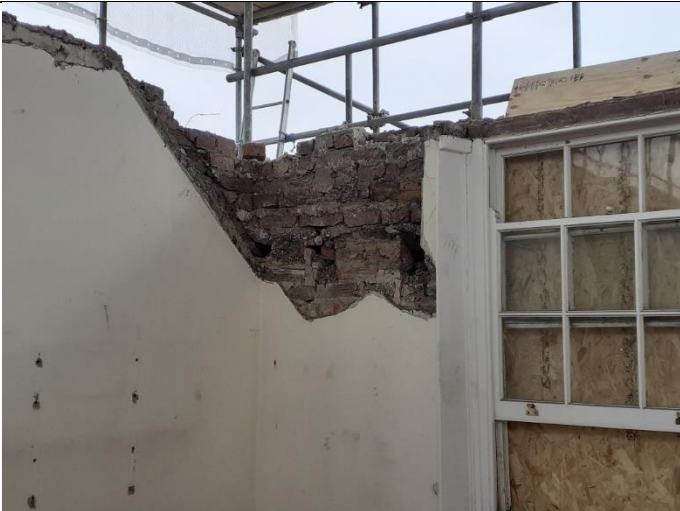
| Master Bedroom | | Masonry of side elevation loose and unstable |

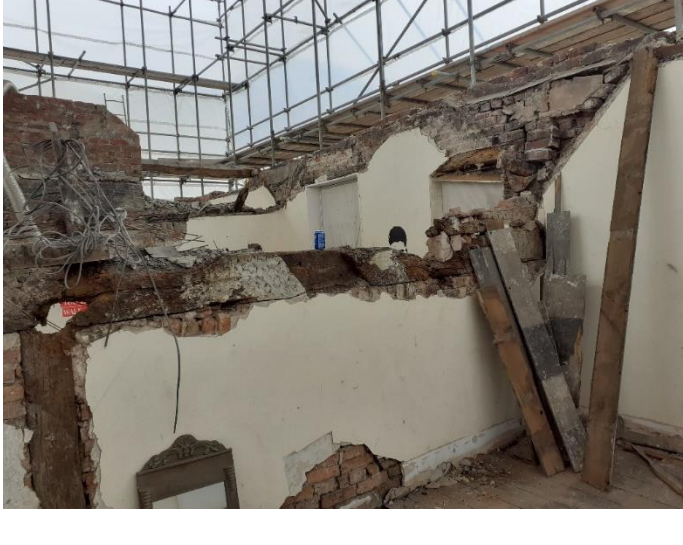
| | | <p>Embedded timber severely rotted and affected by woodworm. Significant loss of cross section</p> |

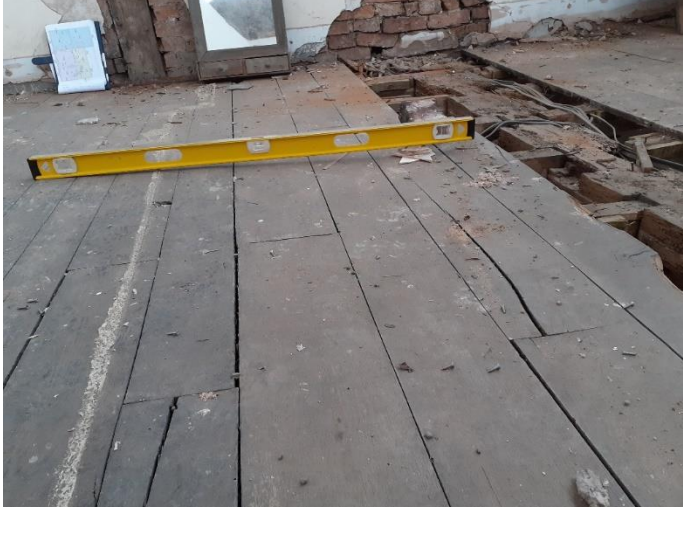
| | | <p>Significant slope in floor towards centre</p> |

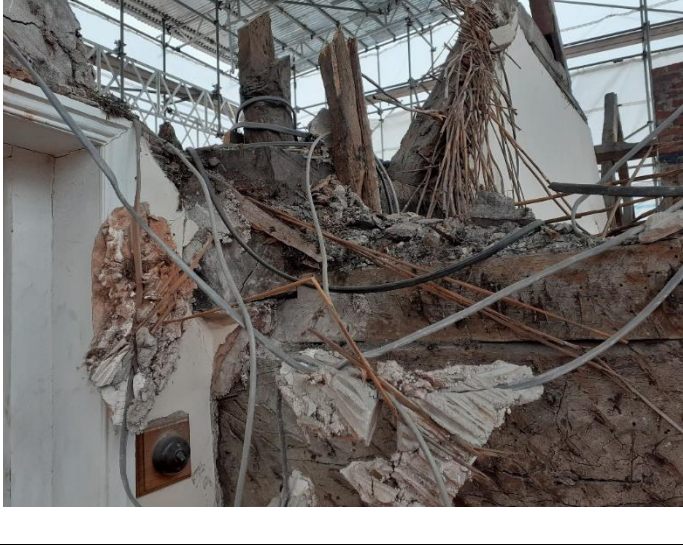
| | | <p>Embedded timber severely rotted and affected by woodworm. Significant loss of cross section</p> |

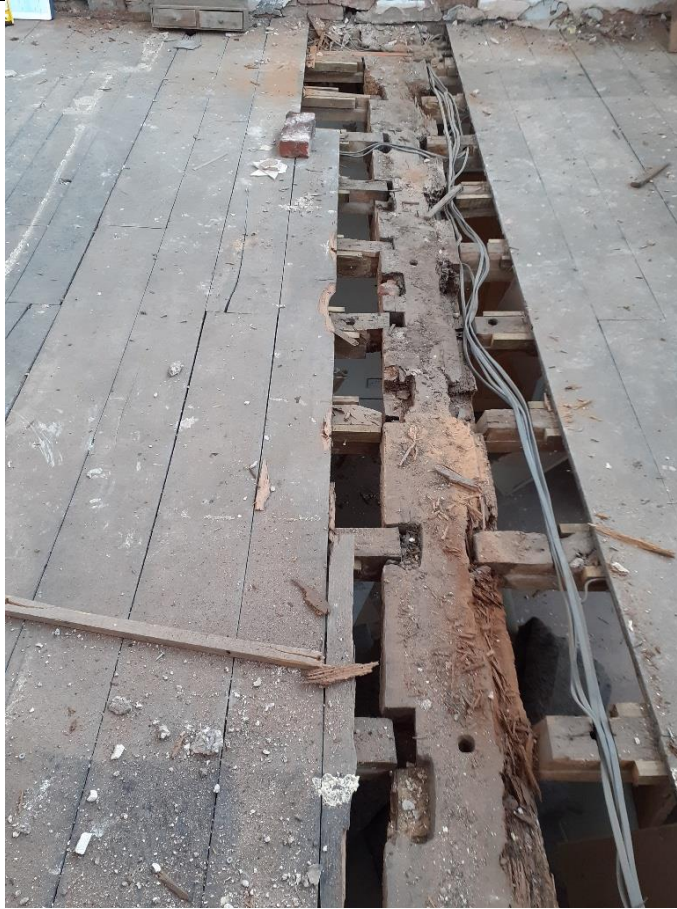
Timber floor severely rotted and affected by woodworm. Significant loss of cross section, inadequate bearing of joists

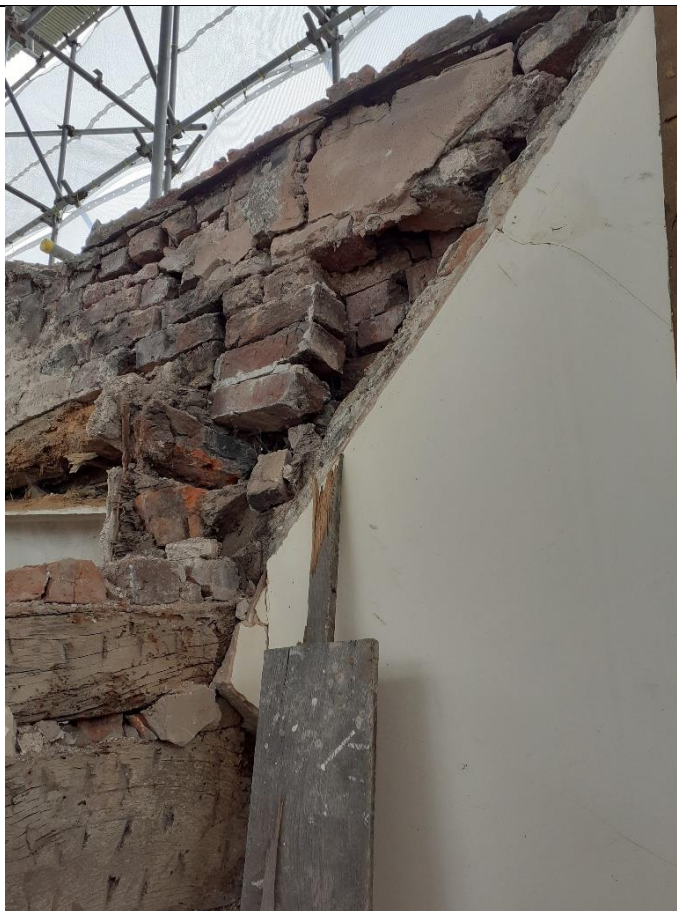
Front wall masonry is loose and unstable

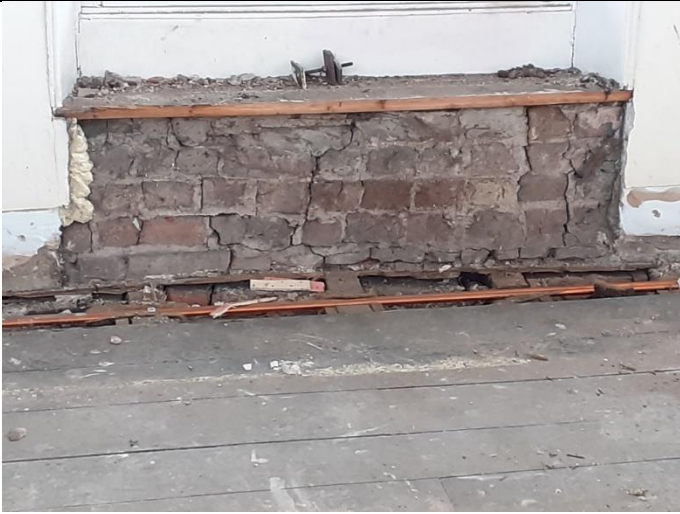
| | | Masonry below front window is cracked and loose |

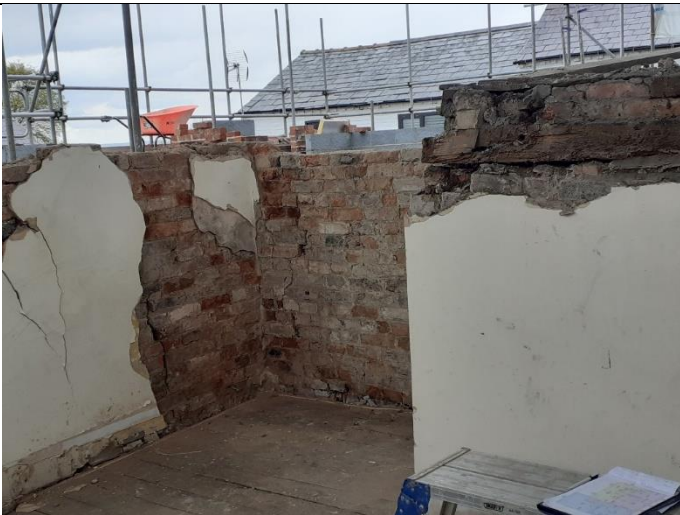
| Bedroom 4 | | Masonry to external elevations is cracked and loose |

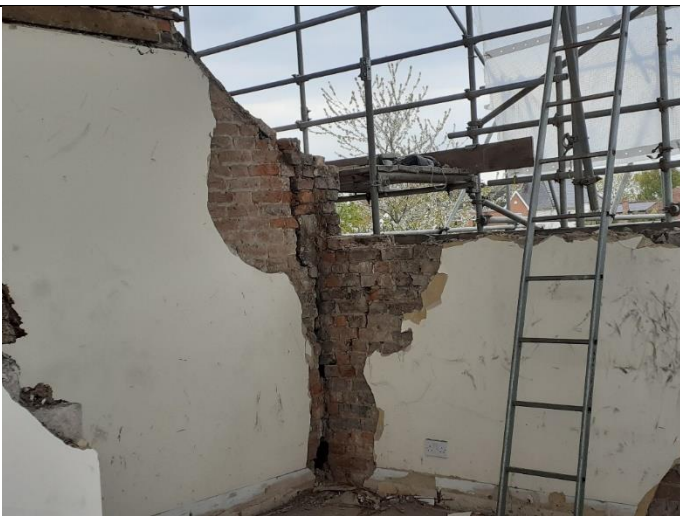
| | | No connection at masonry interfaces |

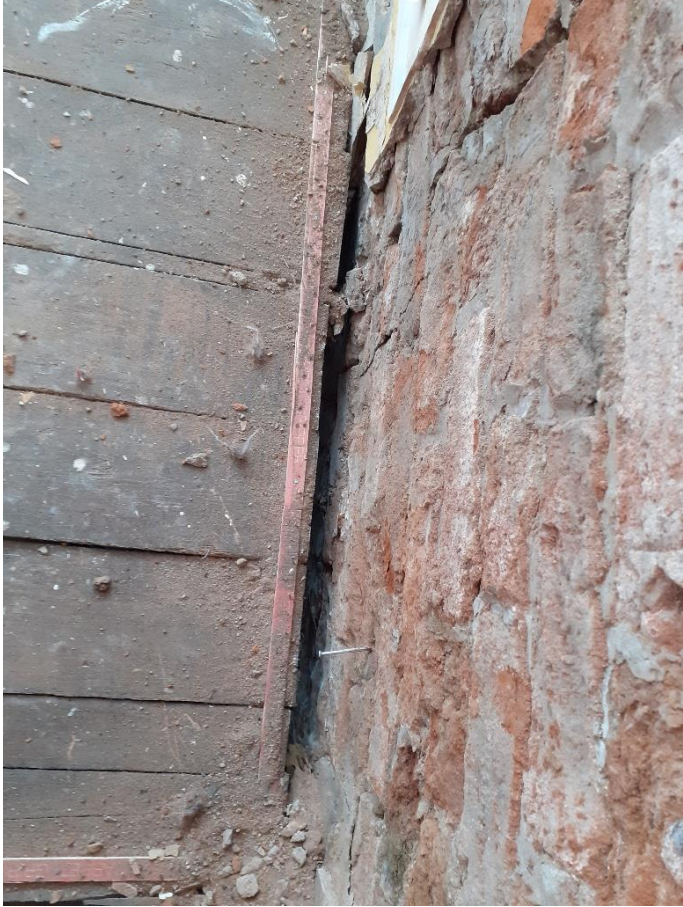
| | | <p>Walls bowing</p> |

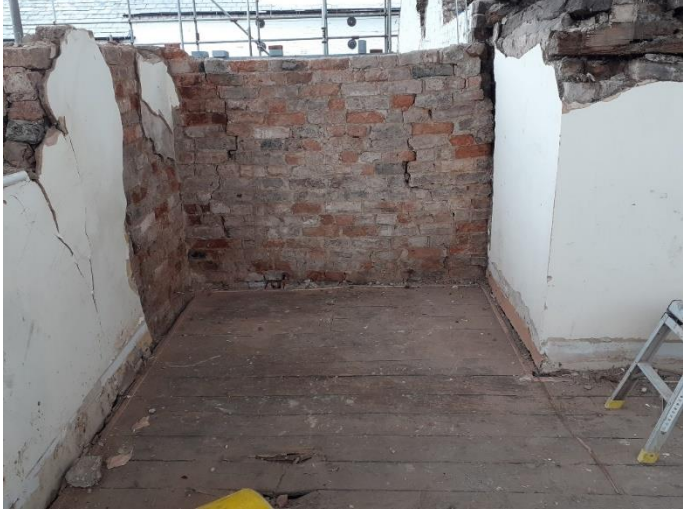
| | | <p>Masonry to external elevations is cracked and loose</p> |

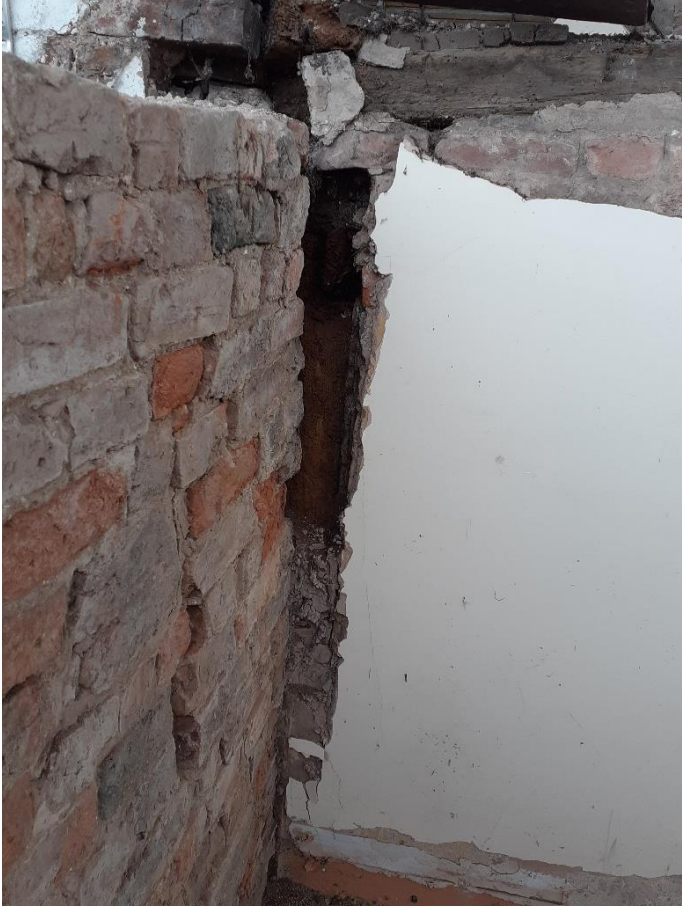
| | | Embedded timber is badly rotted and affected by woodworm with significant loss of cross section offering no restraint to masonry. |

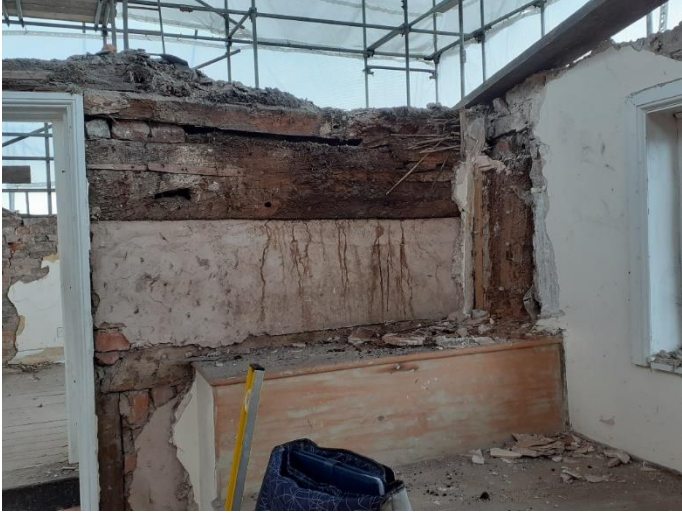
| Hall and landing | | Embedded timber is badly rotted and affected by woodworm with significant loss of cross section offering no restraint to masonry. |

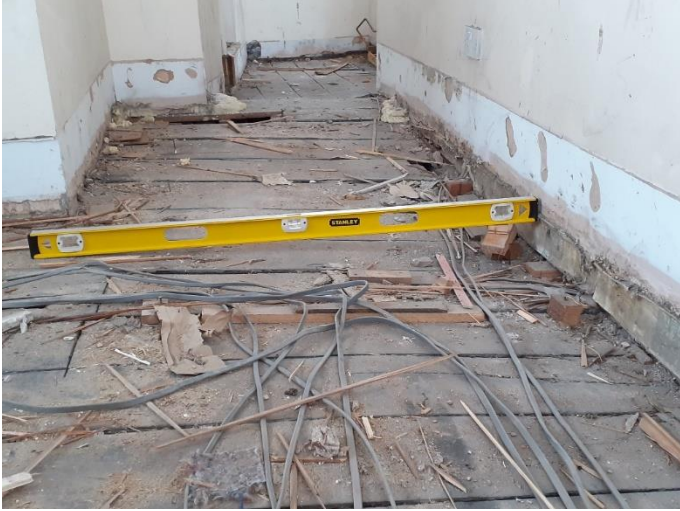
| | | Floor sloping towards front |

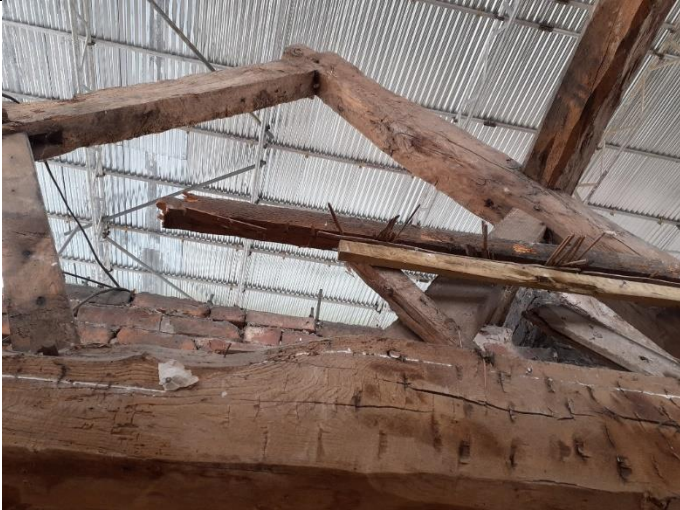
| | | Former trusses (retained) suffering woodworm damage. |

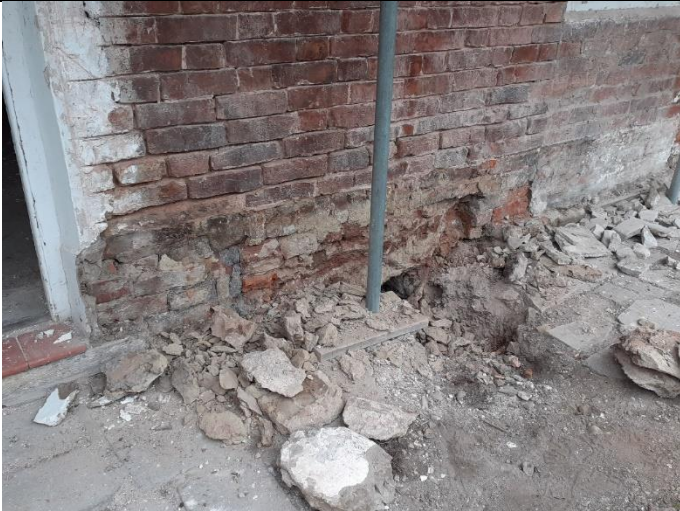
| Front elevation | | Friable/decaying masonry at low level |

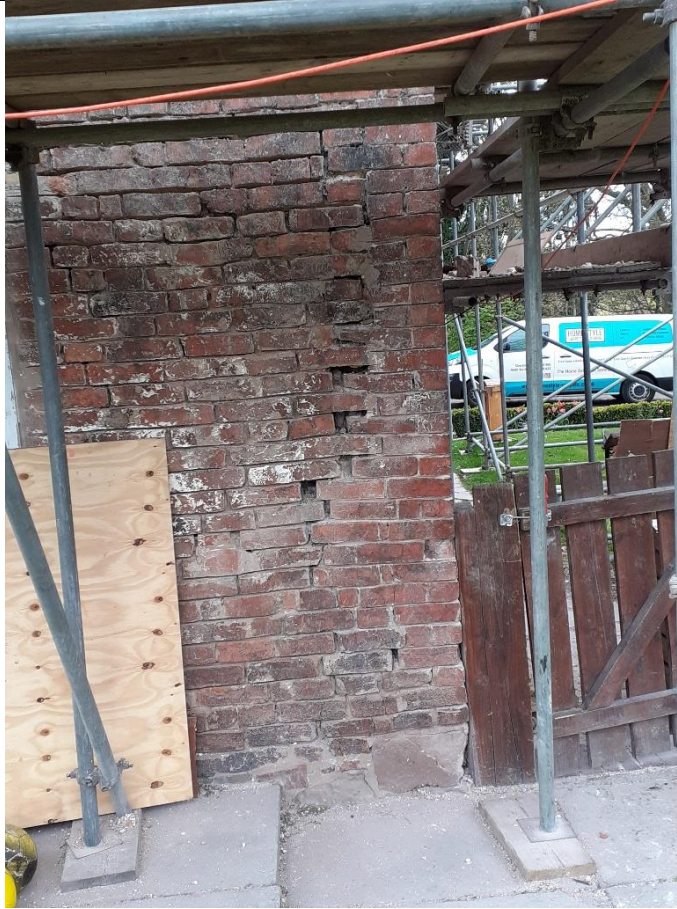
| <p>Left side elevation</p> | | <p>Masonry out of plumb</p> |
| | | <p>Open joints high and low level</p> |

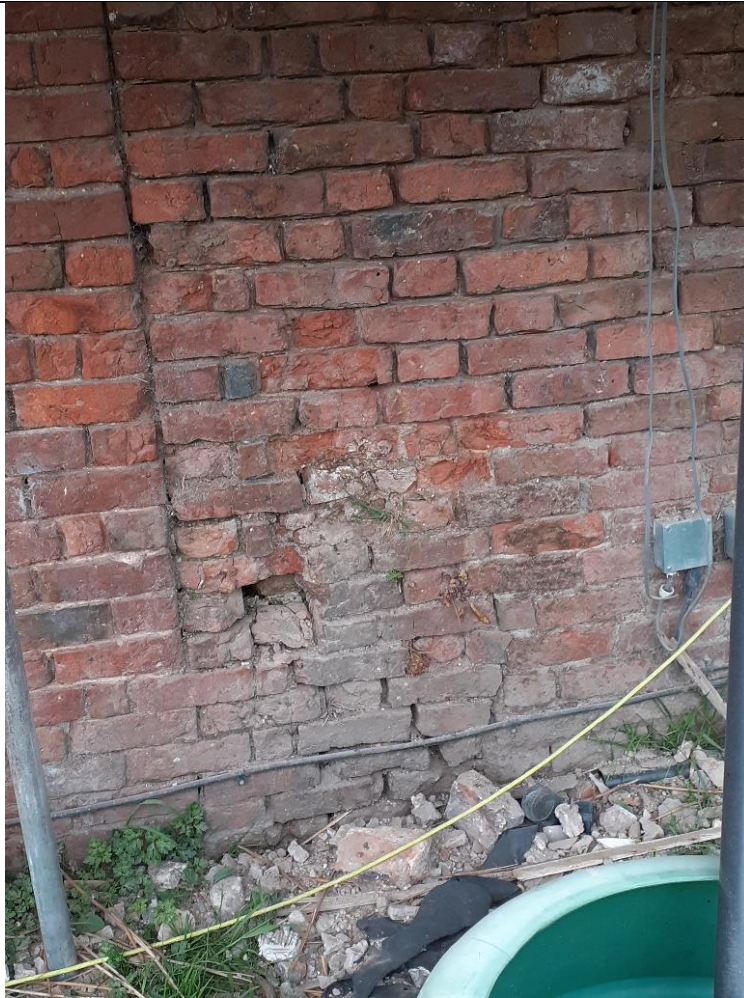
Decayed  
masonry not  
tied in.
