| <b>Proposed Housing, Queens<br/>Road, Brymbo, Wrexham<br/>Geo-environmental Report<br/>TRE Developments</b> |

| <b>Geo-environmental Report</b> |
| <b>TRE Developments</b> |

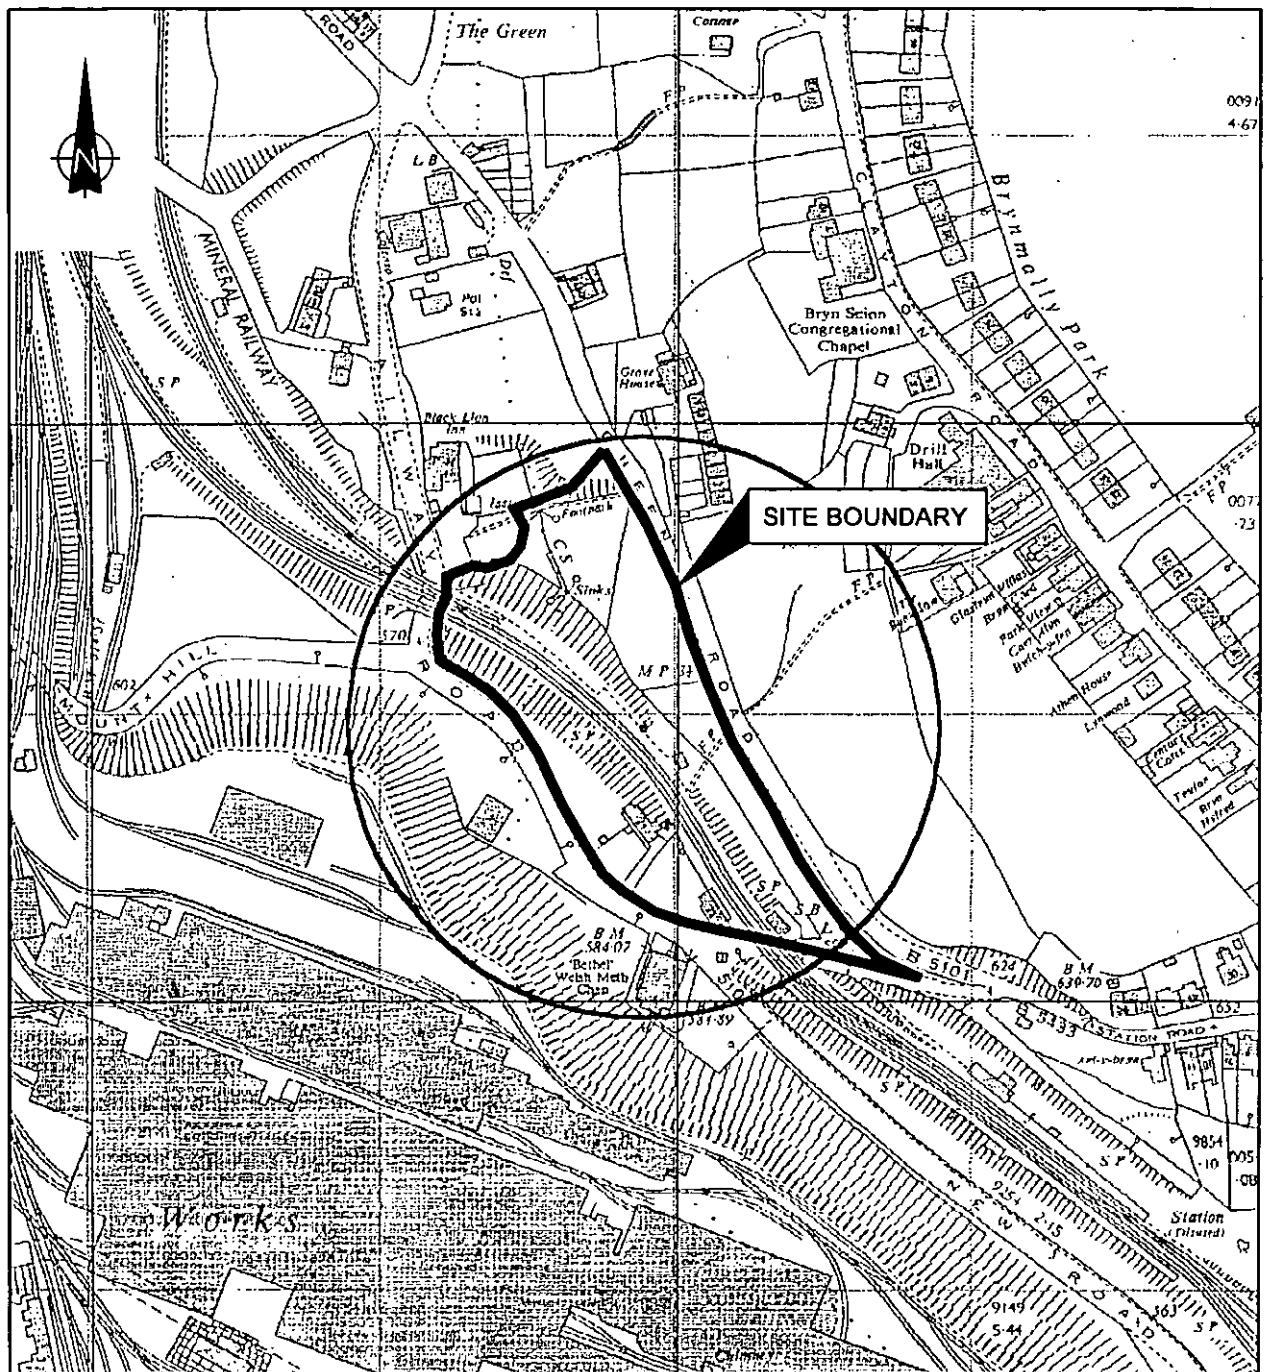
FIGURE **3d**

No changes are shown on the 1962 aerial photograph, although several footpaths can be seen crossing the site, which are also shown on the 1963 OS plan, see Figure 3d. The aerial photograph also showed a level crossing where the railway line crosses the road on the southern site boundary. The OS plan also shows an issue (water seepage) on the northern site boundary leading to a sink (water flow into ground) where the low point on the aerial photograph was observed, which may lead to a drainage culvert beneath the embankment. A spot height recording an elevation of 570'OD (173.78mOD) is on Railway Road on the western site boundary. The plan also shows that Brymbo station had become dis used.

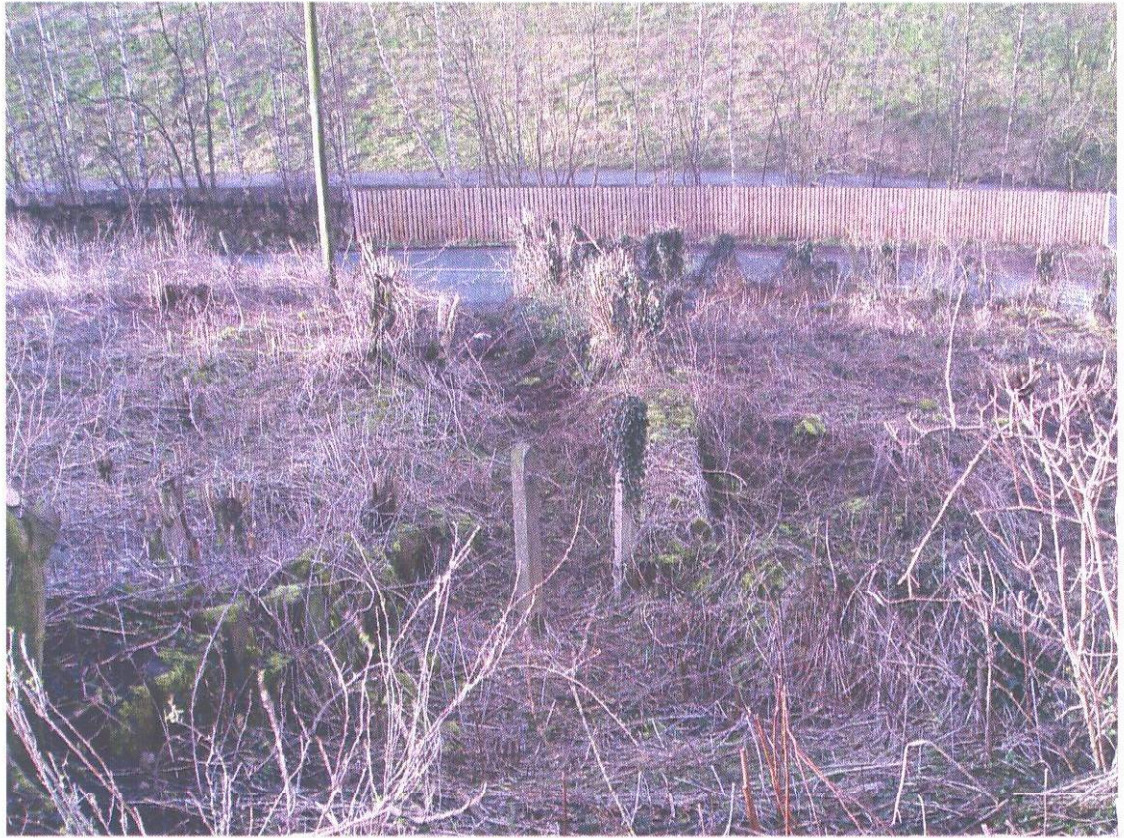
Remnants of footpath crossing site

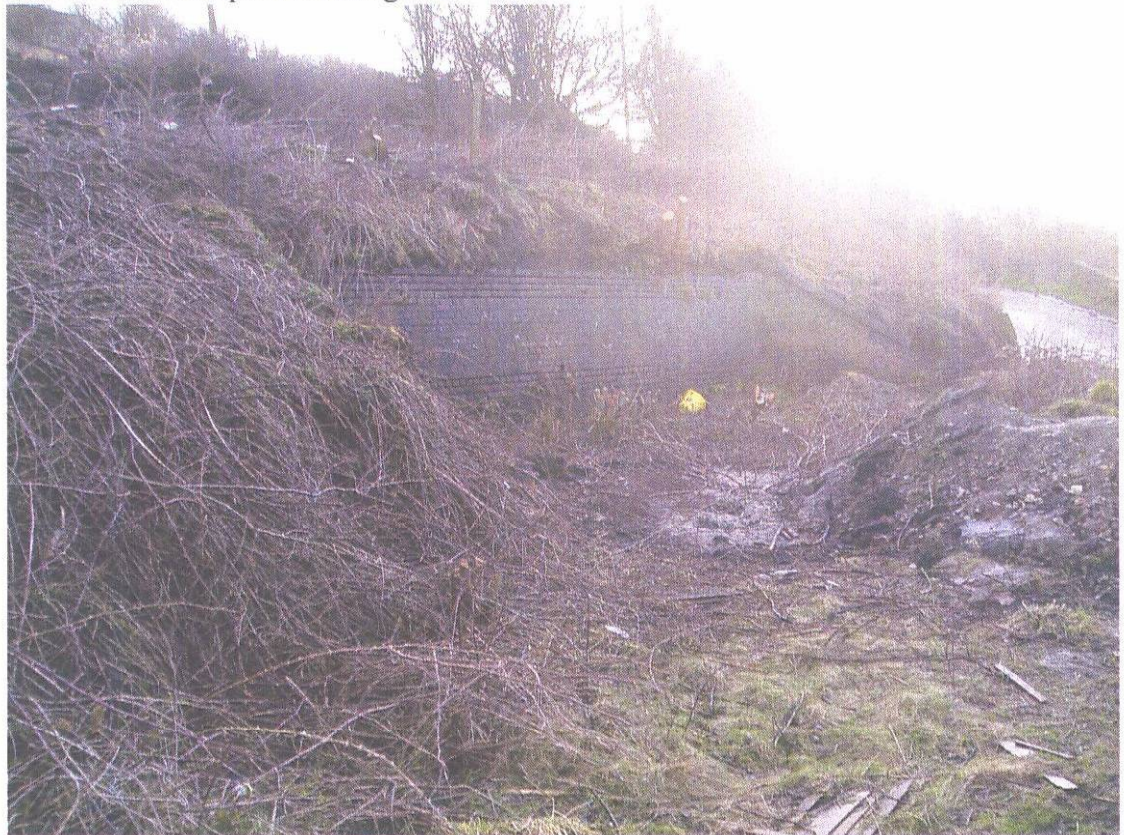
Location of old railway crossing on southern site boundary

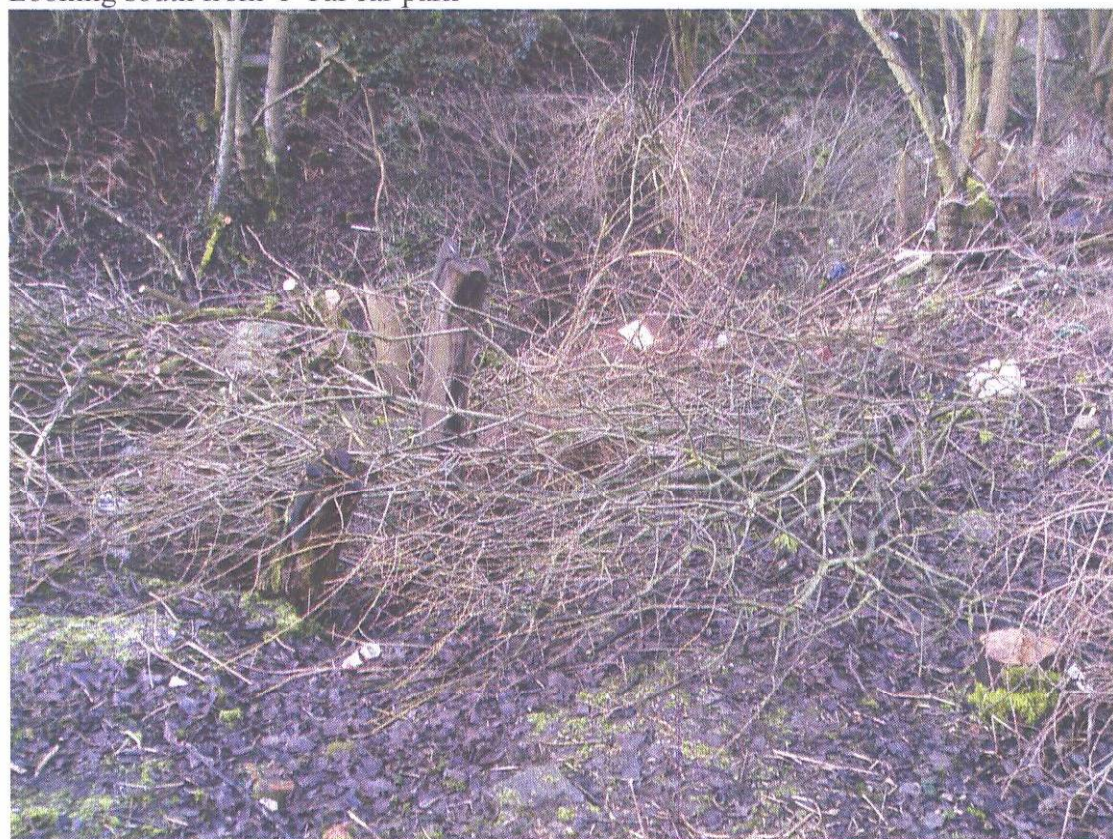
To the east of the embankment is a low area next to the car park, which appears to have been filled and a depression was noted. Several remnants of previous structures on site were noted.

Depression immediately south of Y Tai car park

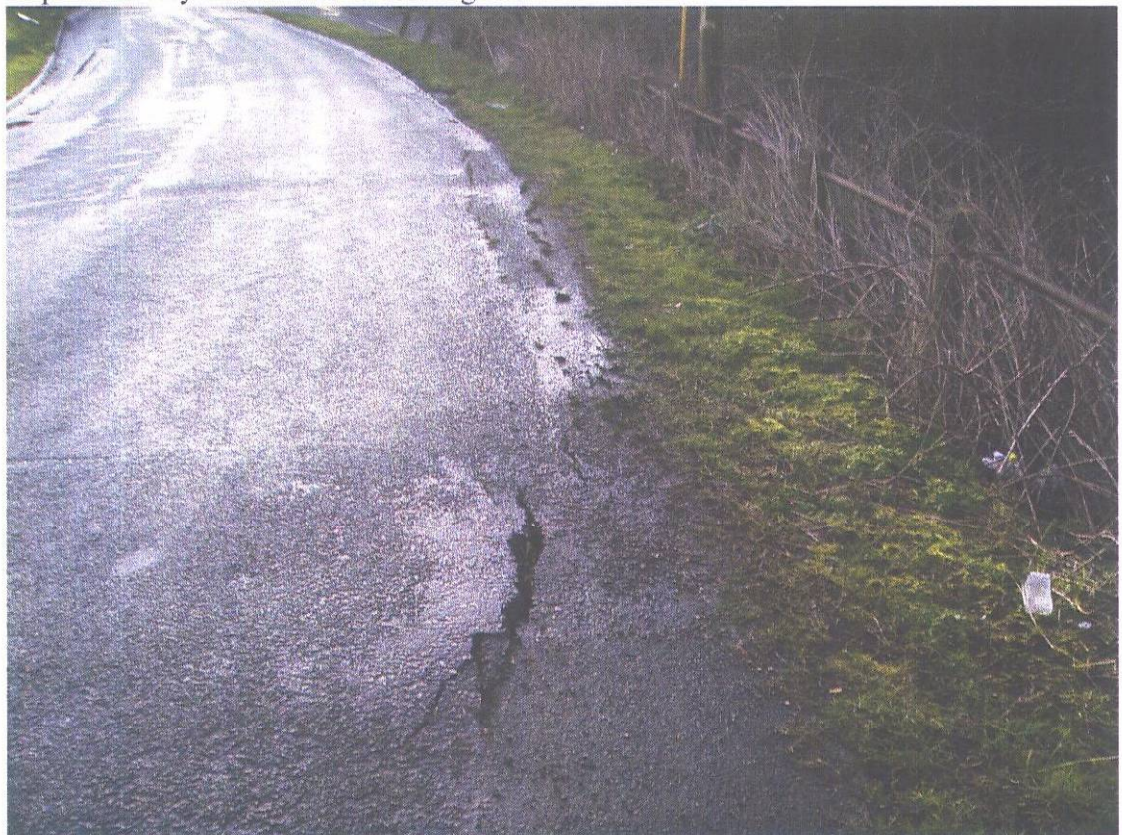
Evidence of slope instability on south eastern site boundary
