# ARBORICULTURAL IMPACT ASSESSMENT

### Tree Condition and Arboricultural Impact Assessment Report

Erddig Hall, Wrexham

The National Trust Wales

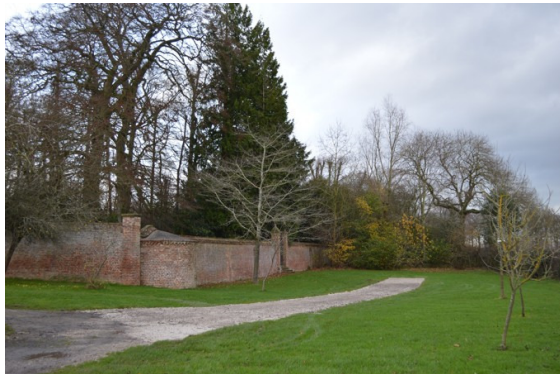
**01**

| 31 | Oak<br>( <i>Quercus sp</i> ) | 10.0 | 260<br>A | 4.0 | 5.0 | 4.0 | 3.0 | 2.5 | Y | 30+ | C1 | Good young specimen.<br>Damage from plastic tree tie<br>at 2.5m | Remove tie. Retain in<br>development | 3.0 | 28 |

General view of north east corner of site with Oak tree T31

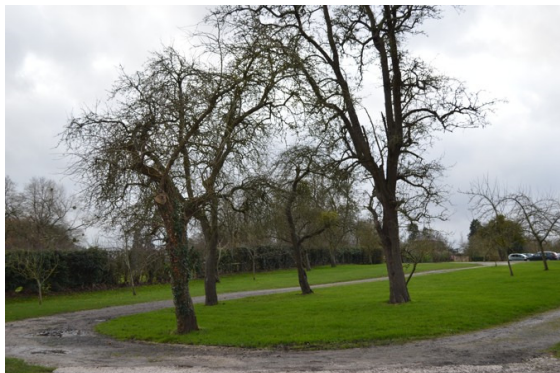
**02**

| T 98 | Apple 'Aromatic Pippin'<br>Tag: 708 | 8.0 | 295<br>A | 3.0 | 2.8 | 3.2 | 2.8 | 2.0 | M | 10+ | B2 | Part of group. Cavity to main stem. Large cavity to S at 700mm. Large decayed cavity to N at 1m. Mistletoe Good wildlife potential. | Check decay. Retain as 'character' tree in development. | 3.6 | 31 |

| T 101 | Pear<br>( <i>Pyrus var</i> )<br>Tag: 720 | 16.0 | 550<br>A | 2.2 | 3.4 | 4.0 | 2.2 | N/A | M | 20+ | B2 | Part of group. Damage to main stem at base | No work. Retain as 'character' tree in development. | 6.6 | 13.7 |

View looking south to tree group T97, T98, T99, T100 and T101

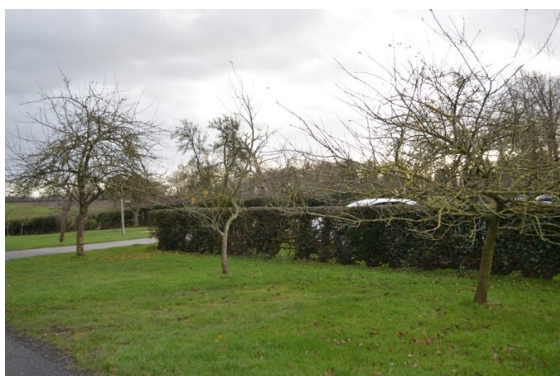
**03**

| T 104 | Apple<br>( <i>Malus var</i> ) | 4.0 | 105<br>at<br>1.2<br>C | 3.0 | 1.8 | 2.0 | 2.8 | 1.0 | EM | 10+ | C1 | Damage to main stem at base N. 40° incline to N. Poor specimen | Remove to facilitate development | 1.2 | 5 |

View looking south east to hedge H116 and trees nos T102, T103 and T104

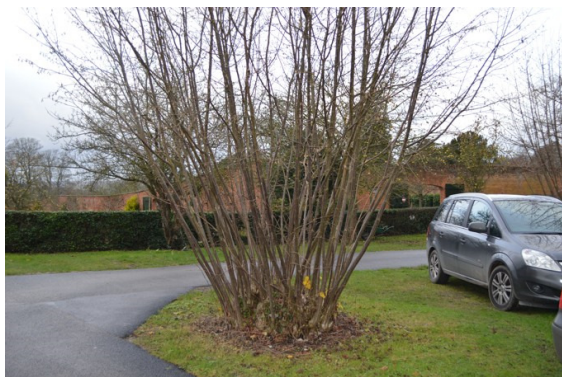
**07**  
View to north to Hazel coppice T78
