**STRUCTURAL INSPECTION REPORT**

**REDUNDANT OUTBUILDINGS**

**BROAD OAK FARM**

10 October 2017

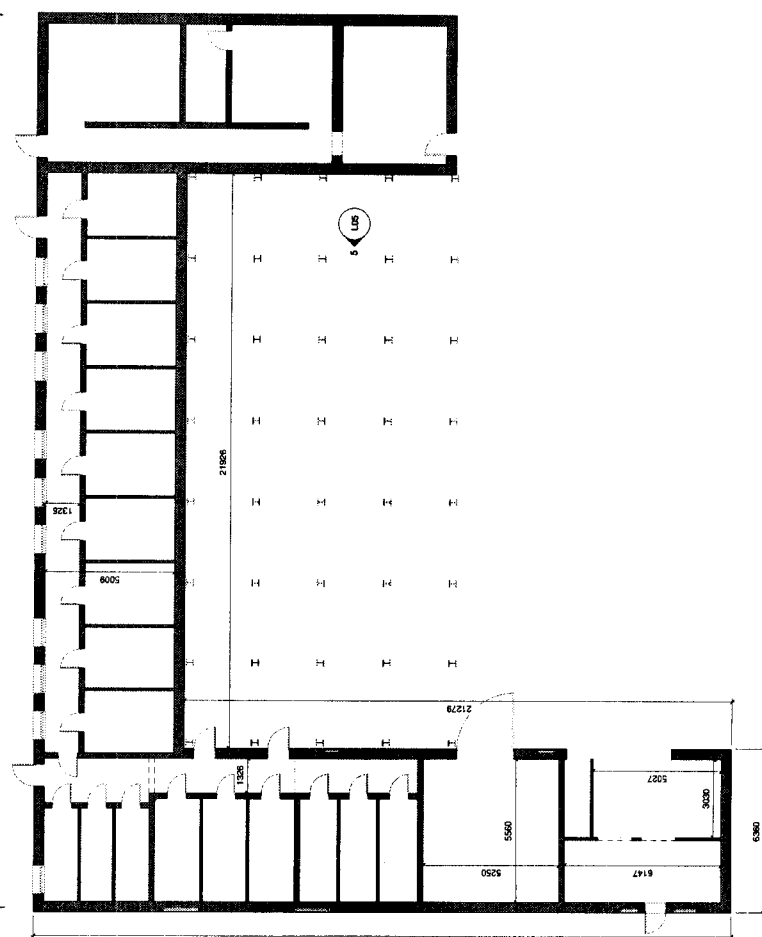
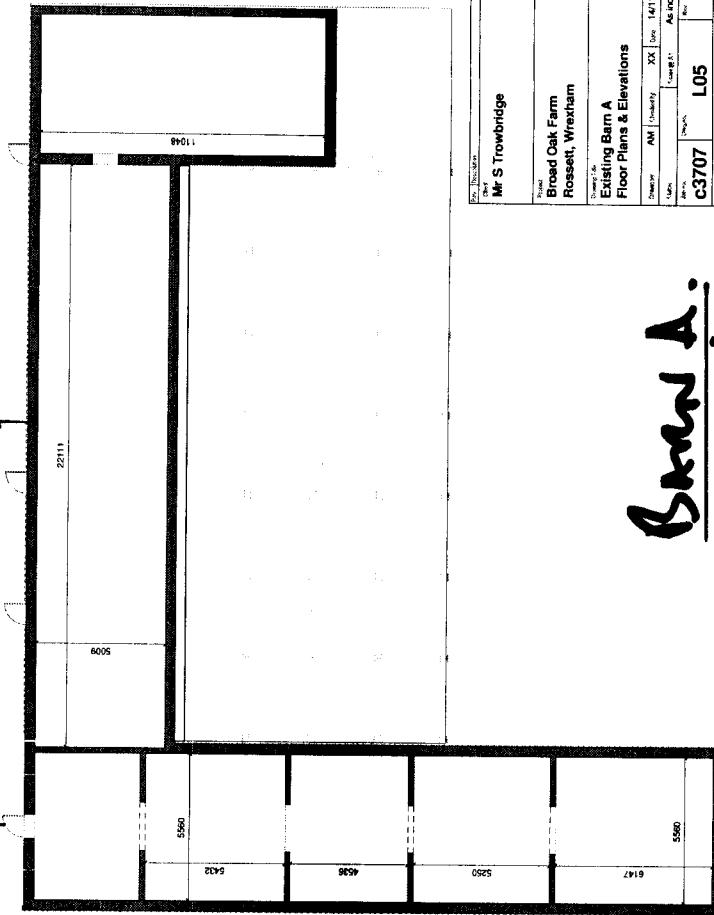
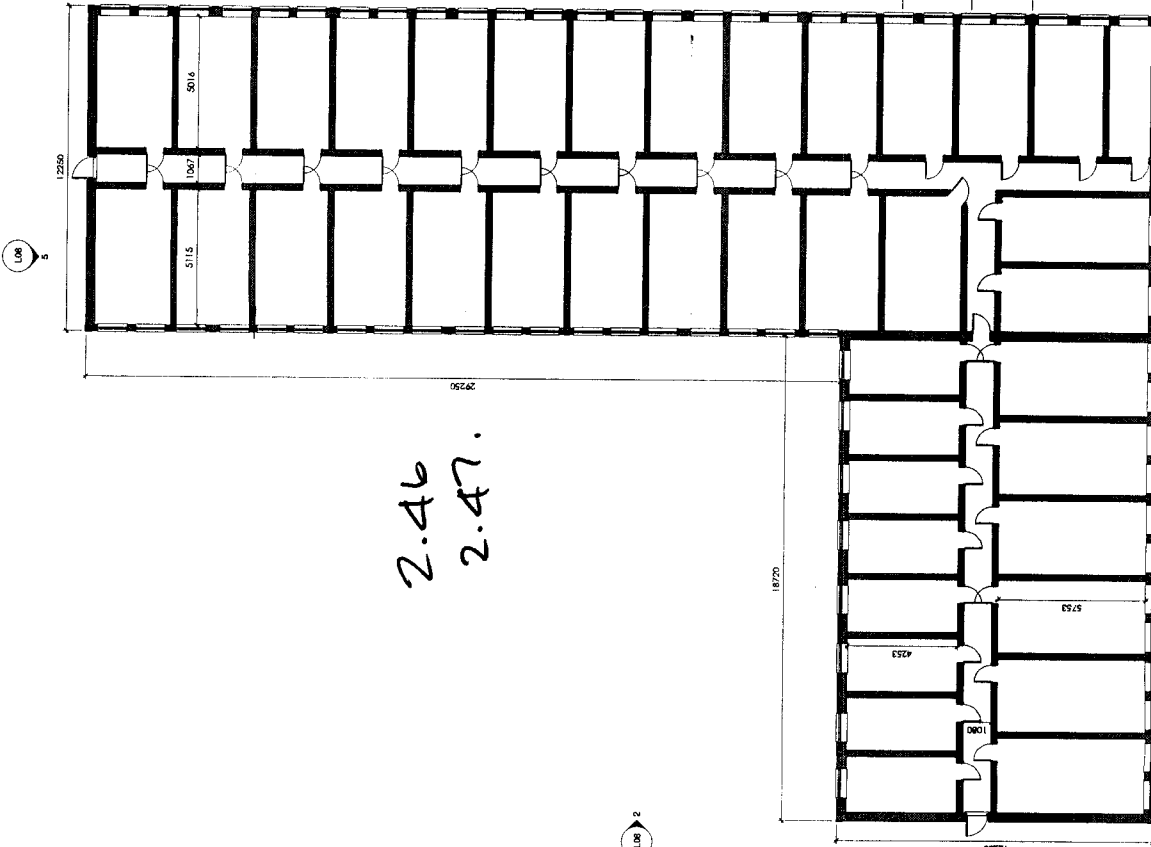
Box A:  
6538/604

- 2.1 Rendered wall above lean-to roof.
- 2.2 Timber pattress 'plates' and tie rods.
- 2.3 Undulating roof.
- 2.4 Wall leans out noticeably.
- 2.5 Wall leans out slightly.

- 2.6 Ivy covered wall.
- 2.7 Stonework section.
- 2.8 Noticeable cracks.
- 2.9 Rebuilt verge brickwork.
- 2.10 Weathered brickwork below stonework at ground level.
- 2.11 Blocked in openings along length of steel framed building.
- 2.12 White painted wall above blocked in openings.
- 2.13 Undulating Roof.
- 2.14 Severely undulating roof and slipped/missing slates.
- 2.15 First floor gable set back from single storey section below.
- 2.16 More recent single storey structure.
- 2.17 Stonework section at high level appears in poor condition.

- 2.18 Rebuilt brickwork above first floor window.
- 2.19 Wall out of plumb.

Widespread eroded mortar joints.
- 2.20 Wall takes an undulating line on plan together with some out of plumb most noticeable below eaves level.

- 2.21 Damp and weathered brickwork behind rwp.
- 2.22 Undulating roof.
- 2.23 Severely undulating roof.

- 2.24 Ivy covered wall.
- 2.25 Timber pattress plates and tie rods.
- 2.26 Older style brickwork.
- 2.27 Rebuilt section below window.
- 2.28 Bricked in window.
- 2.29 Undulating roof.
- 2.30 Straight joint/cracked and weathered brickwork.
- 2.31 Wall takes an undulating line on plan, cannot gauge behind ivy.

- 3.1 Comparing the past ACE external wall observations to our current observations we would say that there has been no significant changes in the condition of the walls which, whilst exhibiting widespread distortions in particular to the West and North elevations have remained stable.

- 3.2 With regard to the proposed conversion we would as normal envisage that the roof and floors will be replaced.
- 3.3 Subject to Planning considerations we would envisage that the most noticeable wall distortions would be corrected/rebuilt e.g. the upper sections of the walls which are leaning out due to roof spread.

- 3.4 In anticipation that widespread rebuilding will not be acceptable it will be necessary to give careful consideration as to how the new internal walls can be used to buttress/restrain the external walls and also allow the current unsightly pattress plates etc. to be removed.

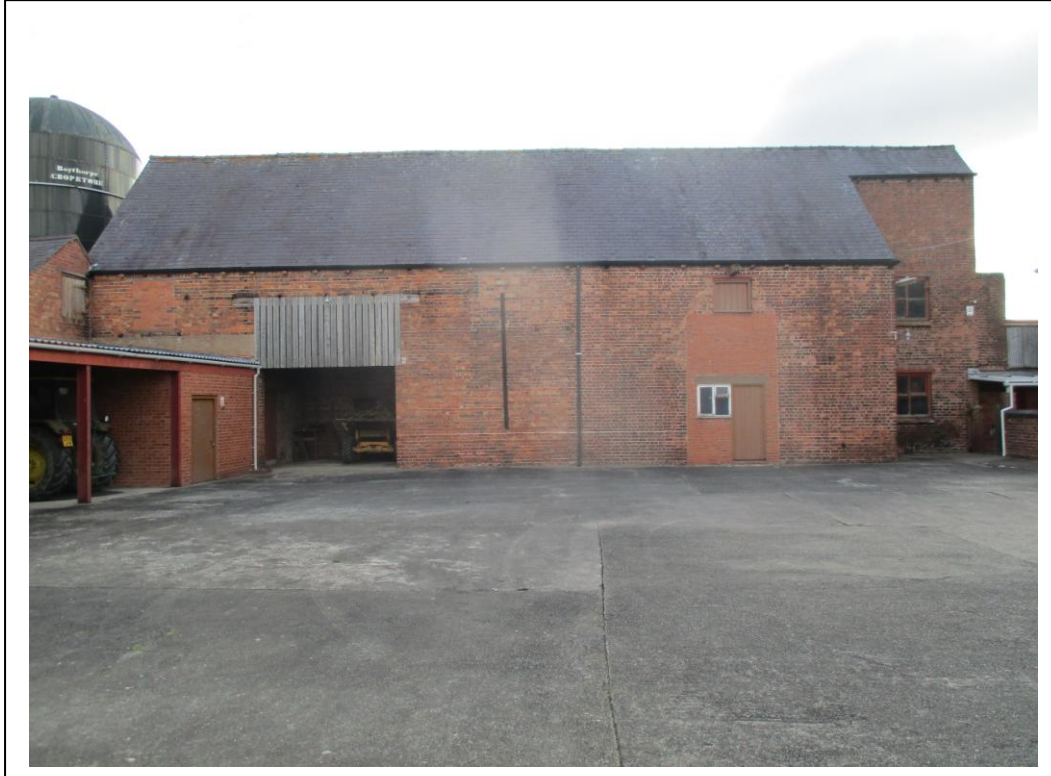
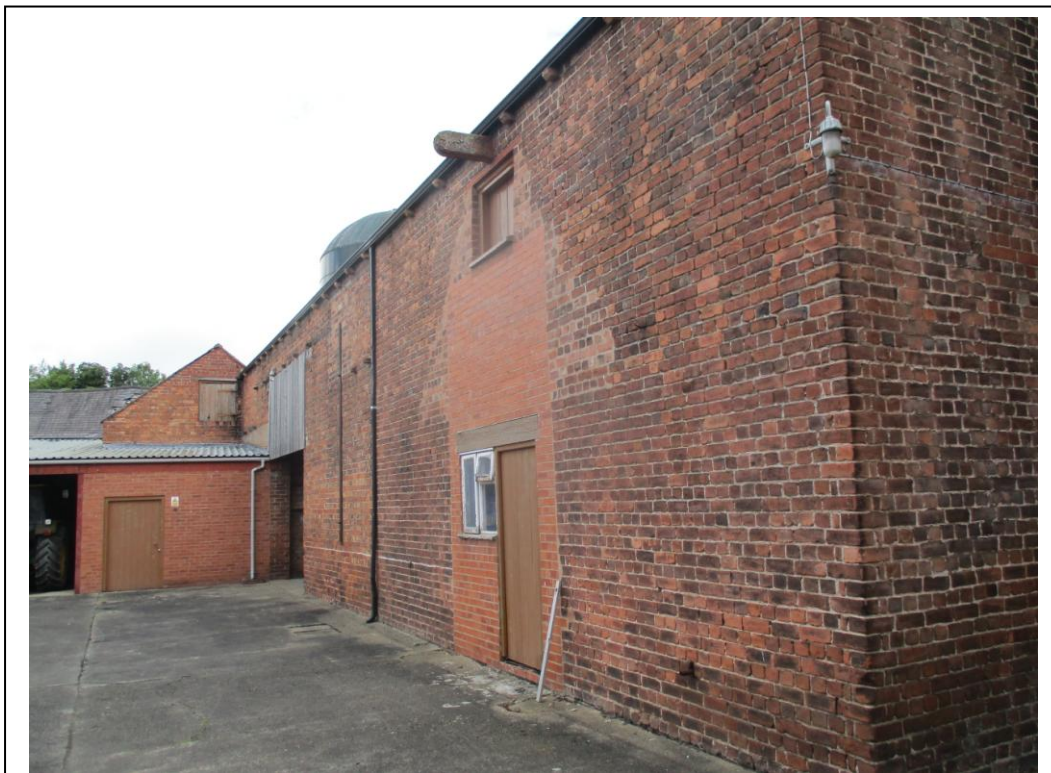
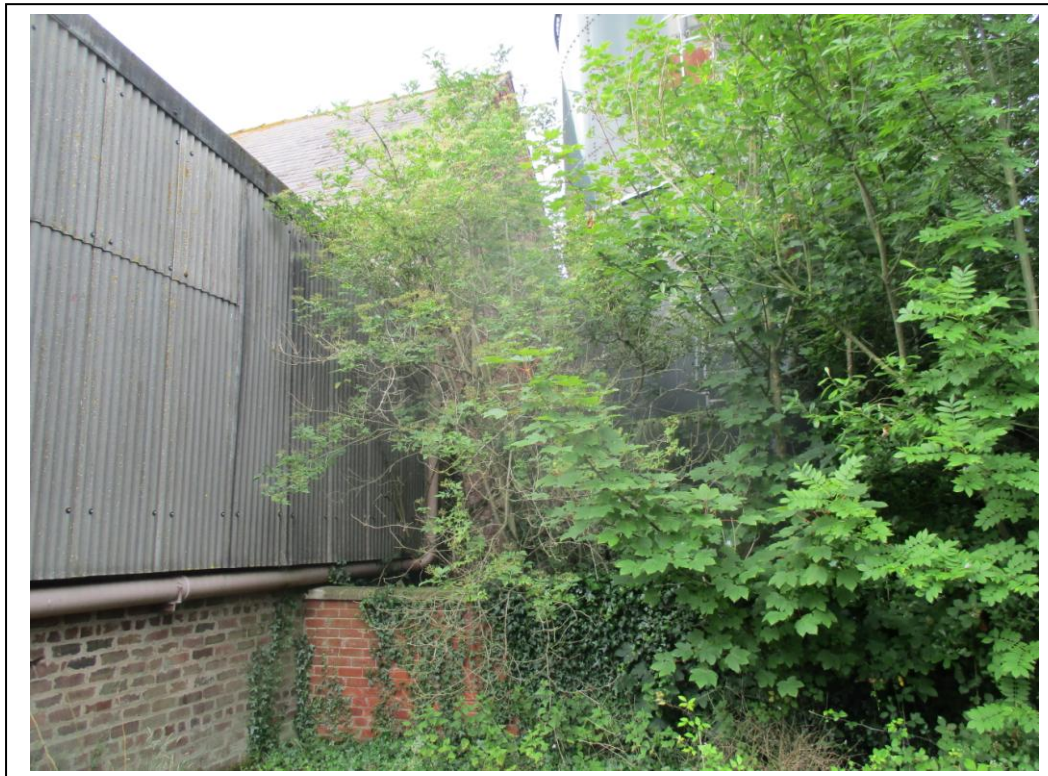
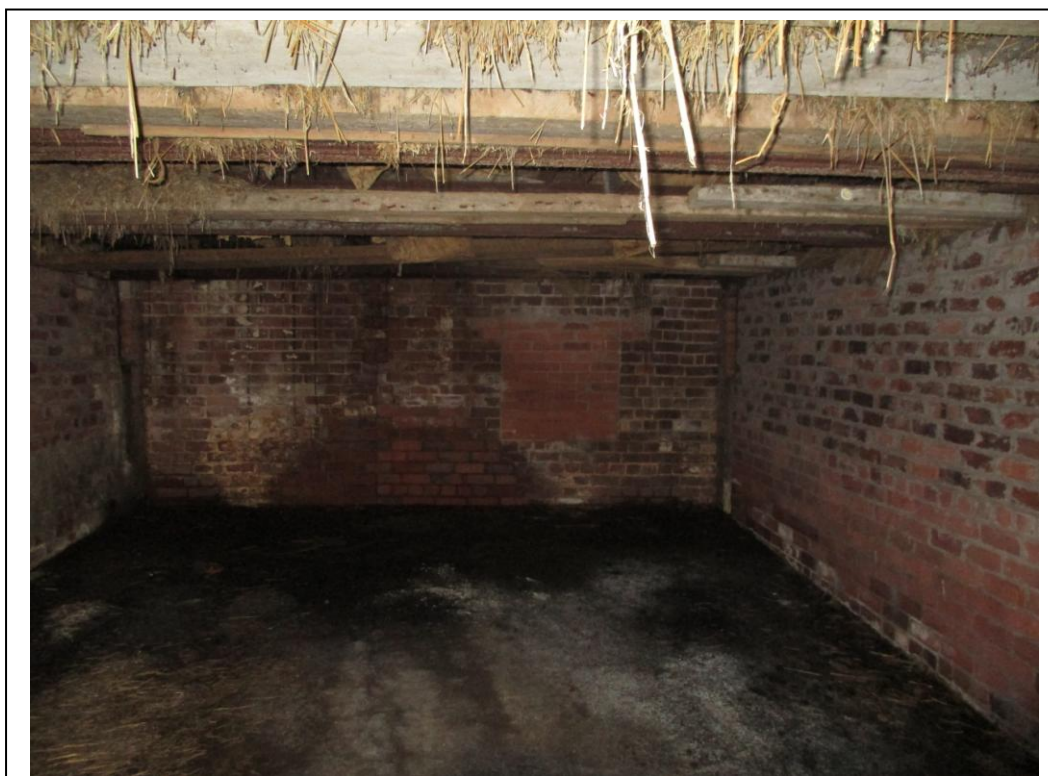
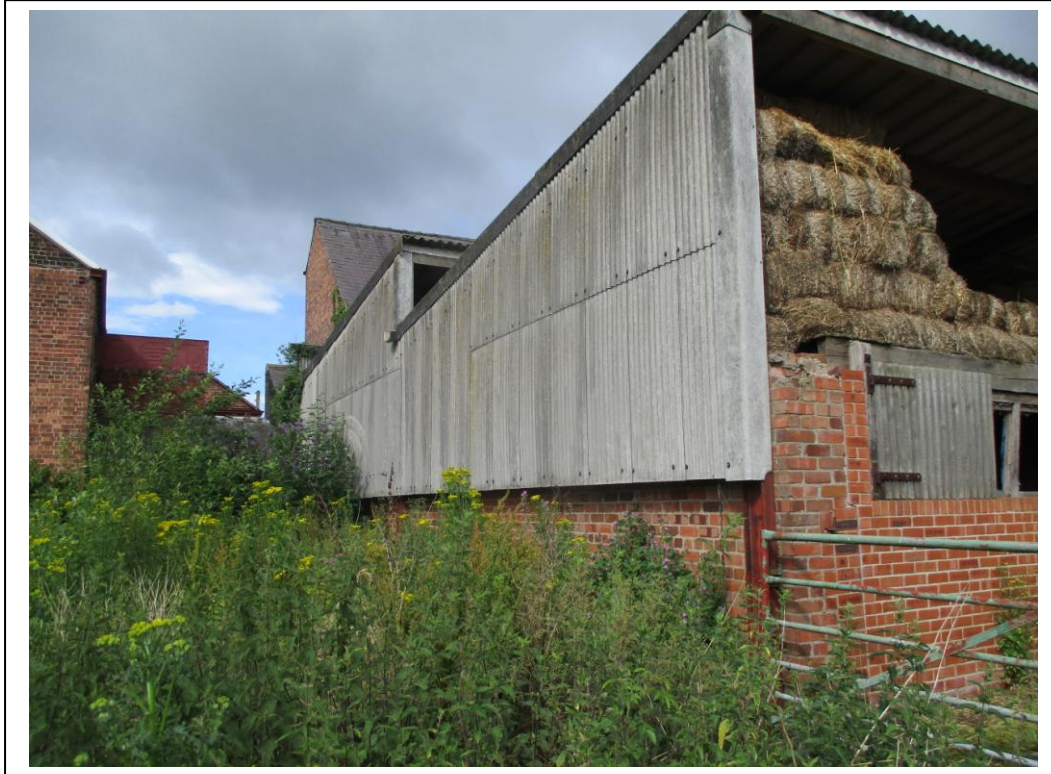
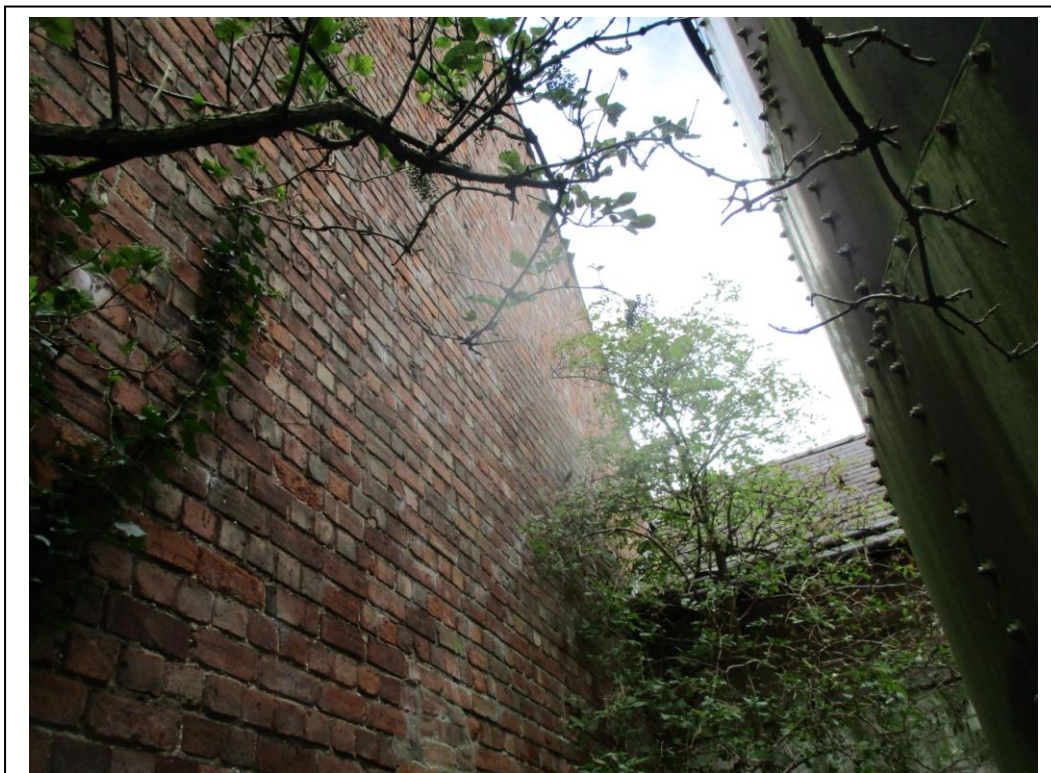
BARN B

- 2.32 Rendered wall above lean-to roof.
- 2.33 Bricked in openings.
- 2.34 Long timber pattress plate and 2No. rods.
- 2.35 Stepped full height vertical crack.
- 2.36 Rebuilt brickwork.
- 2.37 High level stepped vertical crack.
- 2.38 Diagonal crack.
- 2.39 Low level weathered brickwork.
- 2.40 No significant wall out of plumb noted.  
Wall appears in good condition.
- 2.41 No significant undulating roof line noted.

- 3.6 The external walls, where visible, appear in good condition and we do not envisage the need for any major rebuilding.

Local repairs will be necessary e.g. to replace isolated weathered bricks or undertake crack stitch repairs and it will likely be a matter of discretion/agreement whether non matching sections of walling are replaced.
- 3.7 The East elevation is largely hidden by the adjacent steel framed building, however from what we could see we did not note any significant defects.
- 3.8 The roof line is very good, indicative of a sturdy roof.
- 3.9 Notwithstanding, we understand that a new second floor will present some headroom issues requiring at minimum modifications to the main roof trusses structure and this will need to be assessed at Building Regulations Stage as normal.
- 3.10 As normal we would expect that the first floor will be replaced, taking support from the new internal wall arrangement.
- 3.11 The existing foundations will need to be inspected in due course.

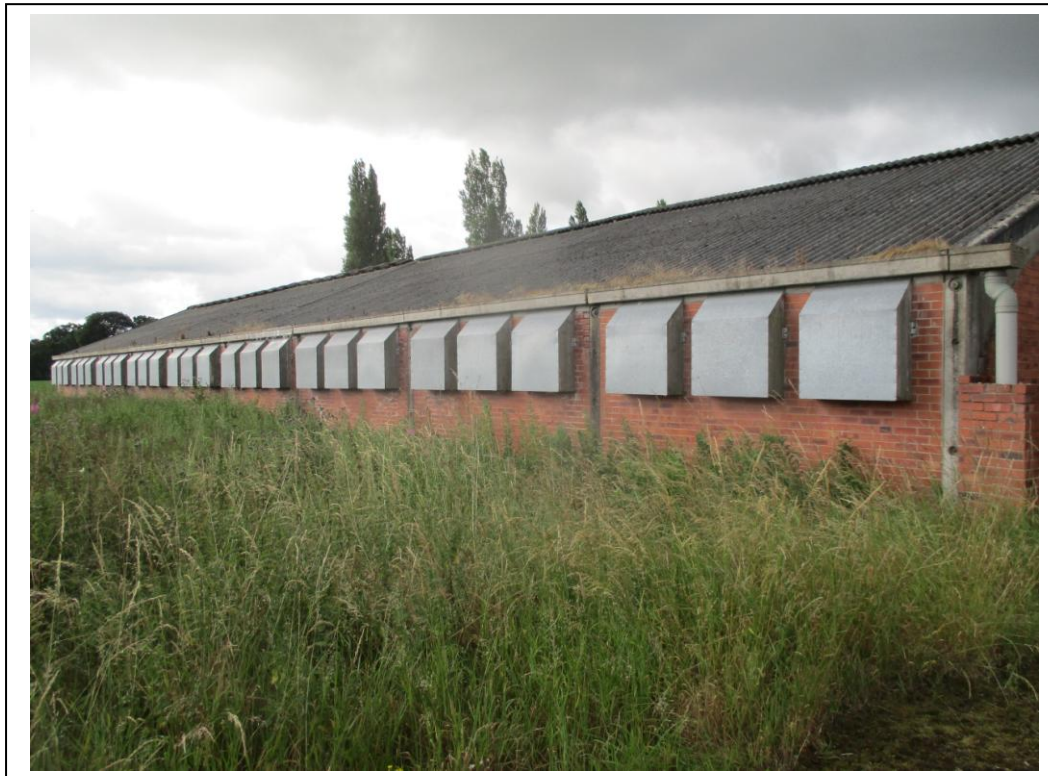
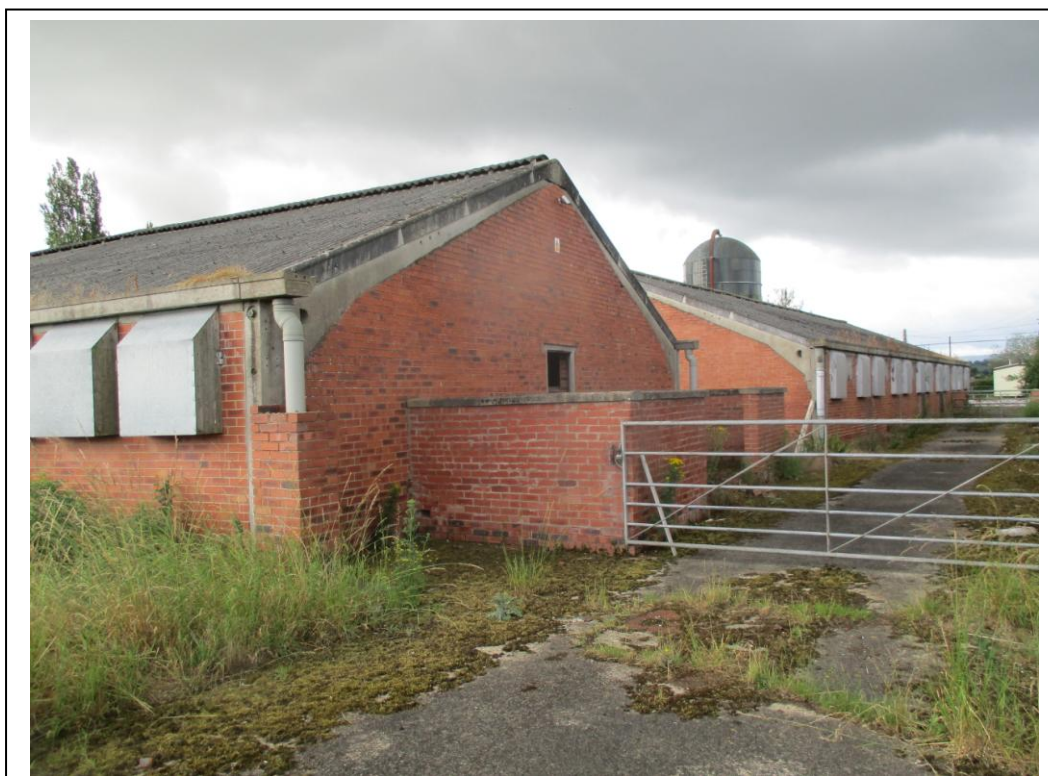
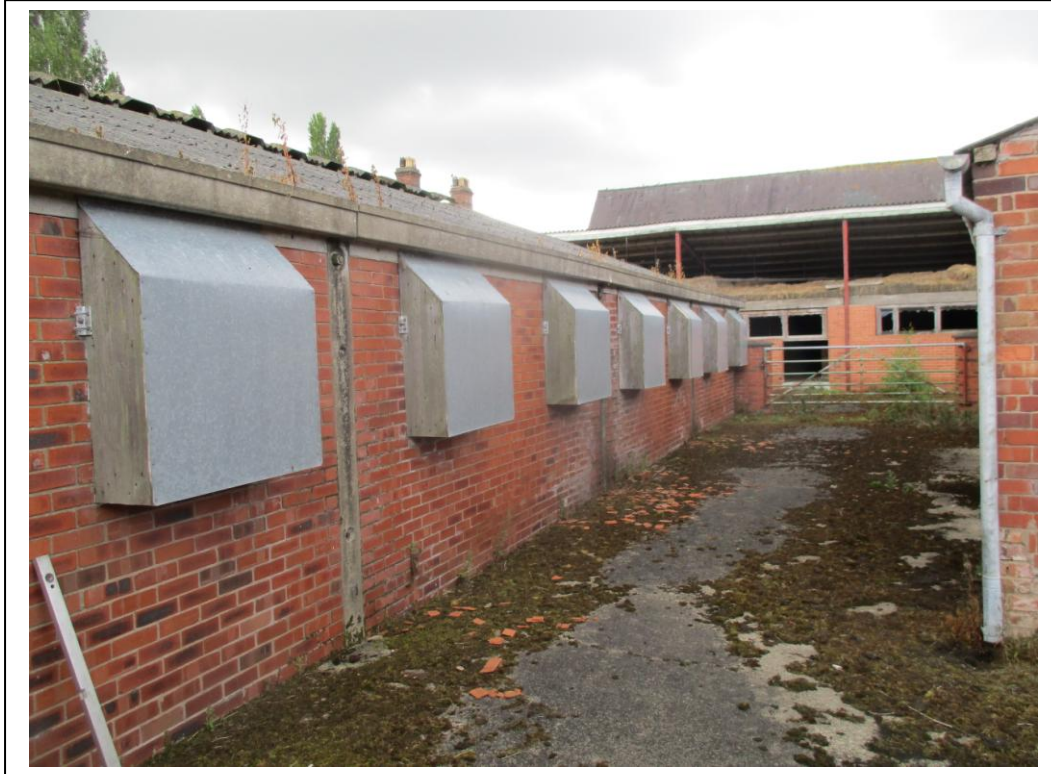
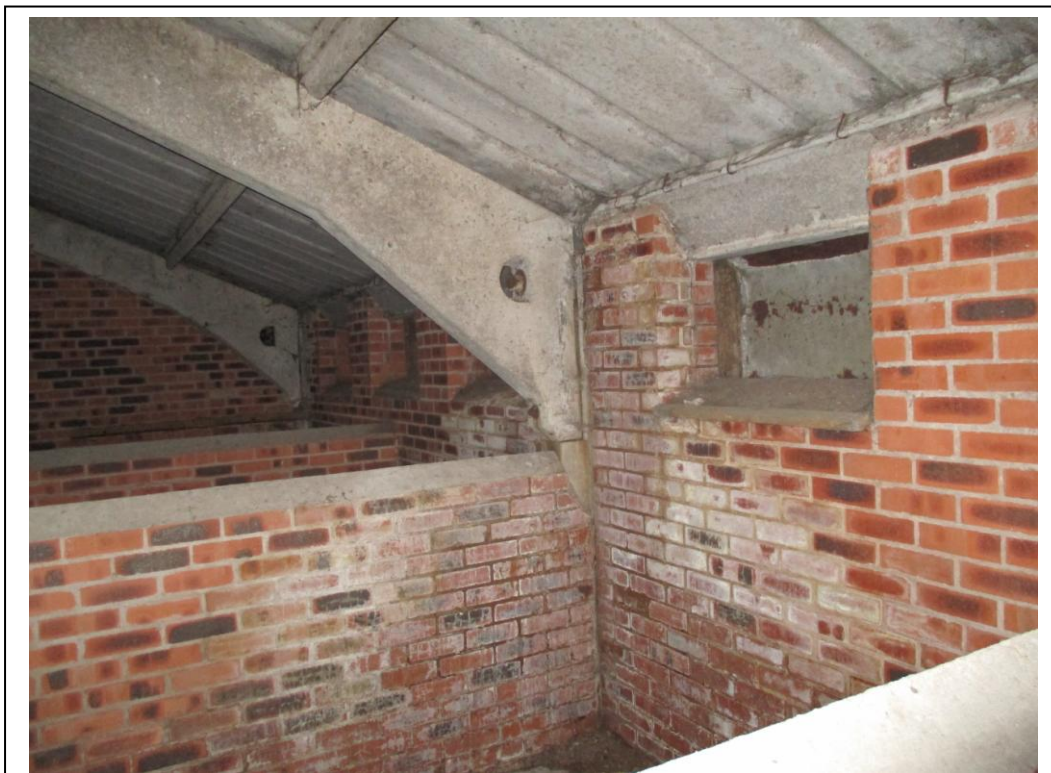
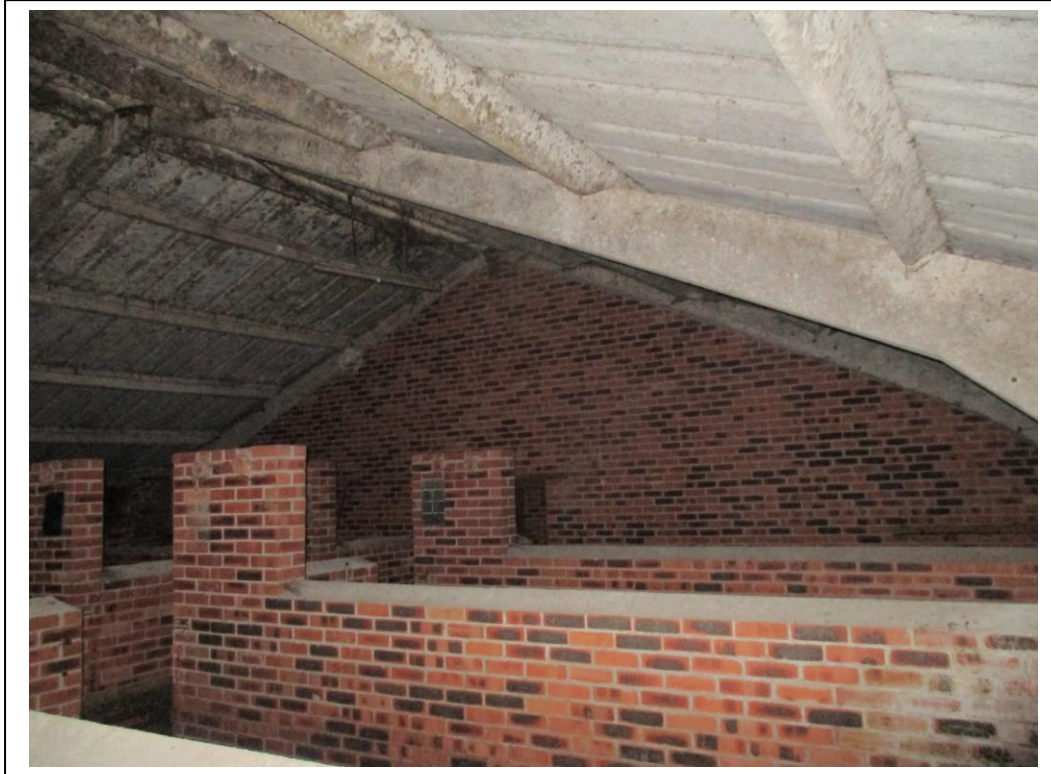
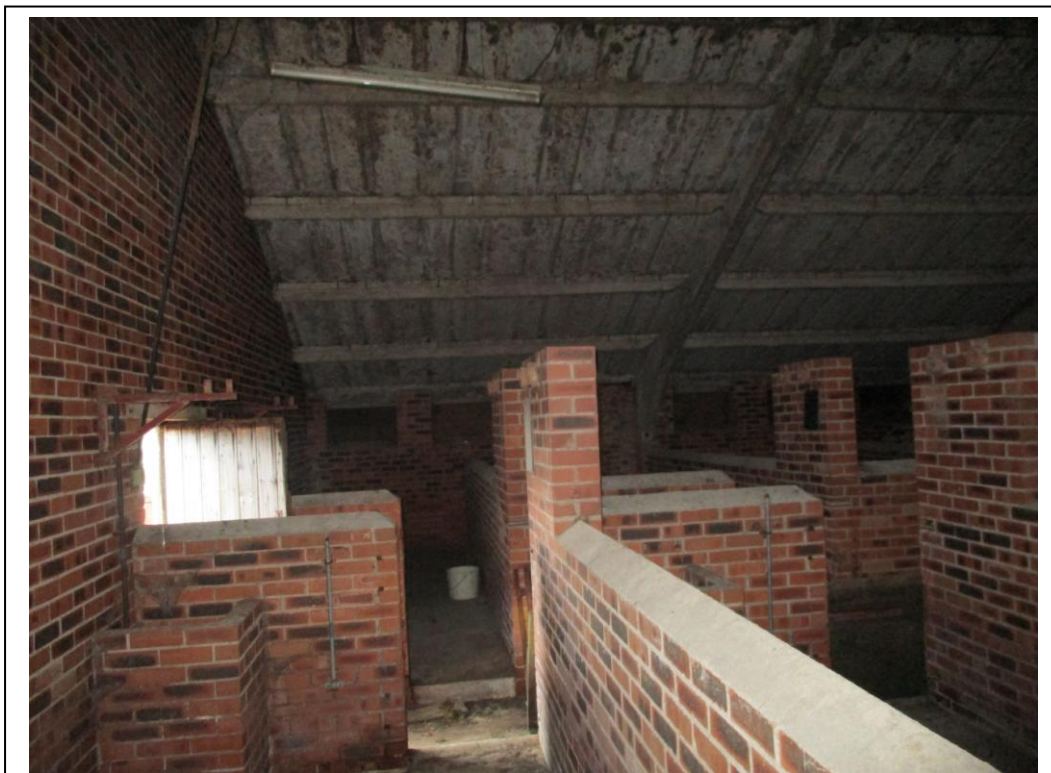
BARN D

2.46 Precast concrete portal framed building with brick external cladding walls and a mix of low level and full height brick internal walls.

Asbestos cement roof covering supported on concrete purlins.

2.47 No significant defects noted.

- 3.12 It would appear that the precast concrete structure and external cladding walls are in good condition and suitable for re-use.
- 3.13 It has been suggested that the 'At cost' portal frames may be suitable to carry additional weight from the proposed replacement slated roof; this will need to be assessed in due course.

In the past we have overcome any doubts as to the strength of similar frames by ensuring that additional support is afforded by for example building cross walls up to the underside of the portal rafters.

- 3.14 The existing foundations will need to be inspected in due course, in particular the portal frame foundations should they be subject to increased loads.
