**Ein Cyf \ Our ref:** 18018/E/01  
**Dyddiad \ Date:** 29<sup>th</sup> January 2018

**Parthed \ Re:** **HAFOD ADAMS, LLANARMON DC.**

Datrys undertook a structural inspection of Hafod Adams, Llanarmon DC on the 24<sup>th</sup> January 2018. The purpose of the inspection was to determine the structural condition of the building prior to its conversion.

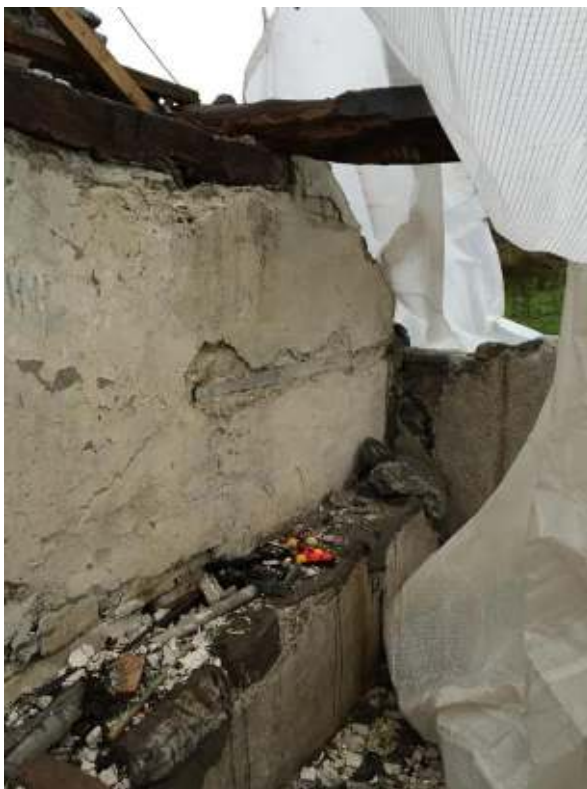
- The timber lintels appear satisfactory.
- The stone walls are generally plumb and free from defects.
- The existing purlins (2 remain in-situ on the roof) are decaying (photograph 2).
- The first floor timber joists do not show signs of any defects but they are flexible suggesting that the timbers are undersized.
- There are a number of hairline cracks within the internal plaster of the first floor walls (photograph 9).
- There is a vertical crack to the north east corner of the north ground floor room (photograph 17).
- There is some cracking of the plaster within the ground floor partition wall (photograph 16).
- All walls above first floor level lean outward slightly.

Photograph 2: The south gable viewed from first floor level.

The two remaining purlins on the roof have been exposed to the weather but have also been decaying for a considerable period of time and should be replaced.

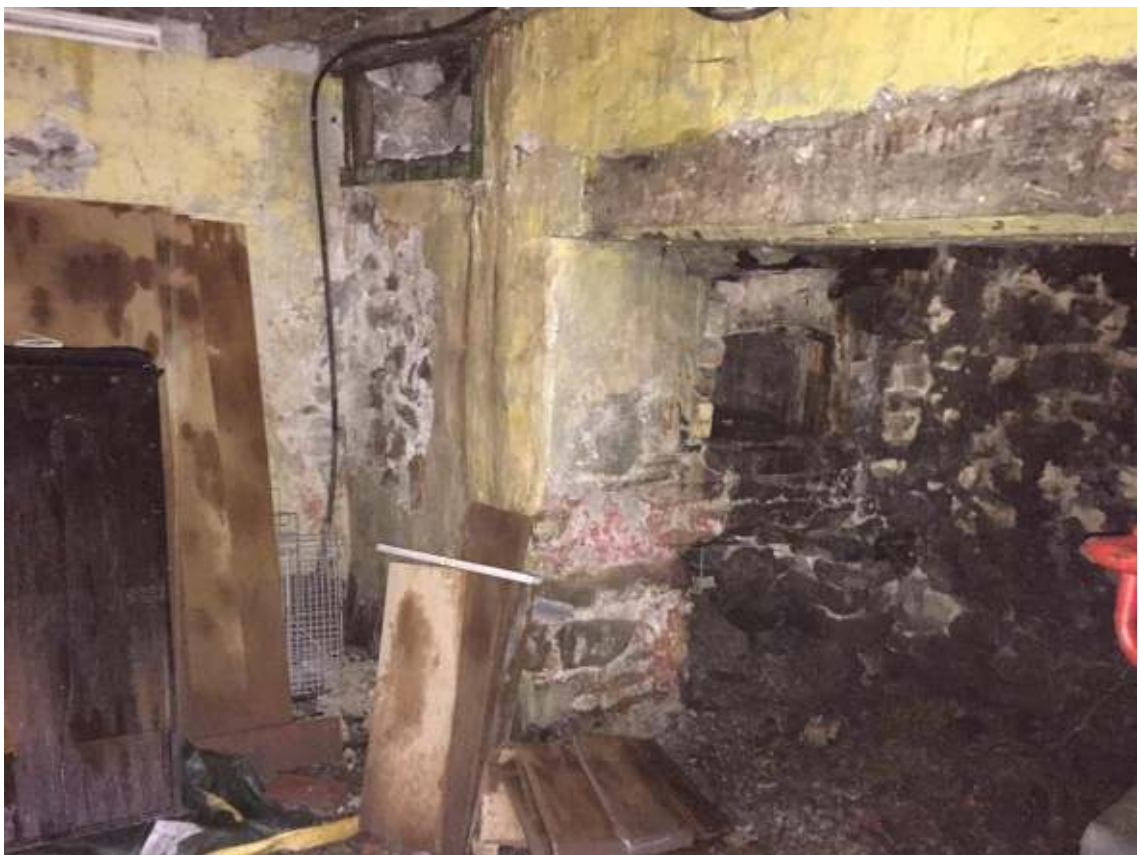
Photograph 13: The fireplace and oven to the south room, ground floor.

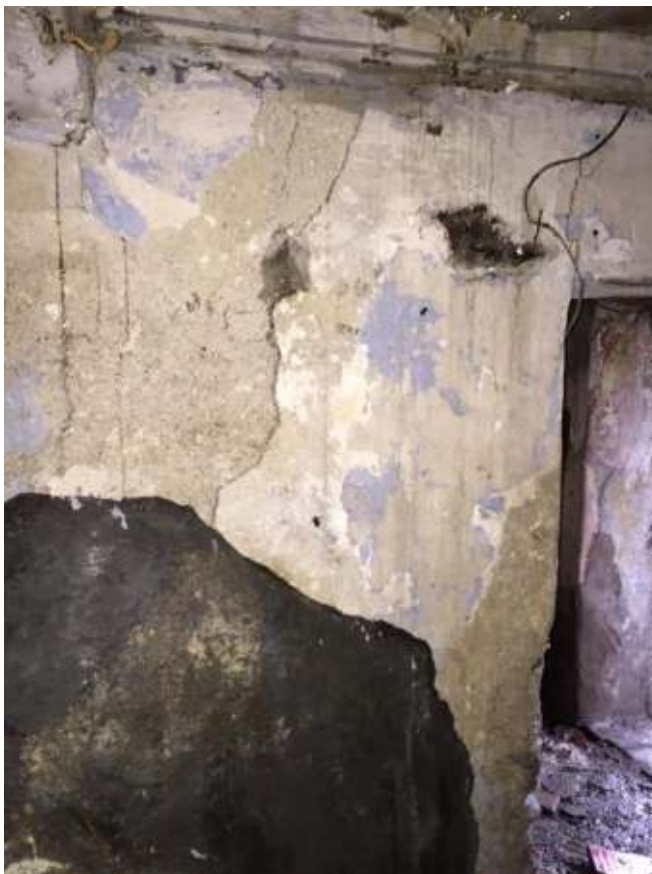
Photograph 16: The partition wall from the north room looking south.
