**Allington Farm  
Wrexham  
Structural Inspection**

**By Steve Naylor** BEng(Hons) CEng MIStructE

**Date:** 04/12/17

This structural inspection concerns, Allington Farm. The report is provided to form part of the Planning application to convert the dilapidated building in to a habitable dwelling.

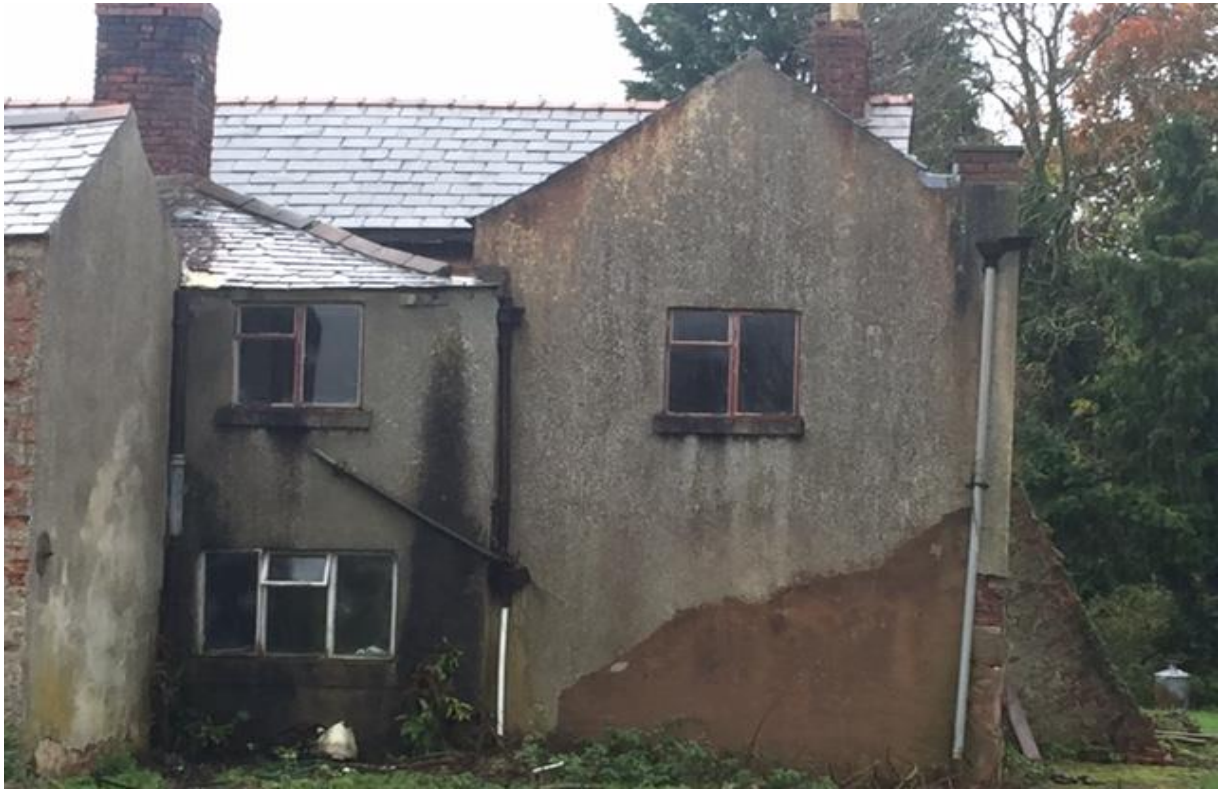
There was a significant lean and bulge to the south-west elevation wall, which is believed to be one of the later additions, a large masonry buttress has been introduced at some time, probably in an attempt to prevent any further movement, the buttress masonry is heavily weathered with crumbling brick work and weathered mortar joints.

The external levels surrounding the property were generally either level with the internal floor level to the front elevation or above the floor towards the rear elevation.

Rear elevation – note, external levels above internal floor and leaning wall with buttress.

- 4) The leaning and bulging wall to the south west elevation appears to be historic movement, there are no signs that this is ongoing, however, any redevelopment should include the introduction of galvanised steel straps between the floors and walls to effectively tie the building together. Where walls are not tied or keyed in it would also be prudent to strap these walls together as part of any works.

- 9) Externally the ground levels are too high around the whole property but particularly to the south, east and west elevations, which is causing the external walls and floor slabs to be damp. The external levels should be reduced throughout to a minimum of 150mm below internal finished floor slab level with a gravel border against the masonry.

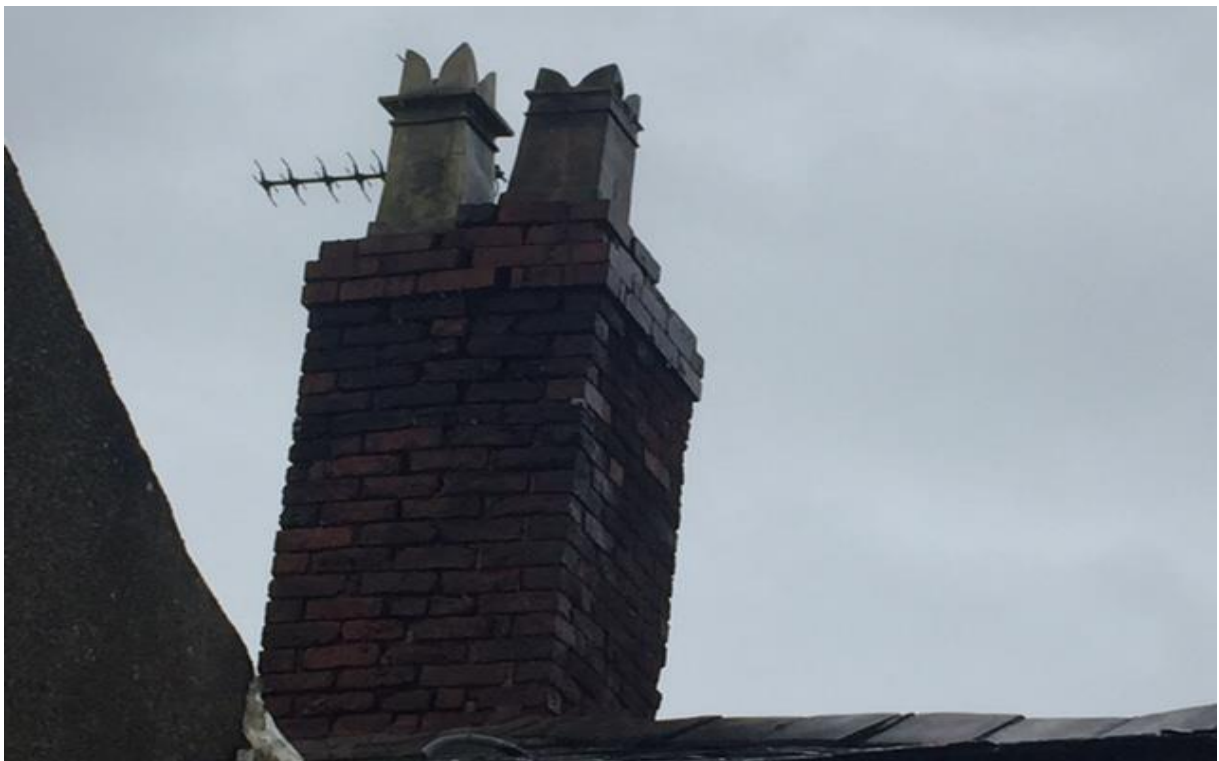
The chimney stacks visible above roof level was in poor condition, particularly the central chimney which has a large crack running vertically up both sides increasing in width at the top, with heavily weathered joints and lead flashing details.

Central chimney with large vertical crack and unstable brick work.

- 2) The chimney stacks above roof level require a complete overhaul and partially taking down and re-building with new flashing details.
- 3) The render should be completely removed from all of the external walls to enable the brick to be exposed, it is envisaged that many of the joints will require raking out and re-pointing. Some of the brick particularly to the rear elevation, the buttress and west/south-west elevations are significantly damaged and will require partially or fully taking down and re-building to replace the damaged bricks.

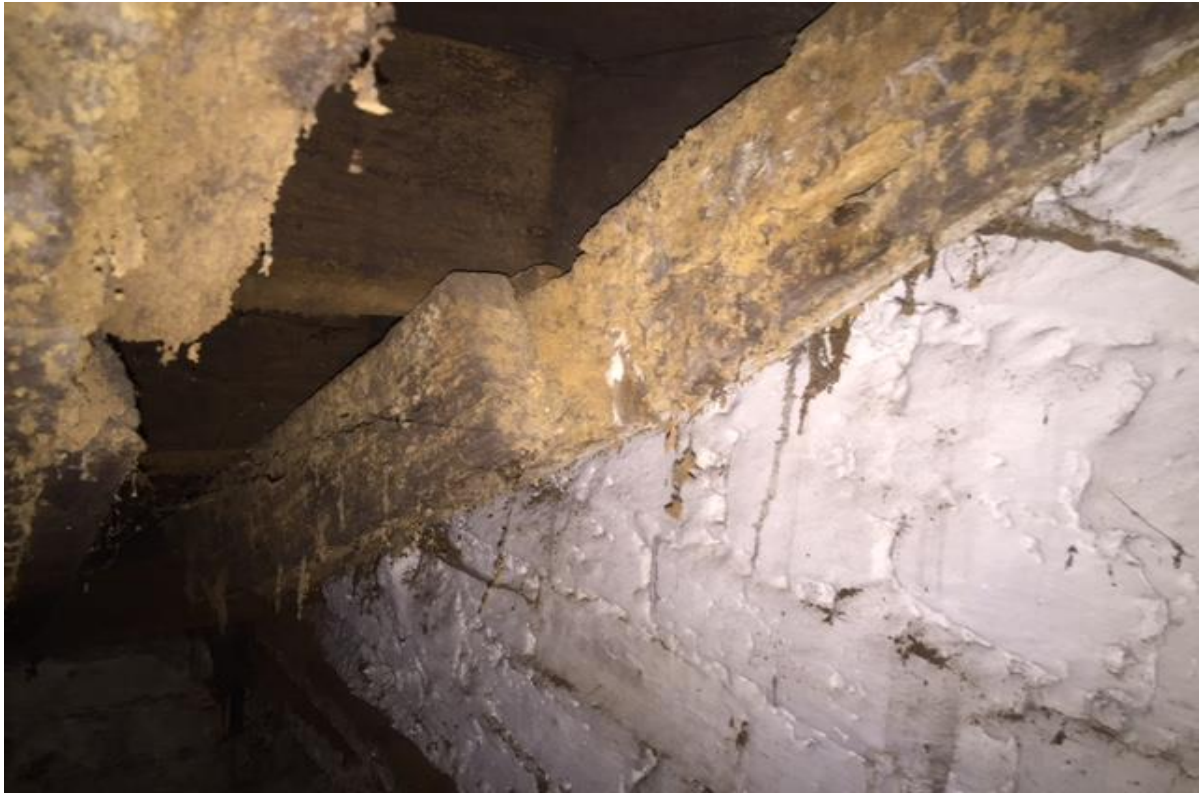
The timber floor above the partial basement was in a very poor state of repair, with rotten timbers throughout and noticeable bowing and deflection. The support timbers for the stairs is within the access down to the partial basement and has also suffered from rot and some members have failed resulting in stairs dropping and becoming unstable and unsafe.

Failed and rotten timbers supporting stairs.

- 6) The suspended timber floor above the basement should be completely replaced with a new insulated timber floor as should the timber staircase due to rotten timbers.

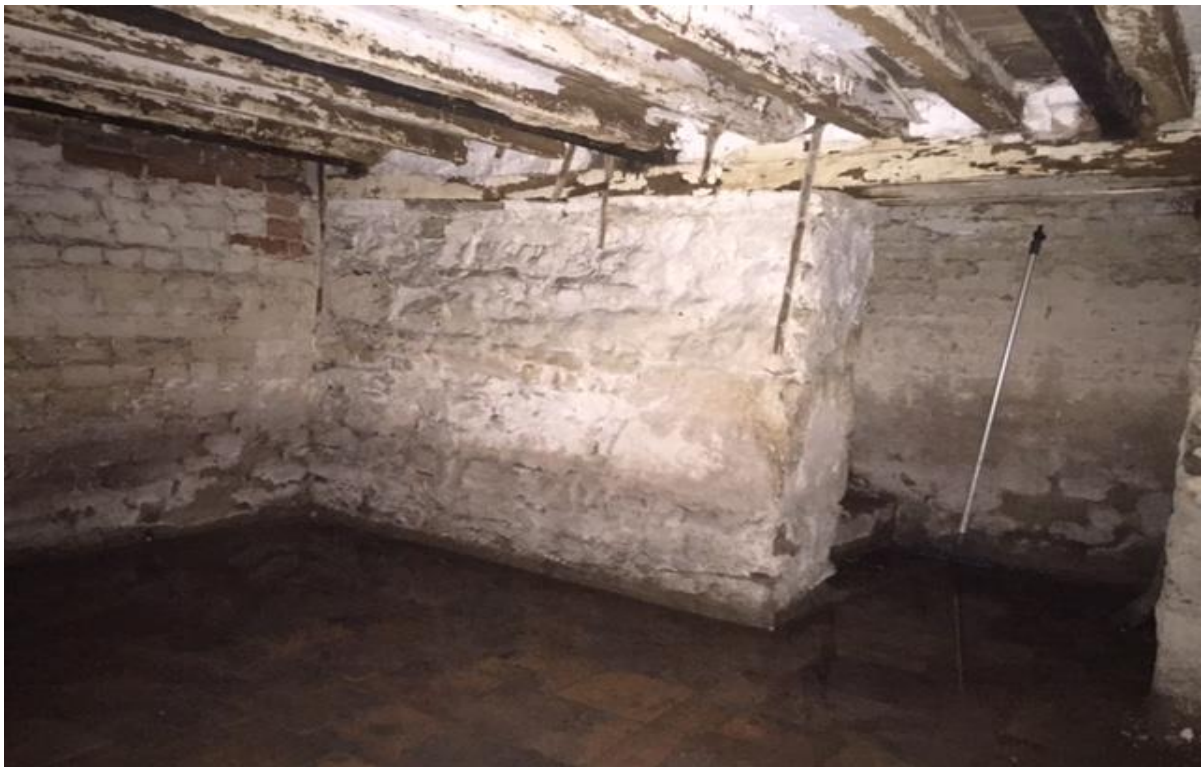
The basement was a very damp environment and partially filled with water at the time of inspection, a drain was present in the floor but appeared to be blocked and the floor appeared to fall away from the drain causing the basement to hold water.

Damp environment within basement

- 7) The basement drainage should be thoroughly cleaned and unblocked and the floors levels adjusted so that they fall towards the drain. Ventilation should be introduced to the basement via air bricks or similar to enable movement of air.

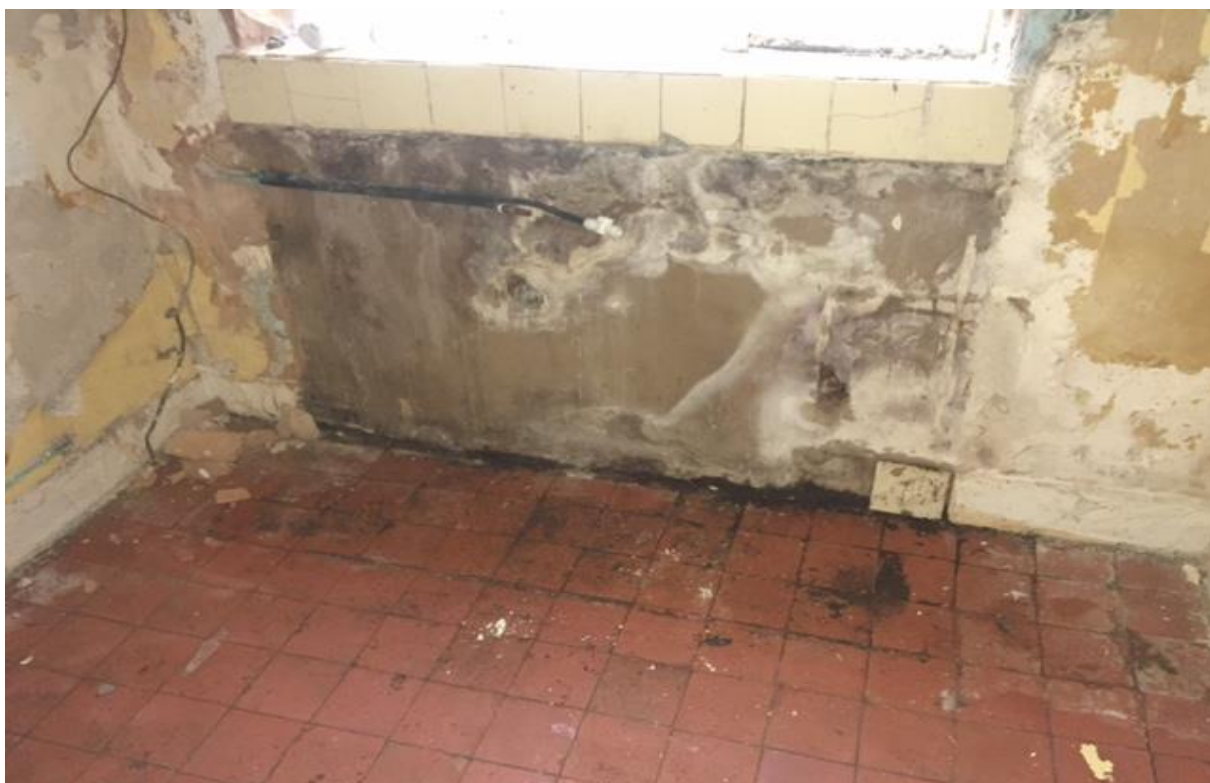
The ground bearing floor slabs were general level with some uneven sections particularly within the older sections to the rear elevation at a lower level, it was also noted that the lower sections of wall and floor, particularly towards the rear elevation were very damp.

Damp walls and floor to rear elevation rooms due to high external levels and lack of membrane.

- 8) The ground bearing floor slabs should be grubbed out to enable a new insulated concrete slab and membrane to be laid. As this will entail significant internal excavation and it is likely that the foundations to the walls will be very shallow, some underpinning of the walls may be required to facilitate this.

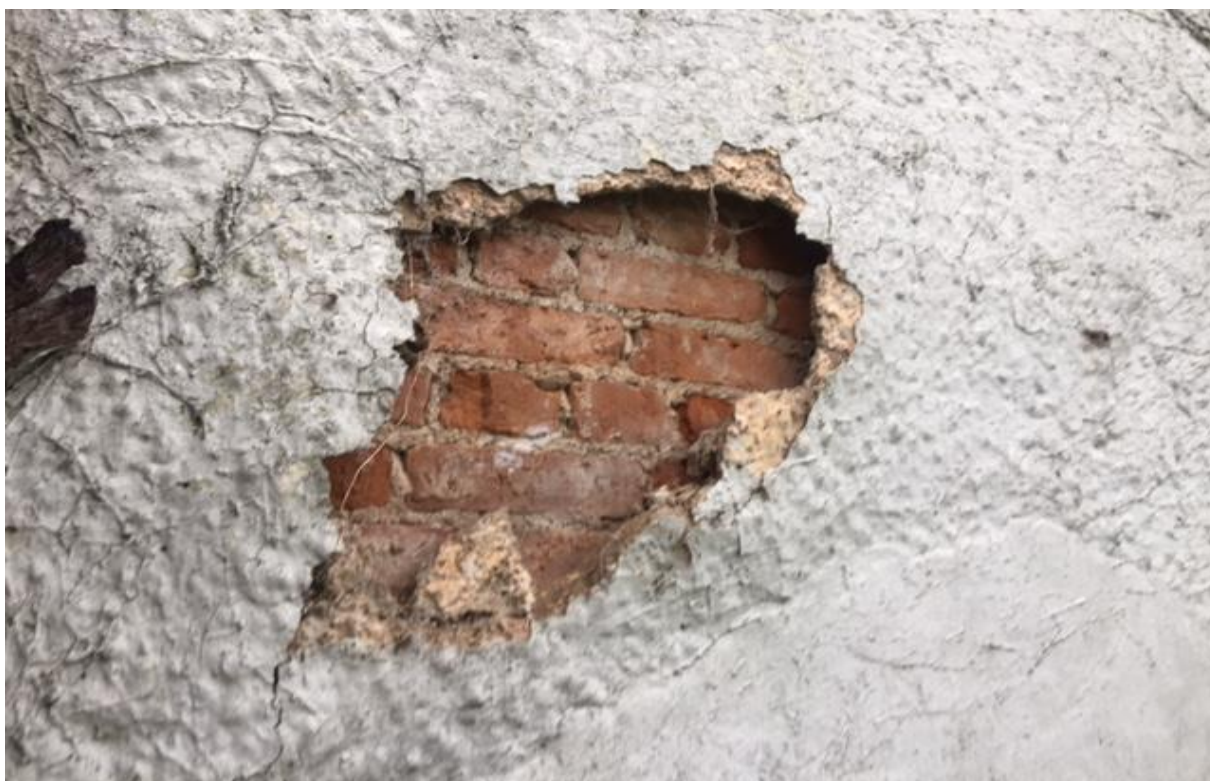
Some of the walls under the render appeared in fair condition, particularly to the north east and south-east elevations.

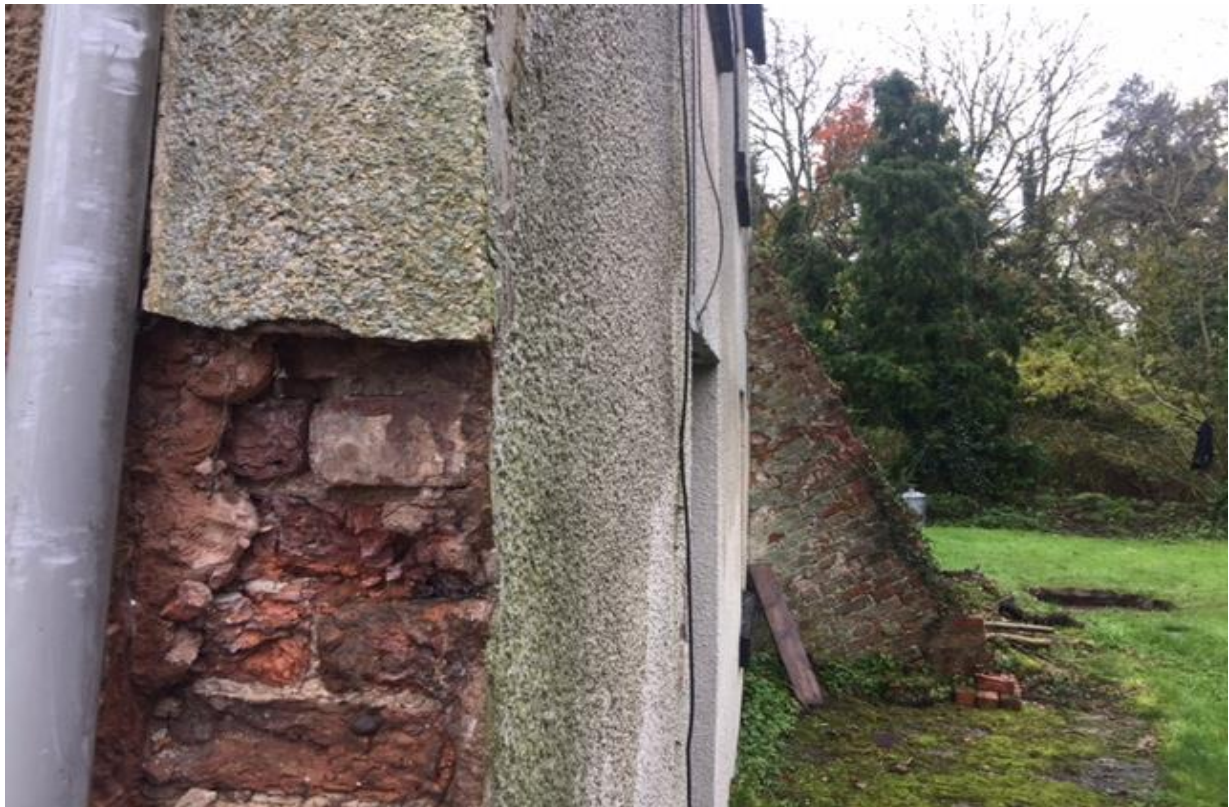
Many of the external masonry walls were rendered and not visible, the render was generally in poor condition and hollow, coming away in places, where the brick work was visible to the front elevation sections to the south and east the brick work appeared to be in reasonable condition under the render. Some of the rear elevation masonry walls to the south west and west elevations were in a poor condition with crumbling bricks vertical cracks and heavily weathered mortar joints.

Some exposed brick work is in poor condition and will require partial re-building to replace the crumbling and damaged masonry.

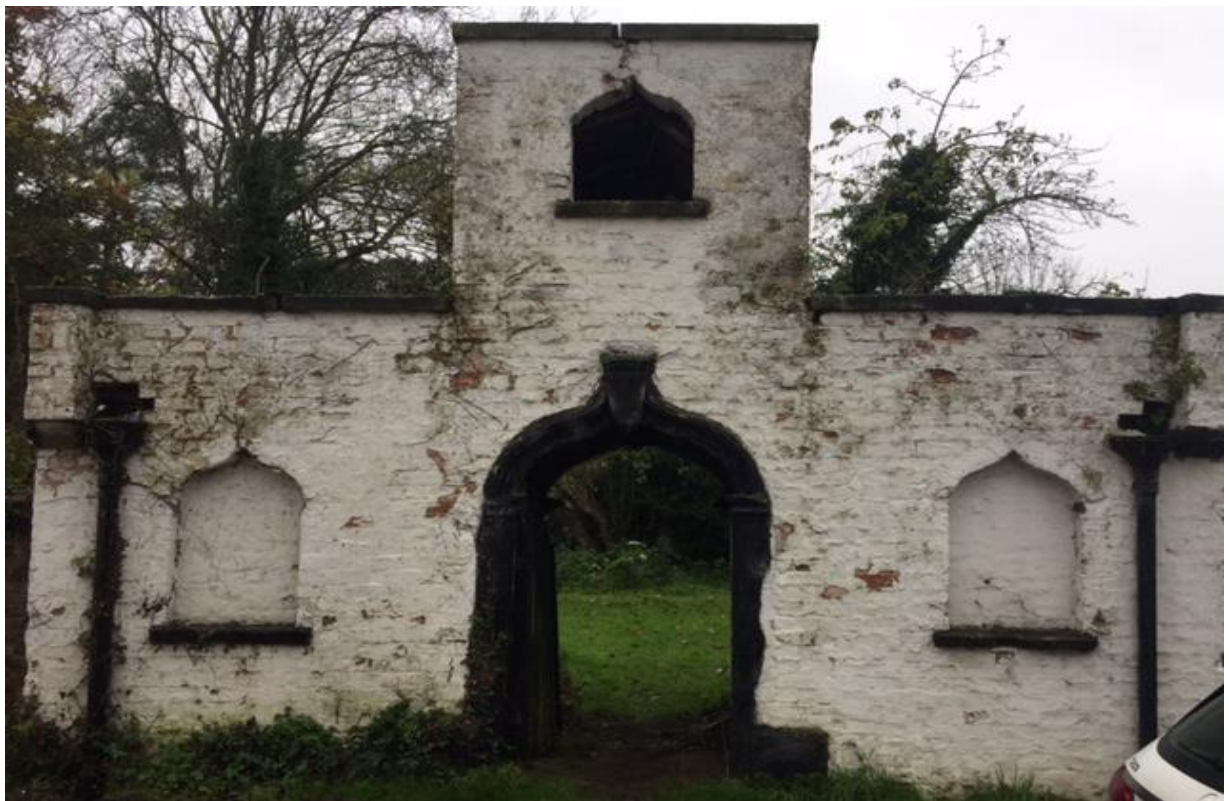
The masonry to the gate house to the garden entrance was generally in fair condition, however, the slate roof and timber elements were in a poor state of repair.

The primary structure of the garden gate house was in fair condition.

- 10) The garden gate house building requires complete new timber structural elements to the roof and internally.

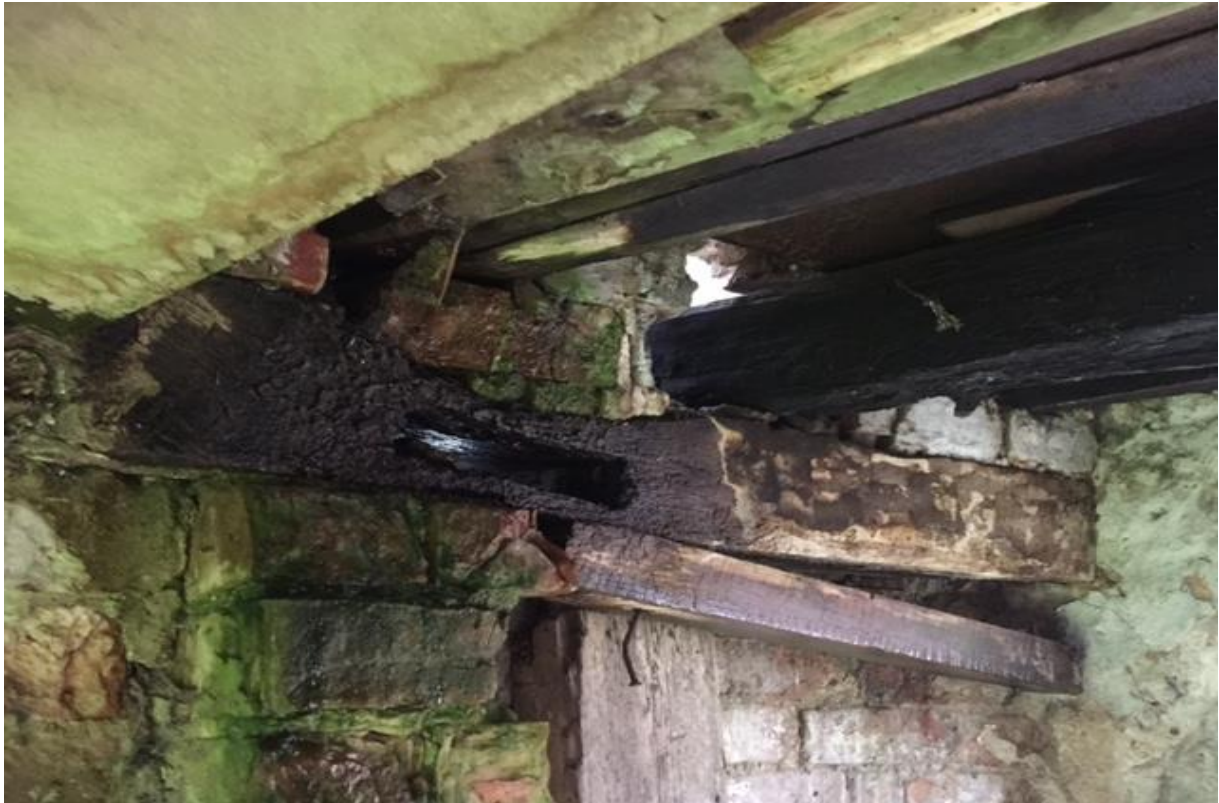
Some of the internal timber and roof elements require complete replacement.

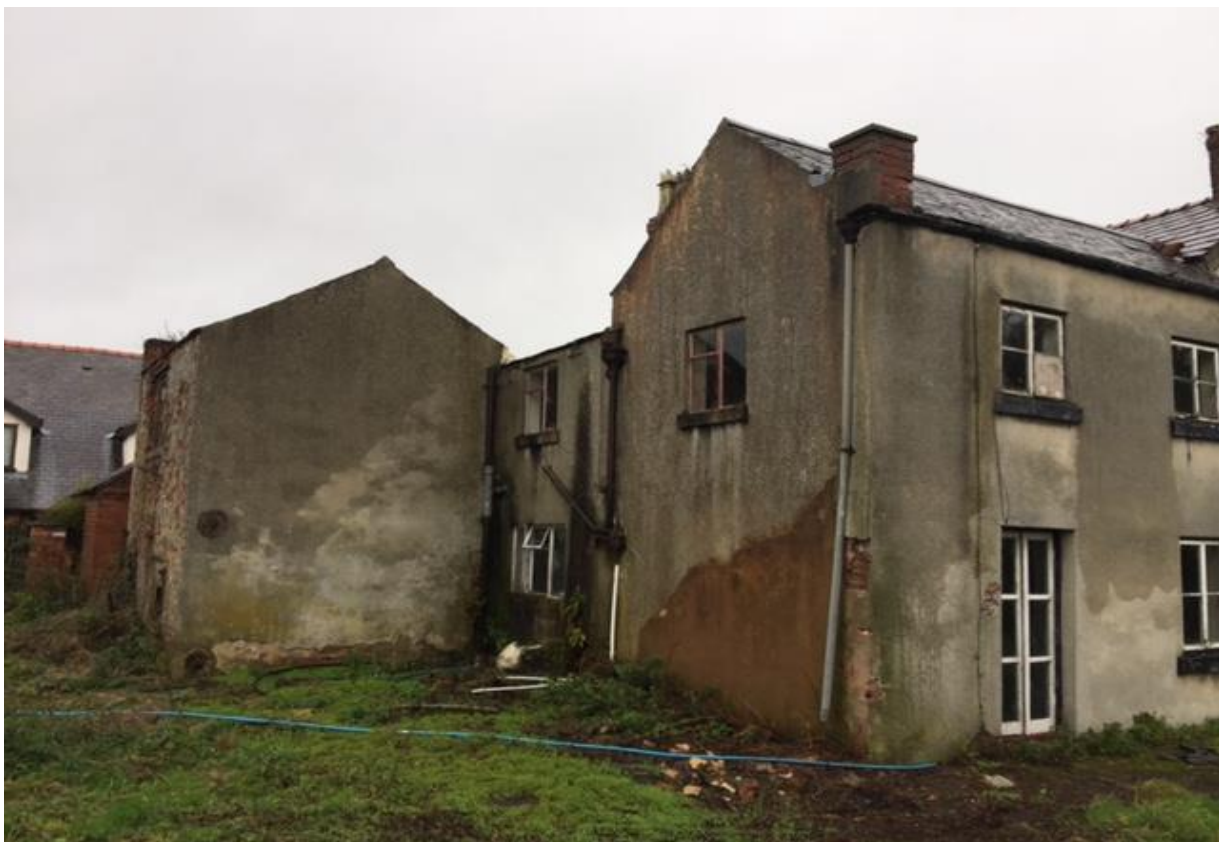
Elevation showing the older section of the property – note very poor brick work to the far elevation that will require partial re-build.
