**DAYTIME BAT SURVEY AT  
GWERN-Y-TO, WORTHENBURY,  
WREXHAM**

**2014**

**RACHEL HACKING ECOLOGY**

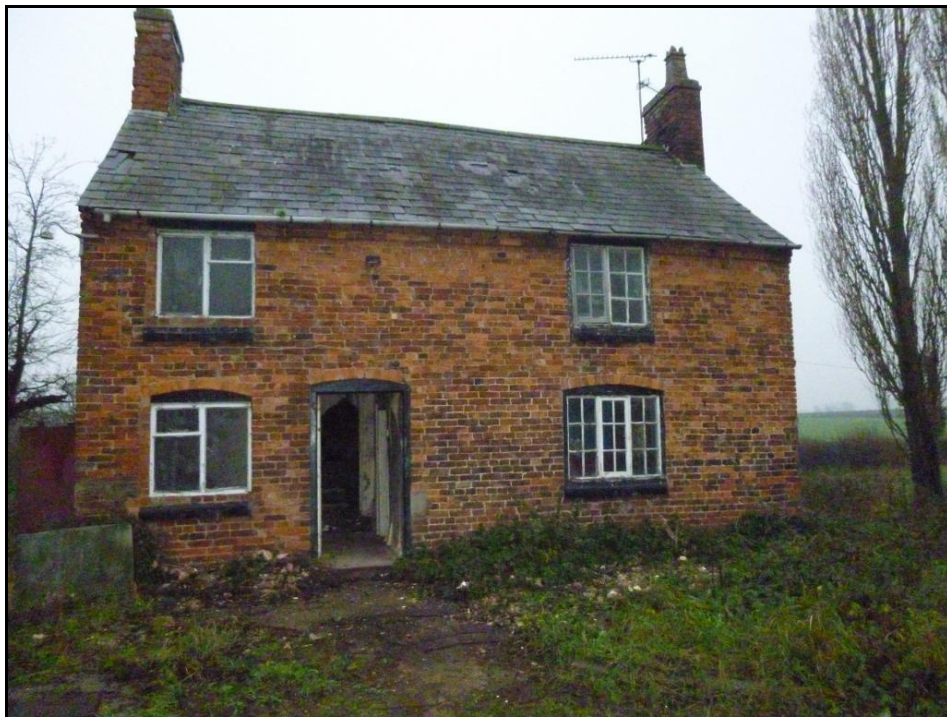
- 3.2 The detached dwelling is an old farmhouse (see Photograph 1), which has been fairly recently occupied. It is two-storey in height with a small brick-built extension to the rear. The window frames and door frames are wooden and are starting to rot. In places, mortar is missing from the brickwork, particularly on the chimneys.

**Photograph 1 showing the detached dwelling**

- 3.4 The roof is generally intact but slipped tiles do exist. In one place, at the front of the building, a tile is missing (see Photograph 1).

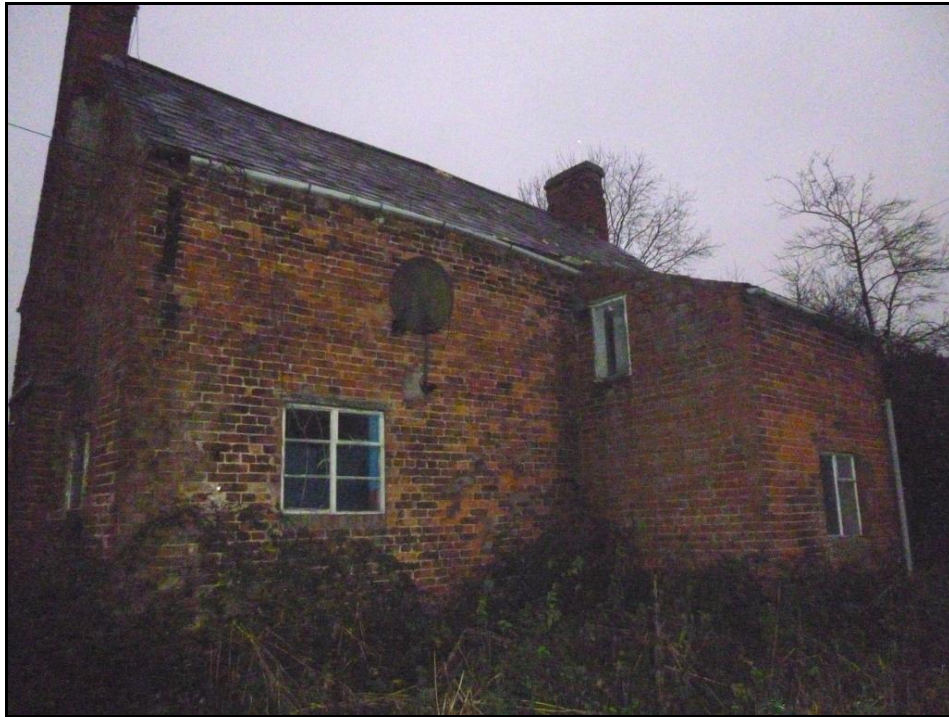
- 3.3 No soffits or barge boards exist on this property. The guttering is coming away from the walls in many places (see Photograph 2).

**Photograph 2 showing the rear of the detached dwelling**

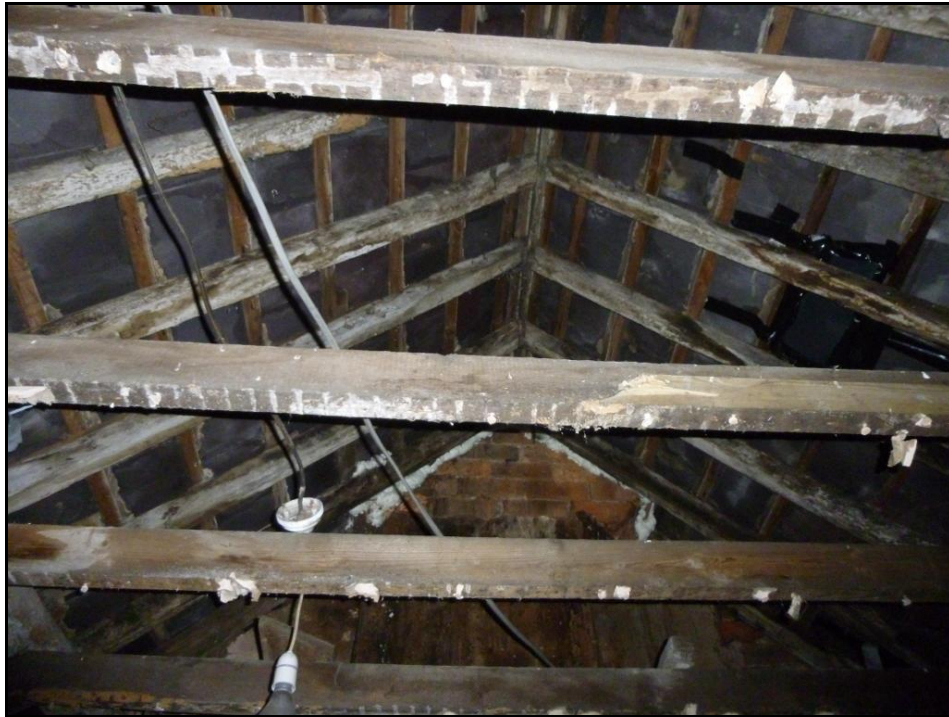
- 3.5 Internally, the property has been stripped. Interior walls remain standing. Water damage has occurred, making the stairs and upstairs flooring unsound. Mould and damp occur throughout.
- 3.6 The ceilings within the first floor have been removed, allowing the whole interior roof to be viewed (see Photograph 3). Where roof tiles have slipped, expanding foam has been used in an attempt to plug any gaps. Extensive water damage has occurred beneath the slipped slates.

**Photograph 3 showing the roof and ceiling joists**

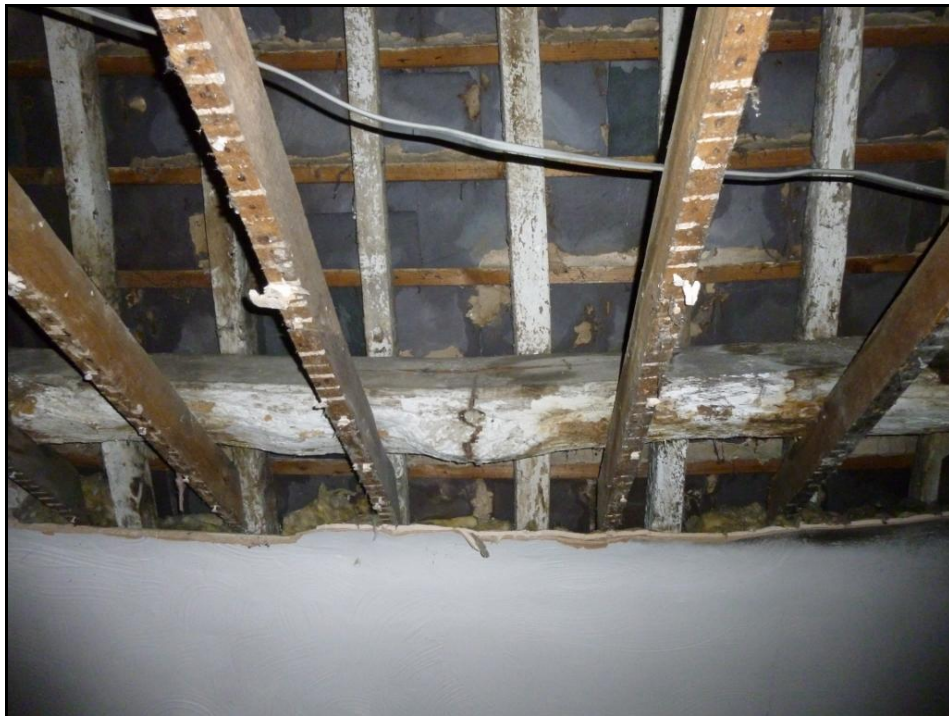
- 3.7 The slate tiles are flush to the brick gable ends of the building. Here, the mortar is intact. Mortar is missing from the slate tiles in many places (see Photograph 4). The wooden beams, roof and ceiling joists are intact, with no cracks or gaps evident. They are becoming mouldy due to water ingress. Where small parts of ceiling plasterboard remain, these could be easily inspected behind.

**Photograph 4 showing roof tiles and wooden beams**

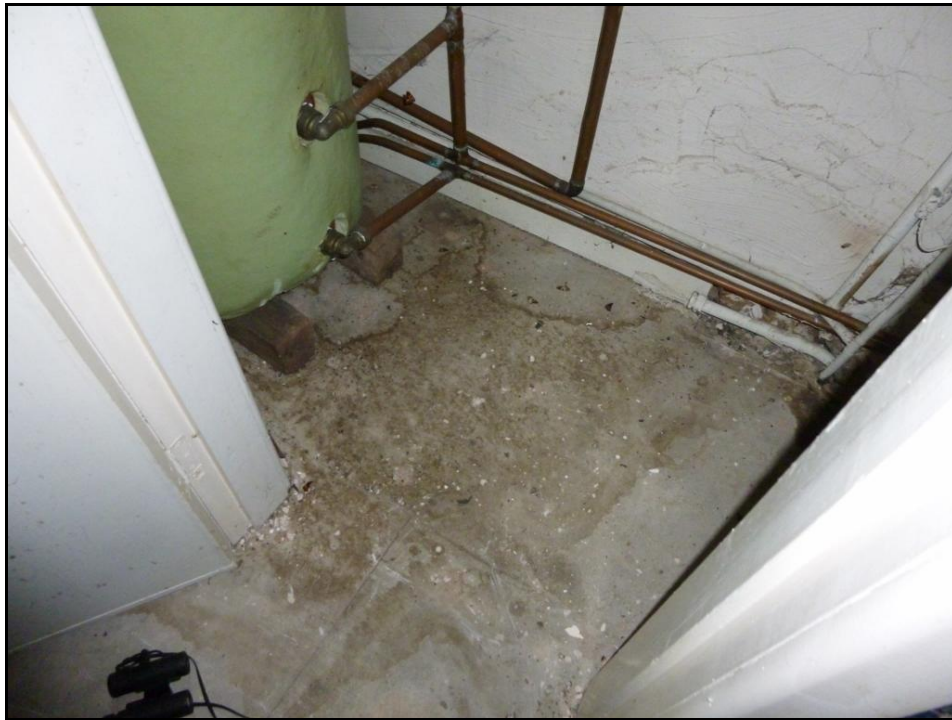
- 3.8 Bat droppings and feeding remains (butterfly wings) were found throughout the first floor, scattered on the floorboards (see Photographs 5 and 6).

**Photograph 5 showing bat droppings in an old airing cupboard**

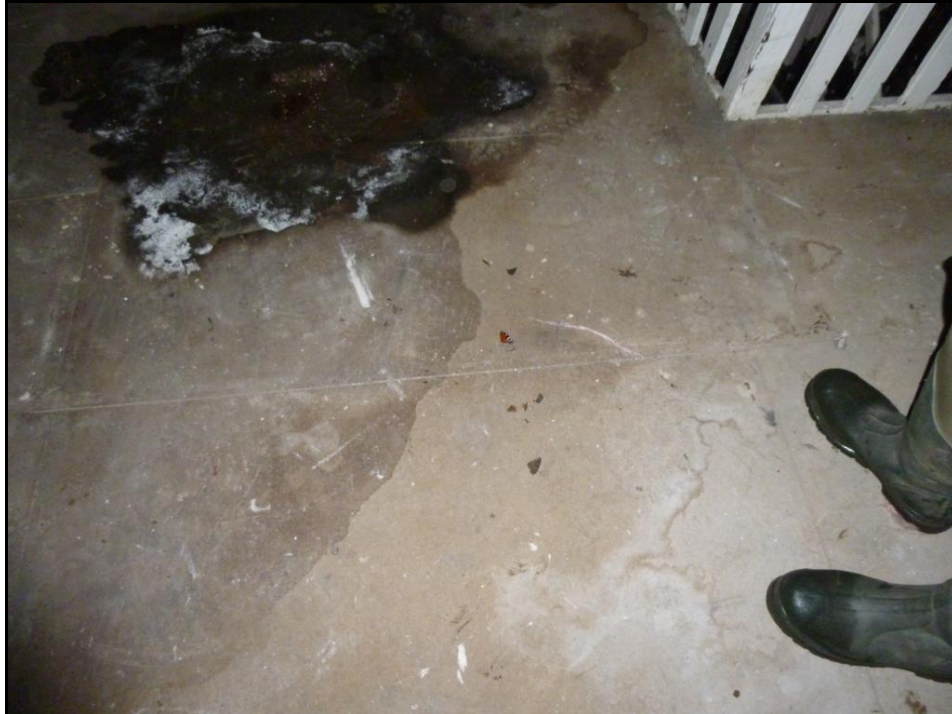
**Photograph 6 showing feeding remains (butterfly wings)**

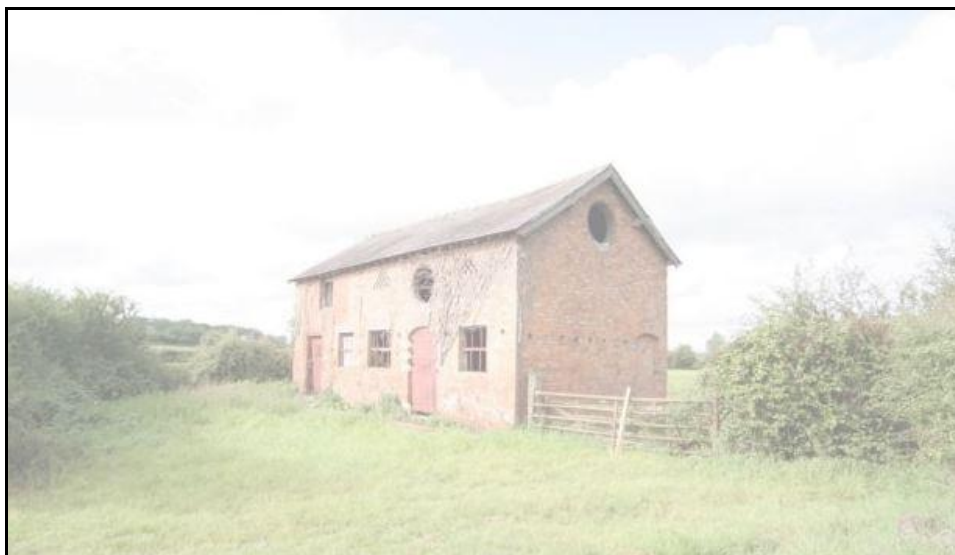
- 3.9 The barn is two-storey in height, of brick construction, with many repairs apparent (see Photograph 7). It has a pitched slate tile roof. All of the windows and doors have been securely sealed with wooden boards (see Photograph 2).

**Photograph 7 showing the barn in the summer (taken from client stock)**

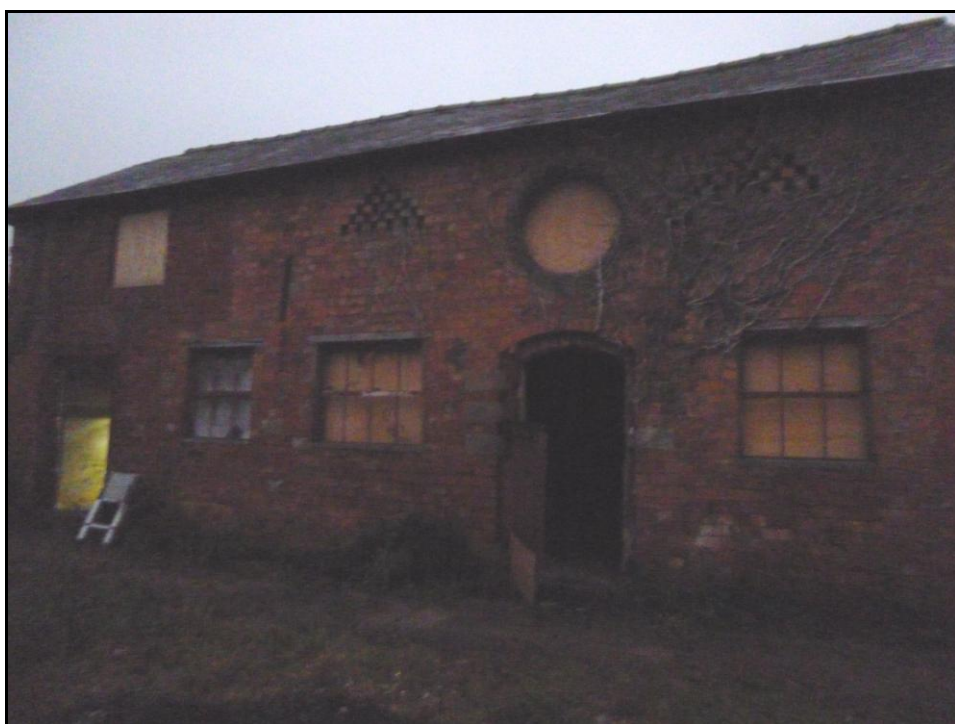
**Photograph 8 showing the secured windows of the barn**

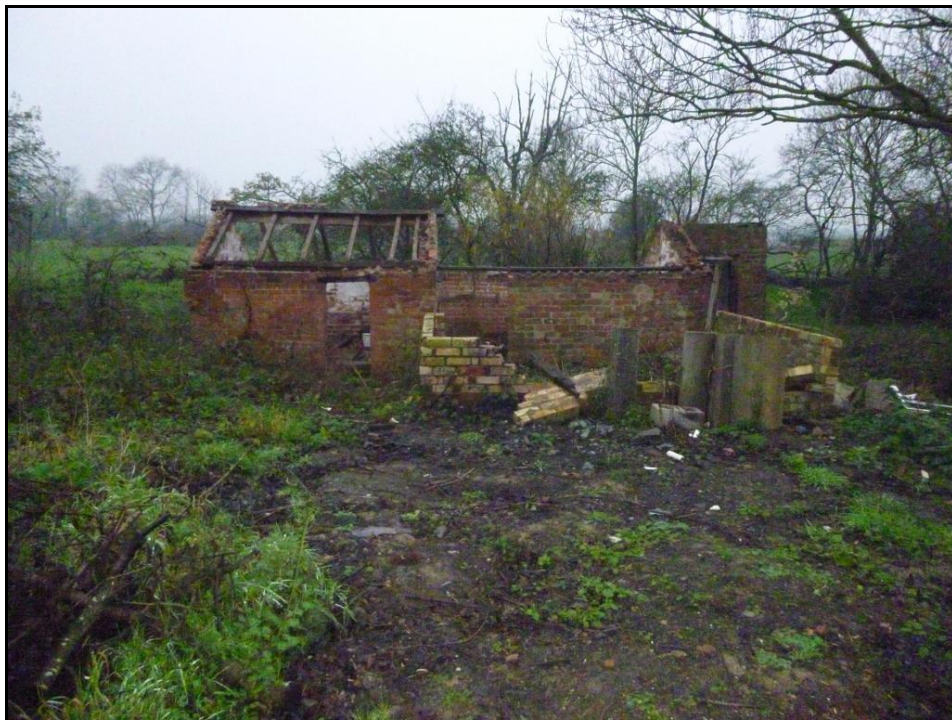
- 3.14 A dilapidated shippon exists on the site at Gwern-y-to. This has no roof (see Photograph 9). This was inspected and found to support no suitable roosting areas for bats.

**Photograph 9 showing the dilapidated shippon**
