**Report No.:** SH33185

**Nature of Work:** Refurbishment Survey

Clwyd Alyn Housing Association  
72 Ffordd William Morgan  
St Asaph Business Park  
St Asaph  
LL17 0JD

3-5 Grosvenor Road  
Wrexham  
LL11 1DY

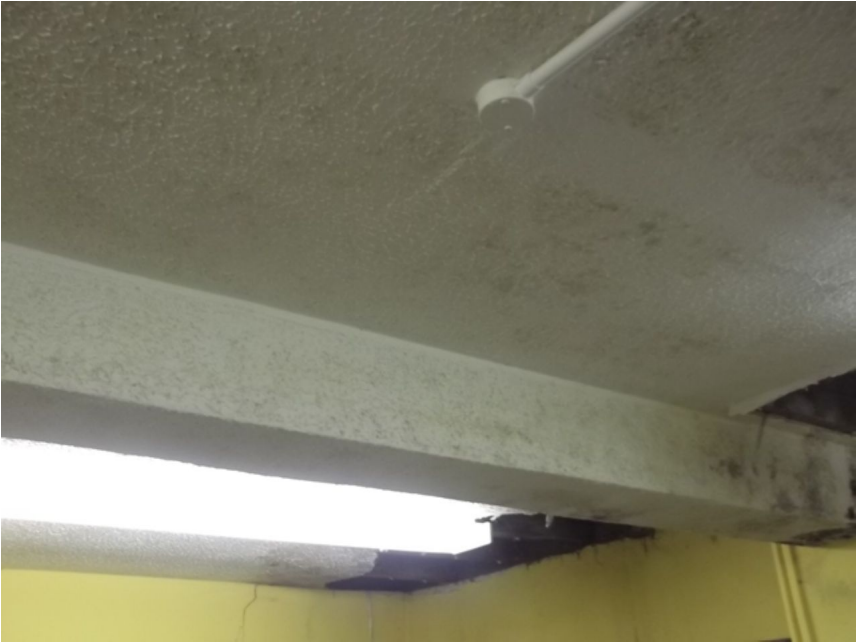
| Item Number: | 001 | Sample Number: | 627/841 | | |

| Item: | Asbestos textured coating to plasterboard ceiling(s) | | | | |
| Asbestos Content: | Chrysotile      Identified | | | | |
| Condition: | 3 (Significant damage) | | | Priority Assessment: | 4 |

| Accessibility: | 0 (Usually inaccessible or unlikely to be disturbed) | | | Recommendation: | Program removal |

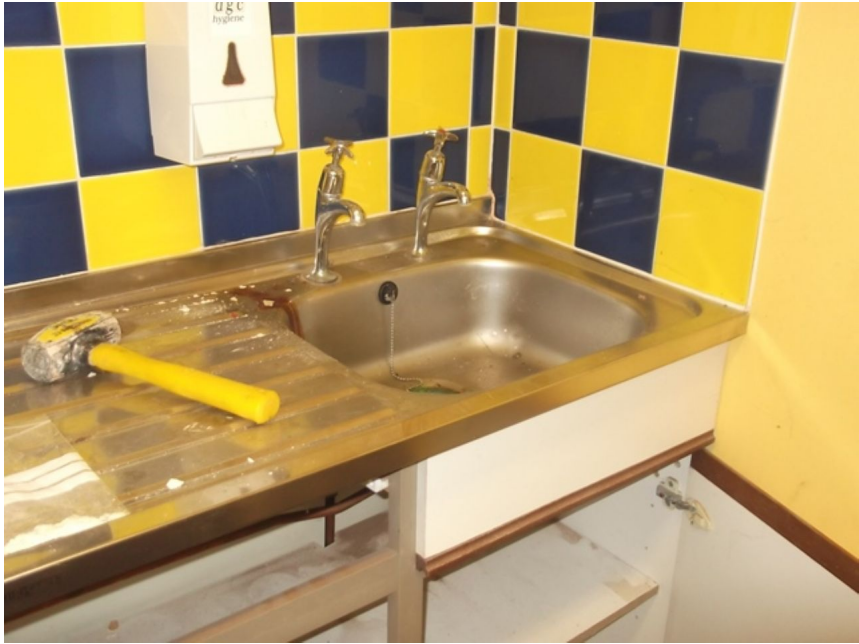
| Condition: | 1 (Minor scratches) | Priority Assessment: | 4 |

| Comments: | Live and connected. Asbestos content presumed as no safe access was available to sample the material. | | |

| Accessibility: | 1 (Occasionally likely to be disturbed) | Recommendation: | Program removal |

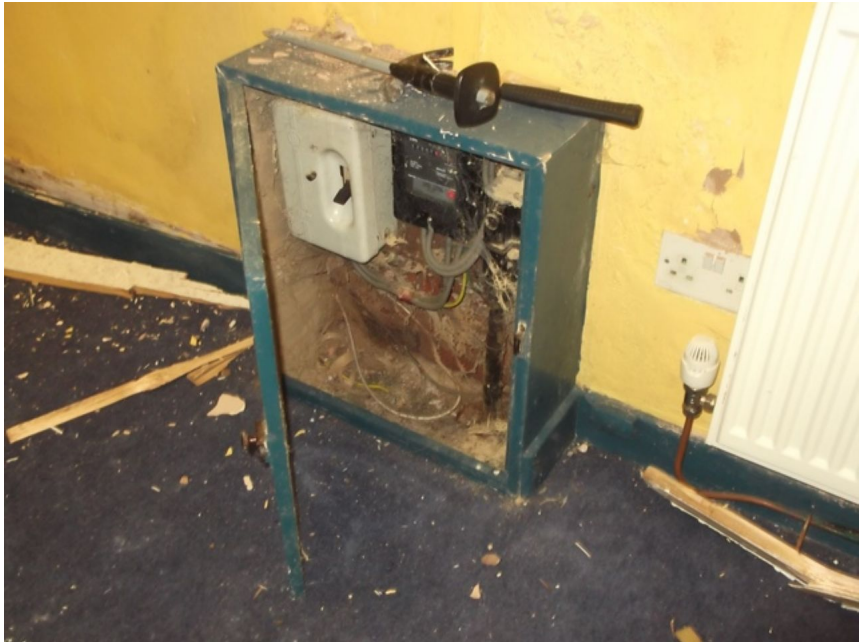
| Extent: | 2 units | Licensable: | No |
| Condition: | 3 (Significant damage) | Priority Assessment: | 4 |

| Accessibility: | 1 (Occasionally likely to be disturbed) | Recommendation: | Program removal |

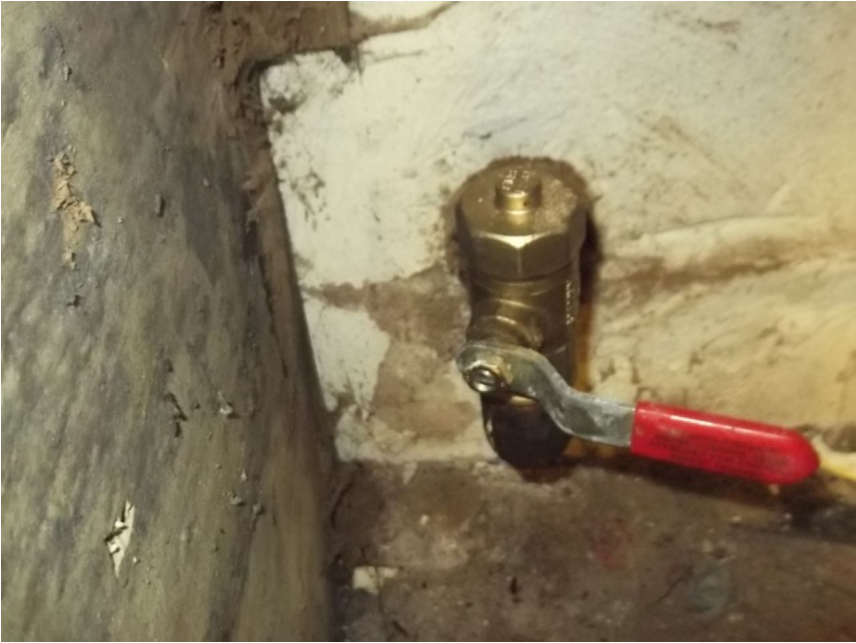
| Item Number: | 004 | Sample Number: | 627/843 | |

| Item: | Bitumen wrap to gas pipe | | | |
| Asbestos Content: | No asbestos detected Identified | | | |

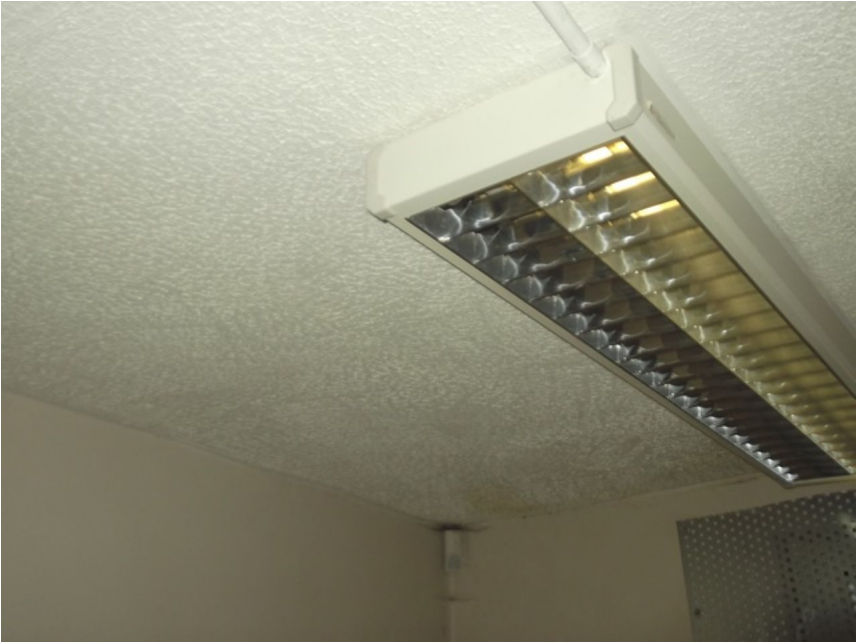
| Item Number: | 005 | Sample Number: | 627/844 | |

| Item: | Asbestos textured coating to plasterboard ceiling(s) | | | |
| Asbestos Content: | Chrysotile      Identified | | | |
| Condition: | 1 (Minor scratches) | Priority Assessment: | 5 | |

| Accessibility: | 1 (Occasionally likely to be disturbed) | Recommendation: | Program removal | |

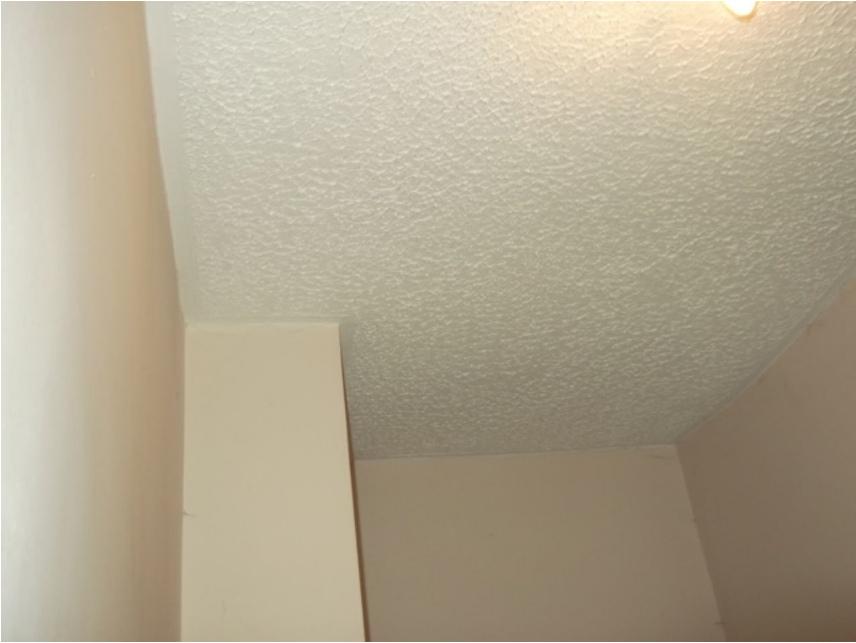
| Item Number: | 006 | Sample Number: | as 627/844 | | |

| Item: | Asbestos textured coating to plasterboard ceiling(s) | | | | |
| Asbestos Content: | Chrysotile Strongly Presumed | | | | |
| Condition: | 1 (Minor scratches) | | | Priority Assessment: | 4 |

| Accessibility: | 1 (Occasionally likely to be disturbed) | | | Recommendation: | Program removal |

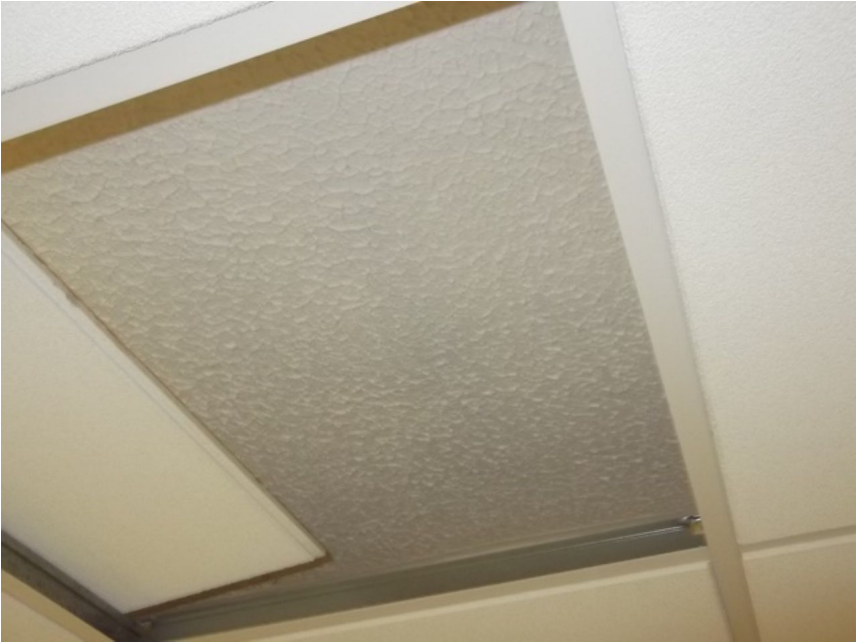
| Item Number: | 007 | Sample Number: | 627/845 | | |

| Item: | Asbestos textured coating to plasterboard ceiling(s) | | | | |
| Asbestos Content: | Chrysotile      Identified | | | | |
| Condition: | 1 (Minor scratches) | | | Priority Assessment: | 5 |

| Accessibility: | 1 (Occasionally likely to be disturbed) | | | Recommendation: | Program removal |

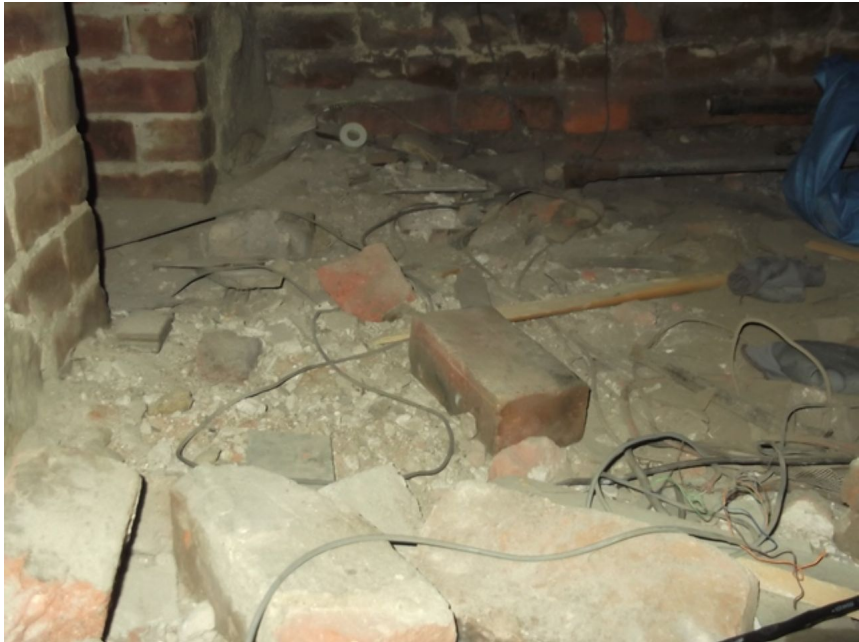
| Condition: | 3 (Significant damage) | Priority Assessment: | 7 |

| Accessibility: | 1 (Occasionally likely to be disturbed) | Recommendation: | Program removal |

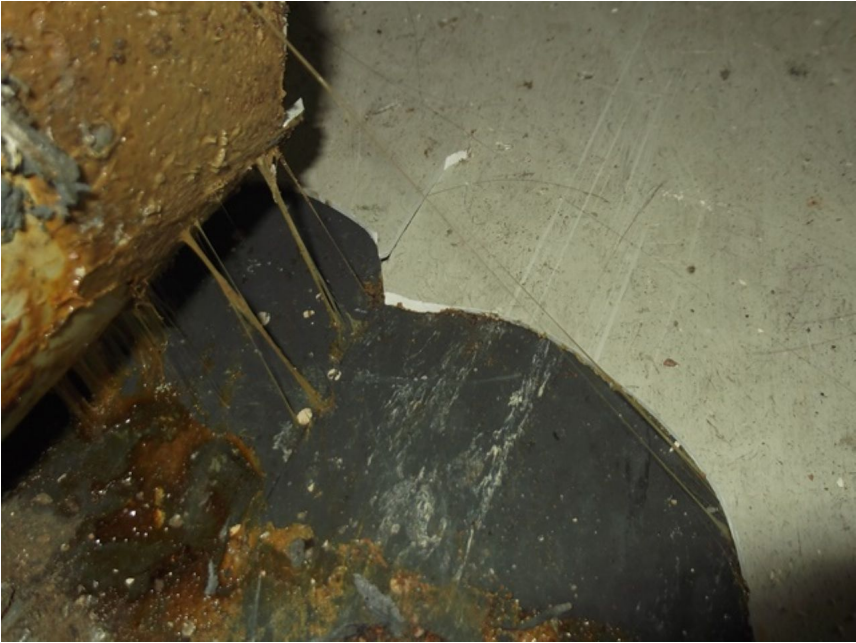
| Item Number: | 009 | Sample Number: | 627/847 | |

| Item: | Thermoplastic floor tiles | | | |
| Asbestos Content: | No asbestos detected Identified | | | |

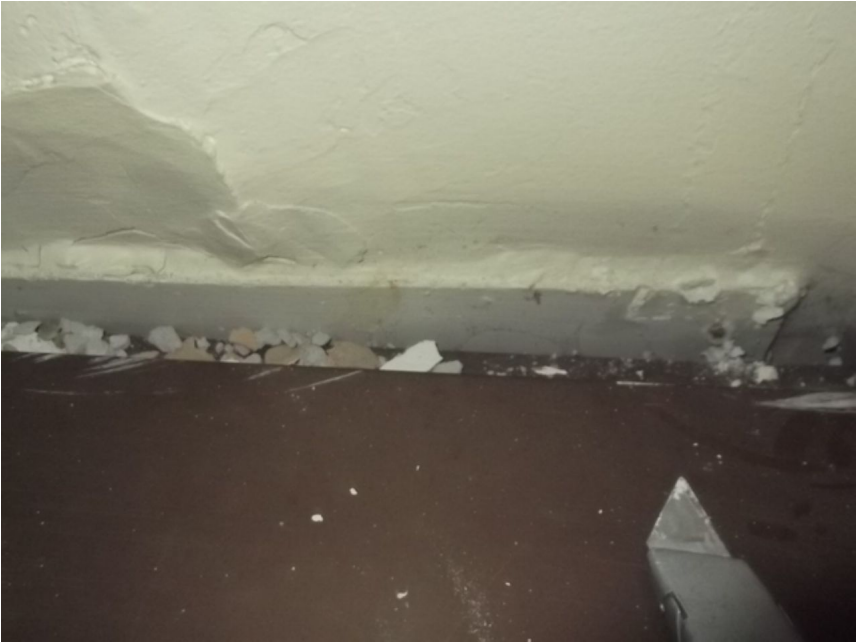
| Item Number: | 010 | Sample Number: | 627/848 | | |

| Item: | Insulating board panel behind heater | | | | |
| Asbestos Content: | No asbestos detected Identified | | | | |

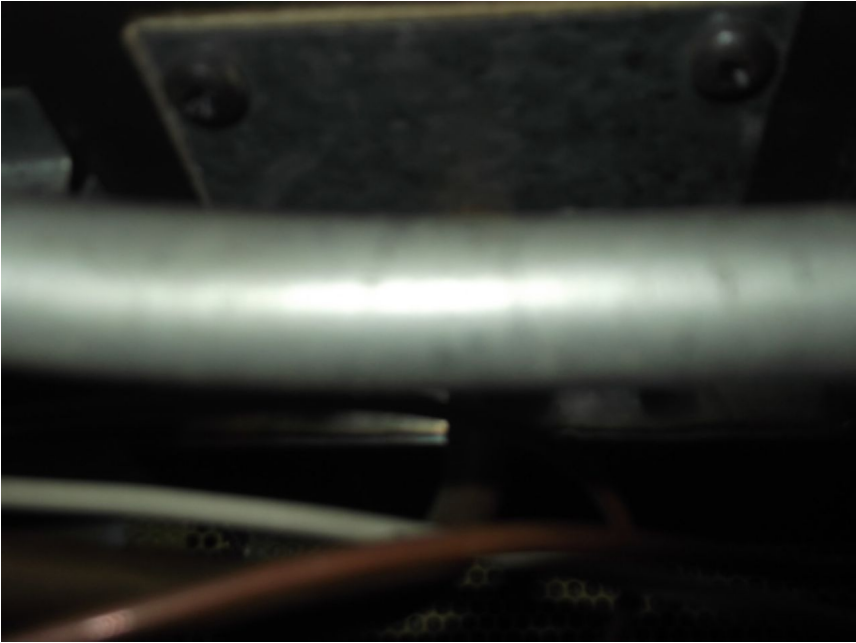
| Item Number: | 011 | Sample Number: | 627/849 | | |

| Item: | Asbestos insulating board gasket to heater | | | | |
| Asbestos Content: | Chrysotile Identified | | | | |
| Condition: | 1 (Minor scratches) | | | Priority Assessment: | 4 |

| Accessibility: | 1 (Occasionally likely to be disturbed) | | | Recommendation: | Program removal |

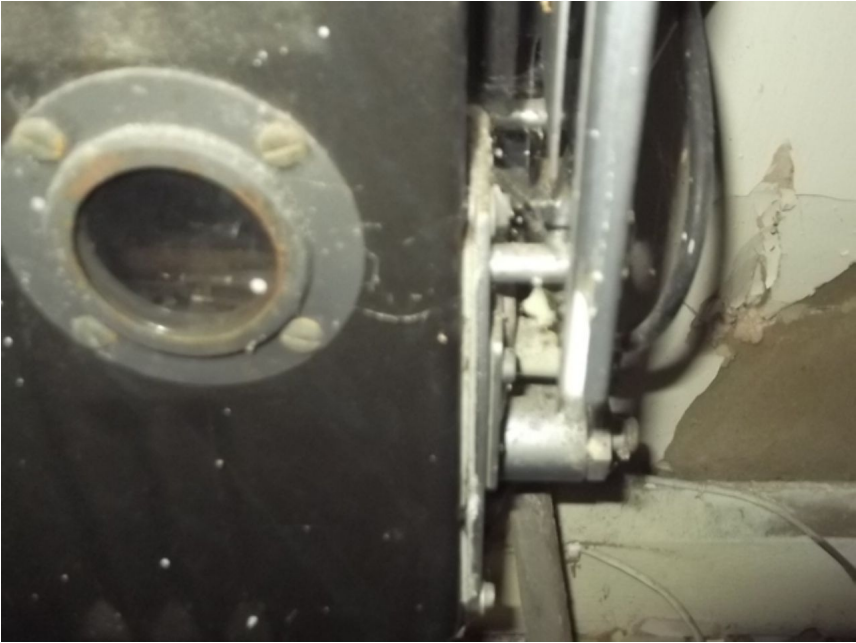
| Item Number: | 012 | Sample Number: | as 627/849 | | |

| Item: | Asbestos insulating board gaskets to heater | | | | |
| Asbestos Content: | Chrysotile Strongly Presumed | | | | |
| Condition: | 1 (Minor scratches) | | | Priority Assessment: | 4 |

| Accessibility: | 1 (Occasionally likely to be disturbed) | | | Recommendation: | Program removal |

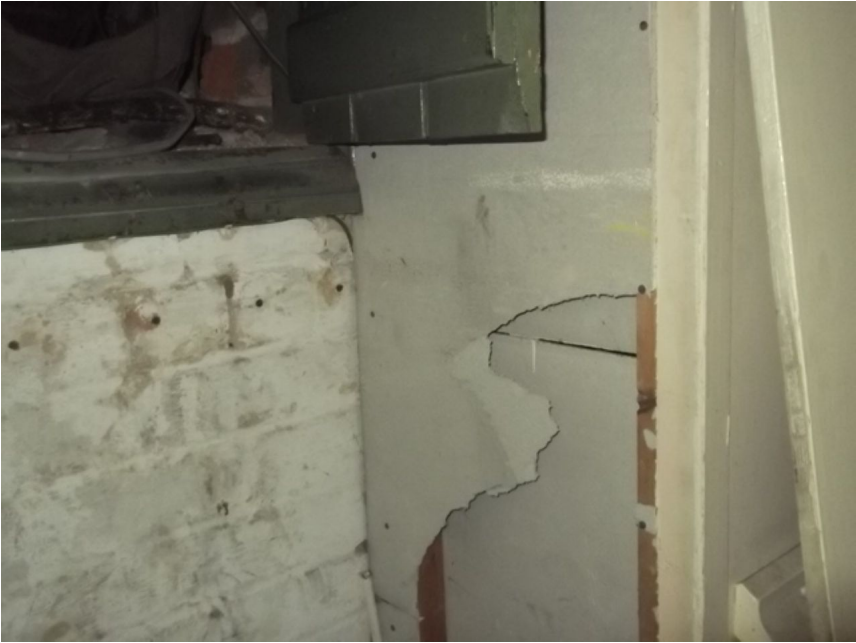
| Item Number: | 013 | Sample Number: | 627/851 | | |

| Item: | Asbestos insulating board debris to wall(s) | | | | |
| Asbestos Content: | Amosite Identified<br>Chrysotile Identified | | | | |
| Comments: | Insulating board to wall of electric meter cupboard. This material is damaged and located throughout the room. Whole room potentially contaminated. | | | | |
| Condition: | 3 (Significant damage) | | | Priority Assessment: | 6 |

| Accessibility: | 2 (Easily disturbed) | | | Recommendation: | Program removal |

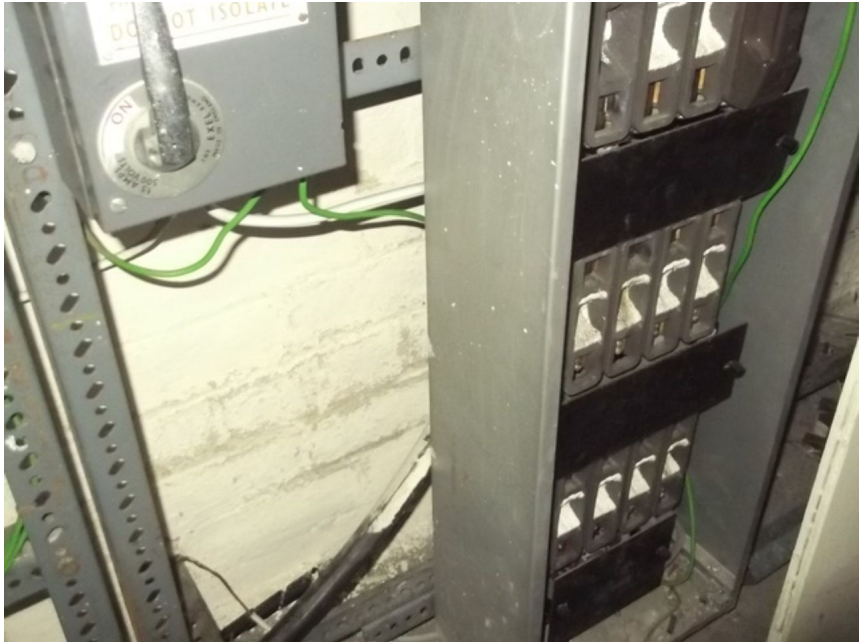
| Comments: | To all electrical boxes. Also some boxes are loose on the floor. | | |
| Condition: | 3 (Significant damage) | Priority Assessment: | 6 |

| Accessibility: | 2 (Easily disturbed) | Recommendation: | Program removal |

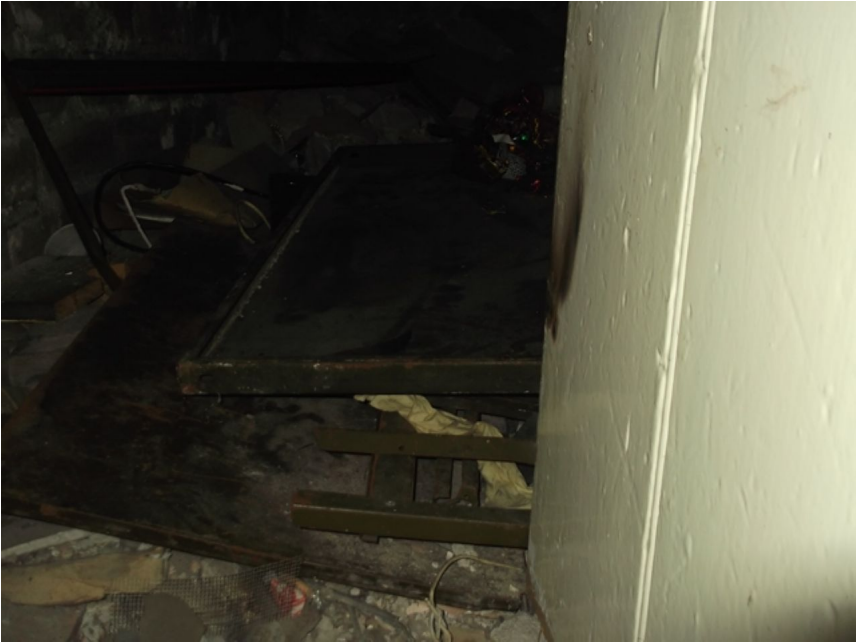
| Item Number: | 015 | Sample Number: | 627/850 | |

| Item: | Asbestos insulating board debris to floor | | | |
| Asbestos Content: | <div>CrocidoliteIdentified</div> <div>AmositeIdentified</div> <div>ChrysotileIdentified</div> | | | |
| Condition: | 3 (Significant damage) | Priority Assessment: | 8 | |

| Accessibility: | 2 (Easily disturbed) | Recommendation: | Program removal | |

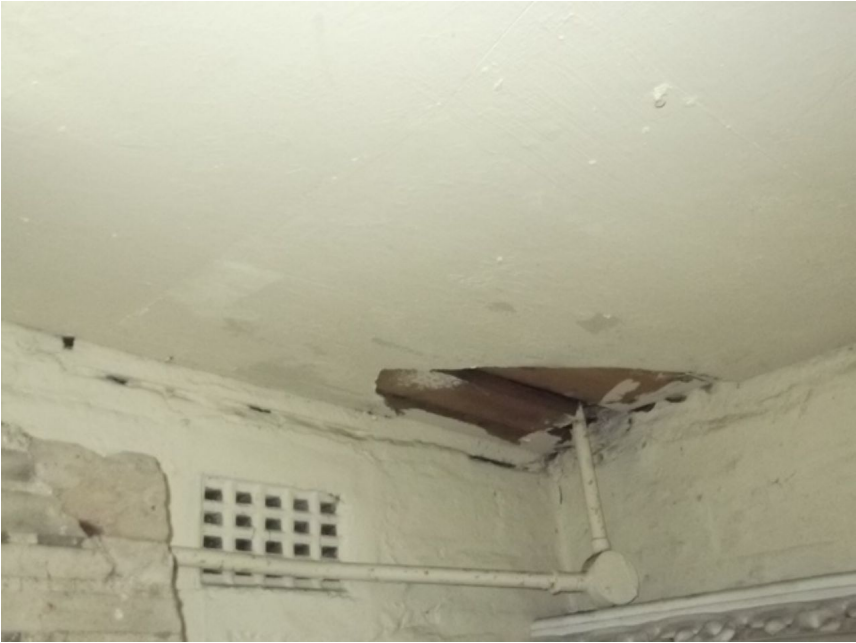
| Item Number: | 016 | Sample Number: | 627/852 | |

| Item: | Asbestos insulating board to ceiling(s) | | | |
| Asbestos Content: | <div>CrocidoliteIdentified</div> <div>AmositeIdentified</div> <div>ChrysotileIdentified</div> | | | |
| Condition: | 2 (Local damage) | Priority Assessment: | 5 | |

| Accessibility: | 1 (Occasionally likely to be disturbed) | Recommendation: | Program removal | |

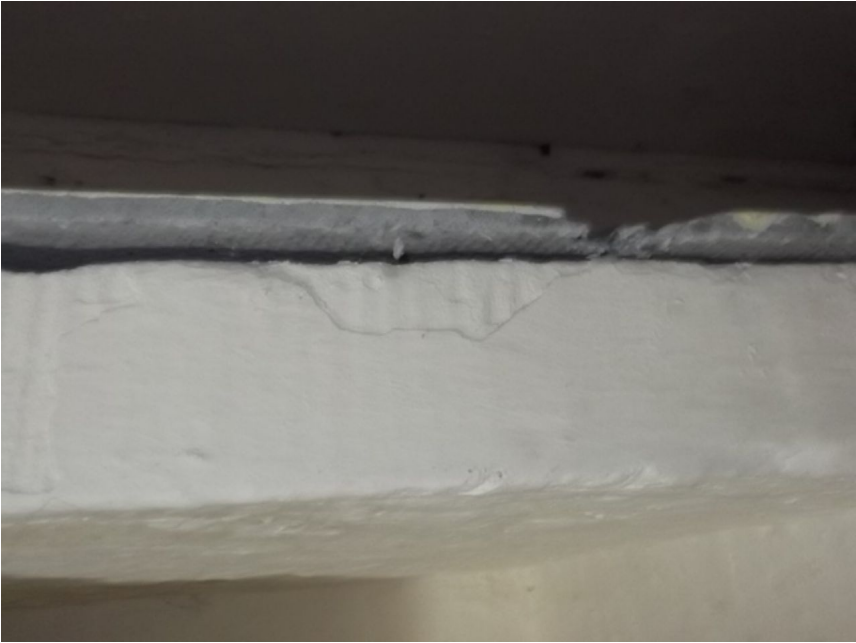
| Item Number: | 017 | Sample Number: | 627/853 | |

| Item: | Asbestos insulating board loose panel | | | |
| Asbestos Content: | <div>CrocidoliteIdentified</div> <div>AmositeIdentified</div> <div>ChrysotileIdentified</div> | | | |
| Condition: | 3 (Significant damage) | Priority Assessment: | 5 | |

| Accessibility: | 2 (Easily disturbed) | Recommendation: | Program removal | |

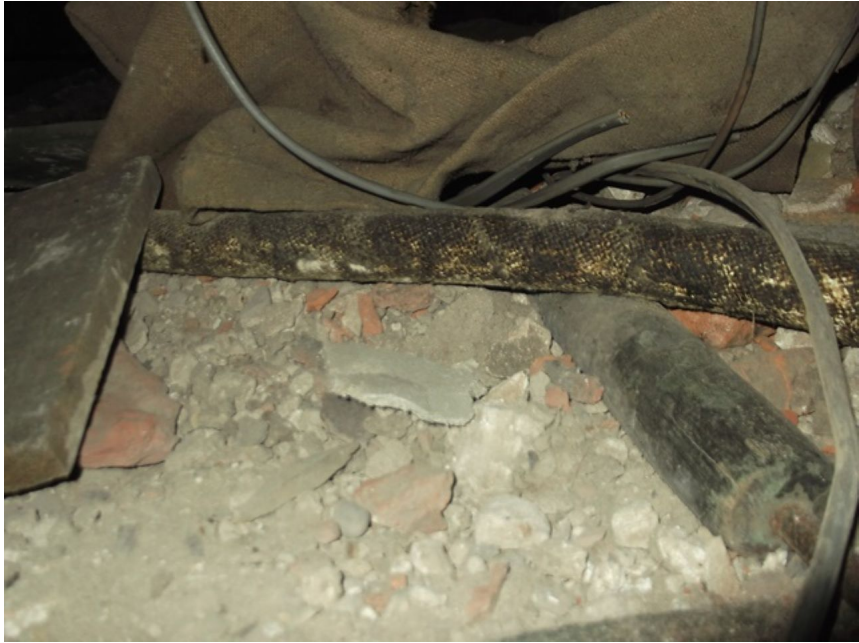
| Item Number: | 018 | Sample Number: | as 627/851 | |

| Item: | Asbestos insulating board debris to floor | | | |
| Asbestos Content: | Amosite Identified<br>Chrysotile Identified | | | |
| Condition: | 3 (Significant damage) | Priority Assessment: | 8 | |

| Accessibility: | 2 (Easily disturbed) | Recommendation: | Program removal | |

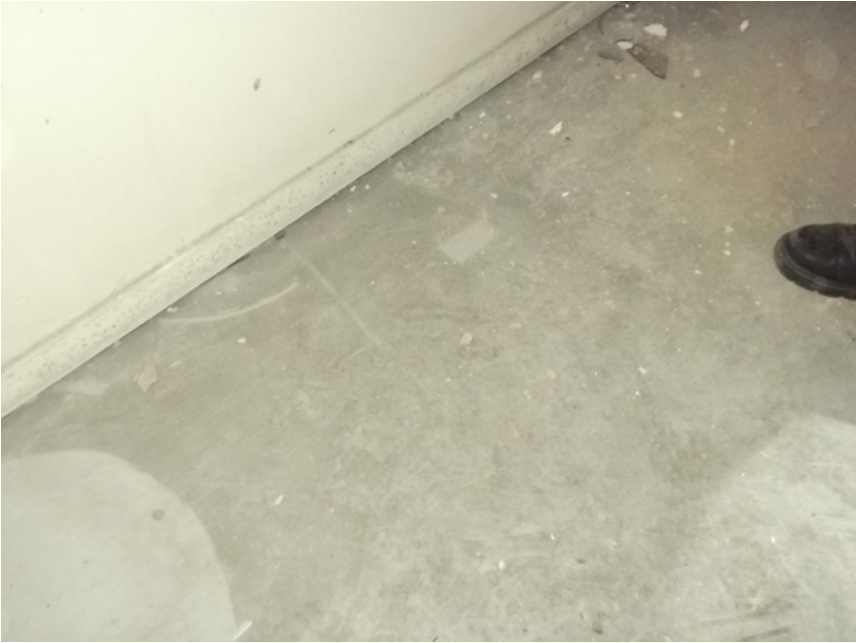
| Item Number: | 019 | Sample Number: | as 627/851 | |

| Item: | Asbestos insulating board to floor | | | |
| Asbestos Content: | Amosite Identified<br>Chrysotile Identified | | | |
| Condition: | 3 (Significant damage) | Priority Assessment: | 4 | |

| Accessibility: | 0 (Usually inaccessible or unlikely to be disturbed) | Recommendation: | Program removal | |

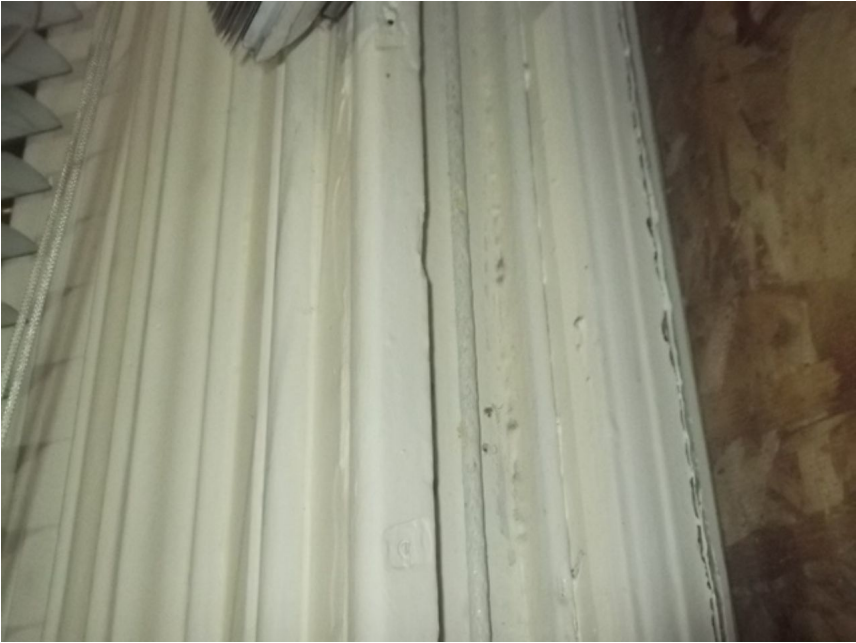
| Item Number: | 020 | Sample Number: | 627/855 | | |

| Item: | | | | | Textile rope to sash windows |
| Asbestos Content: | | | | | No asbestos detected Identified |

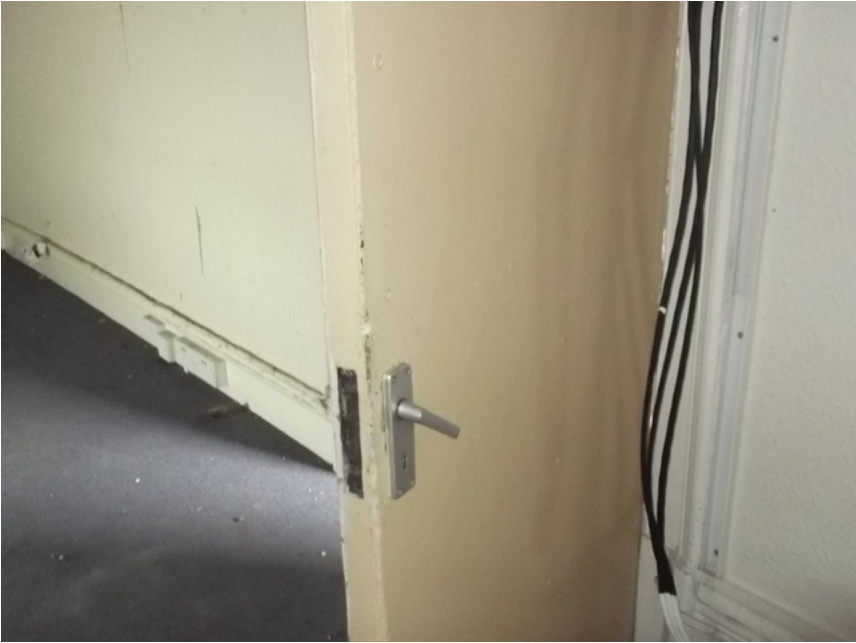
| Item Number: | 021 | Sample Number: | 627/856 | |

| Item: | Asbestos insulating board to door | | | |
| Asbestos Content: | Amosite Identified<br>Chrysotile Identified | | | |
| Comments: | Insulating board to back of door. Door is scraping on carpet, consider contamination to carpet and room due to damage. | | | |
| Condition: | 2 (Local damage) | Priority Assessment: | 5 | |

| Accessibility: | 2 (Easily disturbed) | Recommendation: | Program removal | |

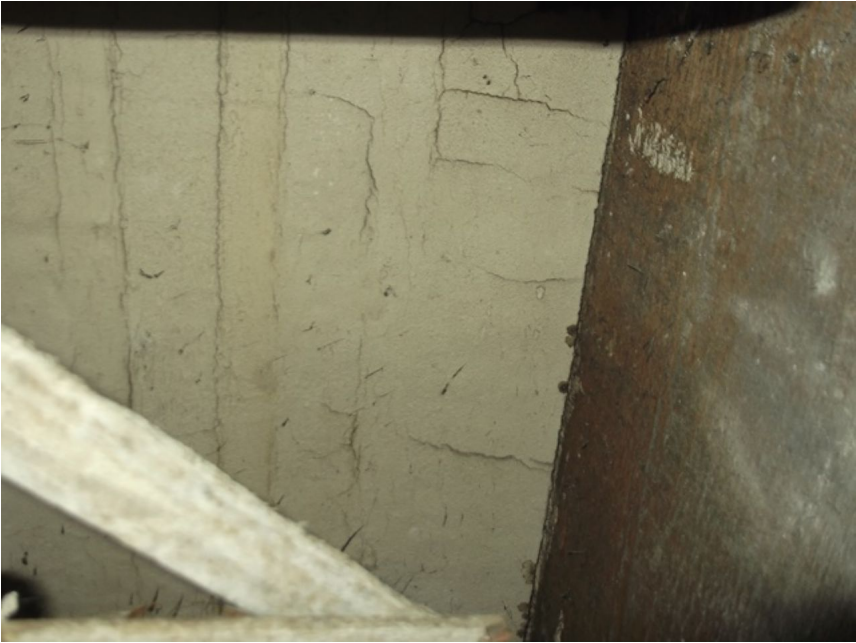
| Item Number: | 022 | Sample Number: | 627/857 | |

| Item: | Insulating board above lath and plaster to ceiling(s) | | | |
| Asbestos Content: | No asbestos detected Identified | | | |
| Comments: | This has been found to be present above all lath and plaster ceilings to main building block. Sample taken to prove negative. | | | |

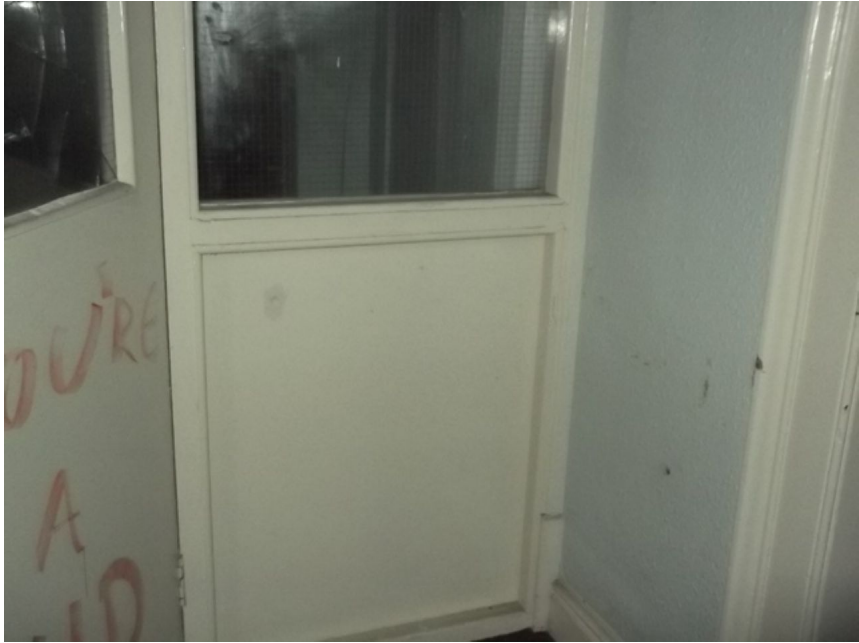
| Item Number: | 024 | Sample Number: | 627/859 | |

| Item: | Asbestos insulating board panels to either side of door | | | |
| Asbestos Content: | Amosite Identified<br>Chrysotile Identified | | | |
| Condition: | 1 (Minor scratches) | Priority Assessment: | 5 | |

| Accessibility: | 2 (Easily disturbed) | Recommendation: | Program removal | |

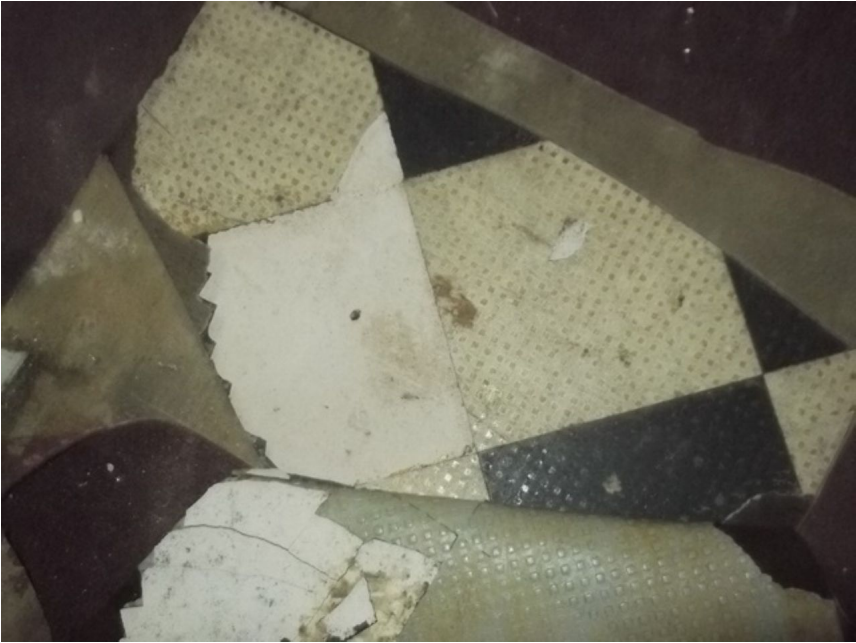
| Item Number: | 025 | Sample Number: | 627/860 | |

| Item: | Thermoplastic floor tiles | | | |
| Asbestos Content: | No asbestos detected Identified | | | |

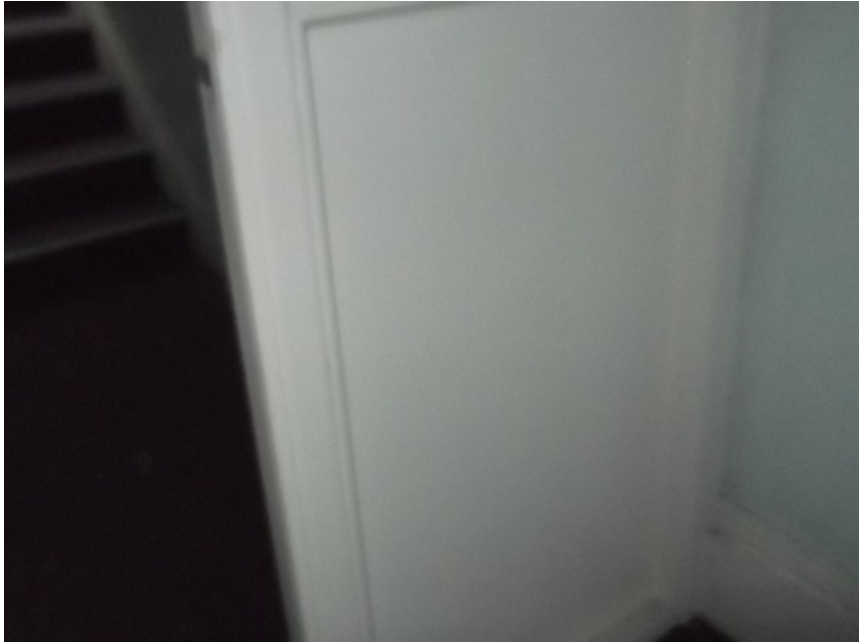
| Item Number: | 026 | Sample Number: | as 627/858 | | |

| Item: | Insulating board panels either side of door | | | | |
| Asbestos Content: | No asbestos detected Identified | | | | |

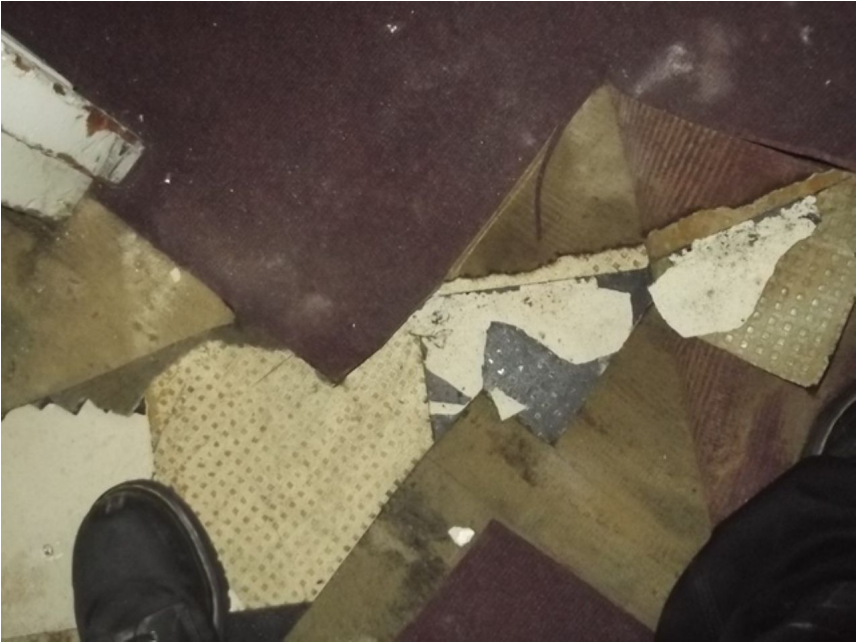
| Item Number: | 027 | Sample Number: | as 627/860 | |

| Item: | Thermoplastic floor tiles | | | |
| Asbestos Content: | No asbestos detected Strongly Presumed | | | |

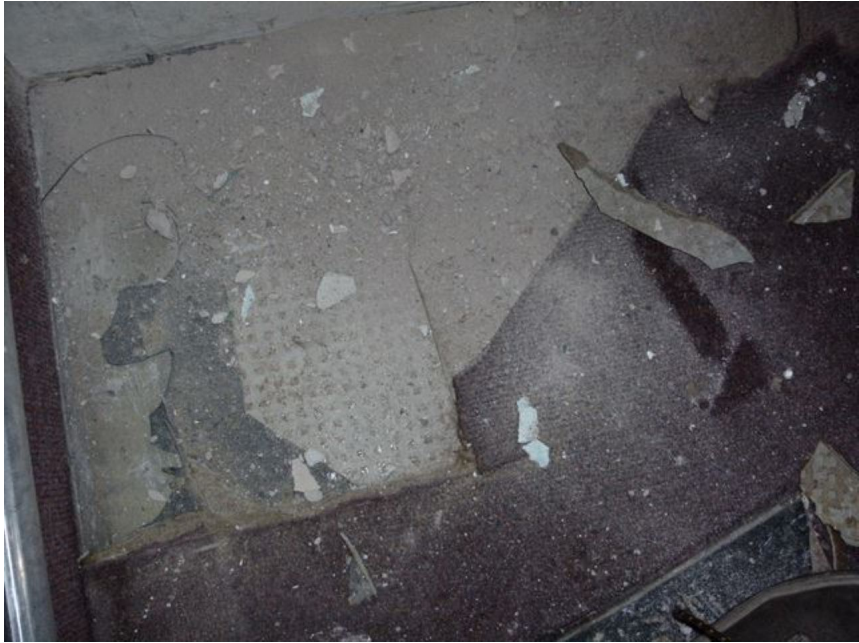
| Item Number: | 028 | Sample Number: | 408/003 | |

| Item: | Asbestos thermoplastic floor tiles | | | |
| Asbestos Content: | Chrysotile      Identified | | | |

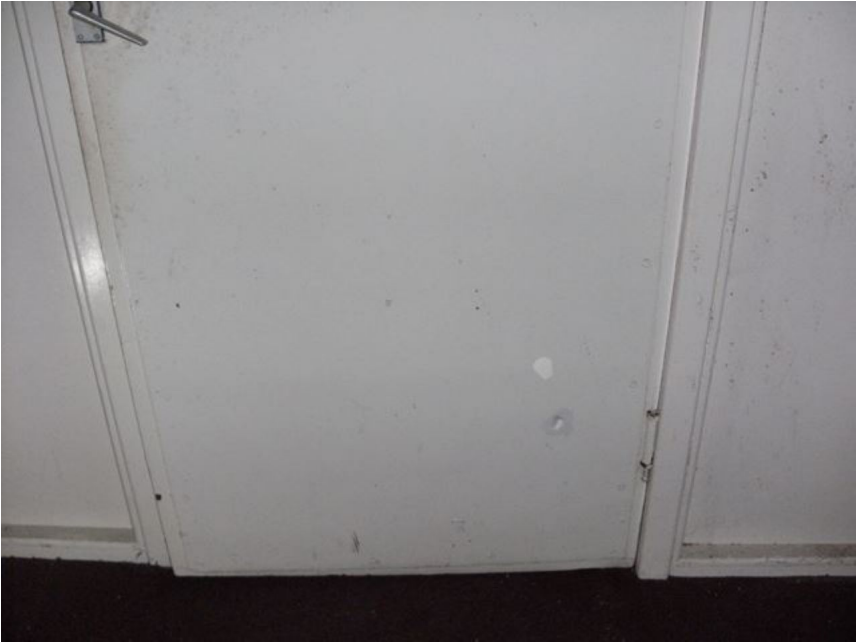
| Item Number: | 029 | Sample Number: | 408/004 | |

| Item: | Asbestos insulating board to door | | | |
| Asbestos Content: | Amosite Identified<br>Chrysotile Identified | | | |

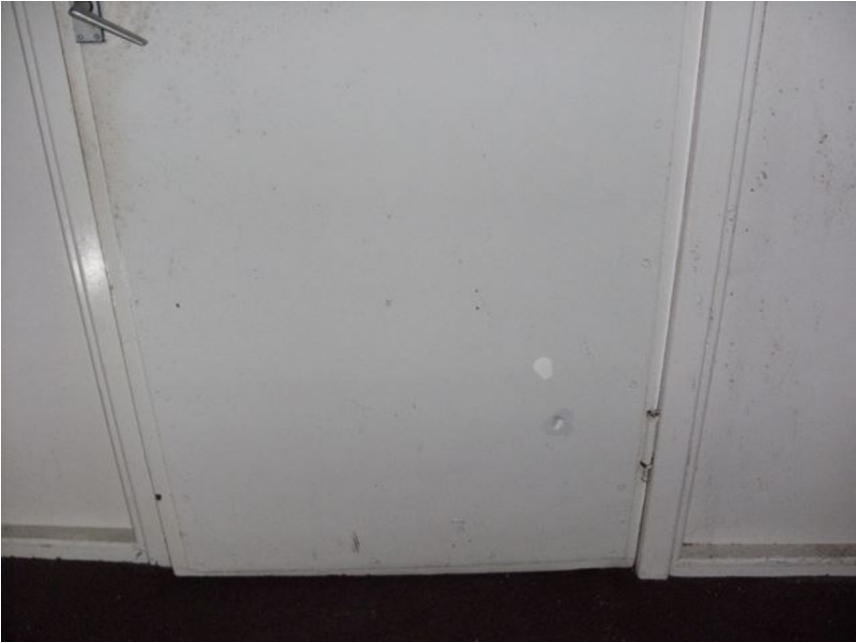
| Item Number: | 030 | Sample Number: | 408/005 | | |

| Item: | Asbestos insulating board debris | | | | |
| Asbestos Content: | Amosite Identified<br>Chrysotile Identified | | | | |

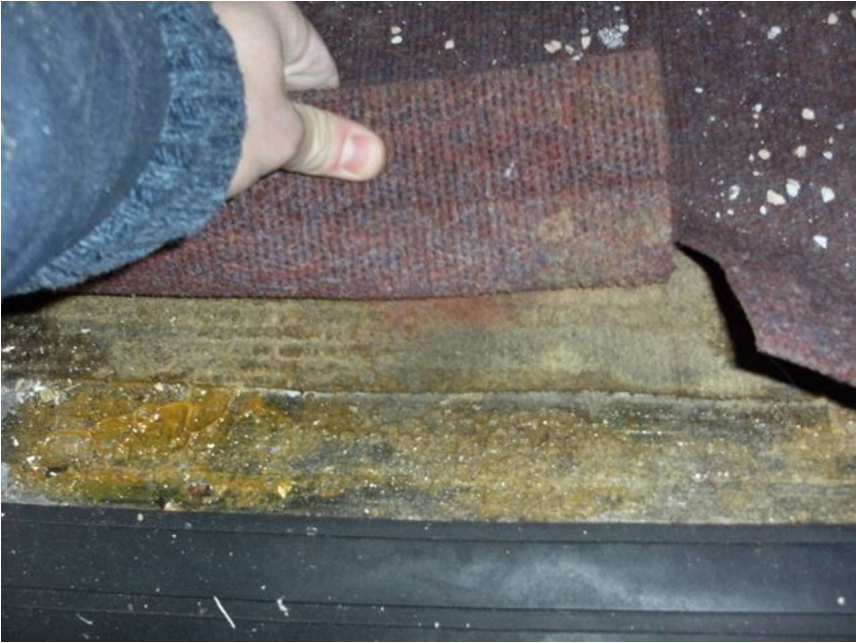
| Item Number: | 031 | Sample Number: | as 408/003 | | |

| Item: | Asbestos thermoplastic floor tiles | | | | |
| Asbestos Content: | Chrysotile      Strongly Presumed | | | | |

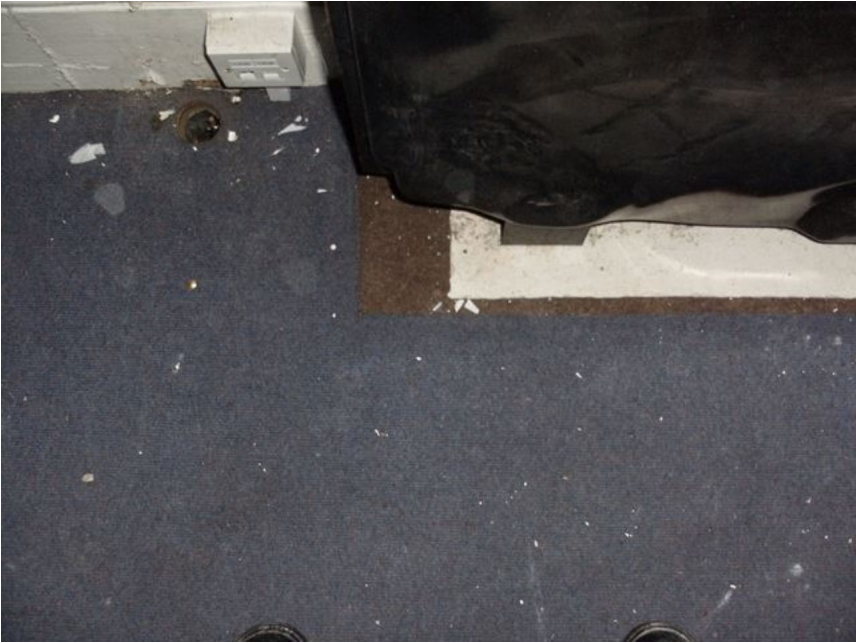
| Item Number: | 032 | Sample Number: | 408/006 | | |

| Item: | Asbestos thermoplastic floor tiles | | | | |
| Asbestos Content: | Chrysotile      Identified | | | | |

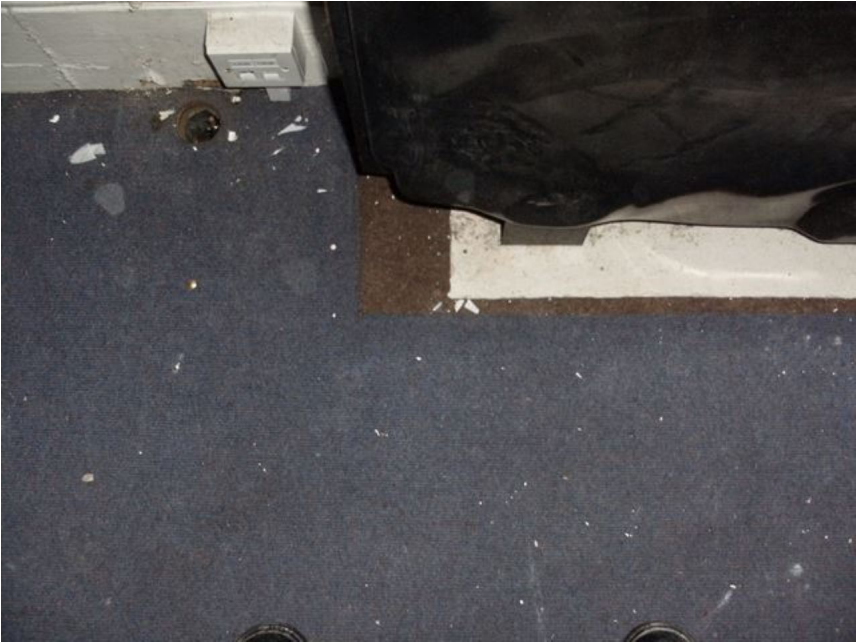
| Item Number: | 033 | Sample Number: | 408/007 | |

| Item: | Insulating board to floor | | | |
| Asbestos Content: | No asbestos detected Identified | | | |

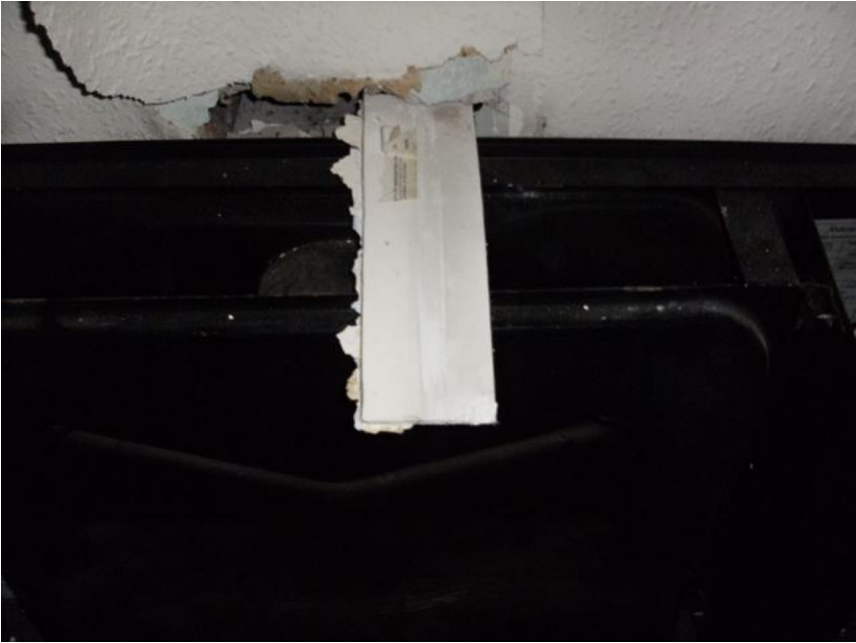
| Item Number: | 034 | Sample Number: | 408/008 | | |

| Item: | Insulating board loose panel | | | | |
| Asbestos Content: | No asbestos detected Identified | | | | |

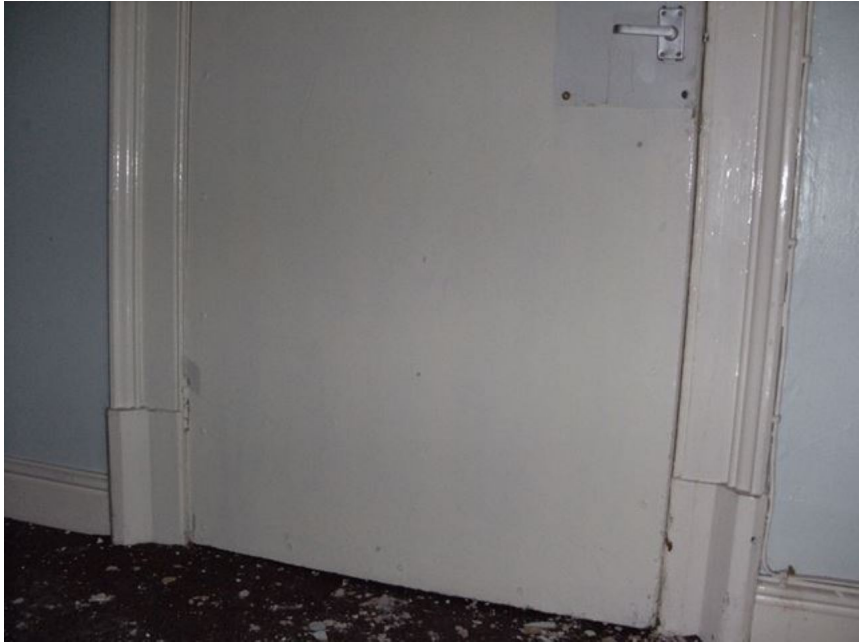
| Item Number: | 035 | Sample Number: | 408/009 | | |

| Item: | Asbestos insulating board lining to door | | | | |
| Asbestos Content: | Amosite Identified<br>Chrysotile Identified | | | | |

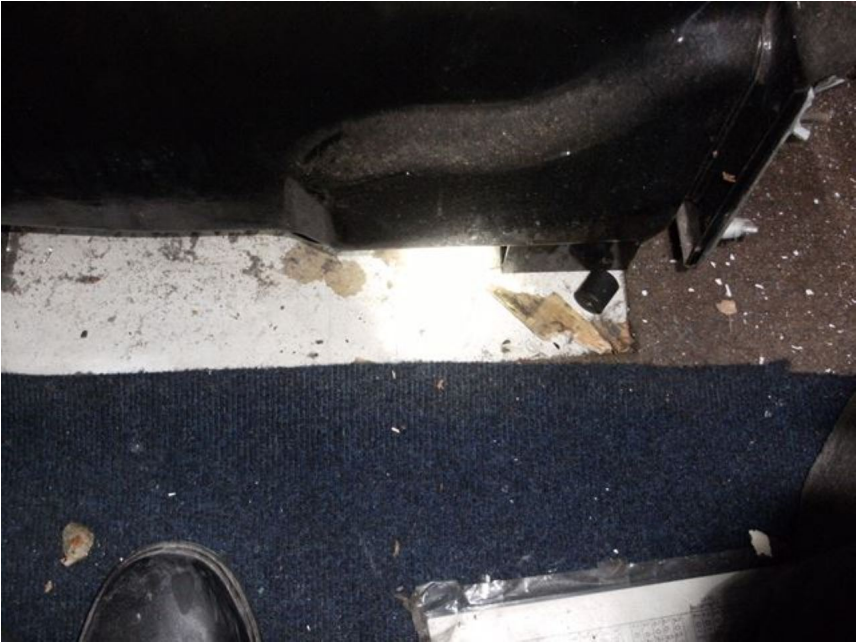
| Item Number: | 036 | Sample Number: | 408/010 | | |

| Item: | Asbestos insulating board to floor | | | | |
| Asbestos Content: | Amosite Identified<br>Chrysotile Identified | | | | |

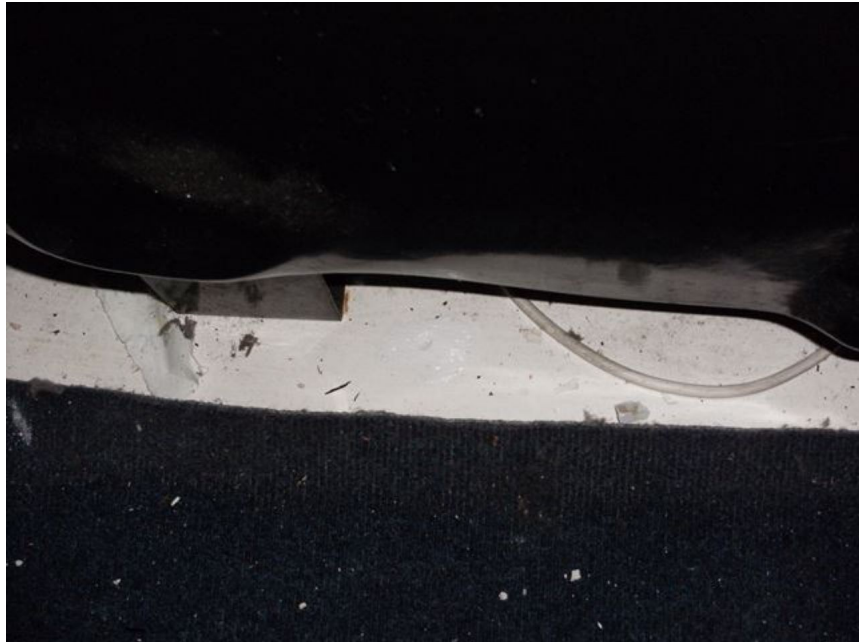
| Item Number: | 037 | Sample Number: | 408/011 | | |

| Item: | Insulating board to floor beneath floor mounted heater | | | | |
| Asbestos Content: | No asbestos detected Identified | | | | |
