**Report No.:** SH33185

**Nature of Work:** Refurbishment Survey

Clwyd Alyn Housing Association  
72 Ffordd William Morgan  
St Asaph Business Park  
St Asaph  
LL17 0JD

3-5 Grosvenor Road  
Wrexham  
LL11 1DY

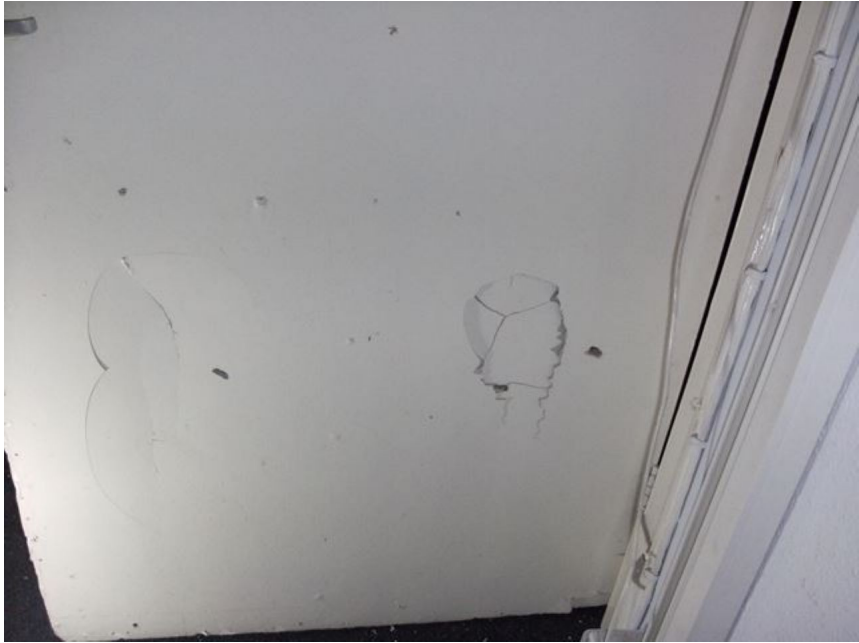
| Item Number: | 038 | Sample Number: | 408/012 | |

| Item: | Asbestos insulating board lining to door | | | |
| Asbestos Content: | Amosite Identified<br>Chrysotile Identified | | | |

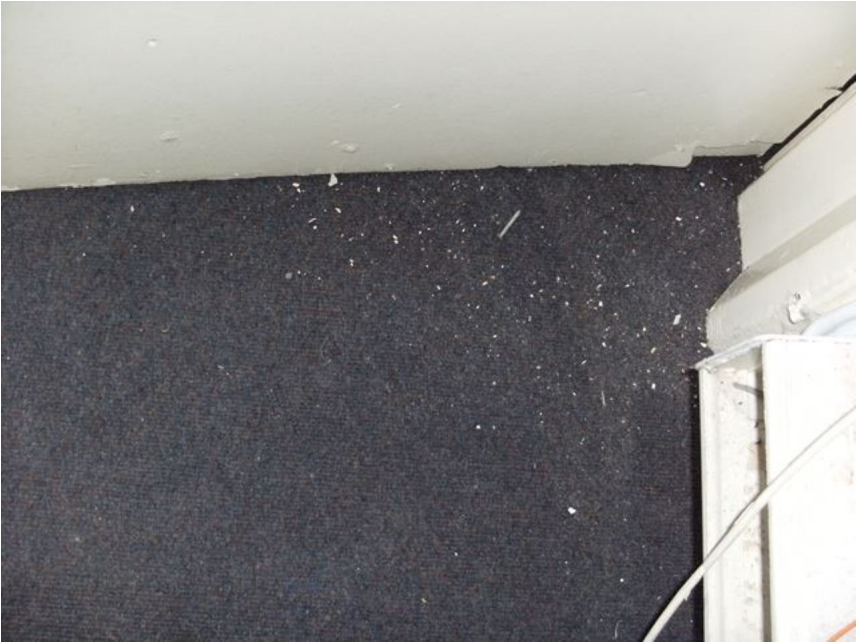
| Item Number: | 039 | Sample Number: | 408/013 | |

| Item: | Asbestos insulating board debris to floor | | | |
| Asbestos Content: | Amosite Identified<br>Chrysotile Identified | | | |

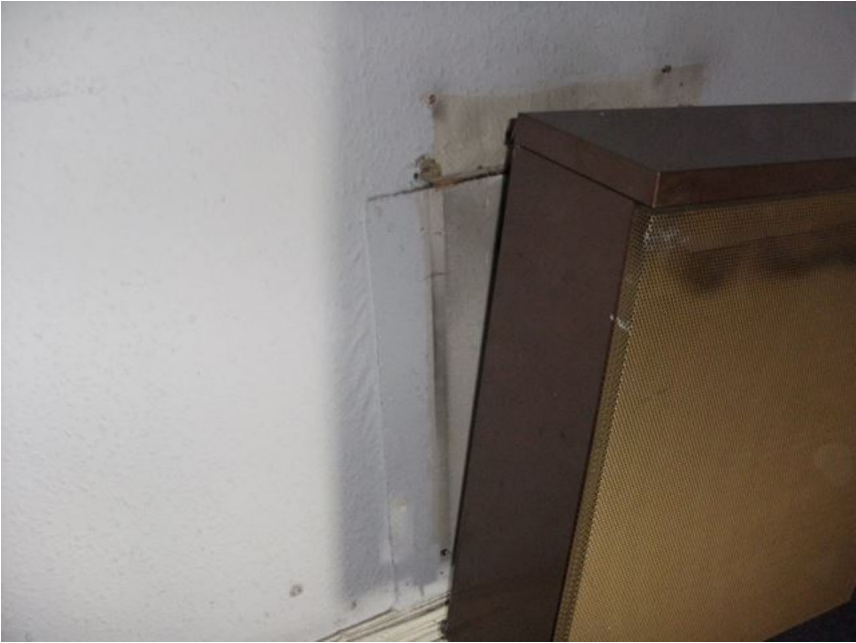
| Item Number: | 040 | Sample Number: | 408/014 | |

| Item: | Insulating board panel behind heater | | | |
| Asbestos Content: | No asbestos detected Identified | | | |

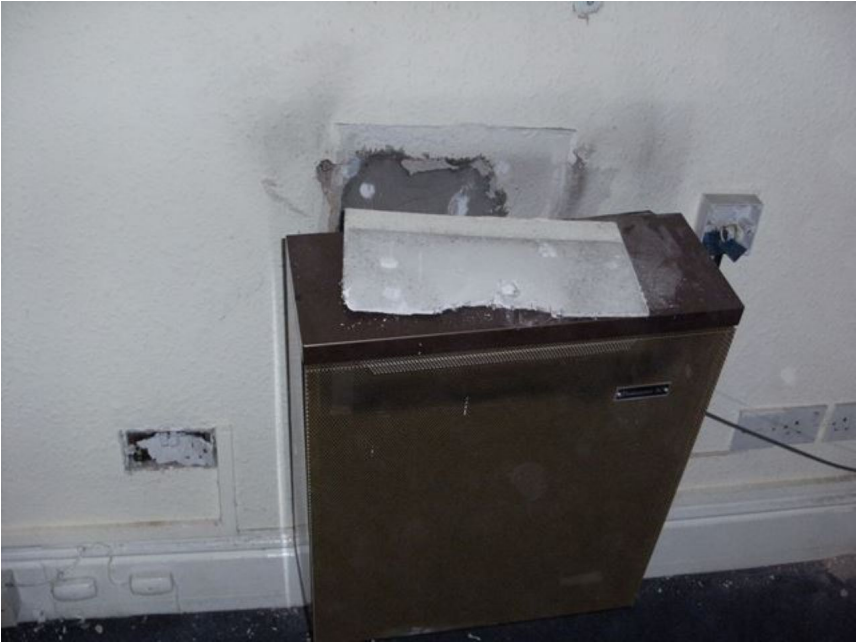
| Item Number: | 041 | Sample Number: | as 408/014 | | |

| Item: | Insulating board loose panel above heater | | | | |
| Asbestos Content: | No asbestos detected Strongly Presumed | | | | |

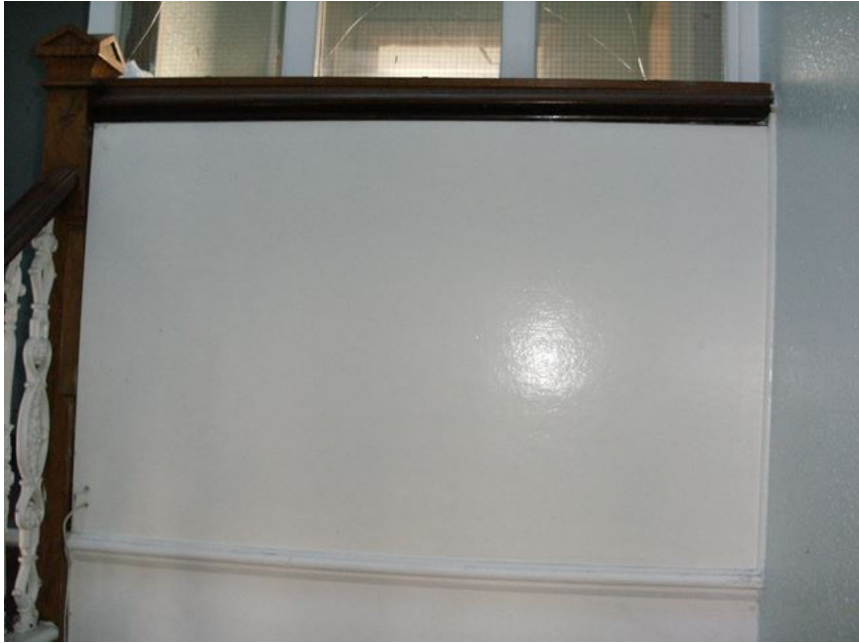
| Item Number: | 042 | Sample Number: | 408/015 | |

| Item: | Asbestos insulating board panel beneath window to wall(s) | | | |
| Asbestos Content: | Amosite Identified<br>Chrysotile Identified | | | |

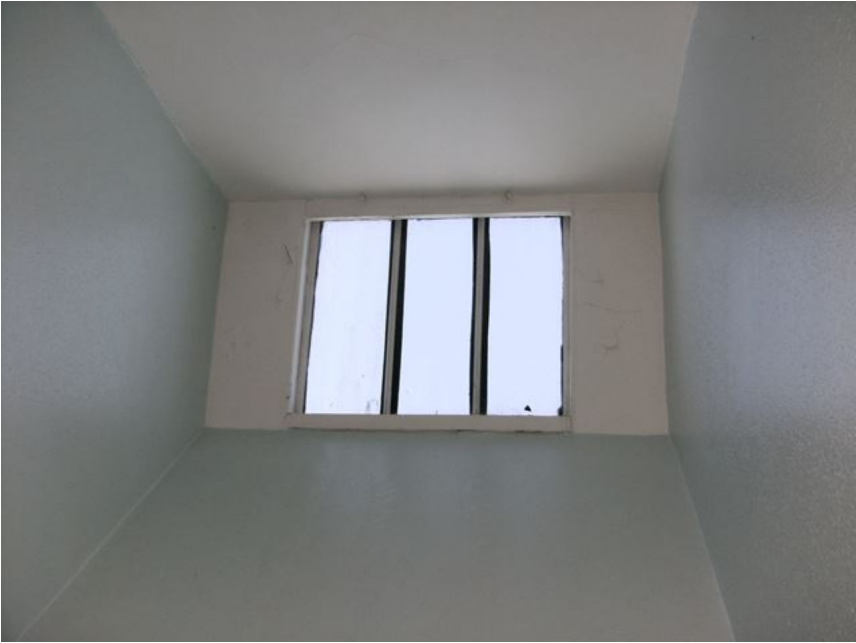
| Item Number: | 043 | Sample Number: | No sample - presumed | | |

| Item: | Asbestos textile rope to skylight | | | | |
| Asbestos Content: | Chrysotile Presumed | | | | |

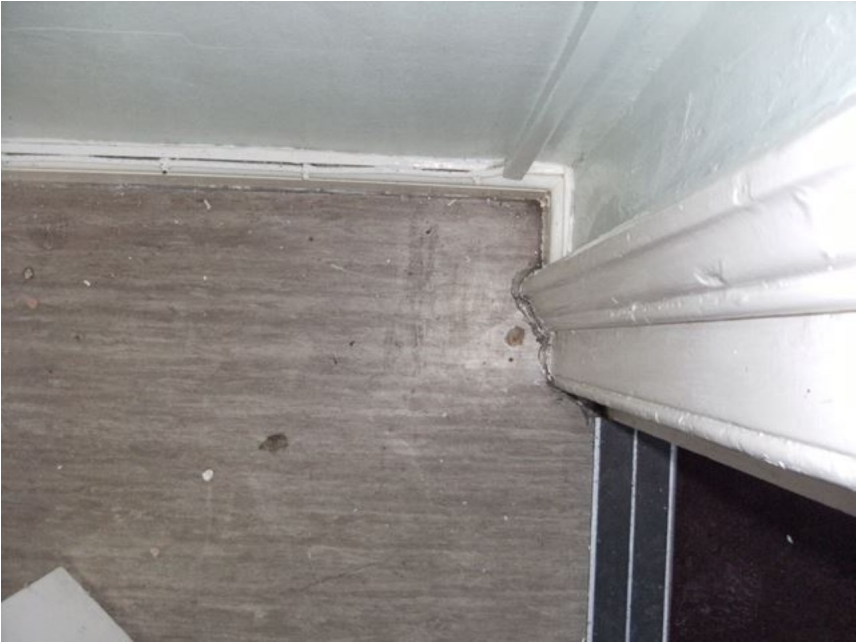
| Item Number: | 044 | Sample Number: | 408/016 | |

| Item: | Vinyl to floor to timber | | | |
| Asbestos Content: | No asbestos detected Identified | | | |

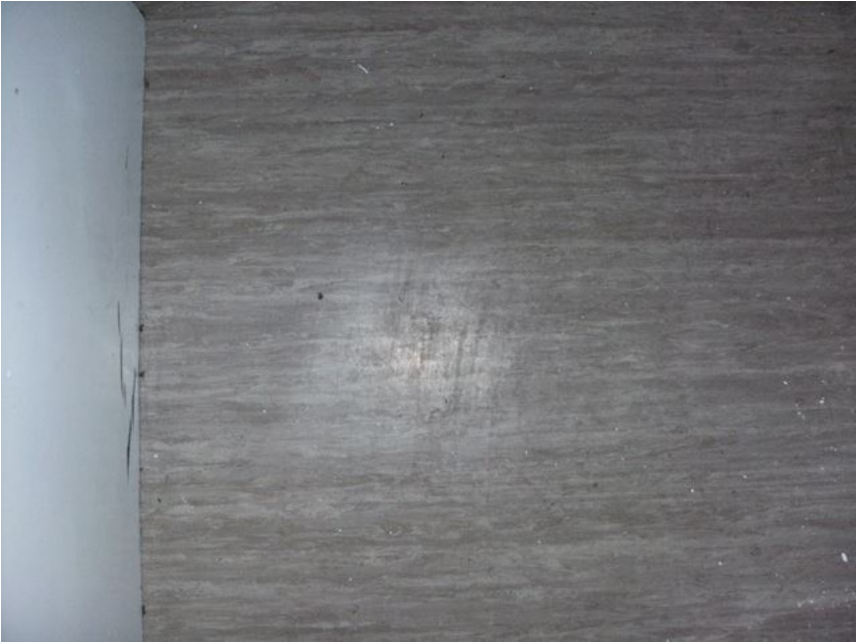
| Item Number: | 045 | Sample Number: | as 408/016 | |

| Item: | Vinyl to floor to timber | | | |
| Asbestos Content: | No asbestos detected Strongly Presumed | | | |

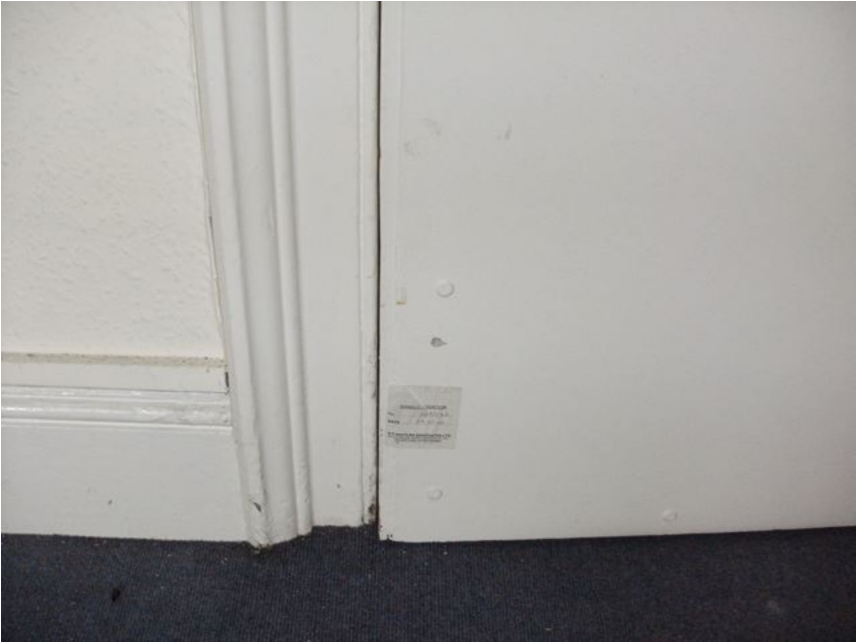
| Item Number: | 047 | Sample Number: | 408/018 | |

| Item: | Insulating board lining to door | | | |
| Asbestos Content: | No asbestos detected Identified | | | |

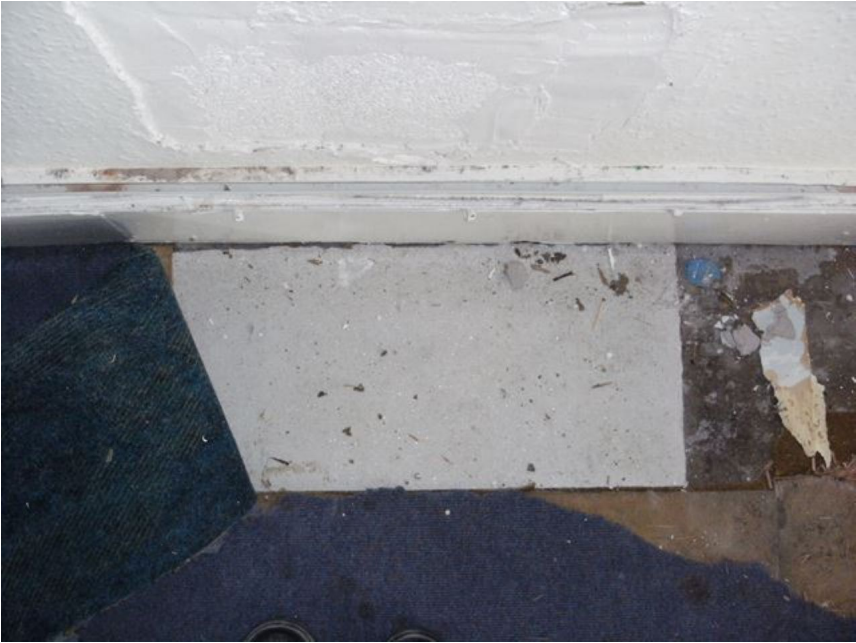
| Item Number: | 048 | Sample Number: | 408/019 | | |

| Item: | Insulating board to floor | | | | |
| Asbestos Content: | No asbestos detected Identified | | | | |

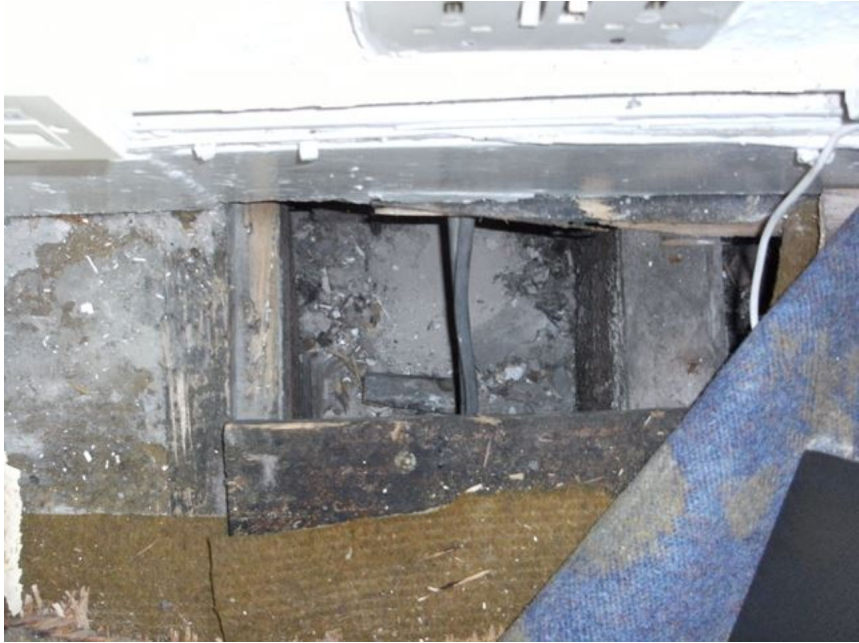
| Item Number: | 049 | Sample Number: | 408/020 | | |

| Item: | Insulation debris | | | | |
| Asbestos Content: | No asbestos detected Identified | | | | |

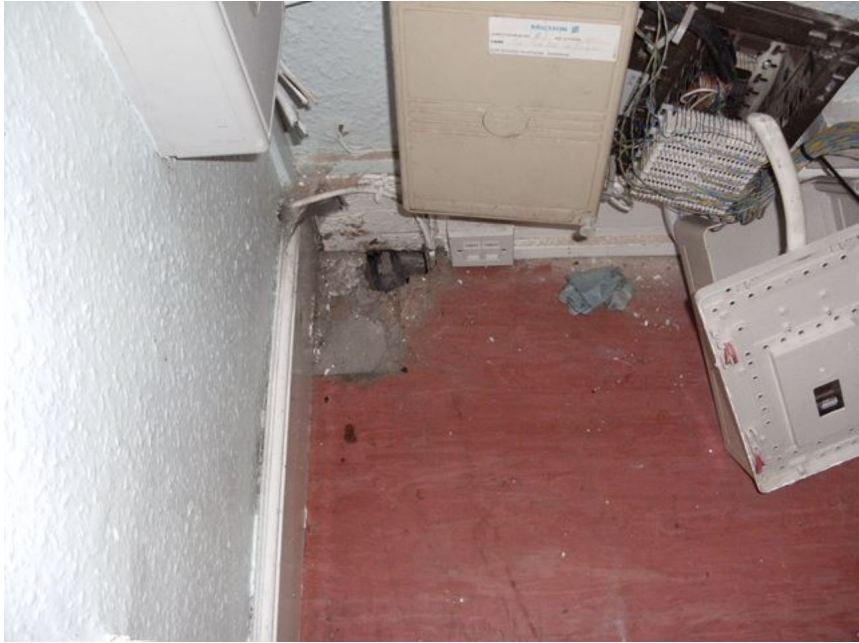
| Item Number: | 050 | Sample Number: | 408/021 | |

| Item: | Vinyl to floor to timber | | | |
| Asbestos Content: | No asbestos detected Identified | | | |

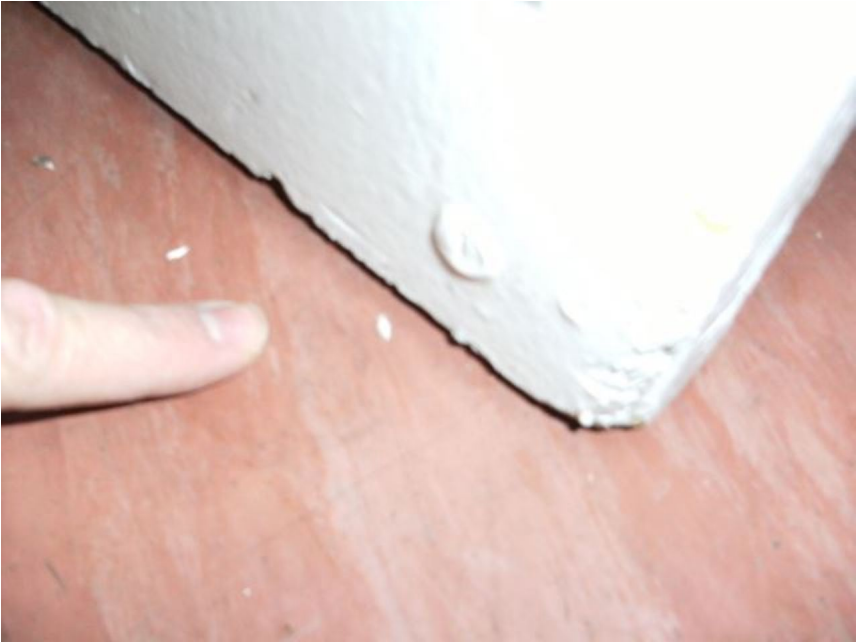
| Item Number: | 052 | Sample Number: | as 408/022 | |

| Item: | Asbestos insulating board debris | | | |
| Asbestos Content: | Amosite Strongly Presumed<br>Chrysotile Strongly Presumed | | | |

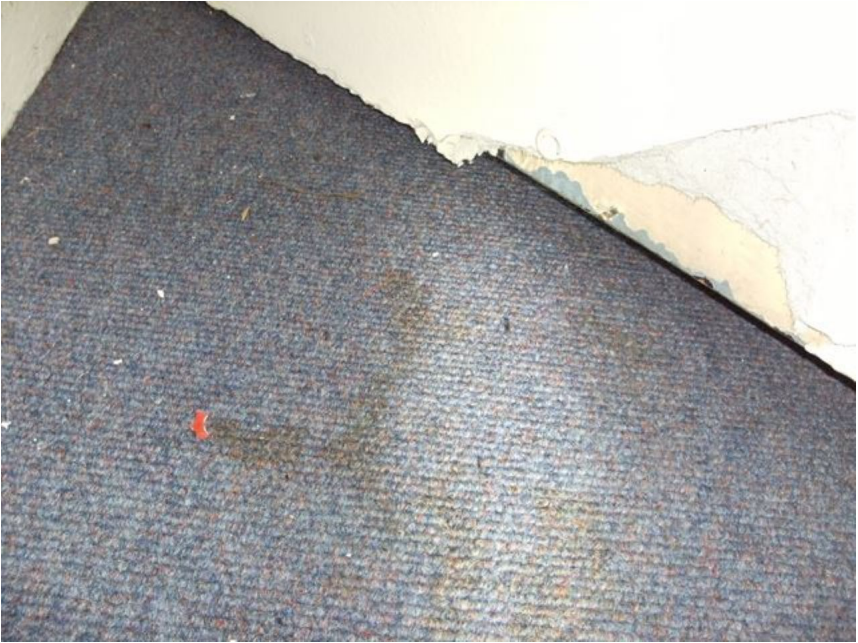
| Item Number: | 056 | Sample Number: | as 408/022 | |

| Item: | Asbestos insulating board debris | | | |
| Asbestos Content: | Amosite Strongly Presumed<br>Chrysotile Strongly Presumed | | | |

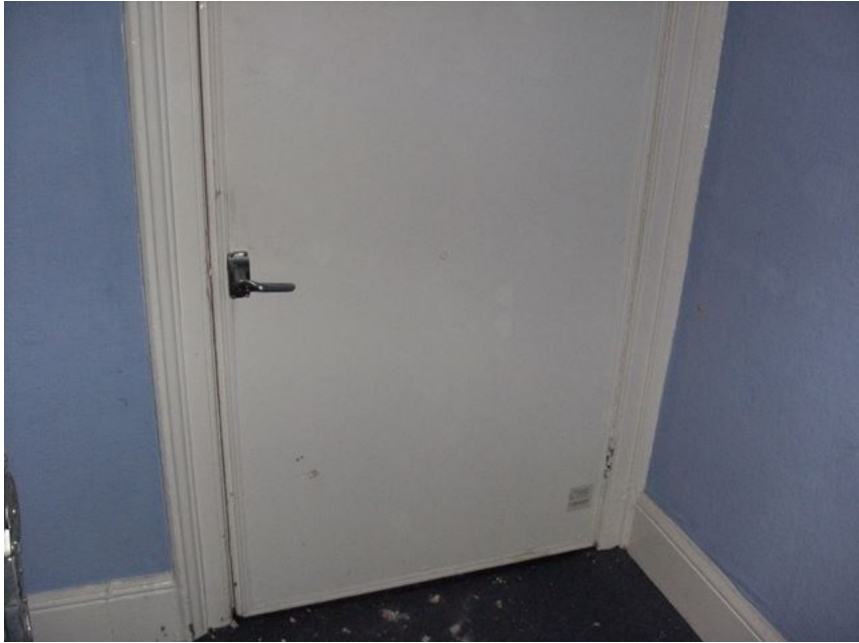
| Item Number: | 067 | Sample Number: | 408/025 | |

| Item: | Insulating board lining to door | | | |
| Asbestos Content: | No asbestos detected Identified | | | |

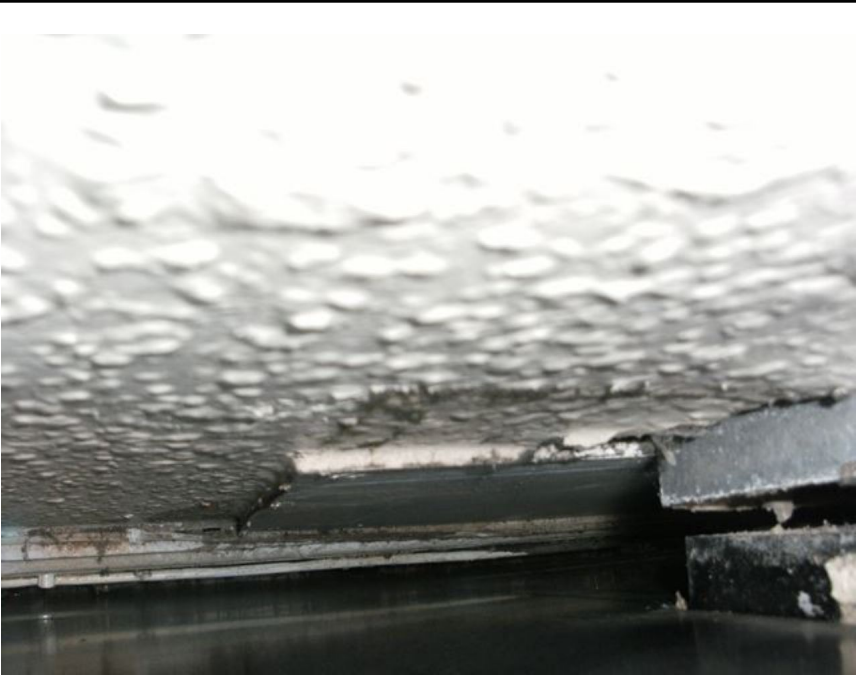
| Item Number: | 070 | Sample Number: | as 408/017 | | |

| Item: | Insulating board to wall(s) behind heater | | | | |
| Asbestos Content: | No asbestos detected Strongly Presumed | | | | |

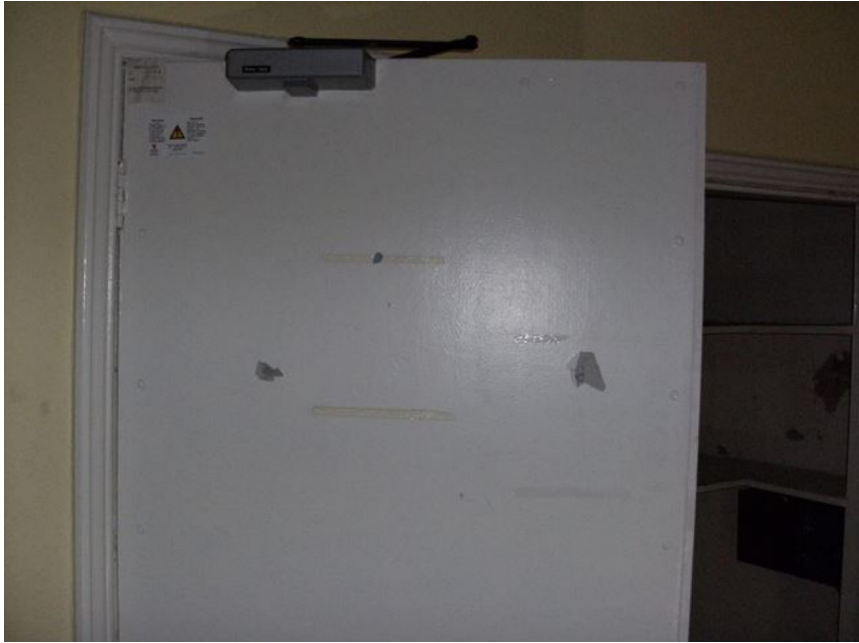
| Item Number: | 078 | Sample Number: | 408/029 | |

| Item: | Asbestos insulating board lining to door | | | |
| Asbestos Content: | Amosite Identified<br>Chrysotile Identified | | | |

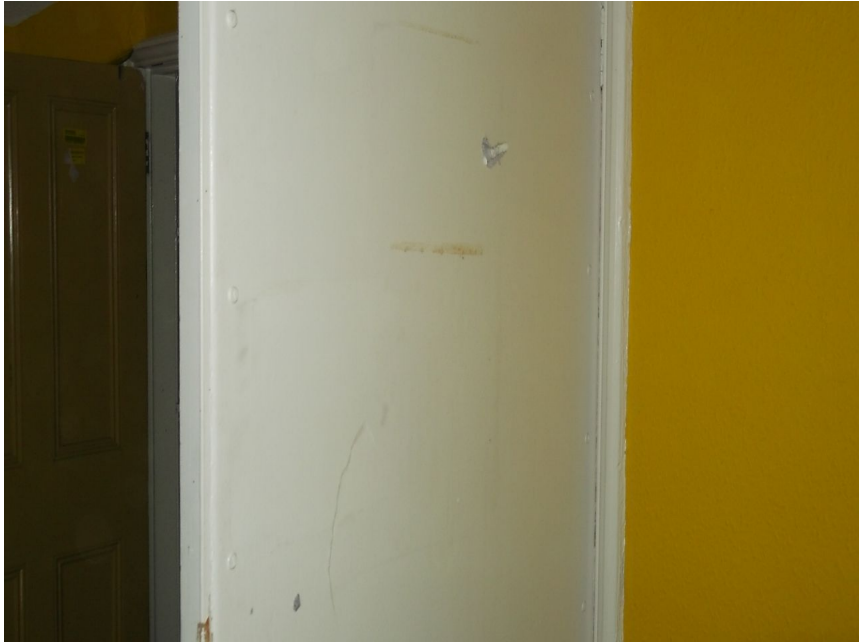
| Item Number: | 082 | Sample Number: | as 408/029 | | |

| Item: | Asbestos insulating board lining to door | | | | |

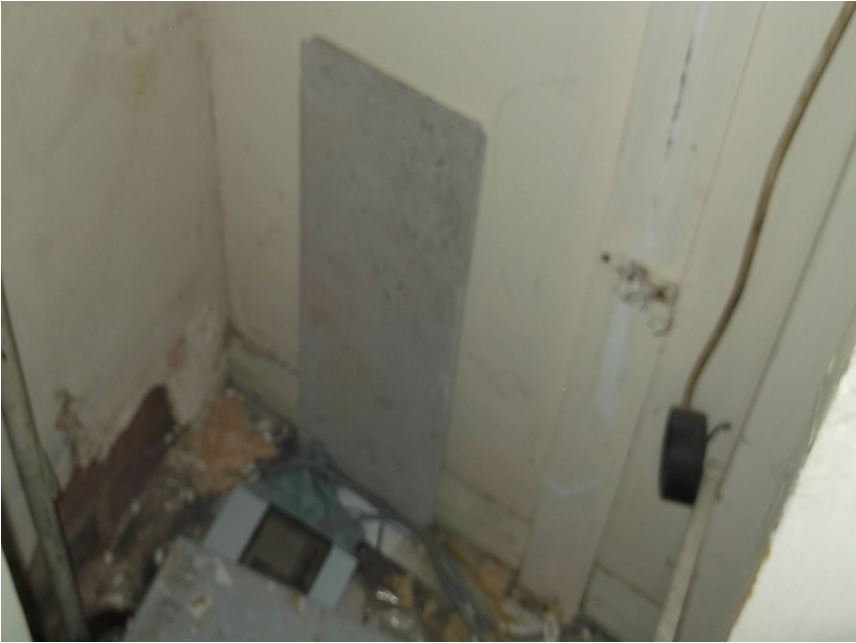
| Item Number: | 088 | Sample Number: | 408/351 | |

| Survey Item No. | Floor Level | Block Name | Location | Item | Asbestos Content | | Extent | Risk Category | Recommendation |
|---|---|---|---|---|---|---|---|---|---|
| 088 | 0 - Ground | Annex | 075 WC | Asbestos insulating board loose panel | Amosite<br>Chrysotile | Identified | 1 sq m | B 12 | Program removal |

| Item: | Asbestos insulating board loose panel | | | |

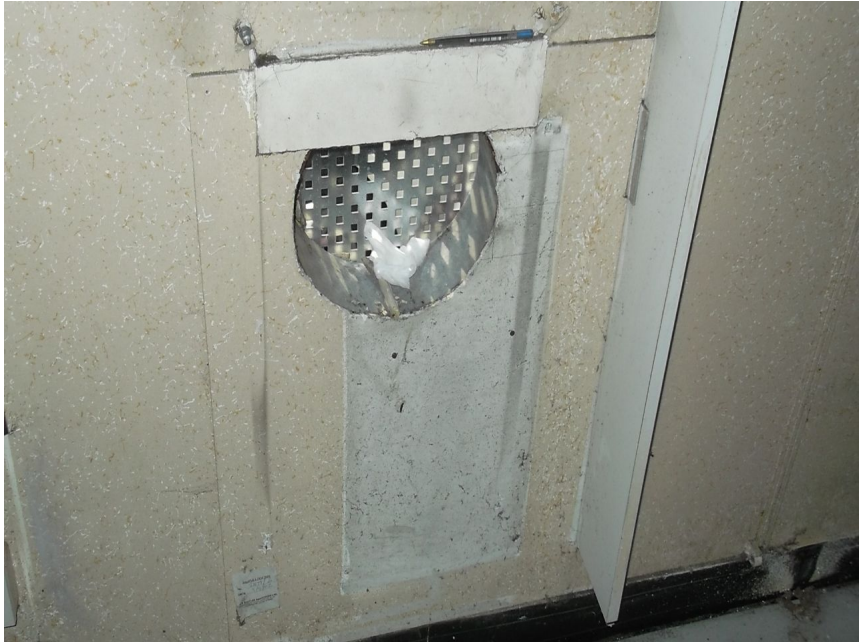
| Item Number: | 092 | Sample Number: | as 408/353 | |

| Item: | Asbestos insulating board to wall(s) | | | |

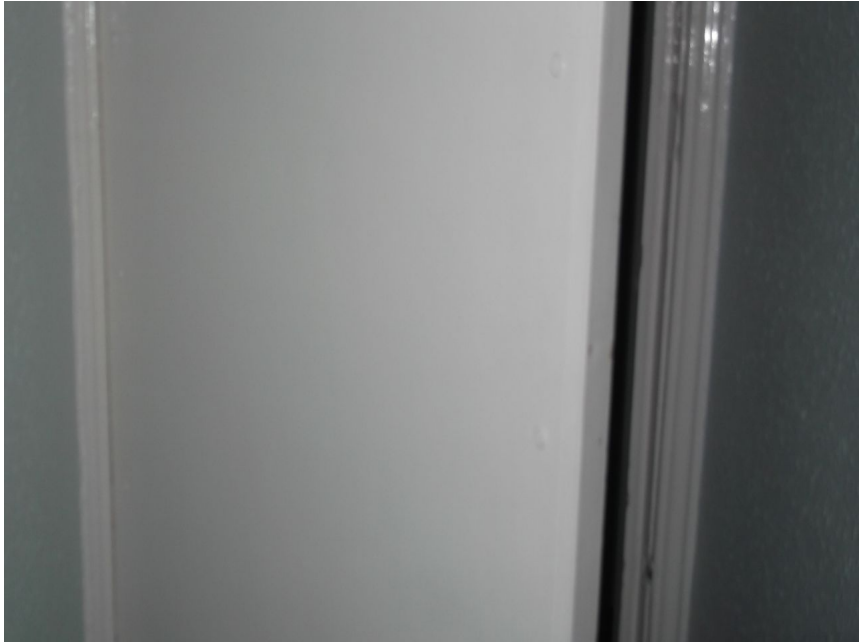
| Item Number: | 096 | Sample Number: | 408/357 | |

| Item: | Asbestos insulating board lining to door | | | |

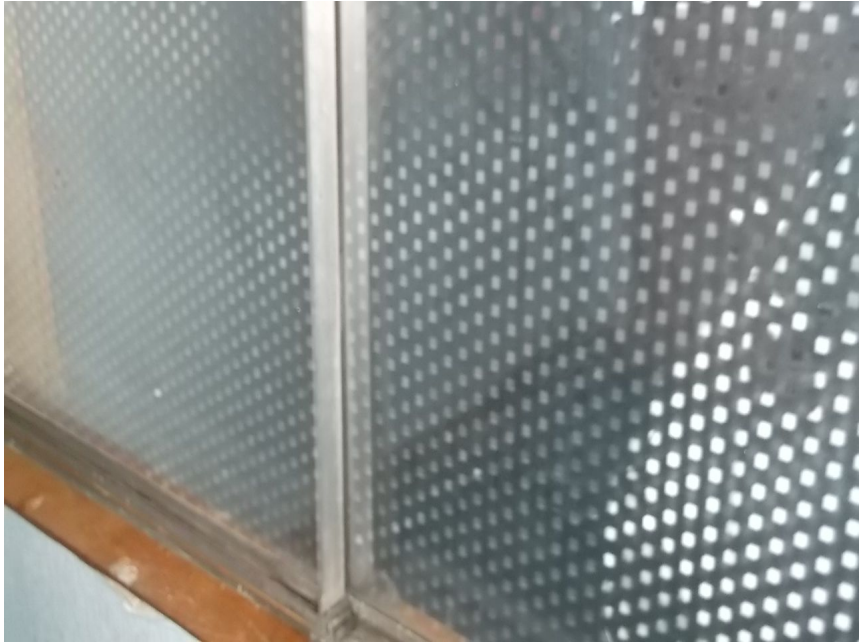
| Item Number: | 098 | Sample Number: | 408/359 | |

| Item: | Bitumen putty seal to windows | | | |
