Our Ref: 01016/Rep 01  
Date: 10<sup>th</sup> July 2015

## **STRUCTURAL INSPECTION AND LETTER REPORT – GAMFORD FARM, ROSSETT**

We thank you for instructing Woodbank Consulting Engineers Ltd (Woodbank) to carry out a visual survey of the barns and main property at Gamford Farm, Rossett, which are to form part of a planning application.

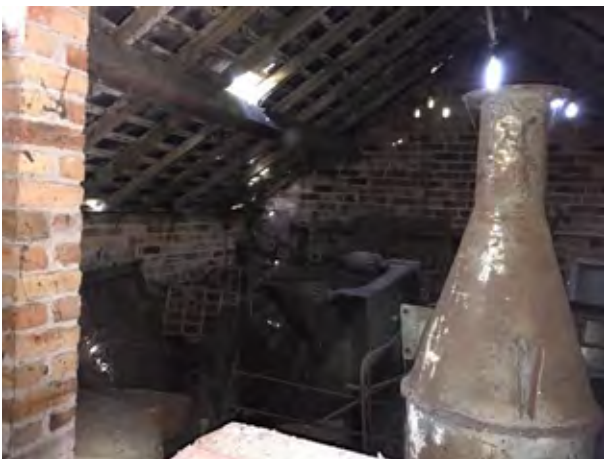
Holes through roof over rooms 2 and 3.

Some holes were noted through the roof which had allowed rainwater to enter the building. The holes should be repaired as part of the refurbishment scheme proposed.

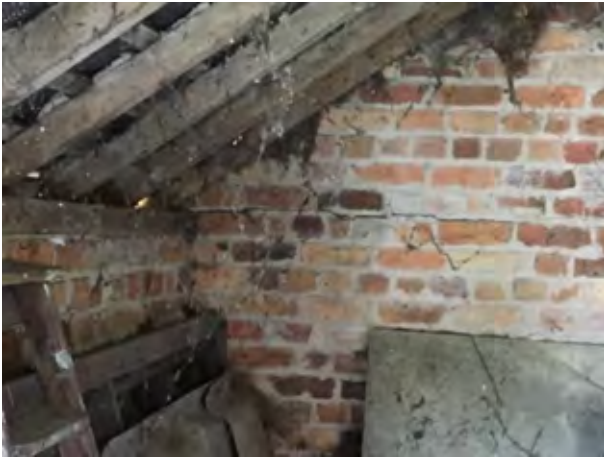
A horizontal crack was noted extending across the left hand gable wall, at eaves level. There were no restraint ties between the gable wall and the roof. These should be provided during any future repair schemes. No vertical restraint straps were noted and these should also be provided.

Horizontal cracking at eaves level.

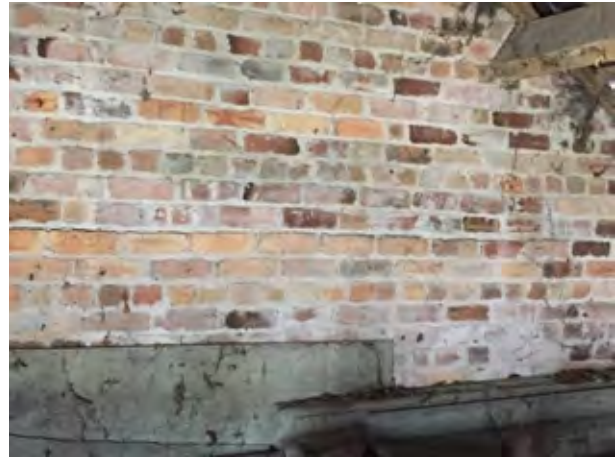
Cracking continues across gable wall.

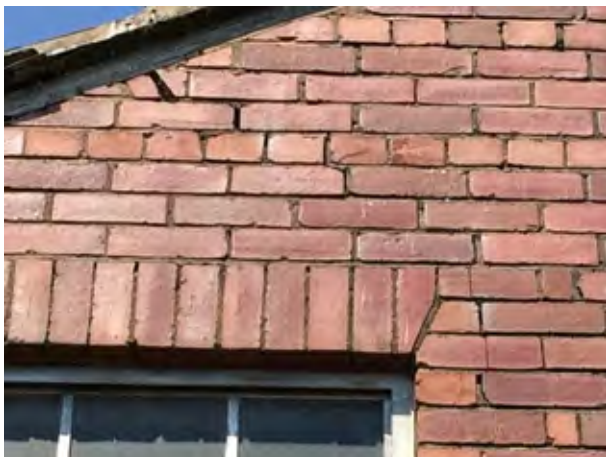
The steel purlins have been built into the front elevation. Steel angles have been used. A vertical crack was noted extending down from the second to top purlin in the right hand side elevation. It is likely that the end of the steel purlin has begun to corrode. As steel corrodes, it delaminates, increasing in size. As the steel size increased within the brittle masonry, the masonry cracks, as it is not able to dissipate the increased stresses within the masonry. It would be prudent to clean and treat the end of the purlins with a corrosion protection product. The brickwork should be stitched using a proprietary stitching product incorporating the installation of helical ties into the bed joints.

Cracking to elevation where purlin end built into the external elevation.

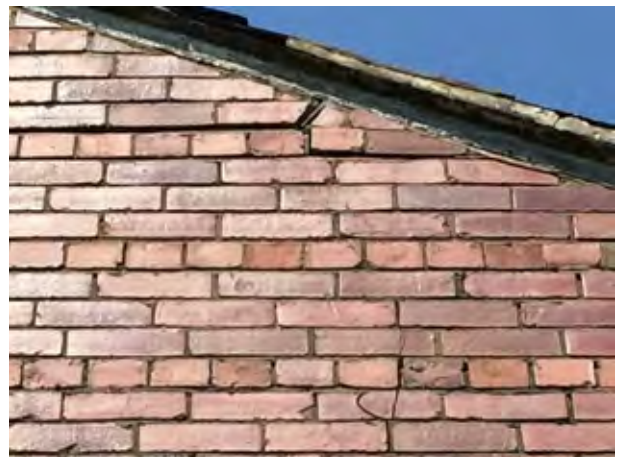
Cracking and lifting brickwork where purlin end built into elevation.

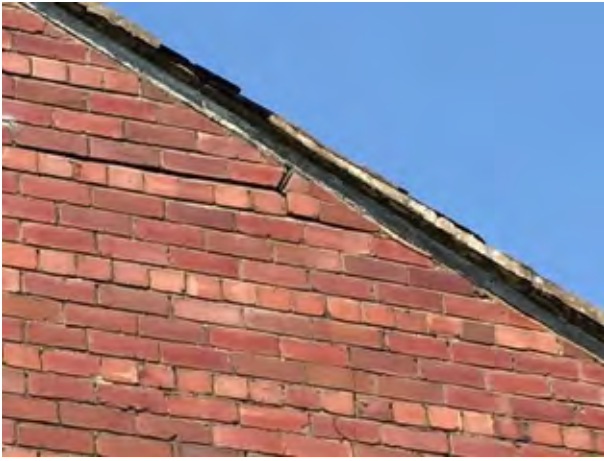
Cracking and lifting brickwork where purlin end built into elevation.

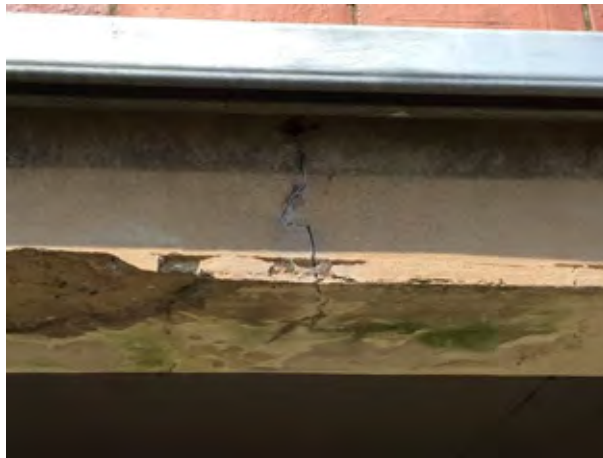
There was some evidence of slight corrosion of the concrete lintel over the central opening and some minor cracking to the brickwork above. The concrete should be treated with a suitable corrosion repair system and the crack repointed.

Concrete lintel cracked.

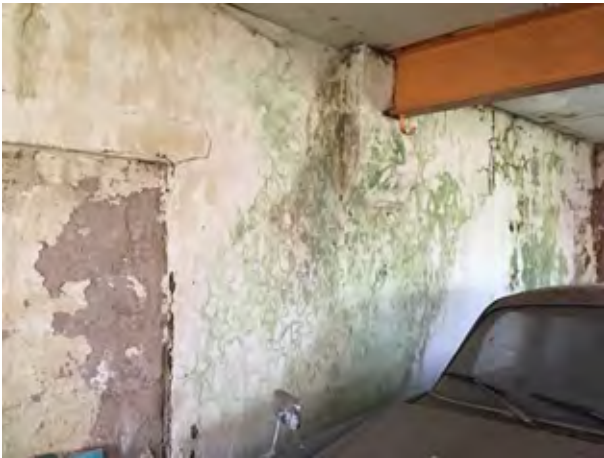
Staining to left hand side wall.

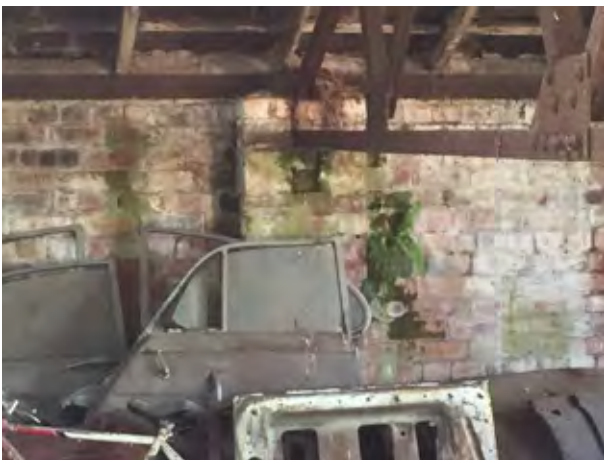
Water staining to left hand side wall.

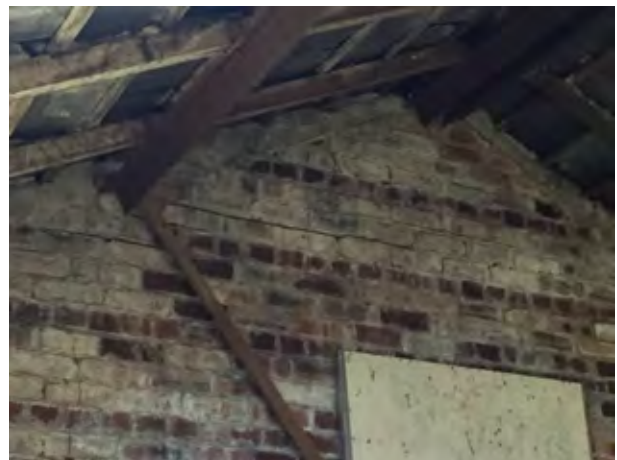
Cracking and brickwork lifting on front elevation, internally.

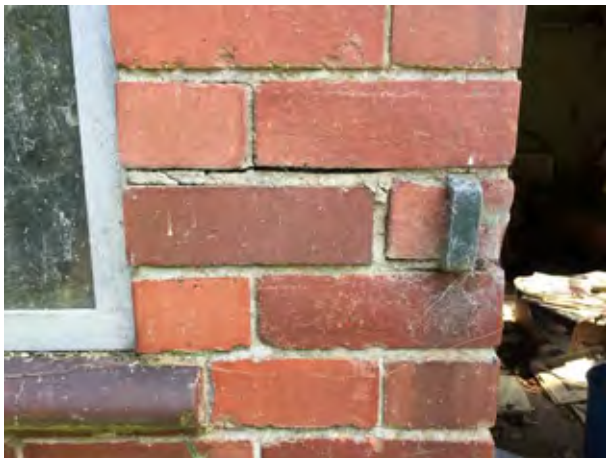
Horizontal and some stepped cracking was noted in a number of places across the elevation. This had generally occurred where steelwork was embedded within the brickwork. It is anticipated that the steelwork has corroded and delaminated, opening up the bed joints. A similar crack had occurred where there was a pipe penetration through the elevation.

Cracked brickwork due to corrosion of embedded steelwork.

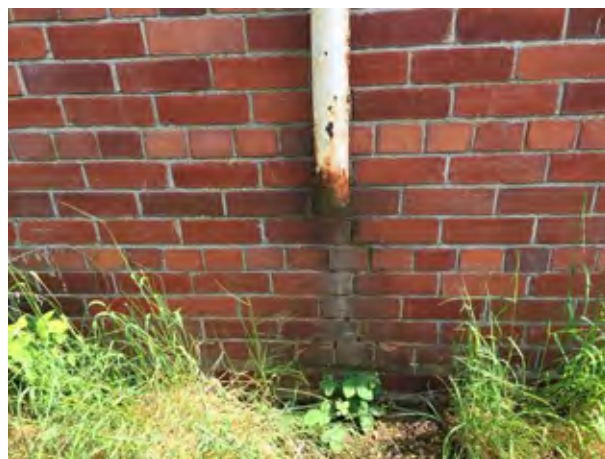
Missing rain water goods.

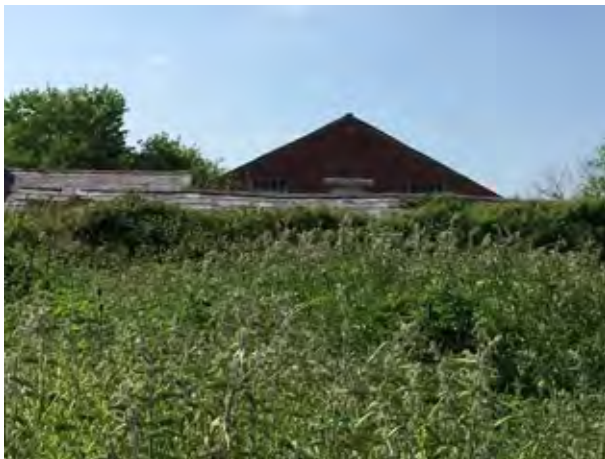
The roof was visible and this was noted to be undulating, indicating that the roof is spreading.

Rear elevation hidden by vegetation. Close access not available.

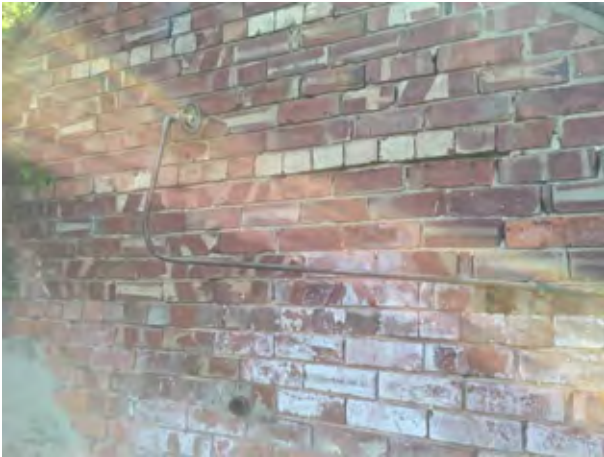
As with the opposite gable elevation, the mortar in the verges has dislodged and should be replaced.

Mortar weathered to left hand side elevation.

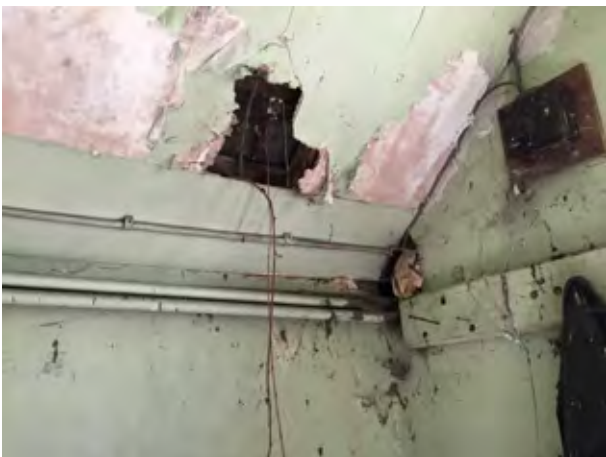
Holes through roof within Room 1.

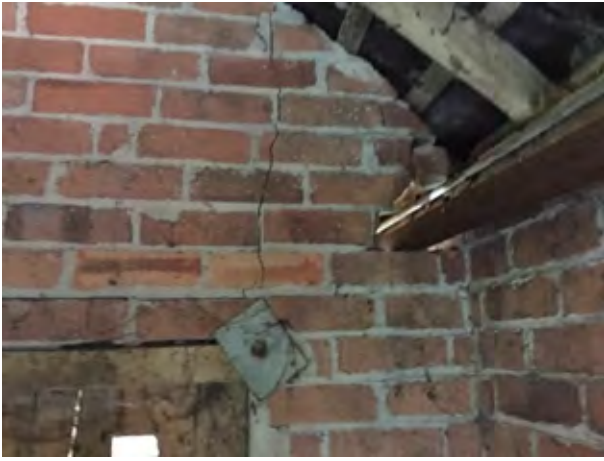
Cracking over lintel in cross wall.

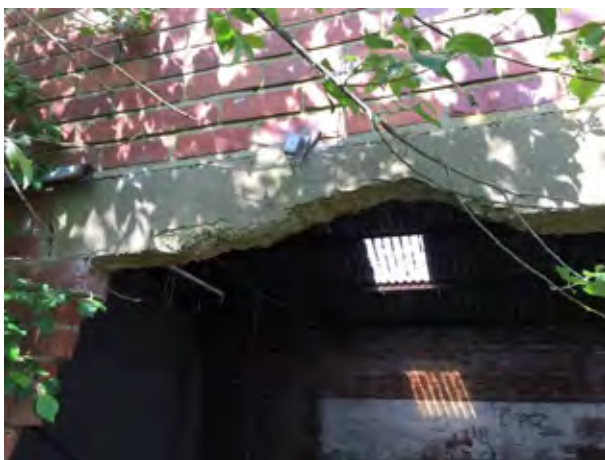
Damage to lintel over poorly widened opening through rear wall.

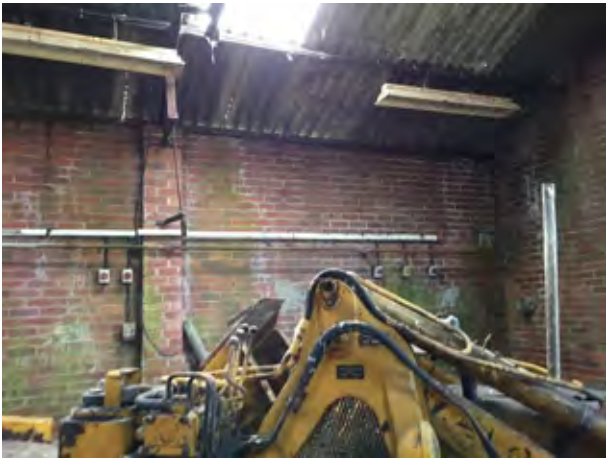
Water staining on rear wall.

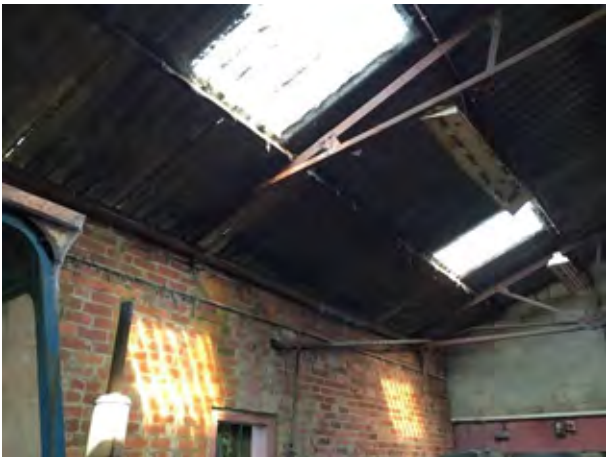
Bottom chord missing from steel truss.

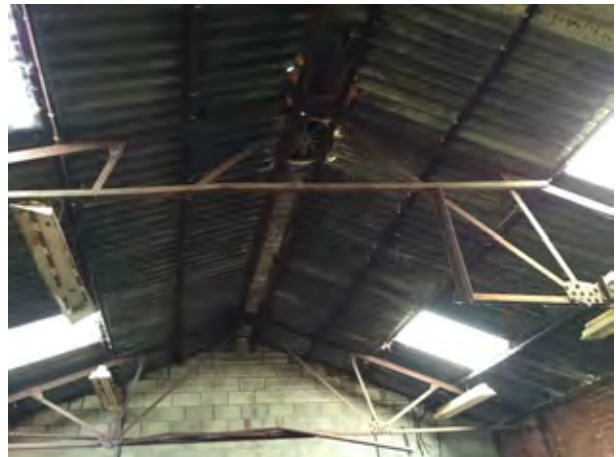
Bottom chord missing from steel truss.

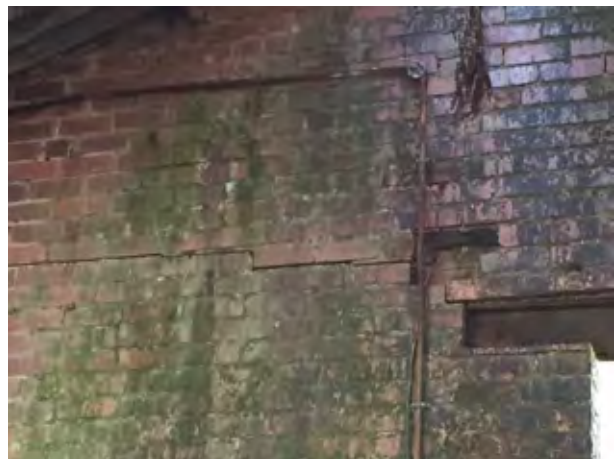
Cracking to right hand side wall.

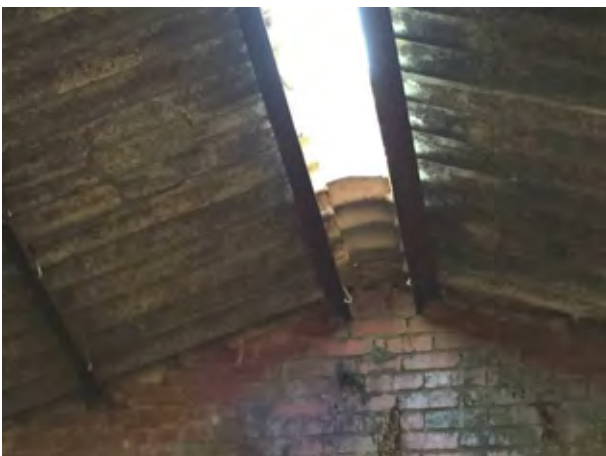
Roof sheeting missing.

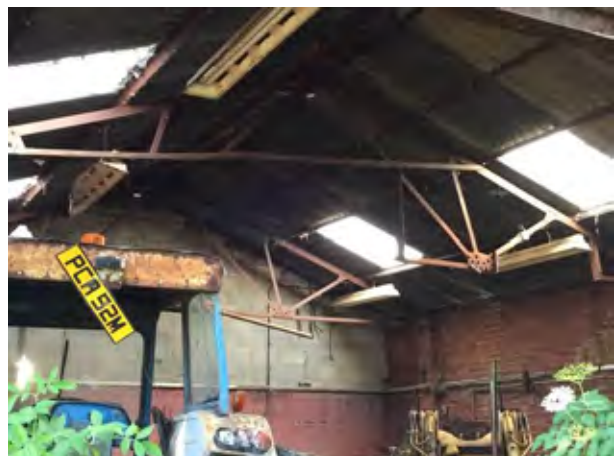
Trusses with bottom chords missing.

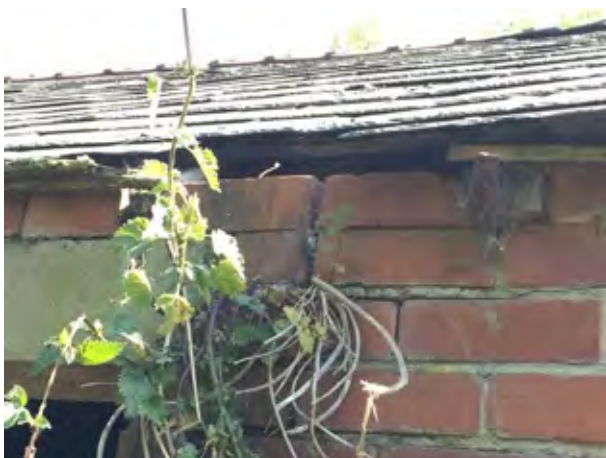
Slates are missing; vegetation is growing within the masonry and cracked and loose brickwork.

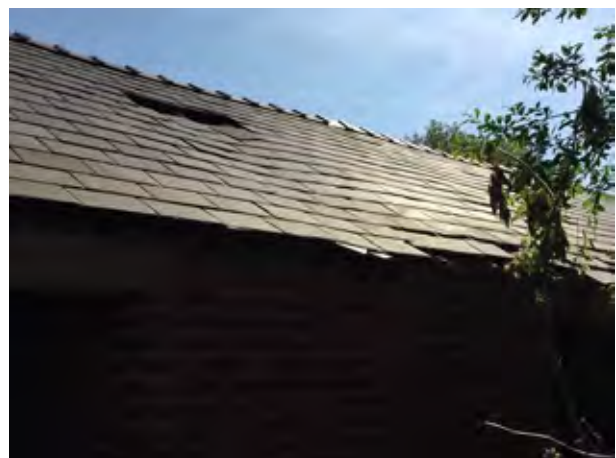
Holes through roof, missing and slipped slates and missing rain water goods.

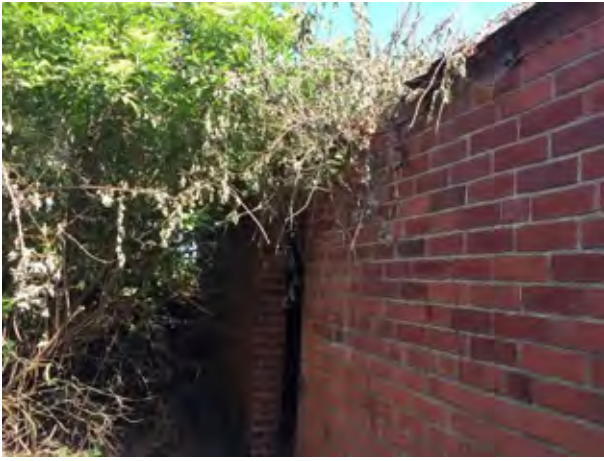
Vegetation obscuring the elevations and growing through the masonry.

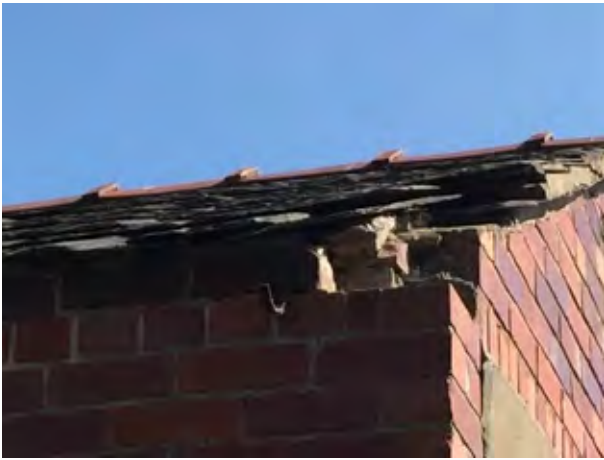
Missing rain water goods, damaged eaves and missing slates.

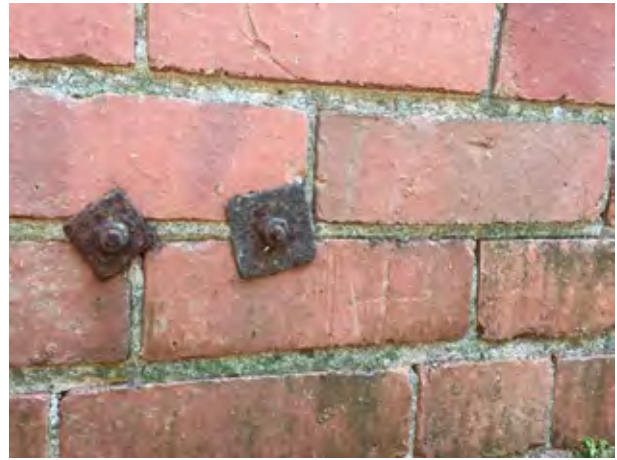
Corroded embedded steelwork has caused a horizontal crack to form.

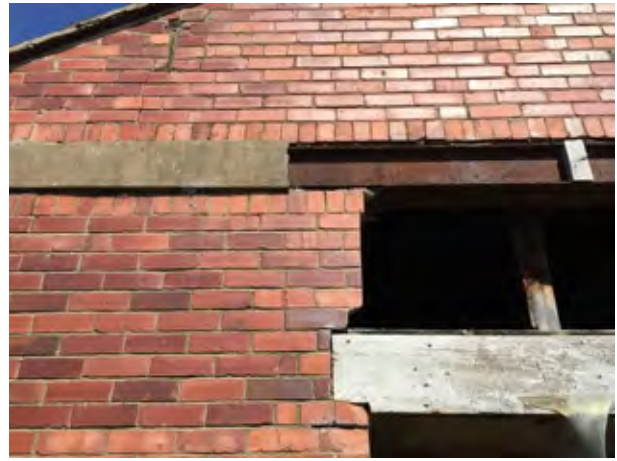
Concrete dislodged from corroding steelwork.

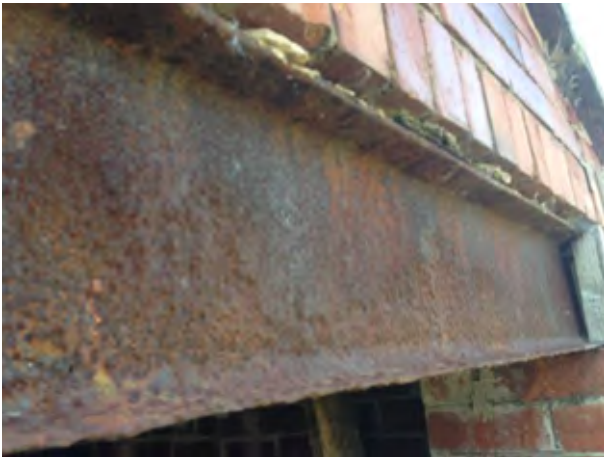
Corroding steelwork.

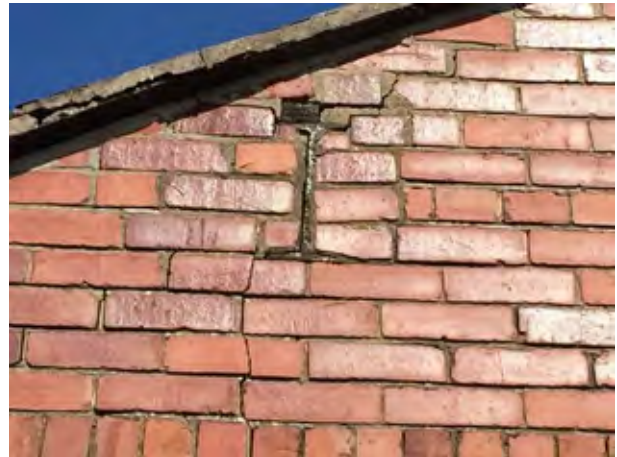
Corroding steel purlins have caused cracks to form in the brickwork.

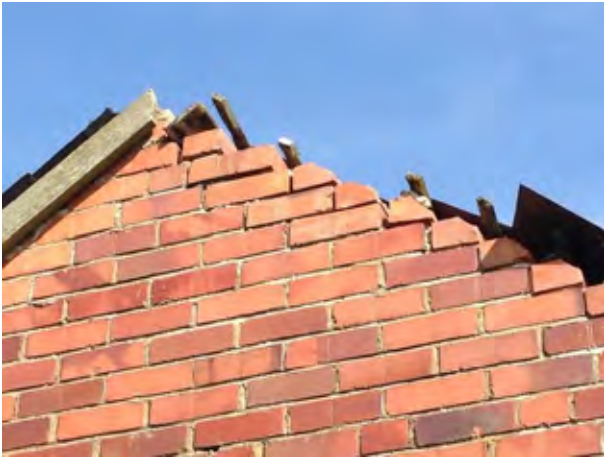
Edge of roof damaged.

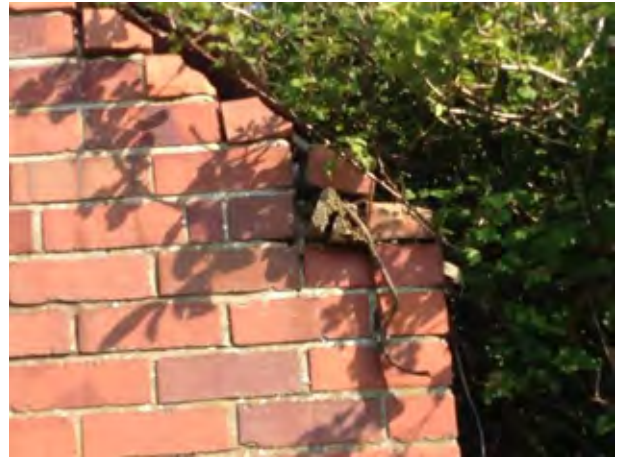
Wall plate rotting. Slate over hang missing.

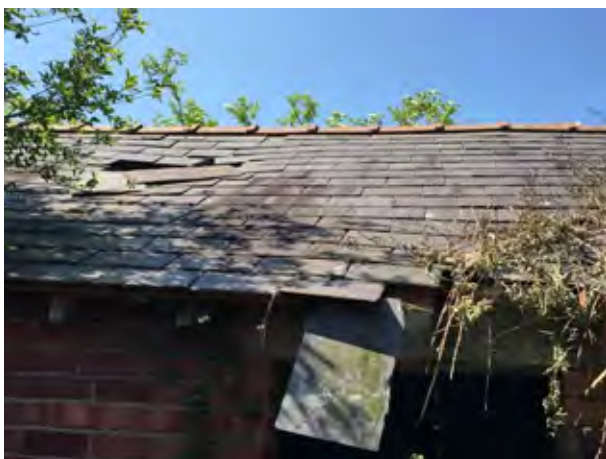
Undulating roof with holes noted. Slipped slates and missing rain water goods.

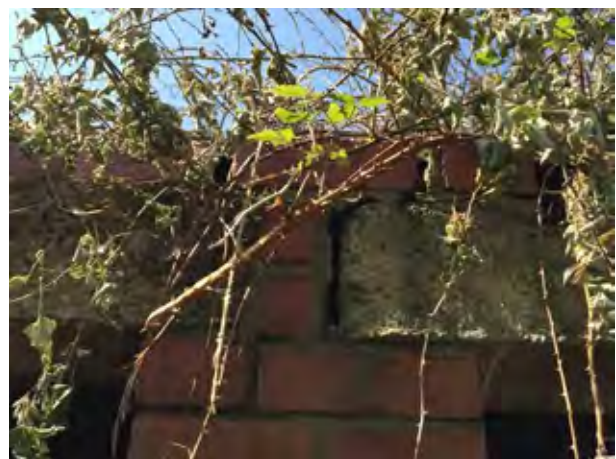
Gaps adjacent to lintels. Vegetation growing through the structure.

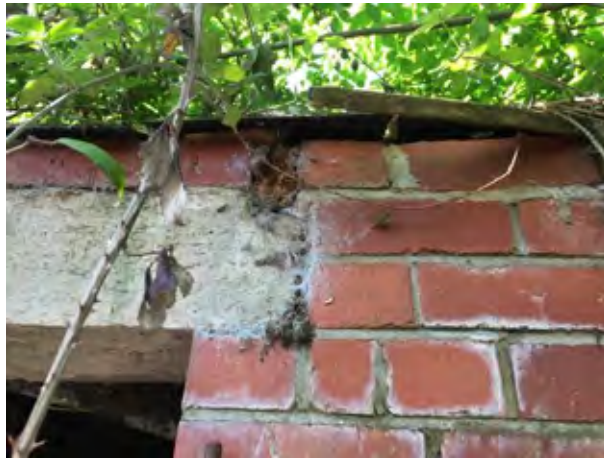
Missing eaves structure.

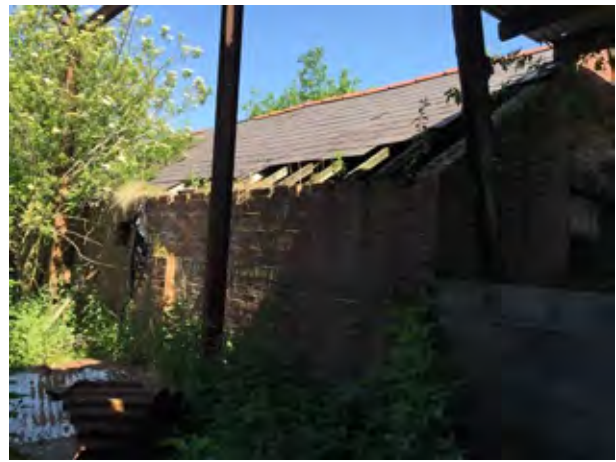
Holes through roof and missing slates at eaves level.

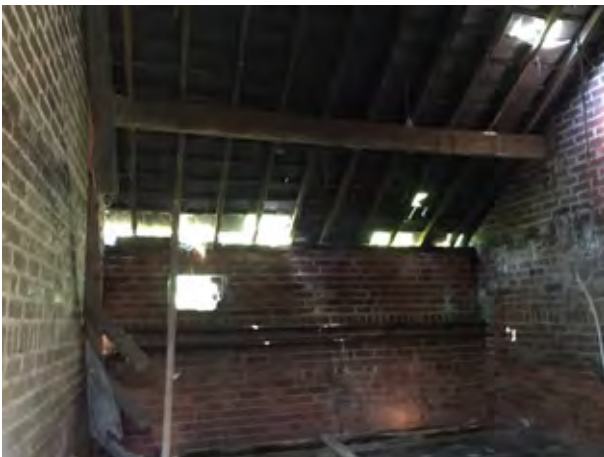
Holes through roof and rear wall.

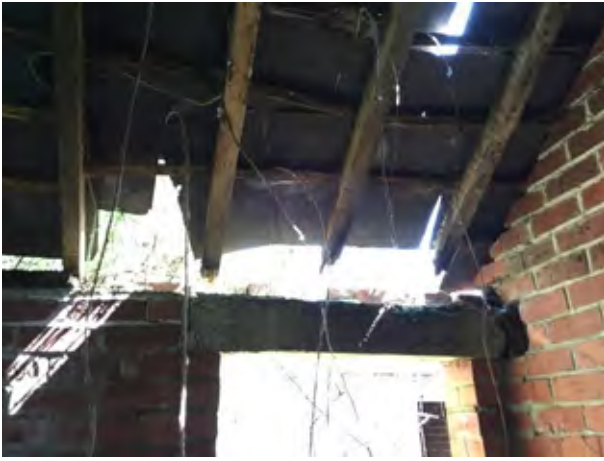
Missing structure at eaves.

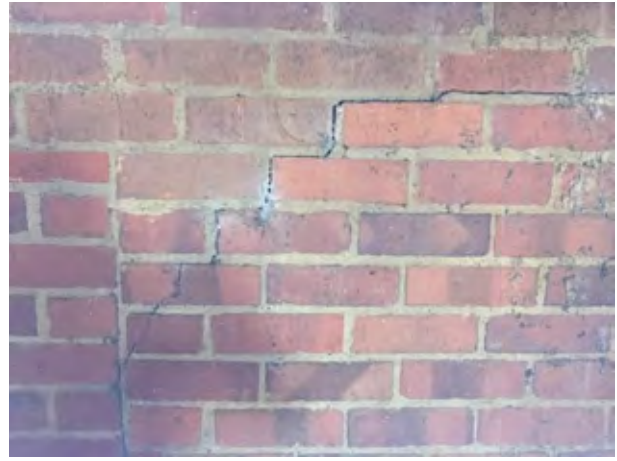
Stepped cracking to right hand side gable wall.

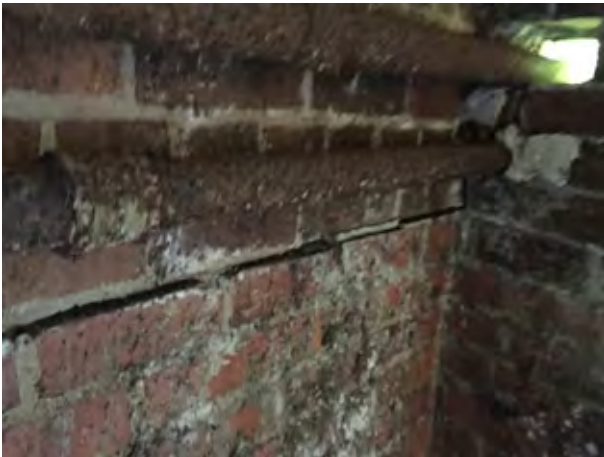
Horizontal cracking to right hand side gable wall.

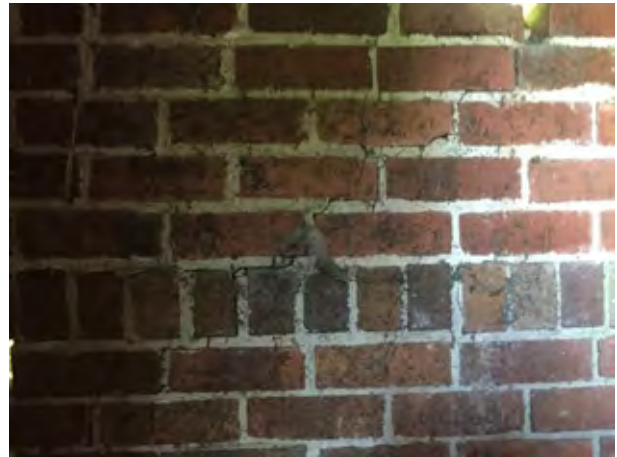
Cracking continues onto front wall.

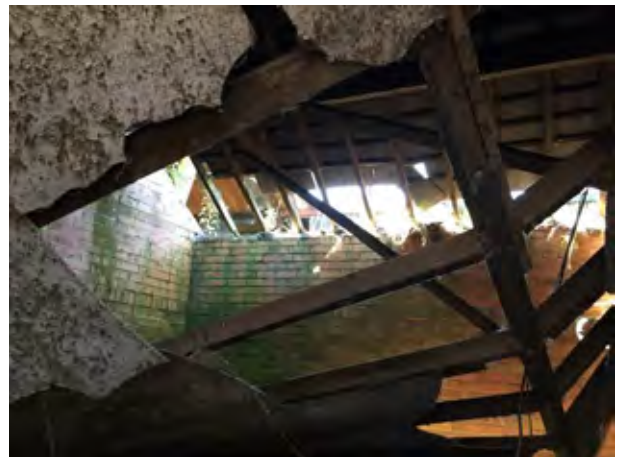
Ceilings collapsing and holed noted through the roof structure.

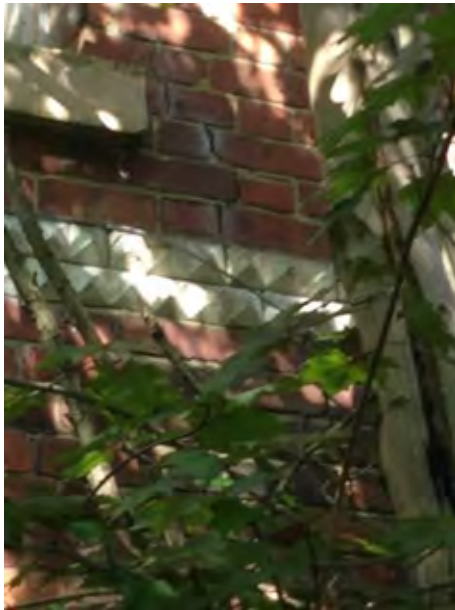
Cracking between ground and first floor level to left hand side of the porch.

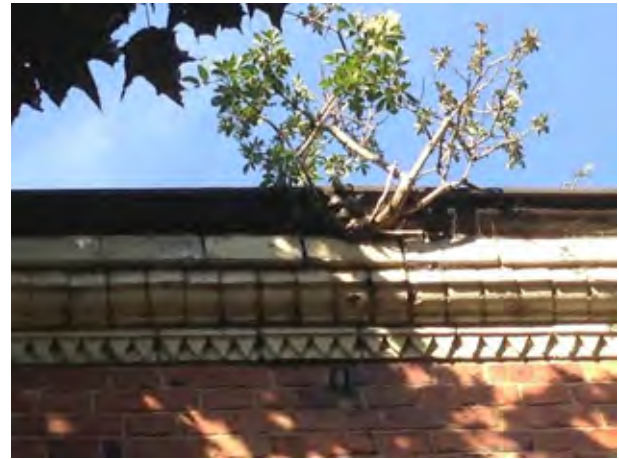
Vegetation growing through the decorative brickwork. Rain water goods appear to be leaking.

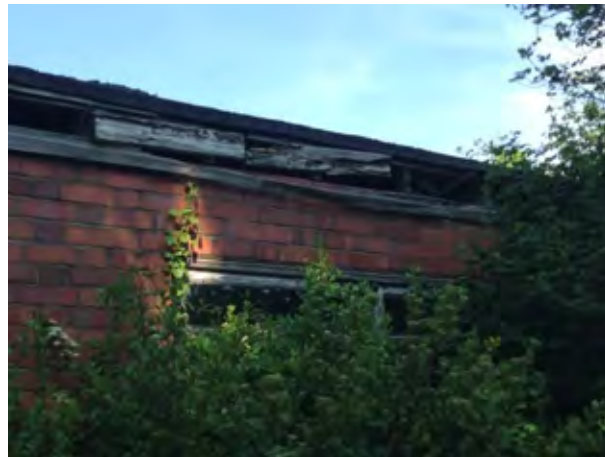
Fascia boards dislodging, exposing flat roof joist ends.

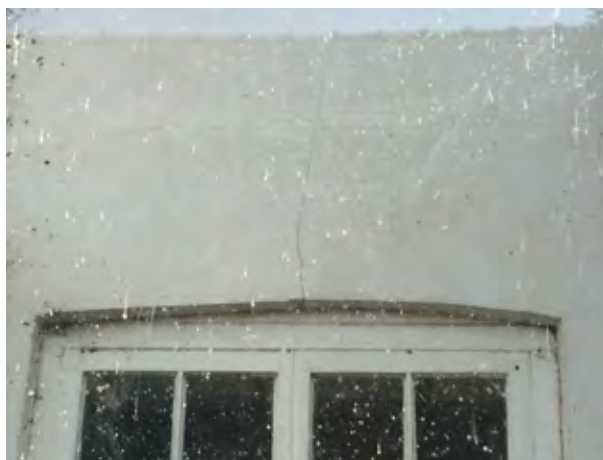
Cracking to brick arch lintel to side elevation within the rear porch structure.

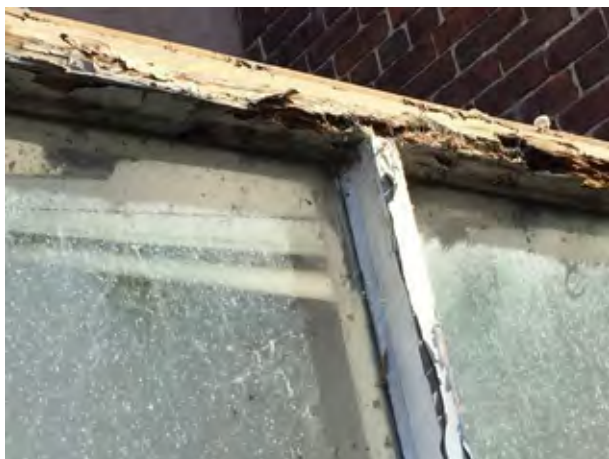
Rotting timbers to rear porch structure.

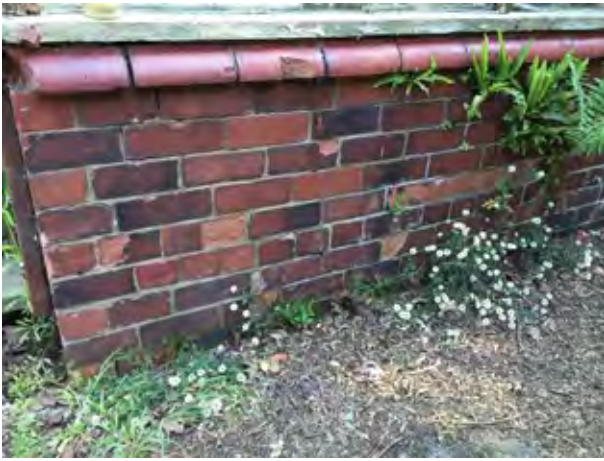
Spalling bricks to rear porch structure.

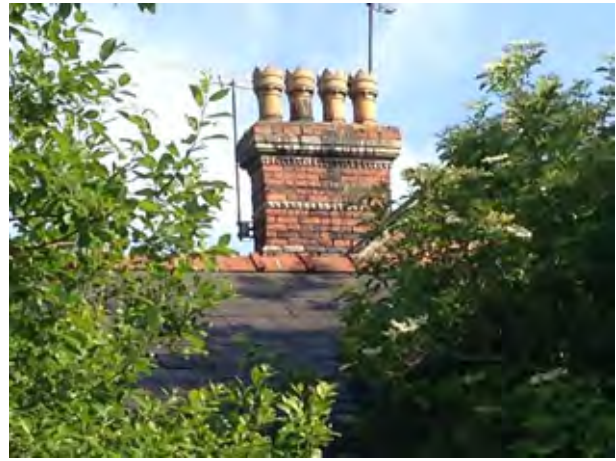
Water staining to main chimney stack.
