**Report No.:** SW3087

**Nature of Work:** Refurbishment Survey

7-9 Grosvenor Road  
Wrexham  
LL11 1BU

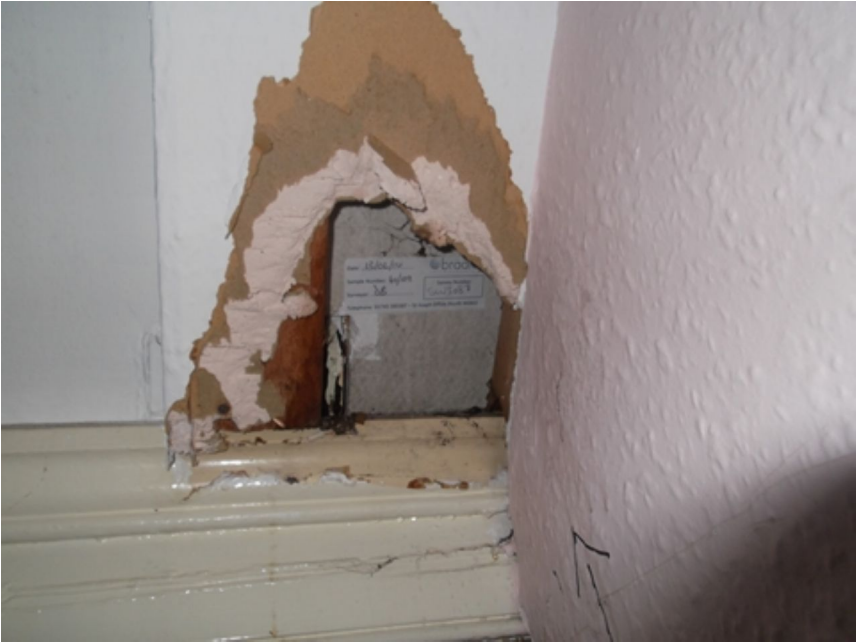
| Item Number: | 01 | Sample Number: | 411/109 | | |

| Item: | Asbestos insulating board closer panel | | | | |
| Asbestos Content: | Amosite Identified<br>Chrysotile Identified | | | | |
| Condition: | 1 (Minor scratches) | | | Priority Assessment: | 3 |

| Accessibility: | 0 (Usually inaccessible or unlikely to be disturbed) | | | Recommendation: | Program removal |

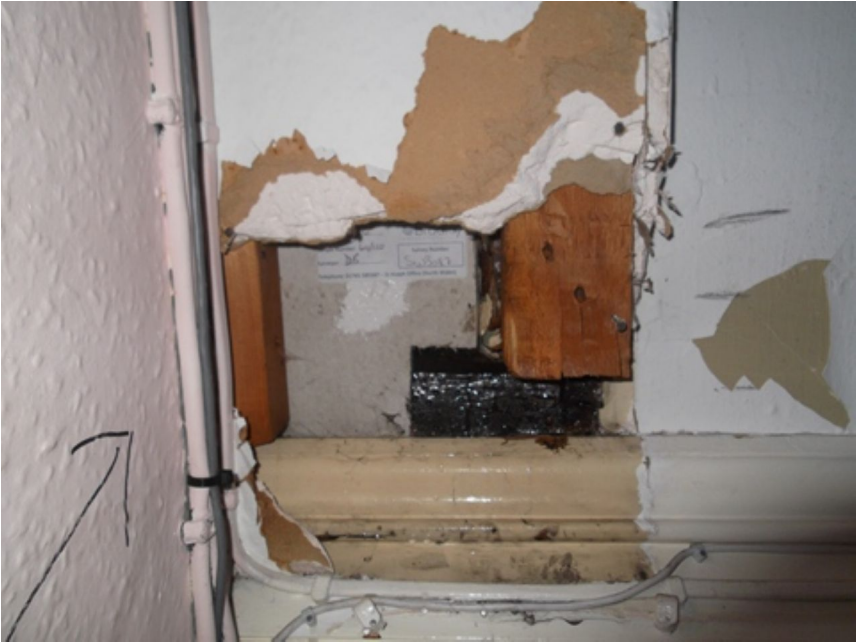
| Item Number: | 02 | Sample Number: | 411/110 | |

| Item: | Asbestos insulating board closer panel | | | |
| Asbestos Content: | Amosite Identified<br>Chrysotile Identified | | | |
| Condition: | 1 (Minor scratches) | Priority Assessment: | 3 | |

| Accessibility: | 0 (Usually inaccessible or unlikely to be disturbed) | Recommendation: | Program removal | |

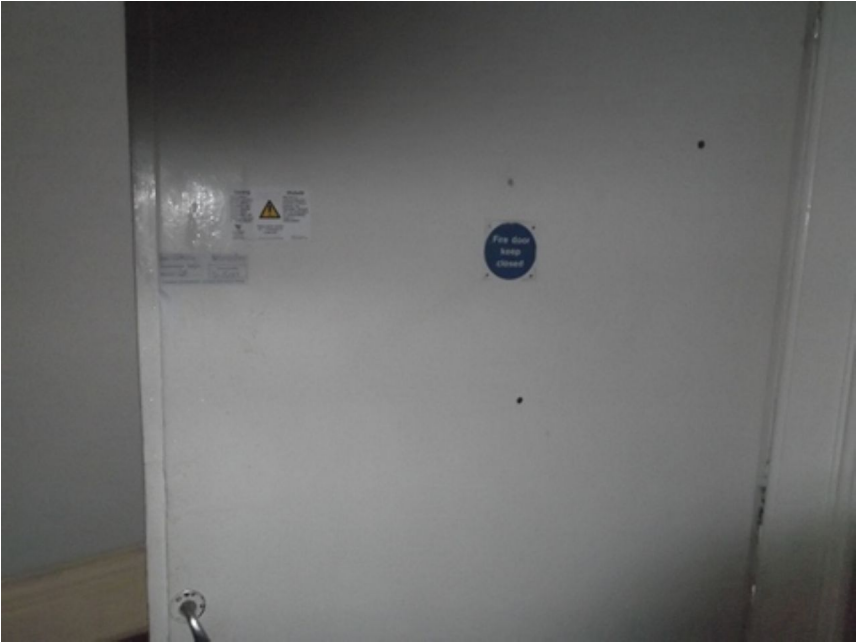
| Item Number: | 03 | Sample Number: | 411/111 | |

| Item: | Asbestos insulating board door panel | | | |
| Asbestos Content: | Amosite Identified<br>Chrysotile Identified | | | |
| Comments: | Item present to rear of door. Local damage to panel. | | | |
| Condition: | 2 (Local damage) | Priority Assessment: | 6 | |

| Accessibility: | 3 (Routinely disturbed) | Recommendation: | Program removal | |

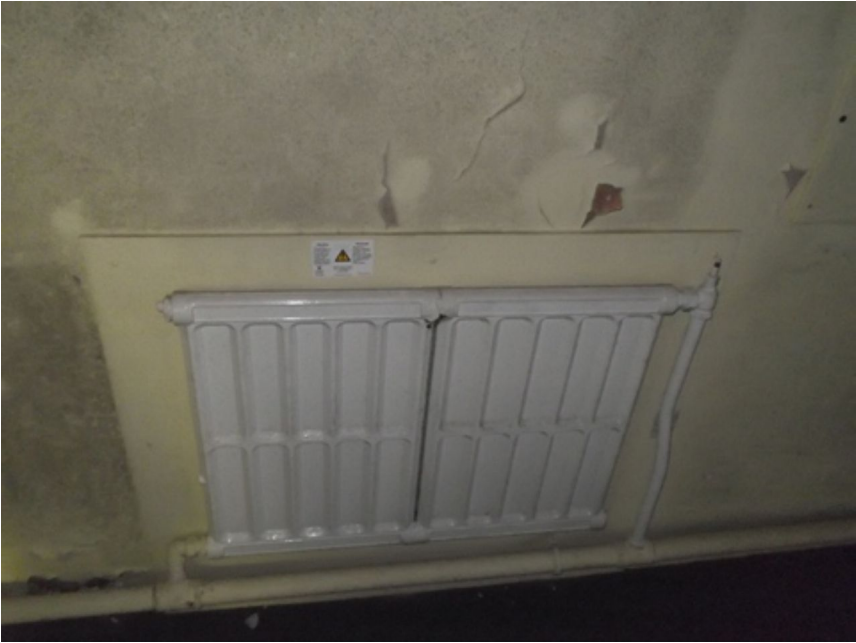
| Item Number: | 06 | Sample Number: | 411/114 | | |

| Item: | Asbestos cement panel | | | | |
| Asbestos Content: | Chrysotile      Identified | | | | |
| Condition: | 1 (Minor scratches) | | | Priority Assessment: | 5 |

| Accessibility: | 2 (Easily disturbed) | | | Recommendation: | Program removal |

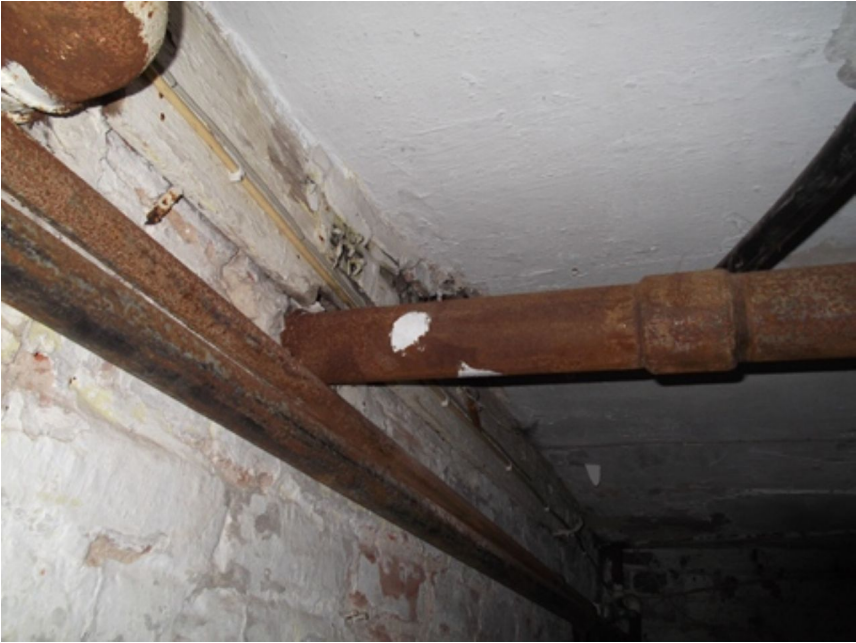
| Item Number: | 09 | Sample Number: | 411/117 | | |

| Item: | Asbestos insulation residues | | | | |
| Asbestos Content: | Amosite Identified<br>Chrysotile Identified | | | | |
| Comments: | Item can be found along pipework. Previous enclosure set up glue can be found around the window. Plant room appears to have undergone an asbestos removal project. | | | | |
| Condition: | 3 (Significant damage) | | | Priority Assessment: | 6 |

| Accessibility: | 2 (Easily disturbed) | | | Recommendation: | Program removal |

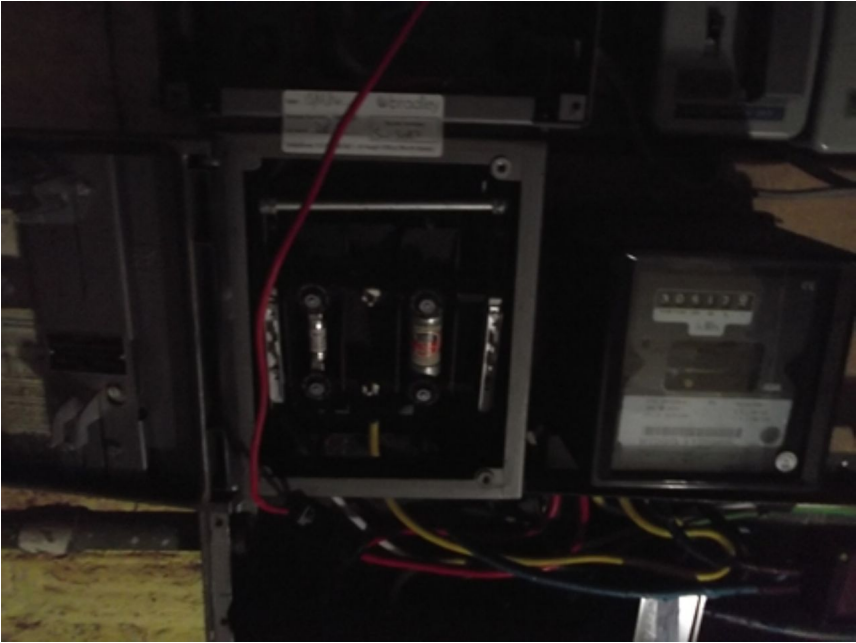
| Item Number: | 13 | Sample Number: | 411/121 | |

| Item: | Asbestos textile fuse tape | | | |
| Asbestos Content: | Chrysotile      Identified | | | |
| Condition: | 1 (Minor scratches) | Priority Assessment: | 4 | |

| Accessibility: | 1 (Occasionally likely to be disturbed) | Recommendation: | Program removal | |

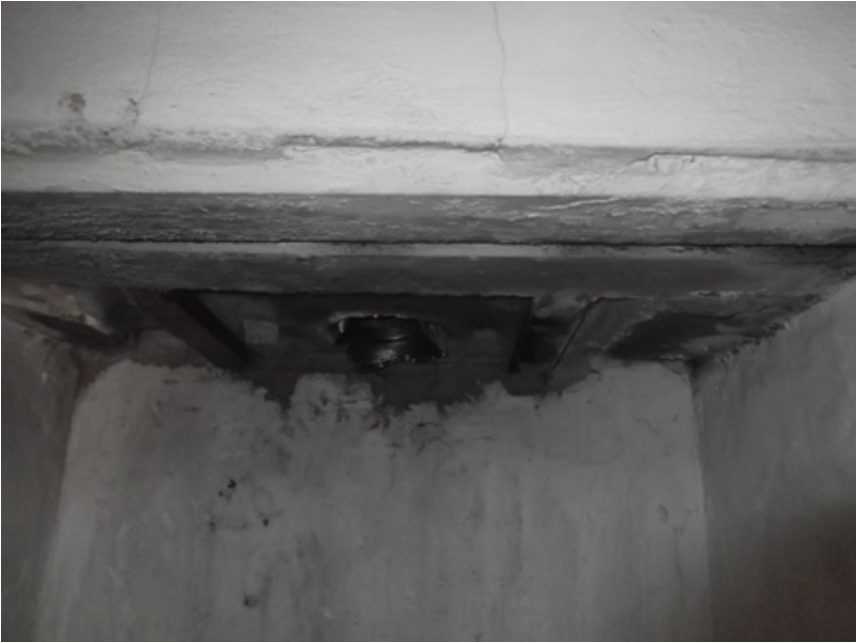
| Item Number: | 22 | Sample Number: | 411/130 | |

| Item: | Asbestos cement panel | | | |
| Asbestos Content: | Chrysotile      Identified | | | |
| Condition: | 1 (Minor scratches) | Priority Assessment: | 5 | |

| Accessibility: | 2 (Easily disturbed) | Recommendation: | Program removal | |

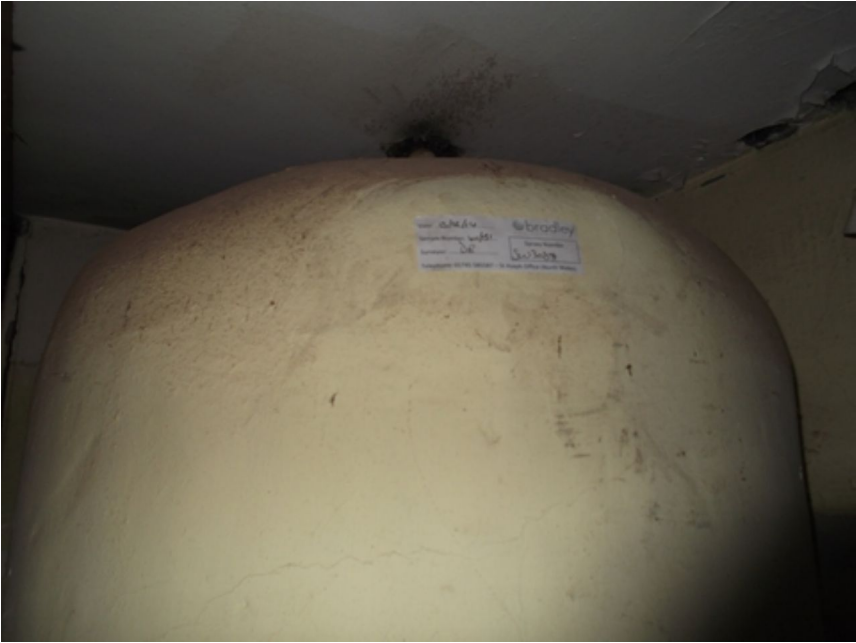
| Item Number: | 23 | Sample Number: | 411/131 | |

| Item: | Asbestos insulation to calorifier | | | |
| Asbestos Content: | Crocidolite Identified<br>Amosite Identified | | | |
| Comments: | Item can be found within cupboard adjacent to chimney breast.<br>Item taken form top section of calorifier. | | | |
| Condition: | 3 (Significant damage) | Priority Assessment: | 5 | |

| Accessibility: | 2 (Easily disturbed) | Recommendation: | Program removal | |

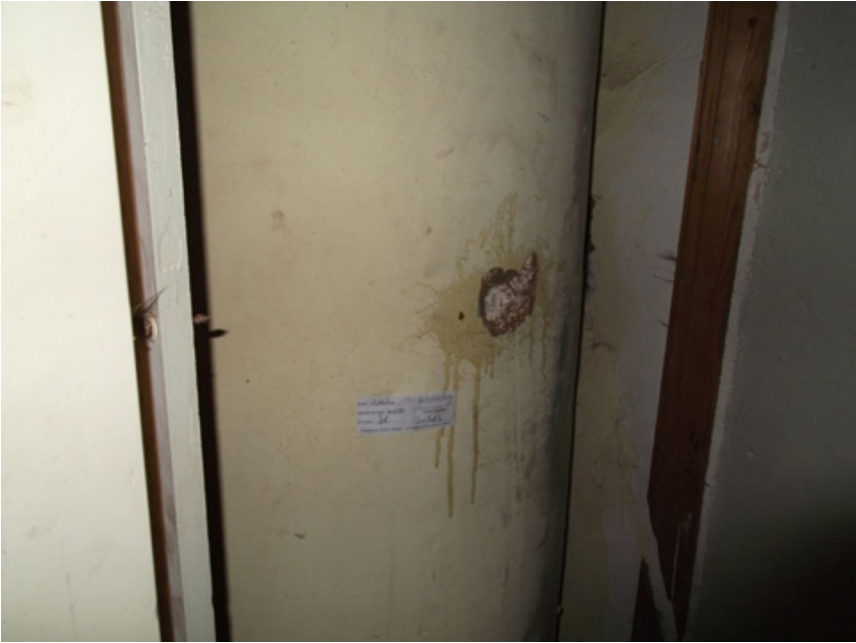
| Item Number: | 24 | Sample Number: | 411/132 | |

| Item: | Asbestos insulation to calorifier | | | |
| Asbestos Content: | Crocidolite Identified<br>Amosite Identified | | | |
| Condition: | 3 (Significant damage) | Priority Assessment: | 5 | |

| Accessibility: | 2 (Easily disturbed) | Recommendation: | Program removal | |

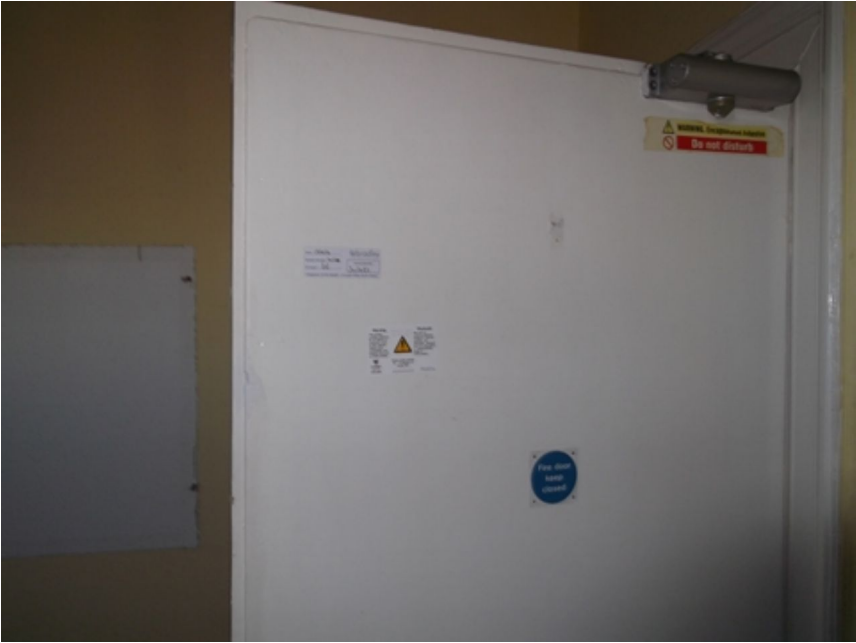
| Item Number: | 25 | Sample Number: | 411/133 | |

| Item: | Asbestos insulating board door panel | | | |
| Asbestos Content: | Amosite Identified<br>Chrysotile Identified | | | |
| Condition: | 1 (Minor scratches) | Priority Assessment: | 6 | |

| Accessibility: | 3 (Routinely disturbed) | Recommendation: | Program removal | |

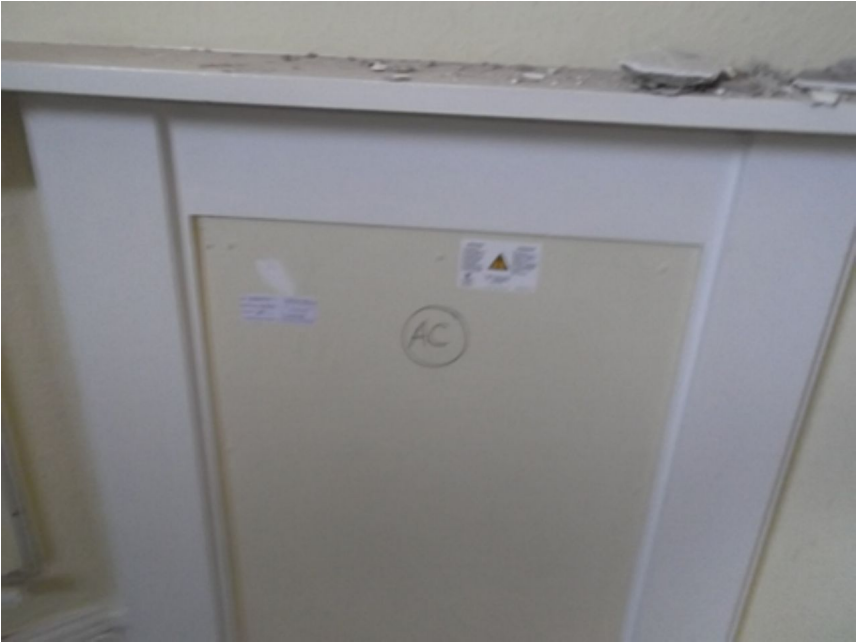
| Item Number: | 26 | Sample Number: | 411/134 | |

| Item: | Asbestos cement panel | | | |
| Asbestos Content: | Chrysotile Identified | | | |
| Condition: | 1 (Minor scratches) | Priority Assessment: | 5 | |

| Accessibility: | 2 (Easily disturbed) | Recommendation: | Program removal | |

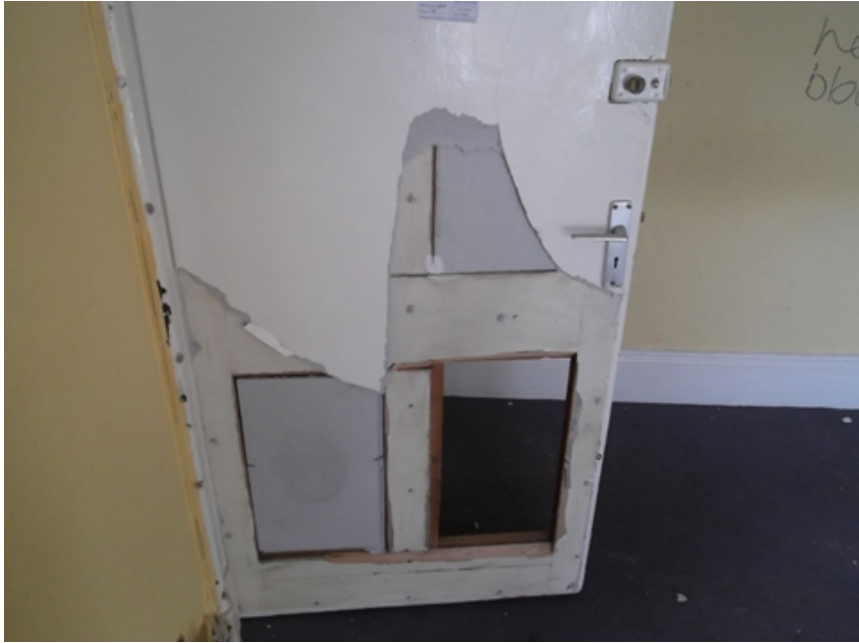
| Item Number: | 27 | Sample Number: | 411/135 | |

| Item: | Asbestos insulating board door panel | | | |
| Asbestos Content: | Amosite Identified<br>Chrysotile Identified | | | |
| Comments: | Item can be found to the rear of the door. Item has been significantly damaged. No debris can be located in the room. Carpets should be considered as contaminated. | | | |
| Condition: | 3 (Significant damage) | Priority Assessment: | 6 | |

| Accessibility: | 3 (Routinely disturbed) | Recommendation: | Program removal | |

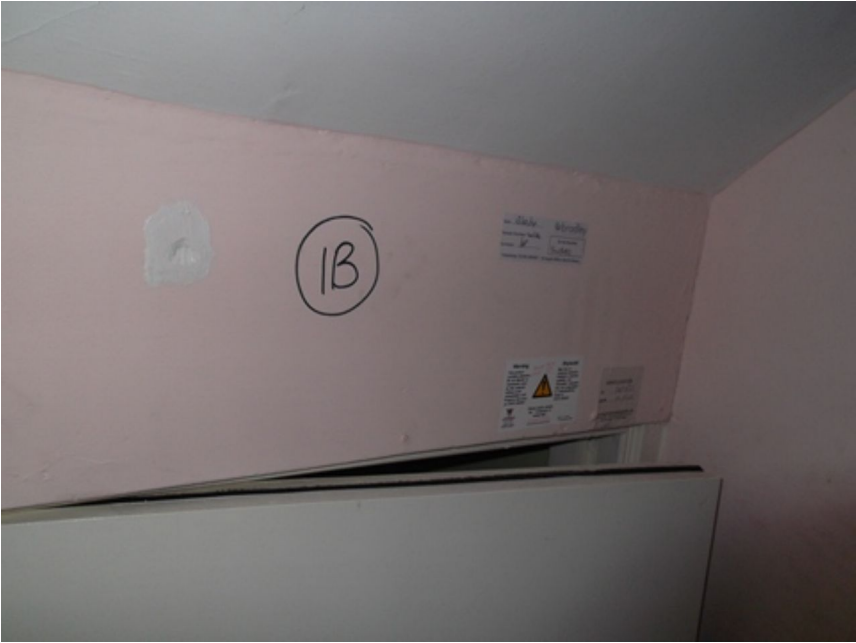
| Item Number: | 29 | Sample Number: | 411/136 | |

| Item: | Asbestos insulating board header panel | | | |
| Asbestos Content: | Amosite Identified<br>Chrysotile Identified | | | |
| Condition: | 1 (Minor scratches) | Priority Assessment: | 5 | |

| Accessibility: | 2 (Easily disturbed) | Recommendation: | Program removal | |

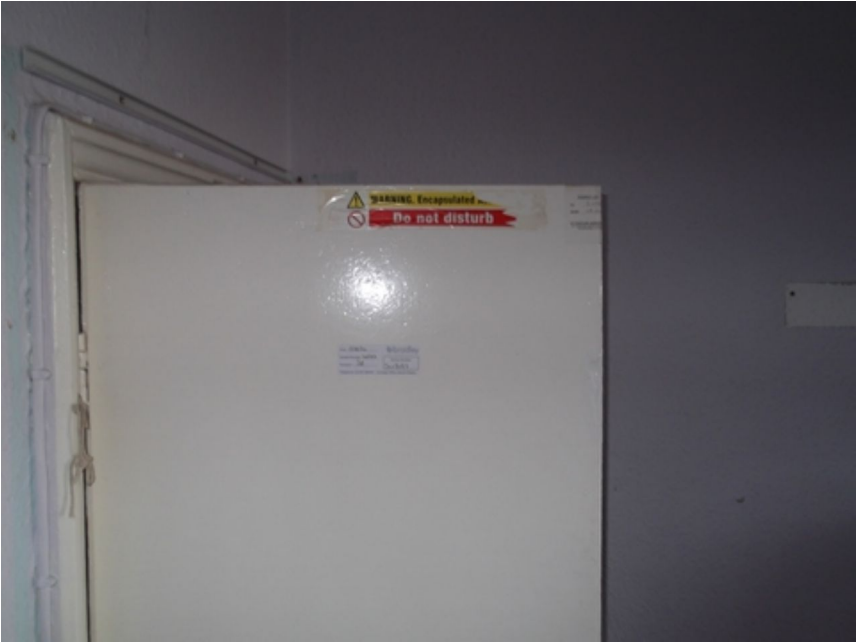
| Item Number: | 30 | Sample Number: | 411/137 | |

| Item: | Asbestos insulating board door panel | | | |
| Asbestos Content: | Amosite Identified<br>Chrysotile Identified | | | |
| Condition: | 1 (Minor scratches) | Priority Assessment: | 6 | |

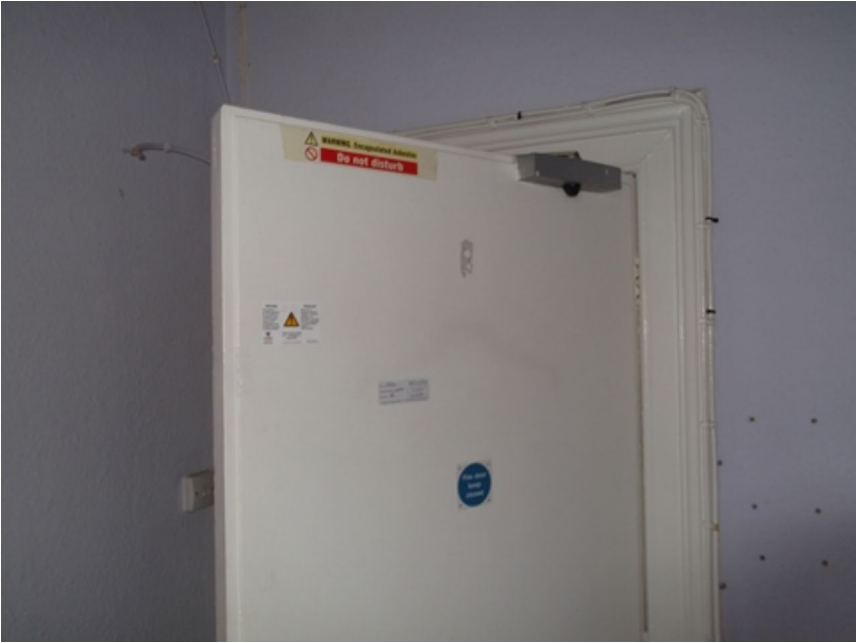
| Item Number: | 32 | Sample Number: | 411/139 | |

| Item: | Asbestos insulating board door panel | | | |
| Asbestos Content: | Amosite Identified<br>Chrysotile Identified | | | |

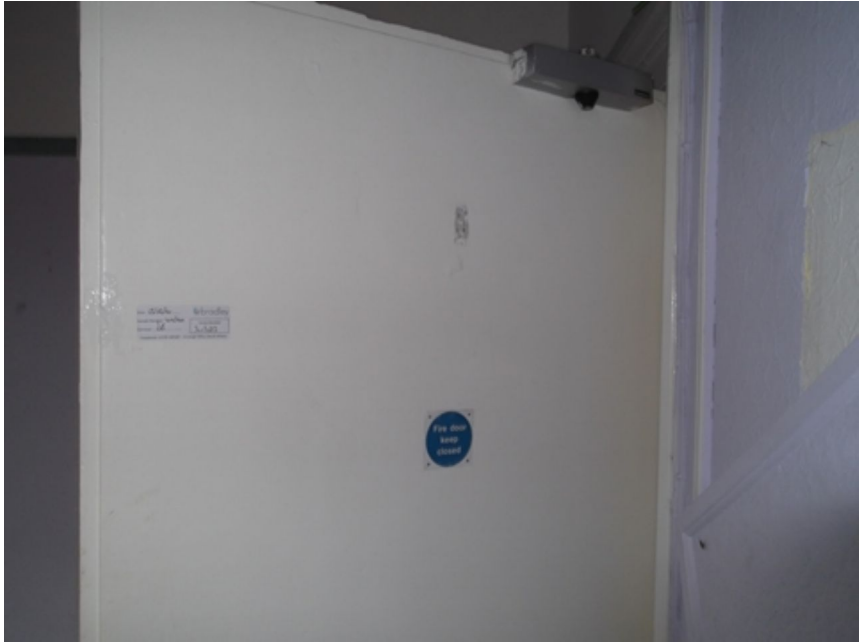
| Item Number: | 33 | Sample Number: | 411/140 | | |

| Item: | Asbestos insulating board door panel | | | | |
| Asbestos Content: | Amosite Identified<br>Chrysotile Identified | | | | |

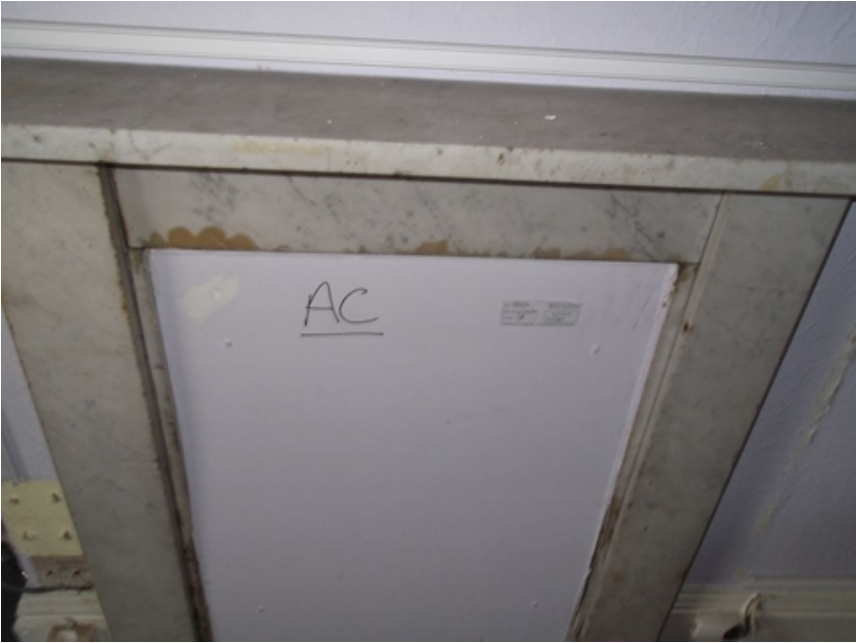
| Item Number: | 34 | Sample Number: | 411/141 | | |

| Item: | Asbestos cement panel | | | | |
| Asbestos Content: | Chrysotile      Identified | | | | |

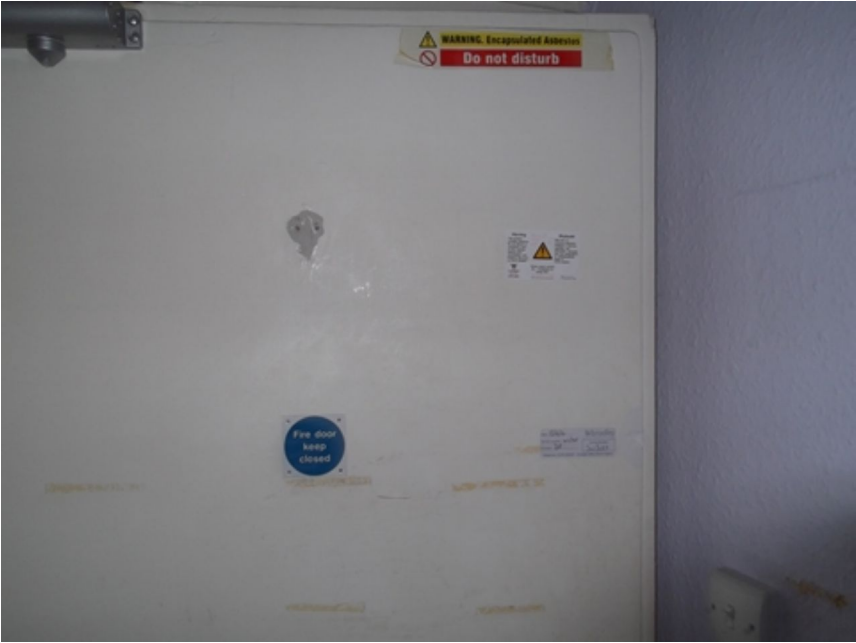
| Item Number: | 35 | Sample Number: | 411/142 | |

| Item: | Asbestos insulating board door panel | | | |
| Asbestos Content: | Amosite Identified<br>Chrysotile Identified | | | |

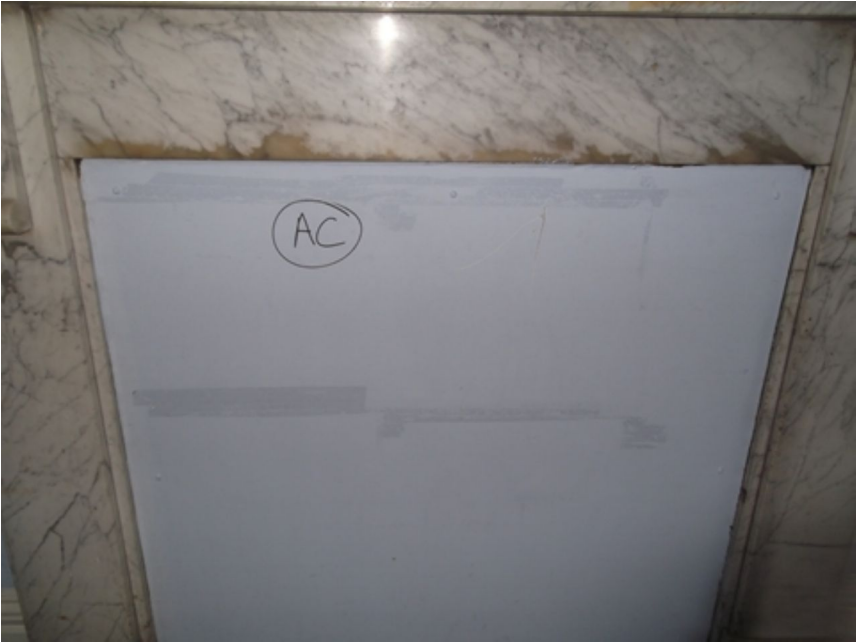
| Item Number: | 38 | Sample Number: | As 411/141 | |

| Item: | Asbestos cement panel | | | |
| Asbestos Content: | Chrysotile      Strongly Presumed | | | |

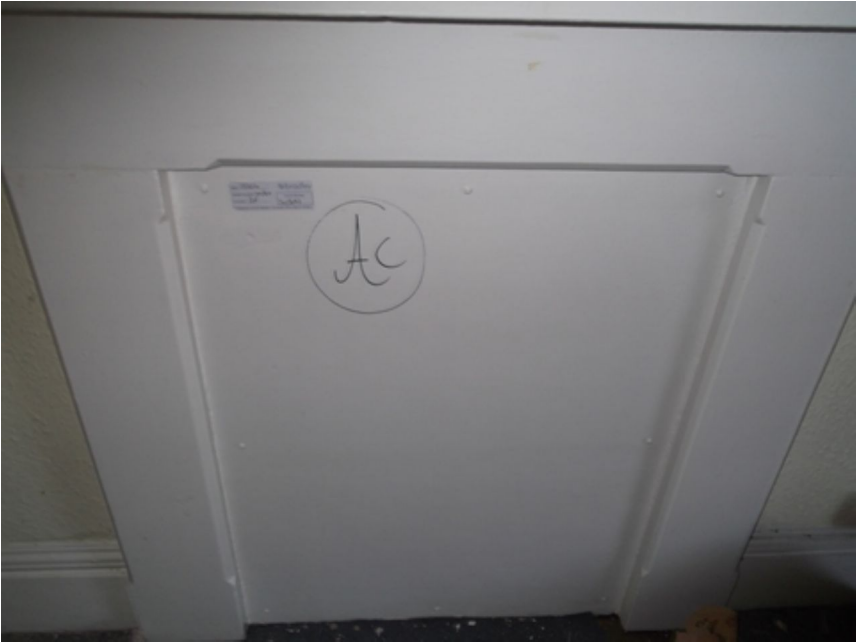
| Item Number: | 41 | Sample Number: | 411/147 | |

| Item: | Asbestos cement panel | | | |
| Asbestos Content: | Crocidolite Identified<br>Chrysotile Identified | | | |

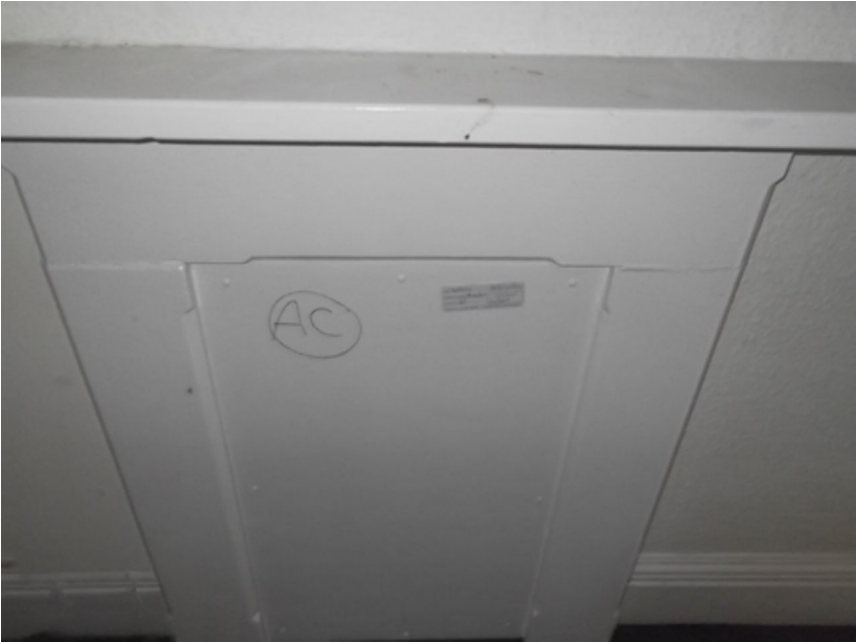
| Item Number: | 43 | Sample Number: | As 411/147 | | |

| Item: | Asbestos cement panel | | | | |
| Asbestos Content: | Crocidolite Strongly Presumed<br>Chrysotile Strongly Presumed | | | | |

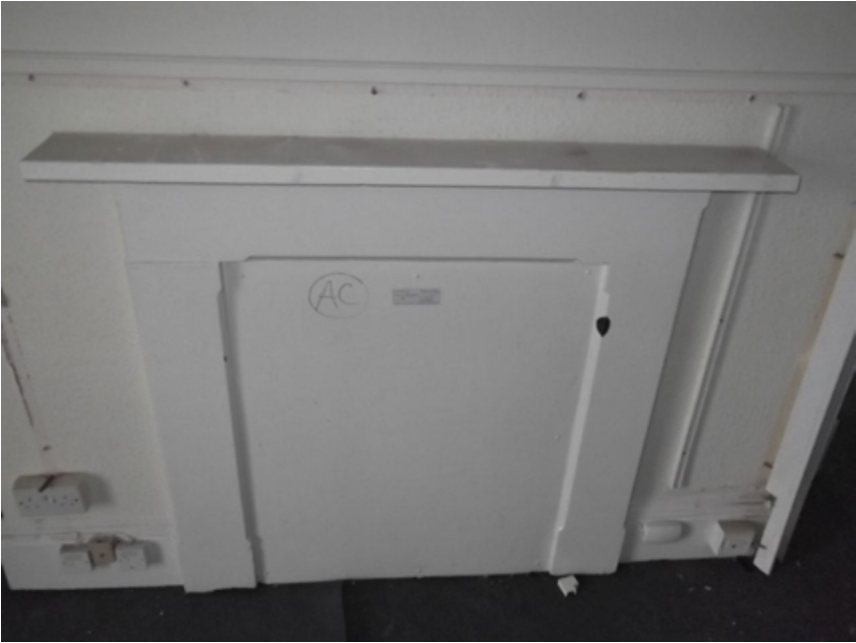
| Item Number: | 46 | Sample Number: | As 411/147 | |

| Item: | Asbestos cement panel | | | |
| Asbestos Content: | Crocidolite Strongly Presumed<br>Chrysotile Strongly Presumed | | | |

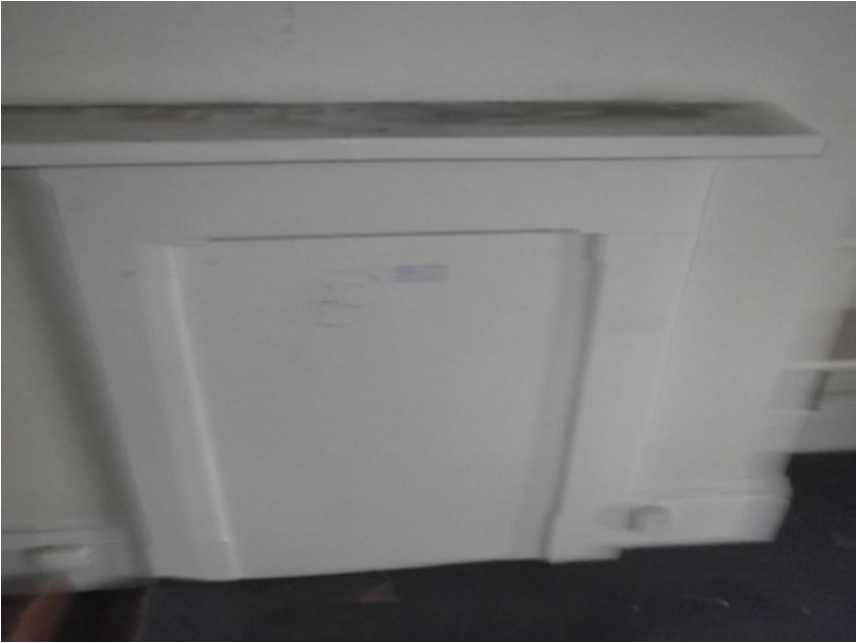
| Item Number: | 48 | Sample Number: | As 411/147 | |

| Item: | Asbestos cement panel | | | |
| Asbestos Content: | Crocidolite Strongly Presumed<br>Chrysotile Strongly Presumed | | | |

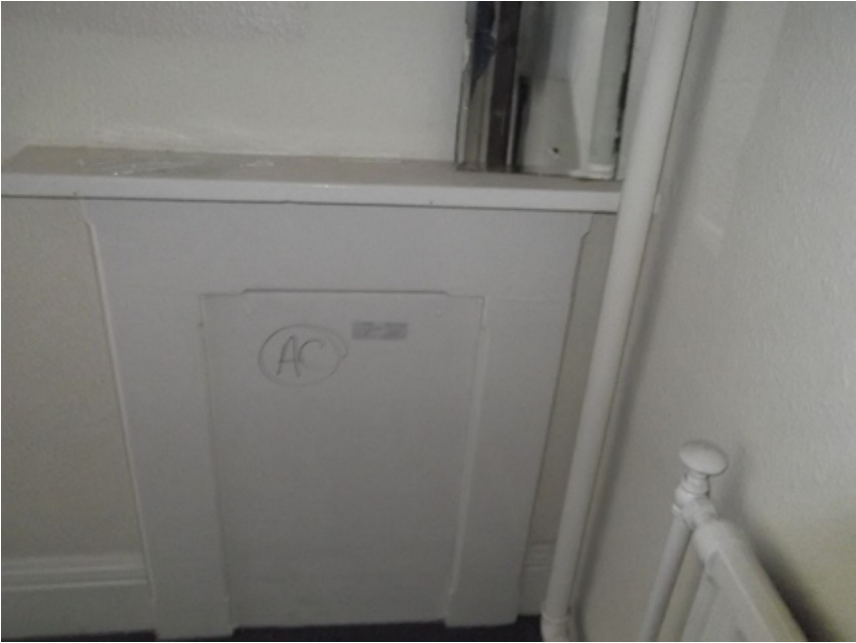
| Item Number: | 50 | Sample Number: | As 411/147 | | |

| Item: | Asbestos cement panel | | | | |
| Asbestos Content: | Crocidolite Strongly Presumed<br>Chrysotile Strongly Presumed | | | | |

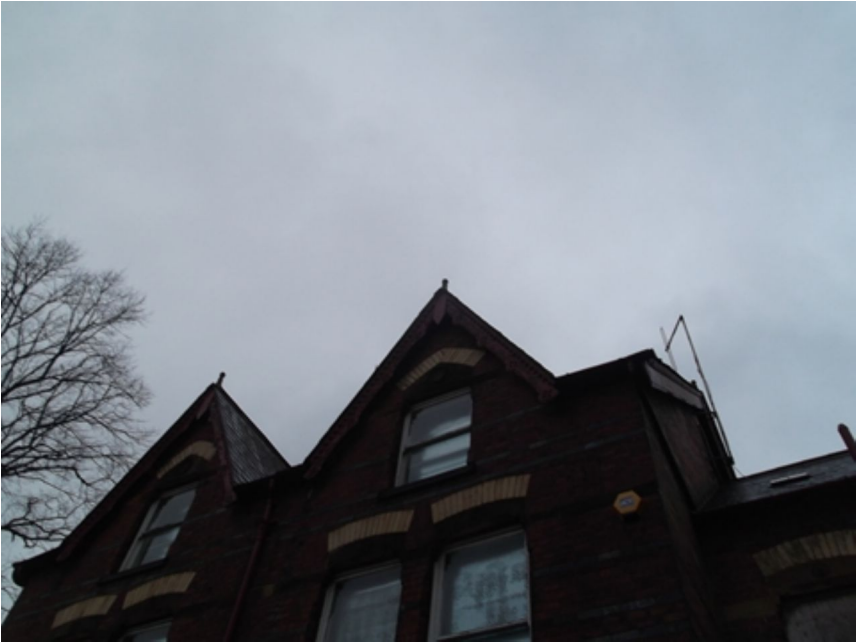
| Item Number: | 54 | Sample Number: | No sample - presumed | |

| Survey Item No. | Floor Level | Block Name | Location | Item | Asbestos Content | | Extent | Risk Category | Recommendation |
|---|---|---|---|---|---|---|---|---|---|
| 54 | External | Main | 63 External | Asbestos cement undercloaking | Crocidolite<br>Chrysotile | Presumed | 16 linear metres | C 8 | Encapsulate, label & monitor condition (or remove as part of planned works) |

| Item: | Asbestos cement undercloaking | | | |
| Asbestos Content: | Crocidolite Presumed<br>Chrysotile Presumed | | | |
