## Scope

A non-invasive assessment was made of one oak tree on 24<sup>th</sup> January 2014. The assessment method followed the principles of VTA and employed a nylon mallet for the purposes of auditory assessment of decay.

The subject tree is within influencing distance of plot 85 Penmere Park, Penley, near Wrexham. The site is defined to the north west by grassland, to the east by an access track and existing residential properties and to the south by the Penmere Park housing development. The assessment was made from ground level by a qualified arboricultural consultant.

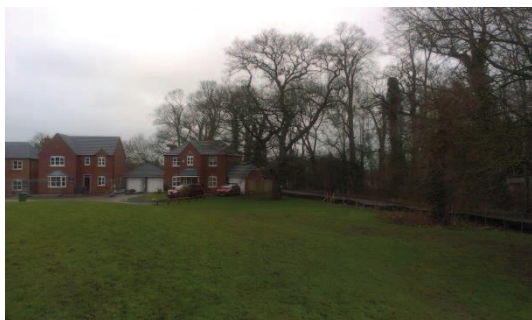
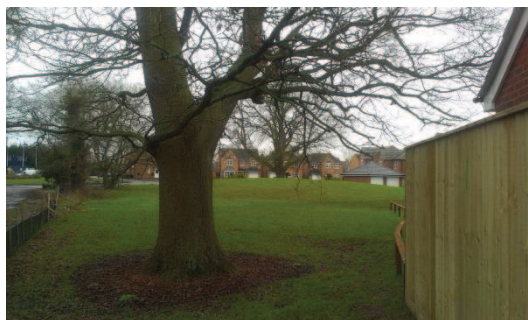
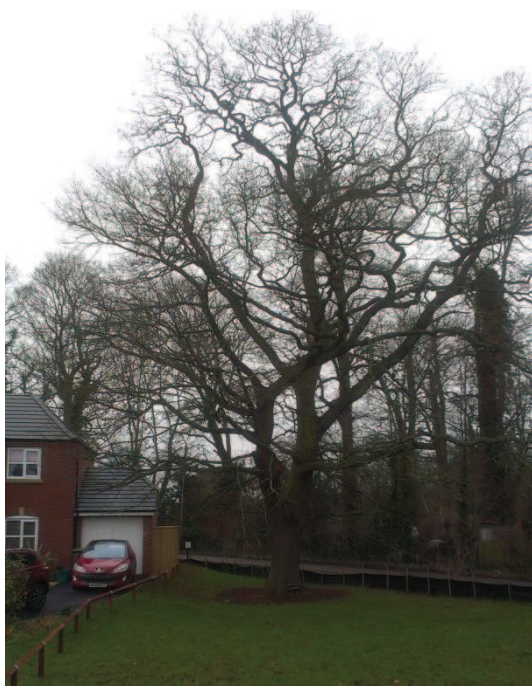
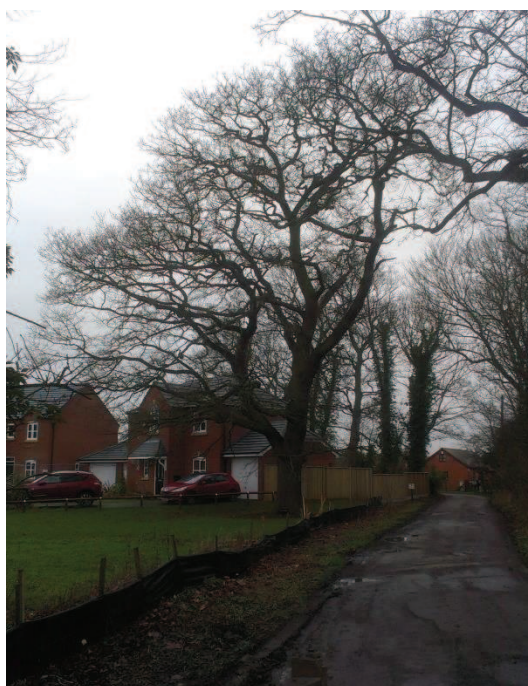
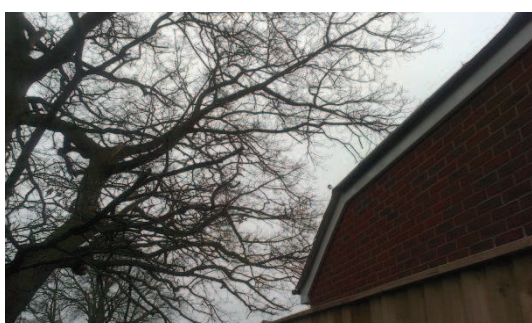
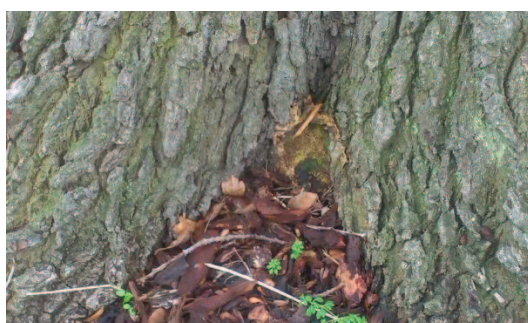
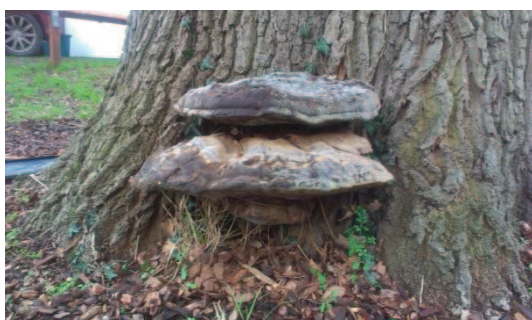
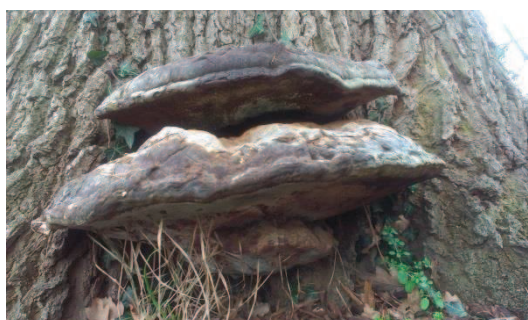
24<sup>th</sup> January 2014

The principal decay fungi *Ganoderma resinaceum* was noted at the base of the tree on the southern side. Two large brackets (38cm and 45cm) were growing between buttresses. There was also evidence of previous bracket growth on one other buttress (staining of bark and residual mycelial tissues). The existing brackets are known to have been growing over the period June 2013 to present (see photographs) and were beginning to just degrade at the time of survey. The uppermost bracket was removed in order to observe the presence of a stalk to confirm the species identification.

Sounding of the main stem, buttresses and root collar with a nylon mallet was undertaken. Degradation of tissues and/or hollowing was noted on the southern side of the tree up to around 0.5m and in principal root buttresses. This area corresponds with the fungal infection and the findings were consistent with the anticipated pattern of decay for the species.

1. Remove the tree;
2. Reduce the tree substantially in size.
