**PROPOSED RESTORATION OF LAND AT CEFN Y BEDD**

**Arboricultural survey (BS5837:2005)**

**JOHN WILLIAMS**

January 2012

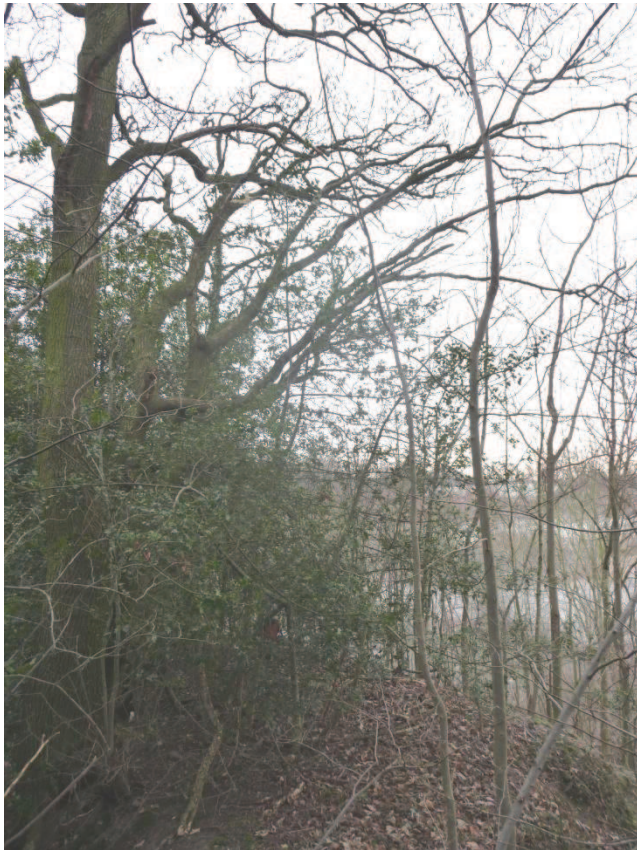
| Tree no. | Species | Height (m) | Stem Ø (cm) | RPA radius (m) | Crown spread (m) | | | | Crown clearance (m) | Age class | Physiological condition | Structural condition | Remaining contribution (yrs) | Quality Grade |
|---|---|---|---|---|---|---|---|---|---|---|---|---|---|---|
| 1429 | <i>Acer pseudoplatanus</i> | 10 | 39 | 4.68 | 5 | 8 | 5 | 0 | 2 | Mature | Fair – suppressed by shade | Fair – poor balance, minor deadwood, wire included | >40 | C |

**Photo 1.** Tree #1428  
(a Pedunculate Oak)  
suppressing tree #1429  
(a Sycamore).

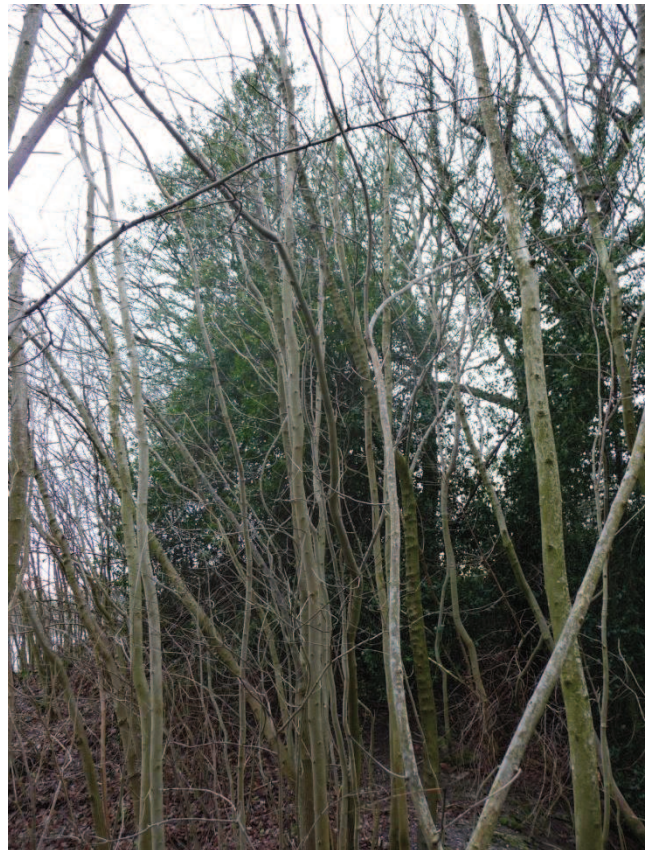
**Photo 2.** Tree #1431 (a Holly) is just visible through the relatively dense cover of naturally regenerated young trees that cloak the steep east-facing slope along the western boundary of the site.

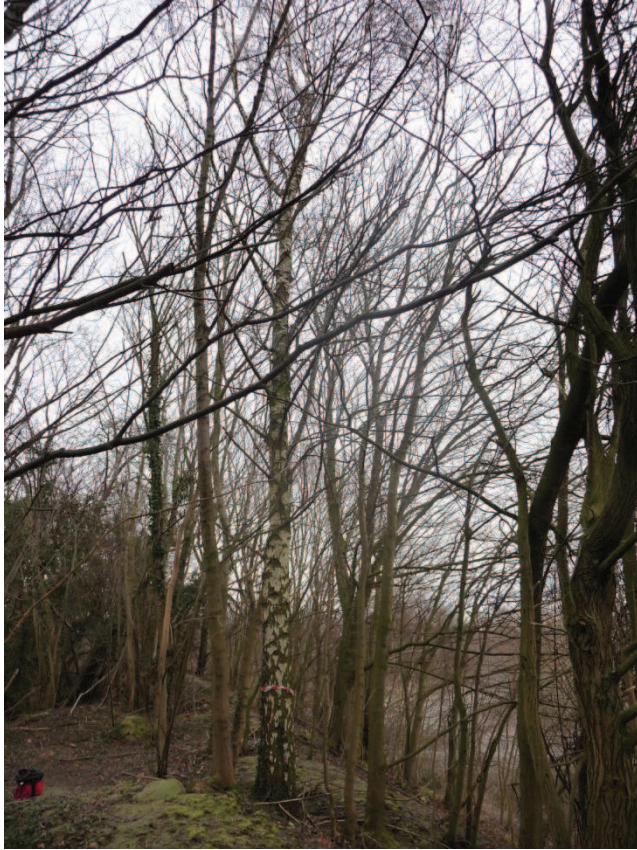
**Photo 3.** A more mature Downy Birch (tree #1432) amongst the press of younger trees.

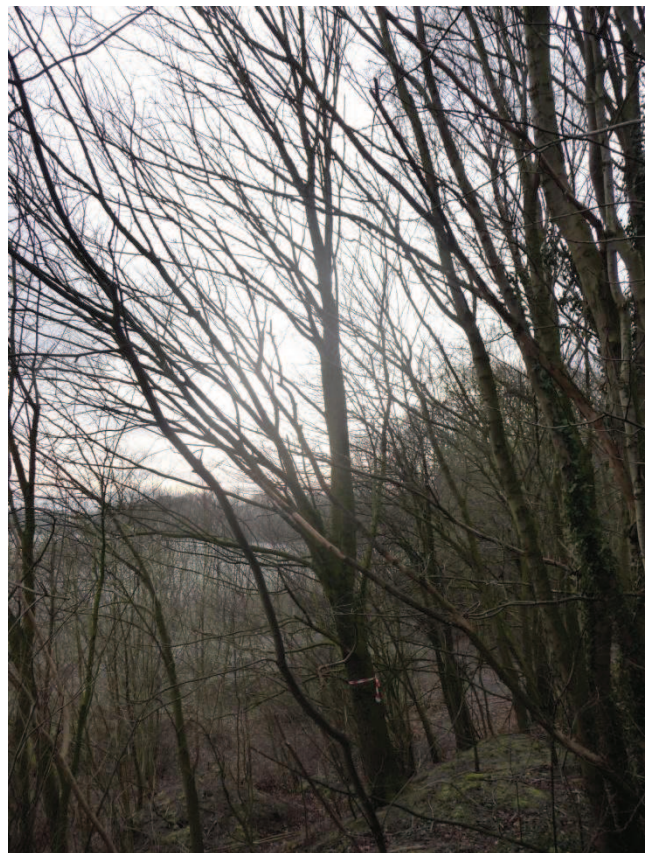
**Photo 4.** One of the young-mature Wych Elms recorded during the survey. No signs of Dutch Elm Disease were observed on the site.

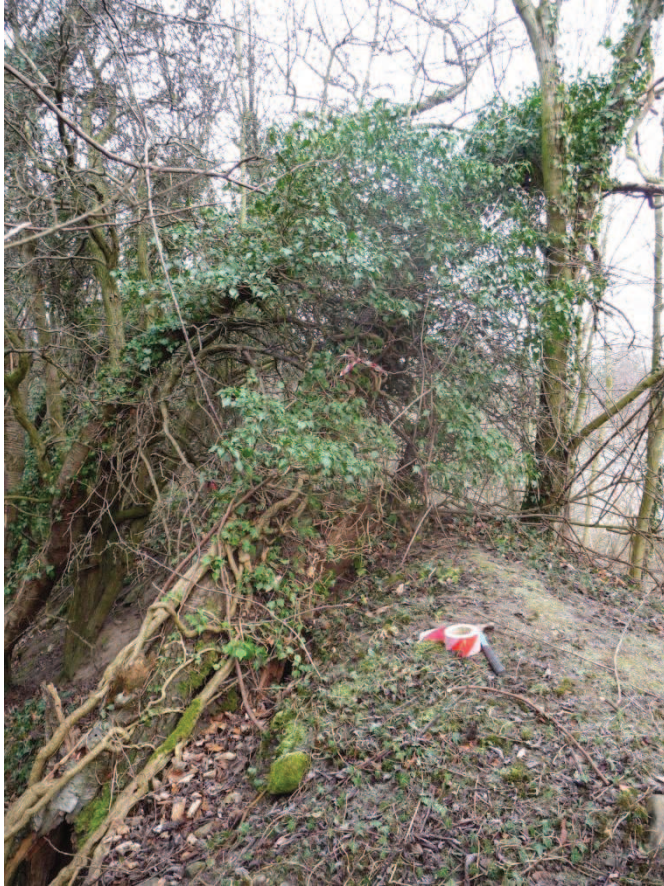
- 4.2.4 Four trees (#1435, #1436, #1438 & #1441) are judged to be structurally unsafe and their removal is recommended (Category R).

| Tree no. | Species | Height (m) | Stem Ø (cm) | RPA radius (m) | Crown spread (m) | | | | Crown clearance (m) | Age class | Physiological condition | Structural condition | Remaining contribution (yrs) | Quality Grade |
|---|---|---|---|---|---|---|---|---|---|---|---|---|---|---|
| 1435 | <i>Prunus avium</i> | 8 | 35 | 4.20 | 1 | 14 | 1 | 0 | 0 | Dead | Dead | Poor – collapsed & lodged | 10-20 | R |

**Photo 5.** Tree #1435 (a Wild Cherry) is dead and has fallen and lodged in the adjacent trees to the east.

- 5.3.1 All tree work should be carried out to BS3998 by appropriately qualified personnel.
- 5.3.2 Trees #1435, #1436, #1438, #1441, #1442, #1448, #1449, #1451 and #1452 should be felled. In order to retain some wildlife conservation value, the wood should be left in large sections, and placed in the adjacent woodland. The brash can also be stacked nearby.

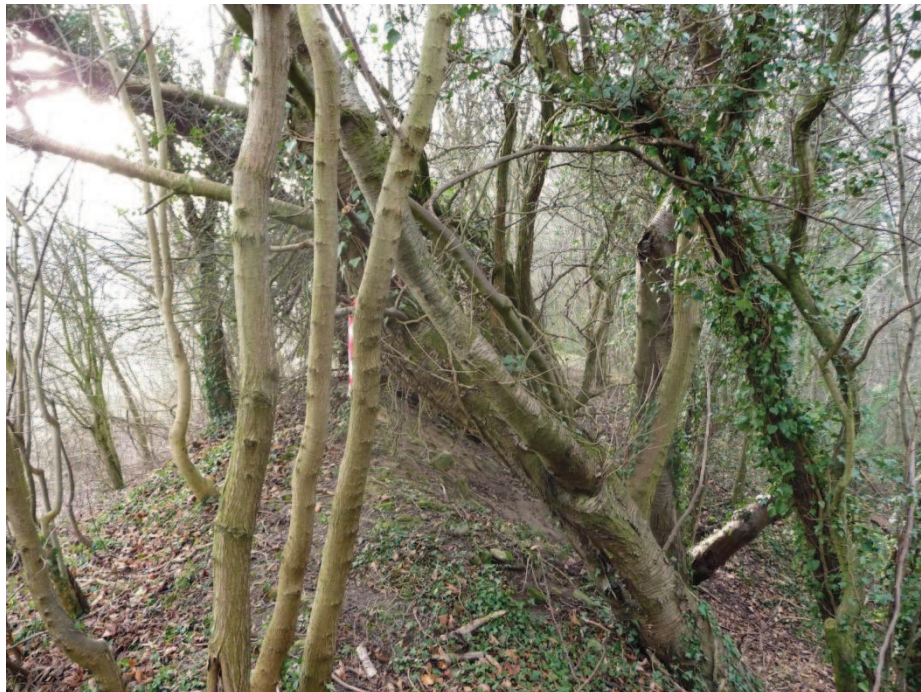
| Tree no. | Species | Height (m) | Stem Ø (cm) | RPA radius (m) | Crown spread (m) | | | | Crown clearance (m) | Age class | Physiological condition | Structural condition | Remaining contribution (yrs) | Quality Grade |
|---|---|---|---|---|---|---|---|---|---|---|---|---|---|---|
| 1436 | <i>Prunus avium</i> | 12 | 36 | 4.32 | 4 | 12 | 2 | 0 | 1 | Mature | Fair – suppressed by shade | Poor – partially collapsed & lodged | 10-20 | R |

**Photo 6.** Tree #1436 (a Wild Cherry) has also fallen and lodged in the surrounding trees, but is still alive.

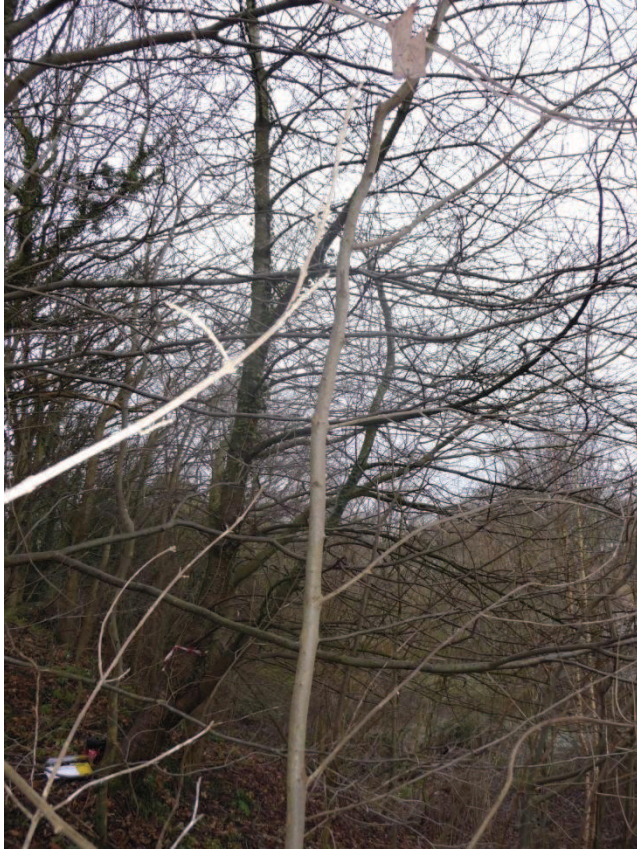
**Photo 7.** Tree #1437 (a Wild Cherry) with poor balance, and possible movement on its root plate.

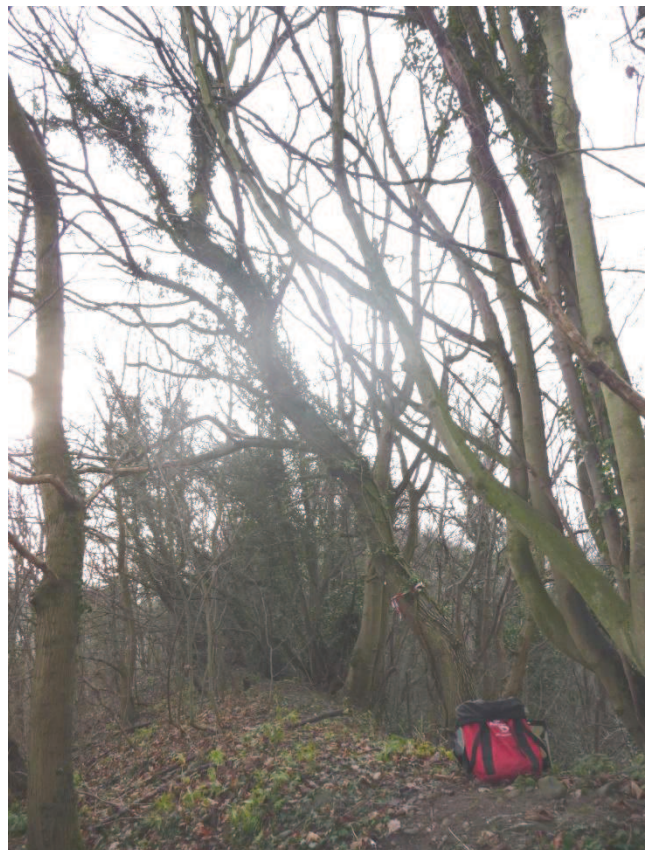
| Tree no. | Species | Height (m) | Stem Ø (cm) | RPA radius (m) | Crown spread (m) | | | | Crown clearance (m) | Age class | Physiological condition | Structural condition | Remaining contribution (yrs) | Quality Grade |
|---|---|---|---|---|---|---|---|---|---|---|---|---|---|---|
| 1439 | <i>Quercus robur</i> | 15 | 39 | 4.68 | 4 | 11 | 4 | 2 | 3 | Mature | Good – minor deadwood | Fair – poor balance, minor deadwood | >40 | C |

**Photo 8.** Tree #1439 (a Pedunculate Oak) with poor balance. Due to its relatively deep-rooting habit, this tree is more likely to stay upright than the Wild Cherries.

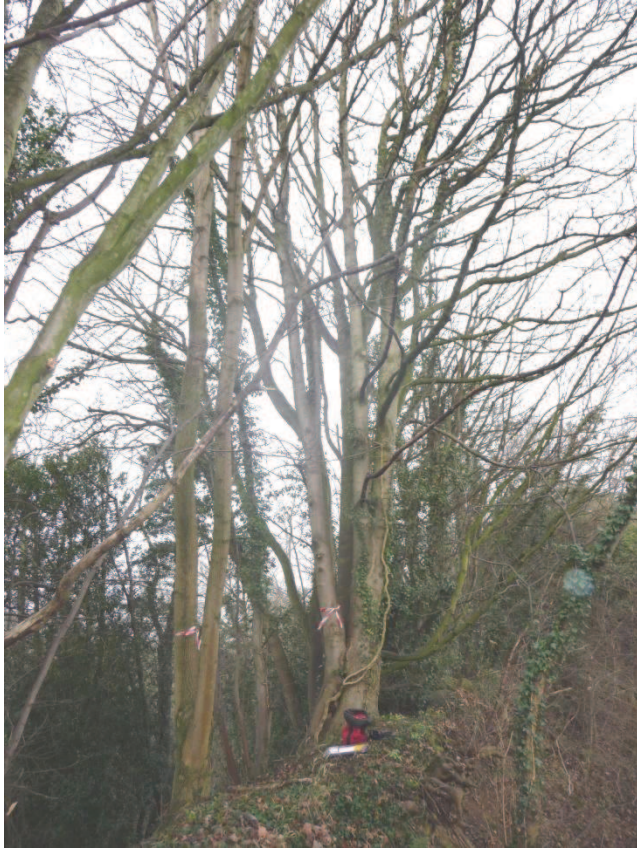
**Photo 9.** Trees #1440 and #1441 (an Ash and a Sycamore) on the top of the ridge (Wat's Dyke).

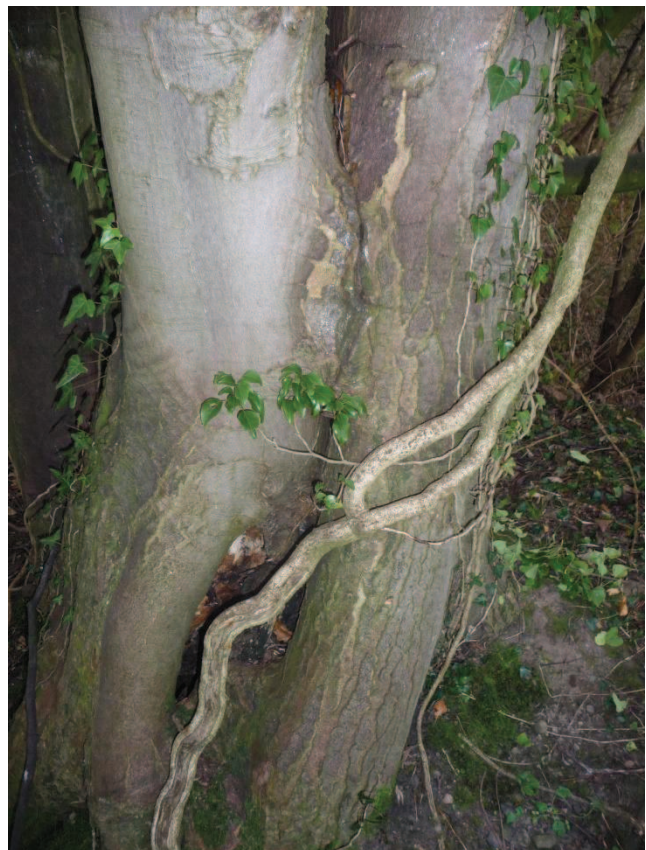
| Tree no. | Species | Height (m) | Stem Ø (cm) | RPA radius (m) | Crown spread (m) | | | | Crown clearance (m) | Age class | Physiological condition | Structural condition | Remaining contribution (yrs) | Quality Grade |
|---|---|---|---|---|---|---|---|---|---|---|---|---|---|---|
| 1441 | <i>Acer pseudoplatanus</i> | 17 | 104M | 10.40 | 6 | 8 | 6 | 7 | 1 | Mature | Good | Fair -exposed decay pocket at base, tight forks with included bark, wire included, root plate undercut | <10 | R |

**Photo 10.** An exposed pocket of decay and a tight fork with included bark at the base of tree #1441.

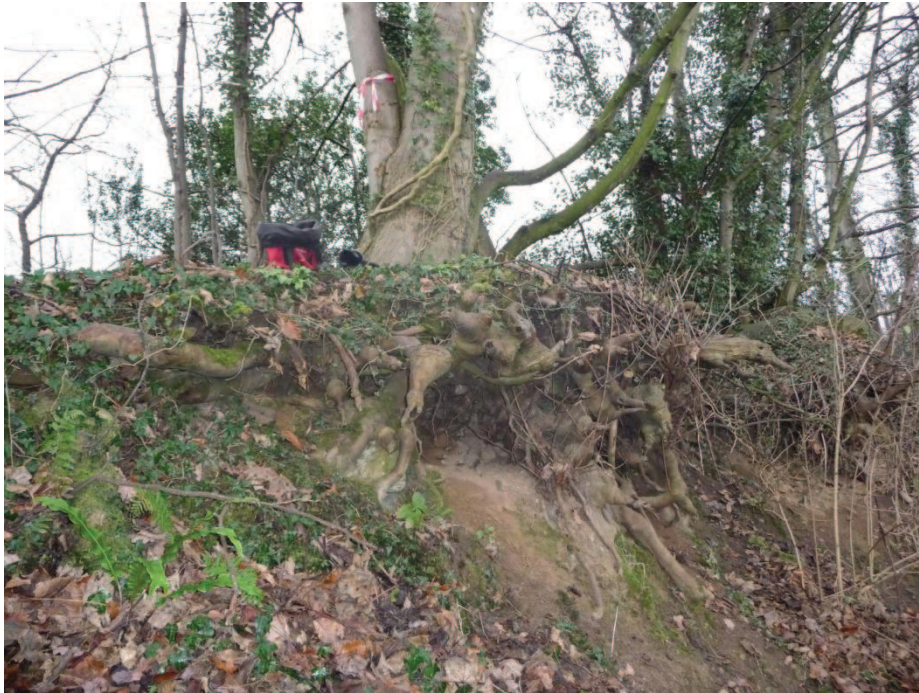
**Photo 11.** Erosion along the original quarry excavation line has seriously undercut the root plate of this Sycamore (tree #1441), earning it a recommendation for removal.

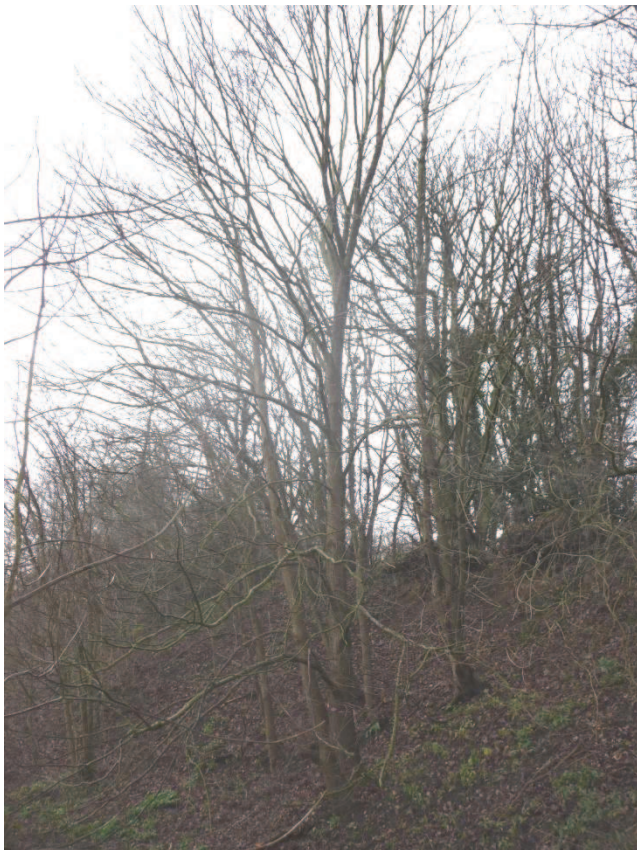
**Photo 12.** Tree #1442 (a Wych Elm) is within the proposed construction zone, and will need to be felled.

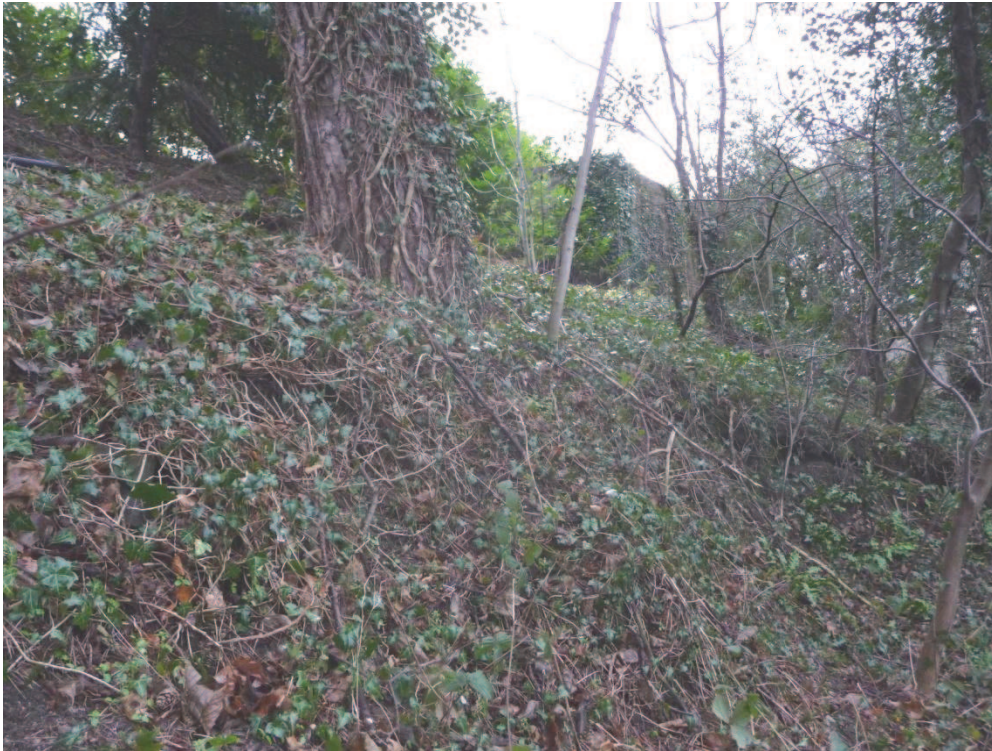
| Tree no. | Species | Height (m) | Stem Ø (cm) | RPA radius (m) | Crown spread (m) | | | | Crown clearance (m) | Age class | Physiological condition | Structural condition | Remaining contribution (yrs) | Quality Grade |
|---|---|---|---|---|---|---|---|---|---|---|---|---|---|---|
| 1444 | <i>Pinus sylvestris</i> | 18 | 60 | 7.20 | 3 | 6 | 4 | 3 | 6 | Mature | Good – minor deadwood | Poor – root plate undercut by excavation to west, poor balance, minor deadwood | 10-20 | A2/B2 |

**Photo 13.** Part of the root plate of tree #1444 (a Scots Pine) has been excavated, leading to potential structural instability.

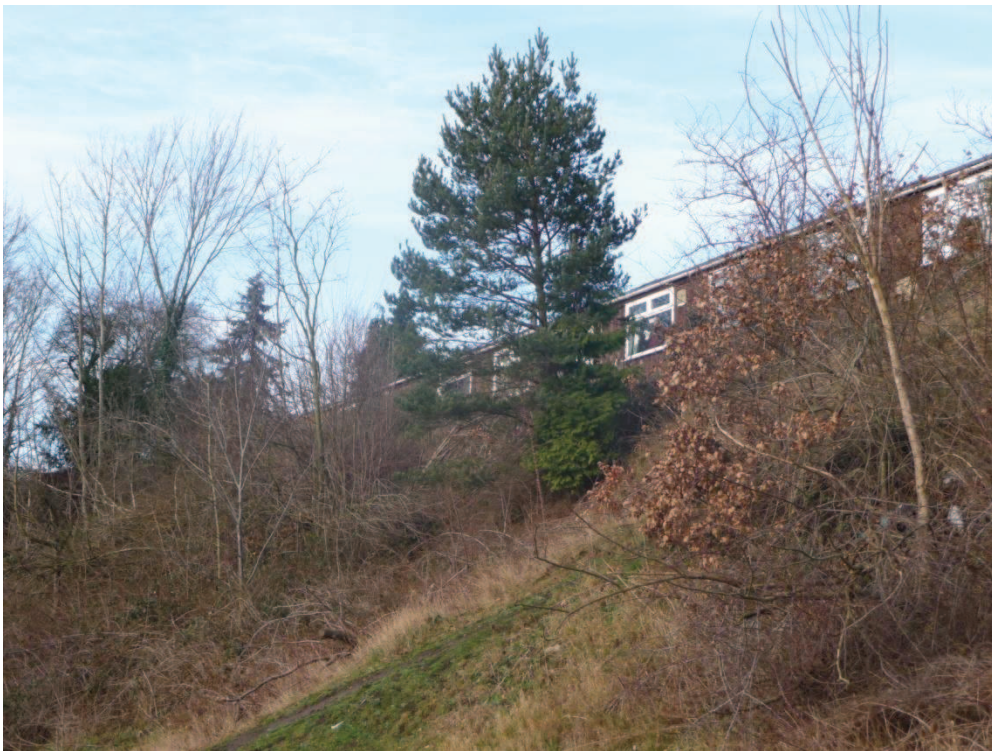
**Photo 14.** A young self-sown Scots Pine (tree #1450) established on the south-facing bank at the north end of the site.

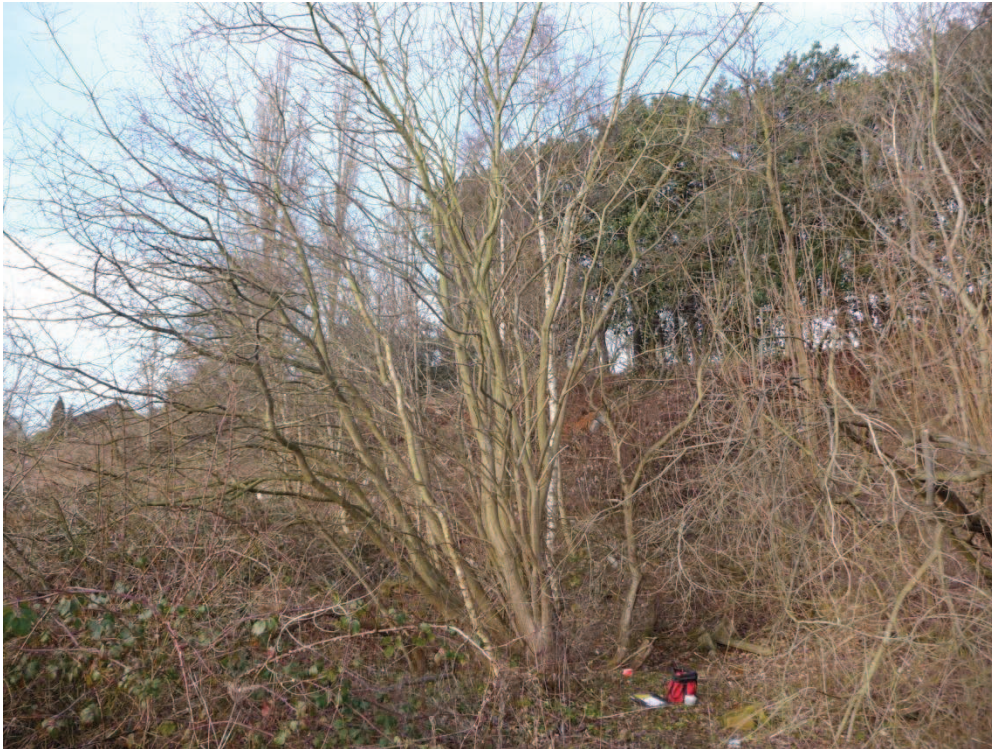
| Tree no. | Species | Height (m) | Stem Ø (cm) | RPA radius (m) | Crown spread (m) | | | | Crown clearance (m) | Age class | Physiological condition | Structural condition | Remaining contribution (yrs) | Quality Grade |
|---|---|---|---|---|---|---|---|---|---|---|---|---|---|---|
| 1451 | <i>Salix caprea</i> | 9 | 160M | 16.00 | 3 | 7 | 7 | 6 | 0 | Mature | Good | Fair – partially collapsed stem | 20-40 | C |

**Photo 15.** A wide-spreading Goat Willow (tree #1451) that is within the construction zone.

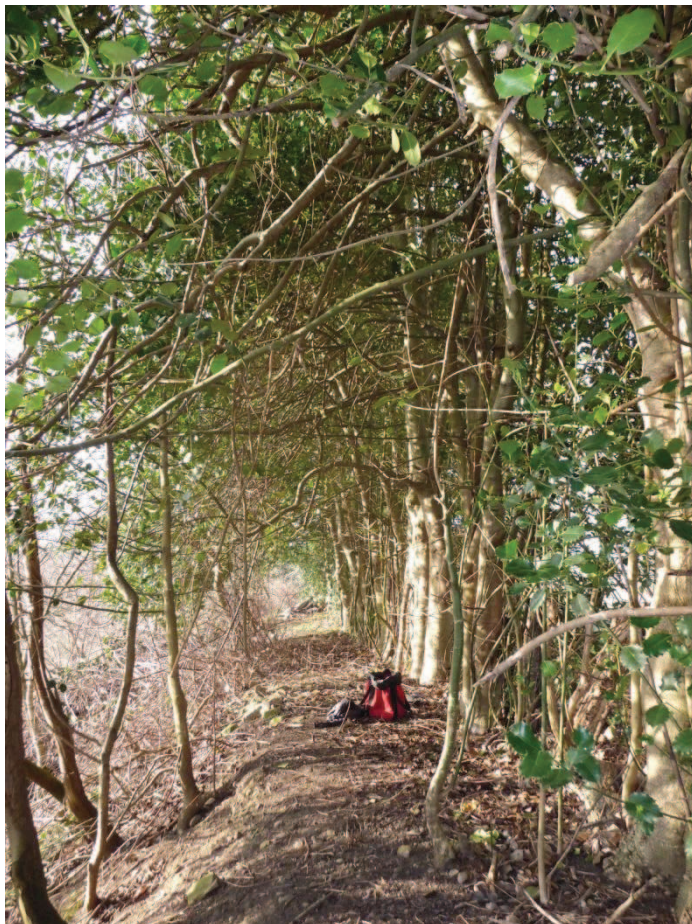
- 3.1.5 Approximately half of the trees in the line of Holly trees adjacent to (outside) part of the northern boundary have been pruned, i.e., topped at about three metres and delimbed, and are currently re-sprouting vigorously.

| Tree no. | Species | Height (m) | Stem Ø (cm) | RPA radius (m) | Crown spread (m) | | | | Crown clearance (m) | Age class | Physiological condition | Structural condition | Remaining contribution (yrs) | Quality Grade |
|---|---|---|---|---|---|---|---|---|---|---|---|---|---|---|
| - | <i>Ilex aquifolium</i> hedge | ≤9 | ≤25 | 2.50 | 4 | 1 | 4 | 4 | 0 | Mature | Good | Good – the trees in the western half of this hedge have been topped @ 3m and side branches have been removed | >40 | C |

**Photo 16.** The line of Hollies along part of the northern boundary of the site.
