## Report on Arboricultural Issues

### Wrexham Football Club Training Ground

April 2010

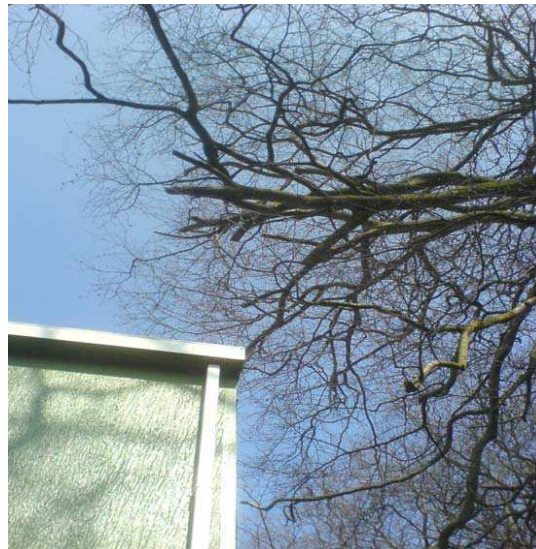
- 3.3 As can be seen from Photograph 1, ‘access facilitation pruning’ has been carried out on T1 (see also appended plan and tables) in order to allow the installation of the two storey portacabin structure beneath the edge of its canopy. The term ‘access facilitation pruning’ implies that the tree works have been carried out in accordance with current industry standards, i.e. the specifications contained within BS3998: 1989 *Tree Work*. However, from observations on site and as can be seen on Photograph 1 this is clearly not the case. The pruning of the crown of T1 has been carried out in a rather crude manner by persons unknown at this stage. Whilst it is regrettable that this work was not carried out to current best practice, it is easily rectifiable by some minor judicious pruning, the overall impact of which will not detract from the visual amenity value that the tree provides.

**Photograph 1 – T1 showing top of two storey portacabin structure and ‘access facilitation pruning’**

- 3.4 The portacabins are clearly located within the canopy spread and Root Protection Area (RPA) of the large Beech tree T1. The cabins have however been installed on stilts / feet resulting in very little, if any physical impact on the root system of T1. There have been no excavations or ground works involved in the installation of the cabins and whilst the footprint of the cabins does slightly reduce the amount of permeable surface area available to the roots of T1, there is a clear gap beneath the cabins, therefore it is only likely to be the dynamics of water percolation that has been slightly altered. We do not consider therefore that the positioning of the portacabins will have any significant or long-term detrimental effect upon the adjacent vegetation.

| T. No | Species | Ht (m) | Stem DBH (mm) | RPA/Radius Max offset | Branch Spread | | | | Ht Crown Clearance (m) | Age Class | P Condition | Structural Condition | Preliminary Recommendations | Est. (yrs) | Cat Grade |
|---|---|---|---|---|---|---|---|---|---|---|---|---|---|---|---|
| T1 | Beech | 15 | 700 | 221.67 | 7 | 8 | 7 | 7 | 10 | FM | F | Large mature tree situated on neighbouring land adjacent boundary. DBH is an estimate. Dense ivy on lower stem. Lower crown to north has been crudely pruned to allow installation of portacabins. No inspection of base of tree made as on neighbouring land. | Carry out corrective remedial pruning to remove stubs back to suitable unions in accordance with BS3998: 1989 Tree work | 20 | B1 |

- 4.1 It is concluded that the recent activities that have taken place at Colliers Park will have had very little detrimental impact upon mature tree cover at the site. There has been some minor damage caused to T1 through poor pruning of the canopy to facilitate the installation of the portacabins in this area, however this damage is easily rectifiable with some remedial pruning in accordance with BS3998: 1989 *Recommendations for Tree Works*. T1 is afforded statutory protection by TPO DT5 and as such Wrexham County Borough Council should advise whether the granting of a retrospective planning consent for the 'development' works would be acceptable under which to carry out this work, or whether a separate application under the Tree Preservation Order should be made.

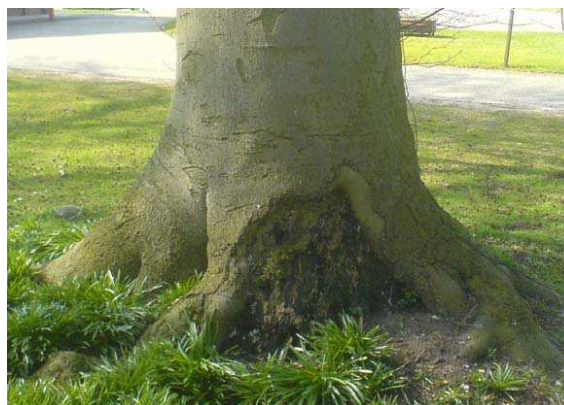
- 3.6 Trees T2 & T3, as can be seen on Photographs 2 & 3 below have large wounds at the base of the stems and are infected by *Kretzschmaria deusta*. This pathogen produces a heart rot which can leave the decayed wood in a brittle condition. Such a decay type can cause failure of the tree with little or no warning. Added to this T3 has a large section of deadwood where it appears that a leader has failed and which has resulted in a decay column extending down a large portion of the upper main stem (see Photograph 4 below). Both trees are situated very close to a driveway/footpath which is used frequently as an informal parking area on training days. Due to the age, species, location, condition, presence of the pathogen and potential 'targets', these trees are in our opinion hazardous in their current context and as such remedial action should be sought without delay to reduce the associated risk to users of the site.

**Photograph 2 – T2 with basal wound and pronounced *Kretzschmaria deusta* infection**

| T. No | Species | Ht (m) | Stem DBH (mm) | RPA/Radius Max offset | Branch Spread | | | | Ht Crown Clearance (m) | Age Class | P Condition | Structural Condition | Preliminary Recommendations | Est. (yrs) | Cat Grade |
|---|---|---|---|---|---|---|---|---|---|---|---|---|---|---|---|
| T2 | Beech | 16 | 720 | 234.518635 | 8 | 6 | 8 | 7 | 6 | FM | P | Large mature tree with large basal wound and pronounced Kretzschmaria deusta infection. Given the use of the site we would consider this tree poses an unacceptable level of risk | Fell to ground level & replace as appropriate | 10 | R |

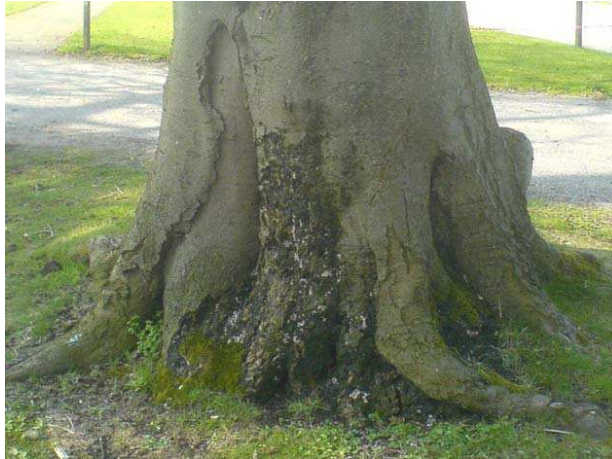
Photograph 3 – T3 with basal wound and pronounced *Kretzschmaria deusta* infection

| T. No | Species | Ht (m) | Stem DBH (mm) | RPA/Radius Max offset | Branch Spread | | | | Ht Crown Clearance (m) | Age Class | P Condition | Structural Condition | Preliminary Recommendations | Est. (yrs) | Cat Grade |
|---|---|---|---|---|---|---|---|---|---|---|---|---|---|---|---|
| T3 | Beech | 14 | 690 | 215.3825658 | 8 | 5 | 5 | 7 | 10 | FM | P | Large mature tree with large basal wound and pronounced Kretzschmaria deusta infection. Large section of deadwood at point of failed leader with cavity and possible decay. Given the use of the site we would consider this tree poses an unacceptable level of risk | Fell to ground level & replace as appropriate | 10 | R |

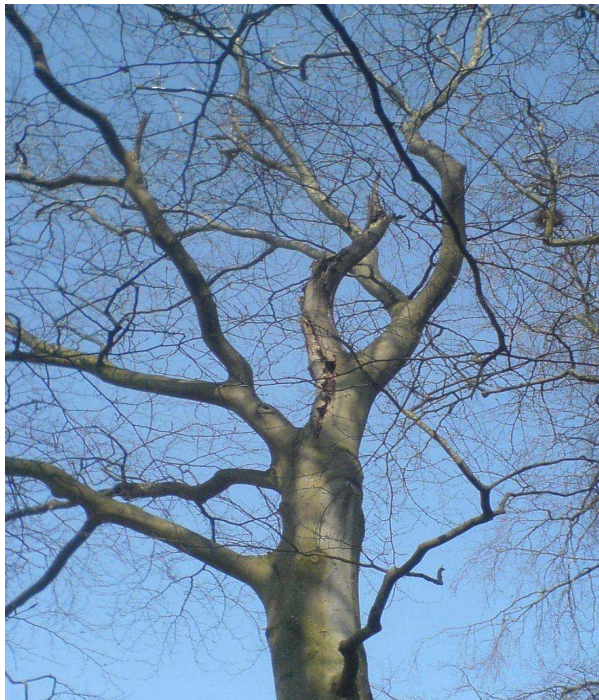
Photograph 4 – T3 showing failed leader with decay column

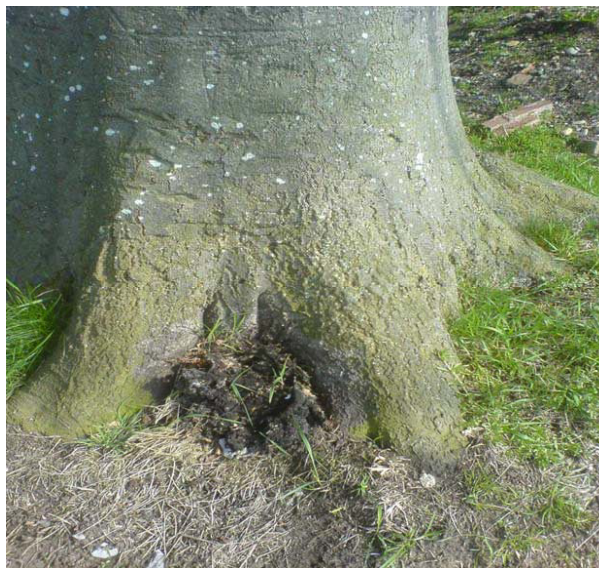
- 3.7 T4 is a mature beech tree located adjacent the access track to the tractor shed/ground maintenance area. At the time of survey two dried fungal fruiting bodies were observed in two different locations within the buttresses of the tree. After liaison with the Local Planning Authority Tree & Landscape Officer and our own inspection of the tree, it is considered that these fruiting bodies are those of the fungus *Meripilus giganteus*. The significance of the presence of this fungus is that due to the impact and likely decay present within the root system, it is likely that a high chance of windthrow exists. We therefore consider that this tree poses an unacceptable level of risk to users of the site and that the tree should be removed as a priority.

Photograph 5 – T4 with *Meripilus giganteus* bracket at base

| T. No | Species | Ht (m) | Stem DBH (mm) | RPA/Radius Max offset | Branch Spread | | | | Ht Crown Clearance (m) | Age Class | P Condition | Structural Condition | Preliminary Recommendations | Est. (yrs) | Cat Grade |
|---|---|---|---|---|---|---|---|---|---|---|---|---|---|---|---|
| T4 | Beech | 16 | 700 | 221.6707776 | 6 | 7 | 6 | 5 | 4 | FM | P | Large mature tree with dried fungal brackets at two different locations within buttresses, possibly Meripilus. Given the use of the site we would consider this tree poses an unacceptable level of risk | Fell to ground level & replace as appropriate | 10 | R |

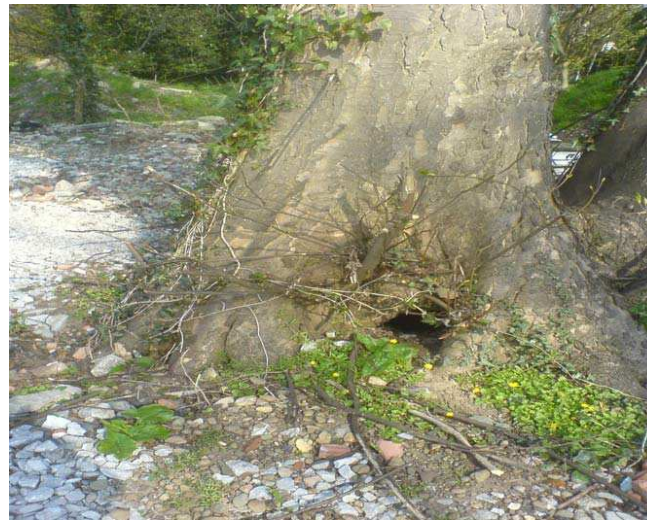
- 3.9 Following on from the above, it is also our opinion that the surfacing of the informal car park area with limestone hardcore/rubble, although not ideal, will provide some level of protection for the roots of the adjacent mature trees, particularly in view of the very low frequency of traffic that uses the access track and parking/turning area. It is accepted that the surfacing could have been laid in a more sympathetic manner by keeping it away from the base of T6, however, as can be seen from Photograph 6 below, T6 was already in a relatively poor condition with a hollow/cavity present at the base of the tree. The relatively hardy nature of the species of the tree and the lack of evidence of root damage suggest that T6 will not necessarily be adversely affected by the porous surfacing applied in its vicinity. We understand that the parking/turning area was constructed after strimming the grass in the area, scraping the surface to achieve something approximating a level surface and then applying the hardcore. It appears that there has been no substantial re-grading of levels in the area or excavations in construction of the parking/turning area. This is evident by the fact that the area when visited remains slightly uneven and is far from being a perfectly flat car park.

**Photograph 6 – T6 showing basal cavity/hollow and new surface around the tree**

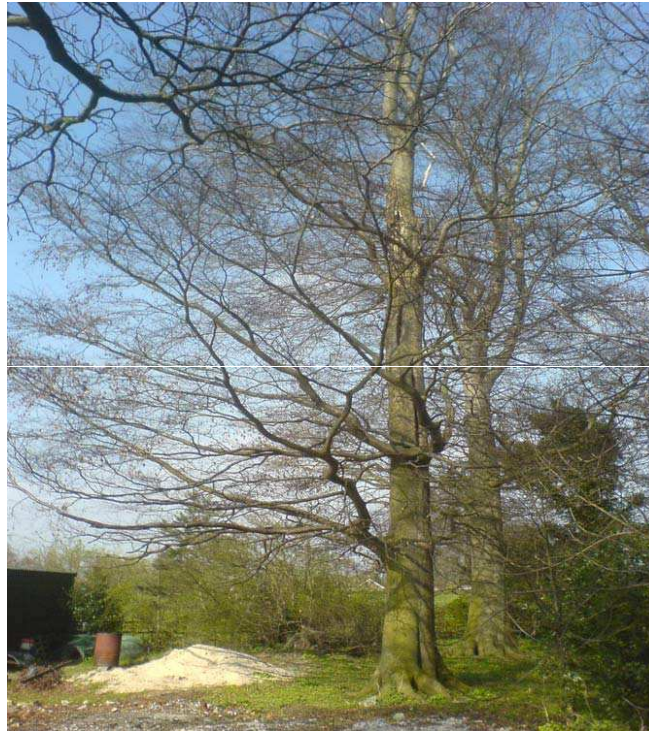
- 3.11 T7 is a mature beech tree which has a severely impaired physiological and structural condition as can be seen on Photograph 7 below. The tree has a decay column which extends almost the entire height of the main stem of the tree. There are also numerous cavities apparent at various heights on the stem. Although a closer inspection of the cavities was not possible at the time of survey, there appears to be significant decay within cavities. The presence of deadwood and decay together with the physical characteristics of the tree indicate that the decay column extends the height of the stem of the tree. On this basis we consider that this tree represents an unacceptable level of risk to users of the site and that action should be taken to reduce such risk either by complete removal of the tree or reduction back to a 'habitat stick' to be left as standing deadwood.

**Photograph 7 – T7 showing cavities on stem and possible decay column**

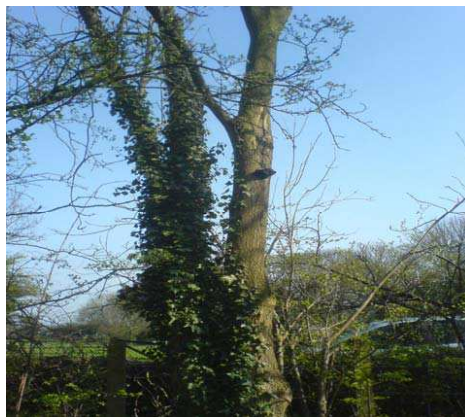
- 3.12 Tree T8 is a semi-mature ash tree which has an occluded scar and fungal bracket on the main stem. The bracket is considered to be the fruiting body of *Inonotus hispidus*. As the tree is located adjacent the boundary of the site with the B5445 Chester Road South, there is the potential for partial tree failure onto the road. Wrexham Football Club has a duty of care to ensure that trees on its property do not present a danger to users of the public highway. As such this tree represents an unacceptable risk to users of the highway and should be removed as a priority.

**Photograph 8 – T8 displaying occluded scar and fungal bracket**

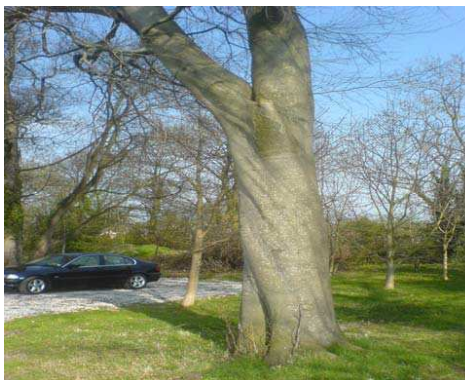
- 3.13 T5 is a mature beech tree that has a large weak /suspect union between the main stem and a large scaffold limb as shown on Photograph 9. This union is a potential failure point on the tree therefore consideration should be given to reduction of the potential impact should the union fail. A short term recommendation would be the reduction / thinning of the canopy on the scaffold limb to reduce the weight on the union. Further inspections would be beneficial to allow future works to be programmed.

**Photograph 9 – T5 with weak union between main stem and large scaffold limb**

| T. No | Species | Ht (m) | Stem DBH (mm) | RPA/Radius Max offset | Branch Spread | | | | Ht Crown Clearance (m) | Age Class | P Condition | Structural Condition | Preliminary Recommendations | Est. (yrs) | Cat Grade |
|---|---|---|---|---|---|---|---|---|---|---|---|---|---|---|---|
| T5 | Beech | 15 | 670 | 203.0775757 | 7 | 4 | 5 | 5 | 6 | FM | P | Large mature tree with heavy scaffold limb over access track/parking area with suspect included union between stem and limb. Tree is potentially unacceptable risk | Reduce weight on weak union by the reduction / thinning of the canopy structure on the scaffold | 15 | R |
