# Conversion of Outbuilding at Moss Bank Farm, Borras Head, Wrexham

## Structural Appraisal Report

February 2020

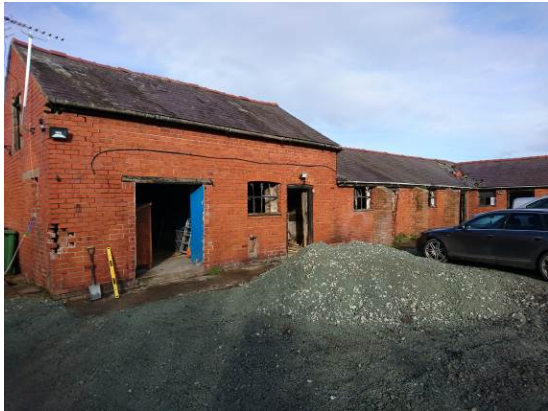
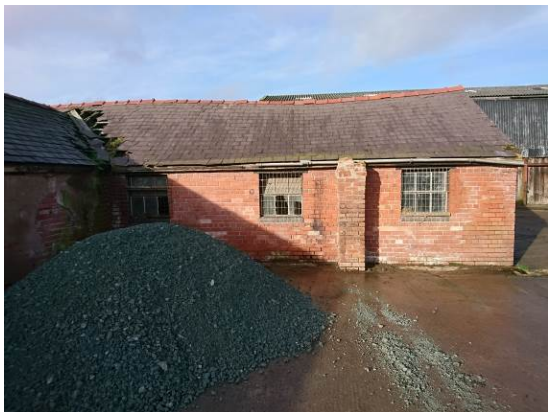
Photos 1 and 2 – Front Elevation (main leg).

The overall condition of the elevation is considered to be fair.

Cracking was apparent to the elevation in several locations. Diagonal bed joint cracking was noted extending from the openings on the two storey section. Cracking up to 10mm wide was apparent extending to eaves level from the left hand opening (see Photo 3). The majority of the movement appeared lateral with no significant vertical movement apparent. Diagonal cracking was noted extending from the door to room six. The arch over the opening has slipped and the brickwork above has been displaced outwards (see Photo 4). The cracking has been repointed in the past and the area appeared stable at the time of inspection. Missing brickwork was apparent at low and high levels adjacent to the left hand end. No damage was apparent to the adjoining areas. Significant impact damage is apparent to the reveal of the door into room two (see Photo 5). The damage appears to be fairly recent and has probably resulted from a vehicle impact. Vegetation was noted growing from the wall plate at the right hand end. The vegetation extends into the brickwork below and several dislodged units were noted (see Photo 6). It is apparent that the buttresses are later additions to try to stabilise the external wall. This would appear to have been partially successful. Eroded brick units were apparent at low level throughout and to an area at the right hand end of the elevation. Erosion of pointing up to 10mm depth is apparent throughout with areas up to 25mm depth apparent in isolated areas. The remainder of the pointing was noted as hard. The lintels to all of the openings have suffered deterioration and should be replaced.

The roof shows evidence of distortion between load bearing walls and the timber trusses – the defect is particularly prevalent at the left and right hand ends. This defect is indicative of roof spread caused by an undersizing of timber purlins and is not uncommon in outbuildings. Cracked, slipped and missing slates were noted to isolated areas throughout. A significant area of missing slated was apparent to the valleys at the intersection of the roof over the main and short legs. The guttering was generally intact, however several sections were missing along with all of the downpipes.

The elevation shows a general slight outwards lean with a significant outwards bulge (up to 2.5%) noted in the centre of the elevation. The apex to the short leg gable has a slight outwards lean. The elevation shows slight settlement at the intersection with the main and small legs.

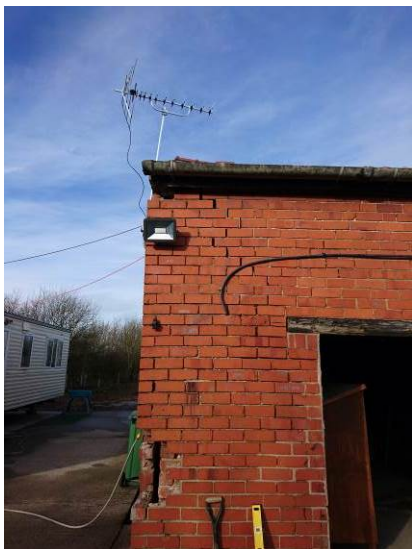
Photo 3 – Cracking above door opening.

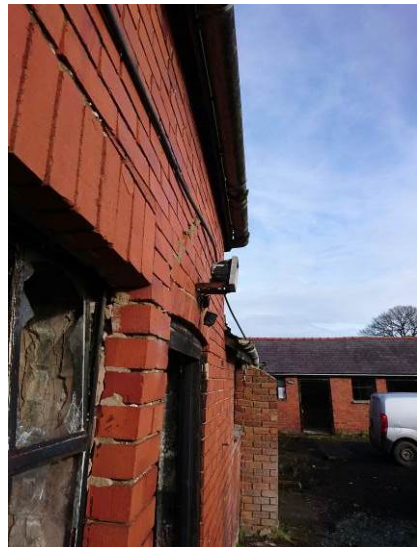
Photo 4 – Dislodged arch over opening and brickwork above.

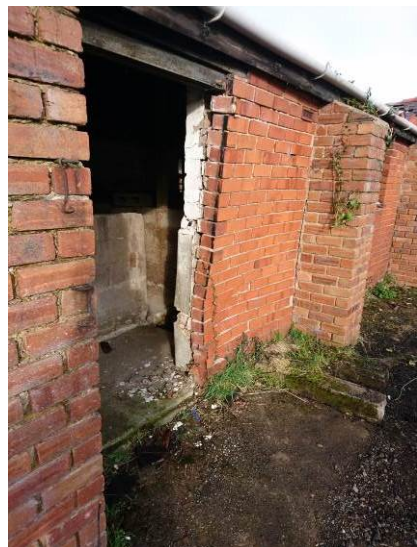
Photo 5 – Impact damage to elevation.

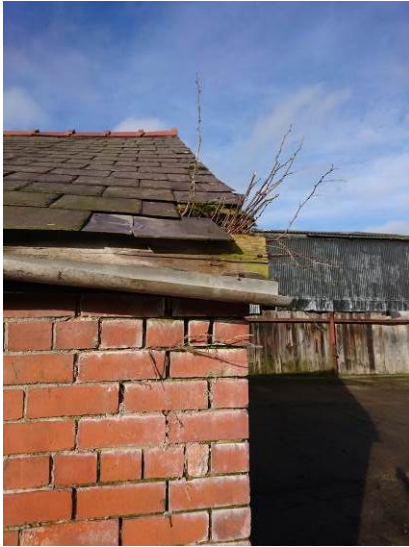
Photo 6 – Vegetation growing from wall plate.

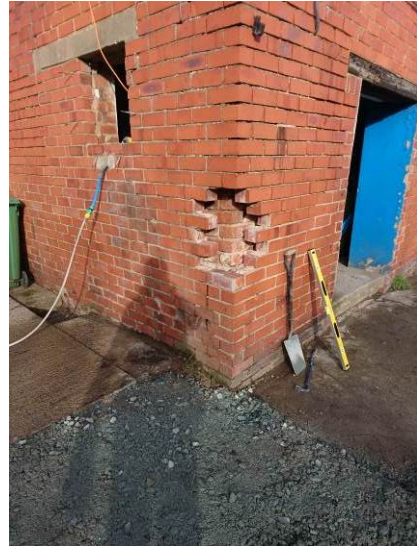
No significant cracking was apparent to the elevation. Missing brickwork was apparent at low and high levels on the two storey gable adjacent to the front elevation (see Photo 9). A small area of missing brickwork was also apparent above the window opening with several loose units noted locally. This is probably as a result of distortion to the timber lintel and is reflected internally. The lintel to room five has been dislodged along with the brickwork above. A small area of brickwork at low level adjacent to the door opening has been

Photos 9 – Missing brickwork at low level.

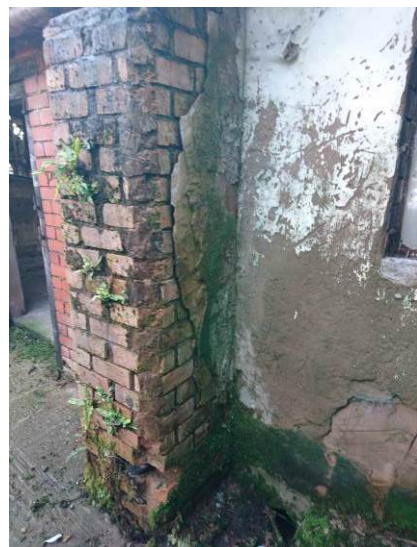
Photo 11 – Severe erosion to buttress.

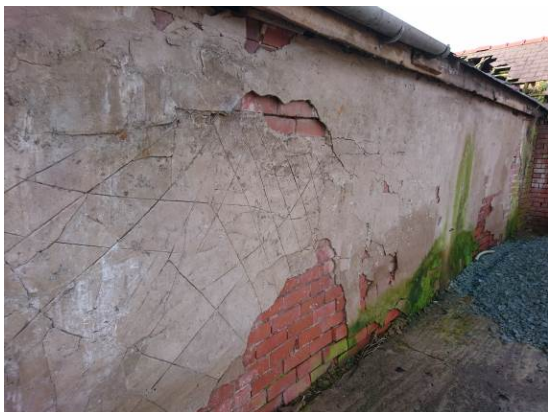
Photo 14 – Inwards bulge in wall.

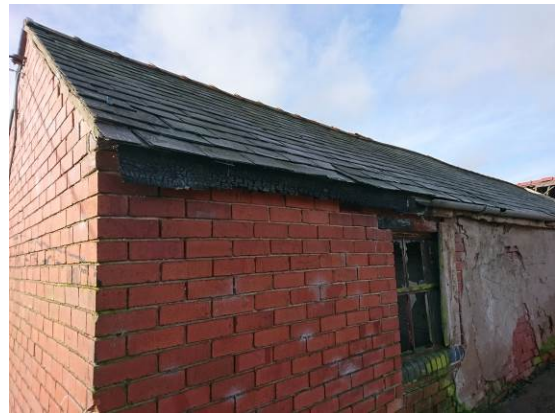
Photo 15 – Fire damage to fascia and lintel.

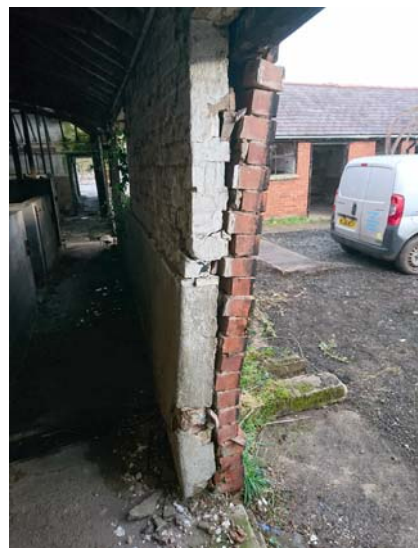
A severe inwards bulge is apparent adjacent to the door opening on the front elevation (see Photo 17). This would appear to have resulted from a vehicle impact – localised reconstruction will be required. Outwards bulges were apparent in centre of the front and rear elevations. This would appear to be attributable to roof spread and appeared longstanding. Cracking was noted to the front and rear elevations in the centre of the room. The cracking was noted as up to 10mm wide in both instances and all of the movement was noted as lateral (see Photo 18). This type of defect is indicative of restrained thermal movements rather than settlement of foundations. Staining and slight rot was apparent to the majority of the lintels, with those on the rear elevation particularly affected. This would appear to be due to blocked and missing guttering on the rear elevation.

Photo 17 – Impact damage to brickwork.

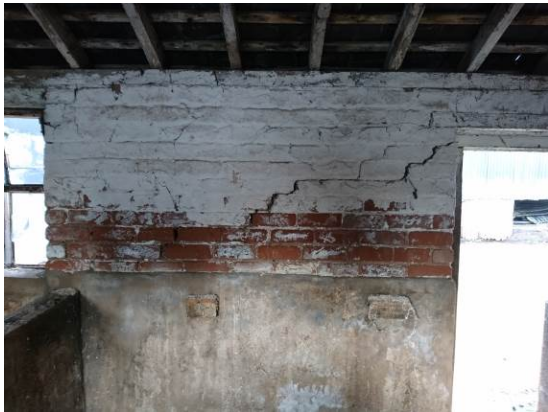
Photo 18 – Cracking to rear elevation.

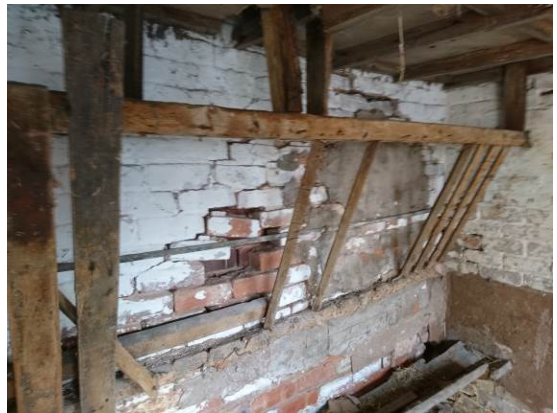
Photo 21 – Severe inwards bulge to wall.

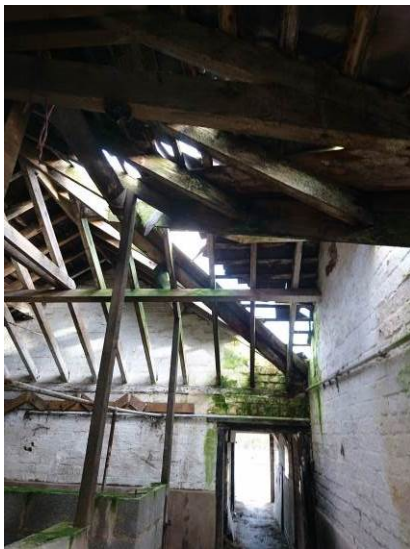
Photo 19 – Missing slates to roof.

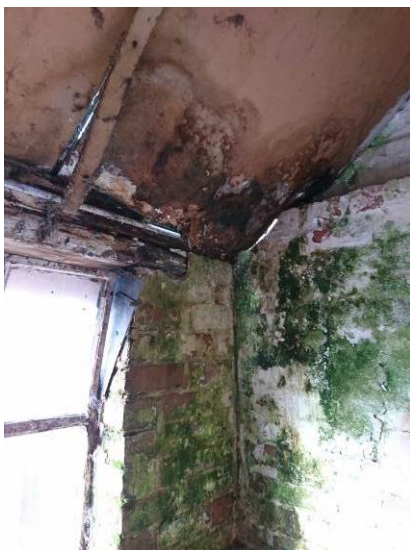
Photo 20 – Weather penetration below valley.

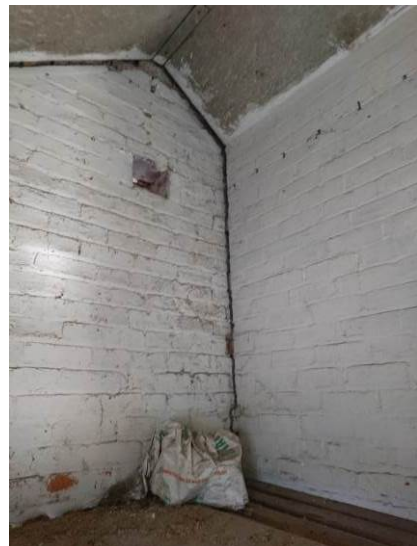
Photo 23 – Gap between internal  
and external walls.

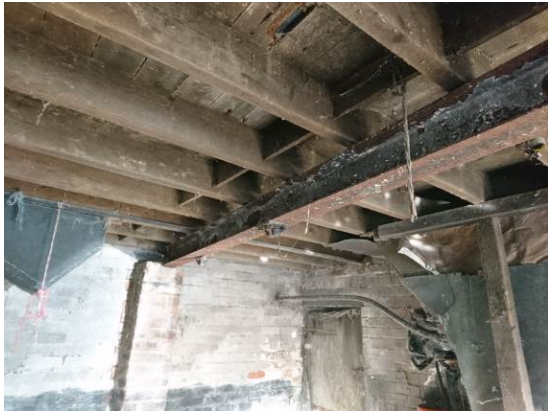
Photo 24 – General view of floor.

The first floor construction appeared to be in reasonably good condition (see Photo 24). No evidence of staining to timbers was apparent. Minor worm infestation is apparent though section losses are considered to be negligible. The steel beam shows evidence of surface corrosion, though negligible section losses were noted. The beam appears undersized for the loading imposed and the span.

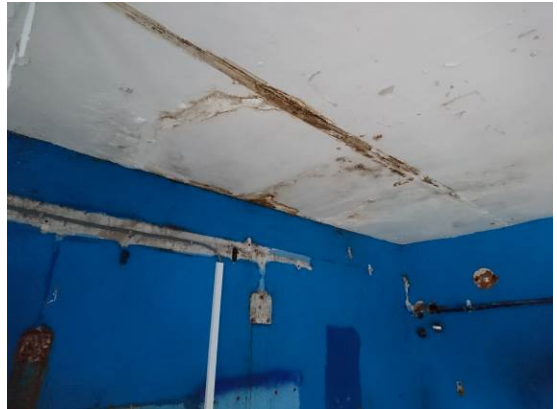
The first floor construction appeared to be in reasonably good condition. Staining was noted to the ceiling finishes adjacent to the gable elevation (see Photo 26). The staining is located below an open window above. The steel beam shows evidence of surface corrosion, though negligible section losses were noted.

Photo 26 – Staining to ceiling finishes.

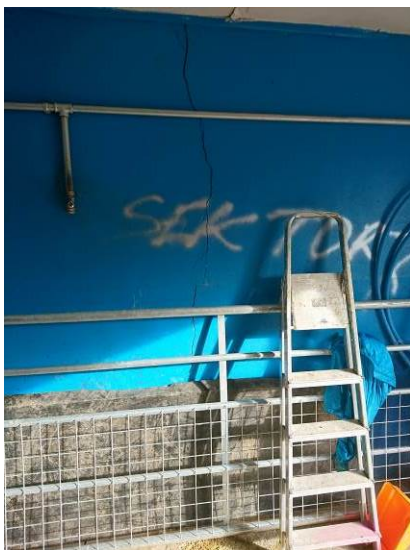
Vertical cracking was noted in the centre of the wall adjoining room six. The cracking was noted as up to 6mm wide at first floor level (see Photo 25). The cracking appeared to be longstanding with no evidence of recent movement apparent. The location is coincident with the cracking noted in room six and is indicative of a slight settlement at the front elevation.

Photo 25 – Cracking to internal wall.

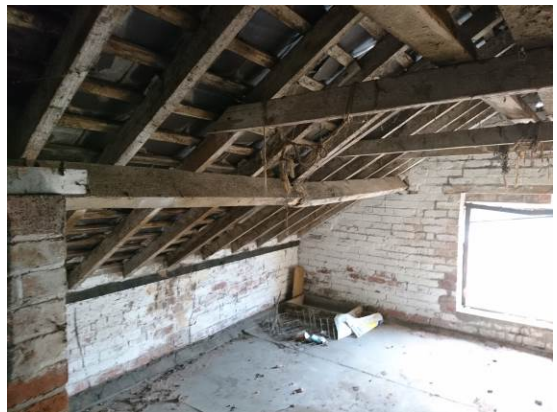
The roof purlins show evidence of significant distortion down the slopes of the roof. This is due to general undersizing of purlins. The purlin to the front slope of the roof has broken above both rooms six and seven (see Photo 27). Above room six, an additional purlin has been inserted and the area appeared stable. Above room seven, new ceiling ties have been installed. This would appear to have stabilised the area, however a new roof is warranted. Slight weather penetration was apparent through slated finishes particularly

Photo 27 – Broken purlin and  
additional ceiling ties.
