## Rock Slope Stability Assessment, Plas Power

Coed Cadw / Woodland Trust

Report Date –22<sup>nd</sup> July 2021  
Report Revision –Issue v.1

Report Title: Rock Stability Assessment

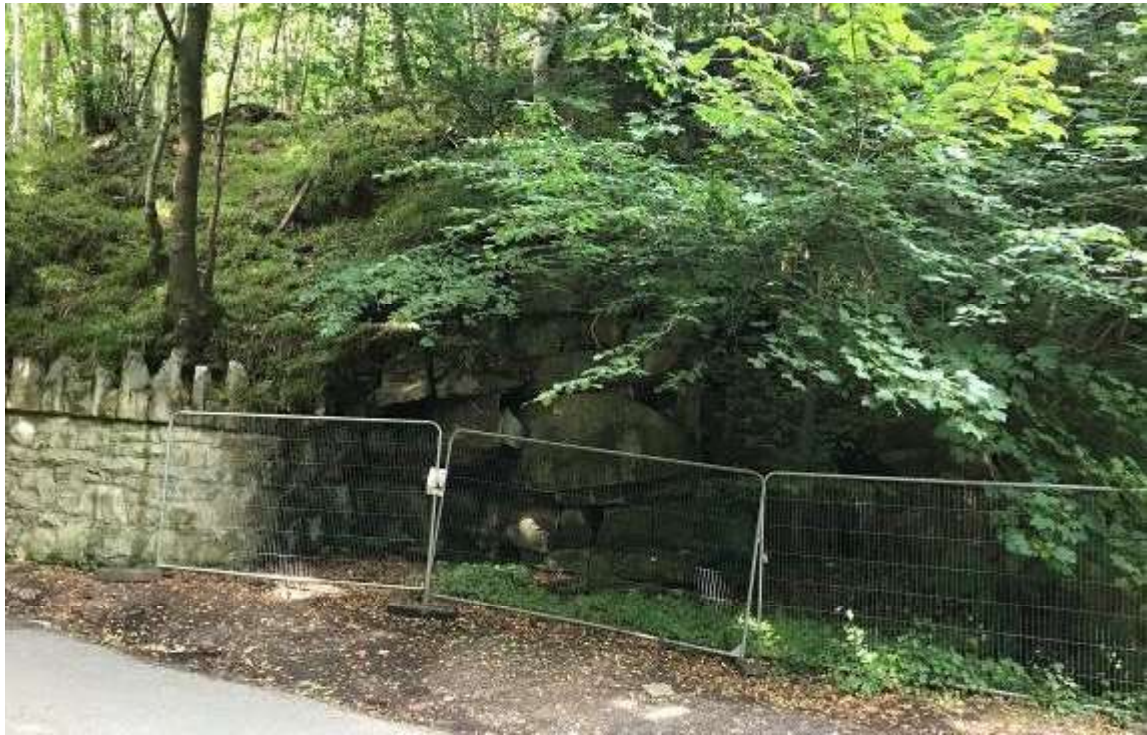
**Photo 1 – Area 1 General View**

This area has a rock face extending from a historic (listed) stone wall to the gate to the footpath, approx. 25m in length, see Photo 1. The section closest to the stone wall, approx. 6m long is positioned c. 3m from the verge, see Photo 2. The rock face is undulating generally with a steep (>60°) dip towards the road, though locally there are overhangs, unfavourable discontinuities and evidence of historical failure, see Photo 3.

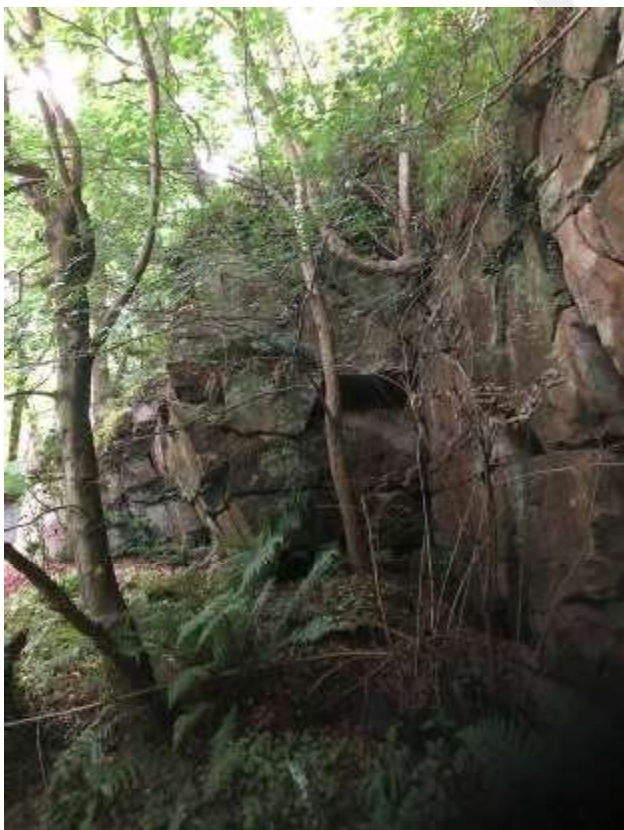
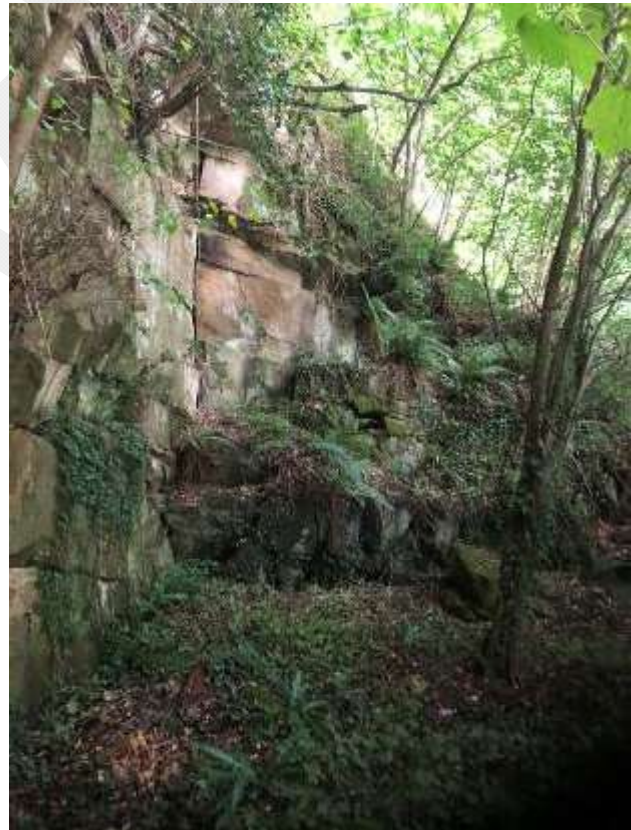
There is a risk of medium and large block instability due to root action and toppling due to the orientation of joints, see photo 2. The presence of large trees growing from the upper face can also lead to largescale failure as roots cause dilation of joint and the strong winds make the large trees act as levers.

**Photo 2** – 6m section closest to listed wall – unfavourable dip of fractures

- 6m section by 'listed' wall; lower slope – Coarse Granular berm to be constructed to support the lower face and overhang, adjacent to the road/footpath and along the return. The granular fill can be placed safely using an excavator and overlaid by site won topsoil and seedbank to allow natural localised vegetation to re-establish, see Figure 4 for details.

- 6m section by 'listed' wall; upper slope – once the berm has been placed works can safely be carried out using rope access or a MEWP to stabilise the potentially loose blocks with unfavourable discontinuity planes. Due to the large size of the blocks, this can be done using dowels, drilled perpendicular to the main release surfaces. This will allow installation without face plates, which makes the dowels practically invisible when the surface of the rock is infilled with coloured grout or a rock core is re-inserted, see Figure 4 for details.

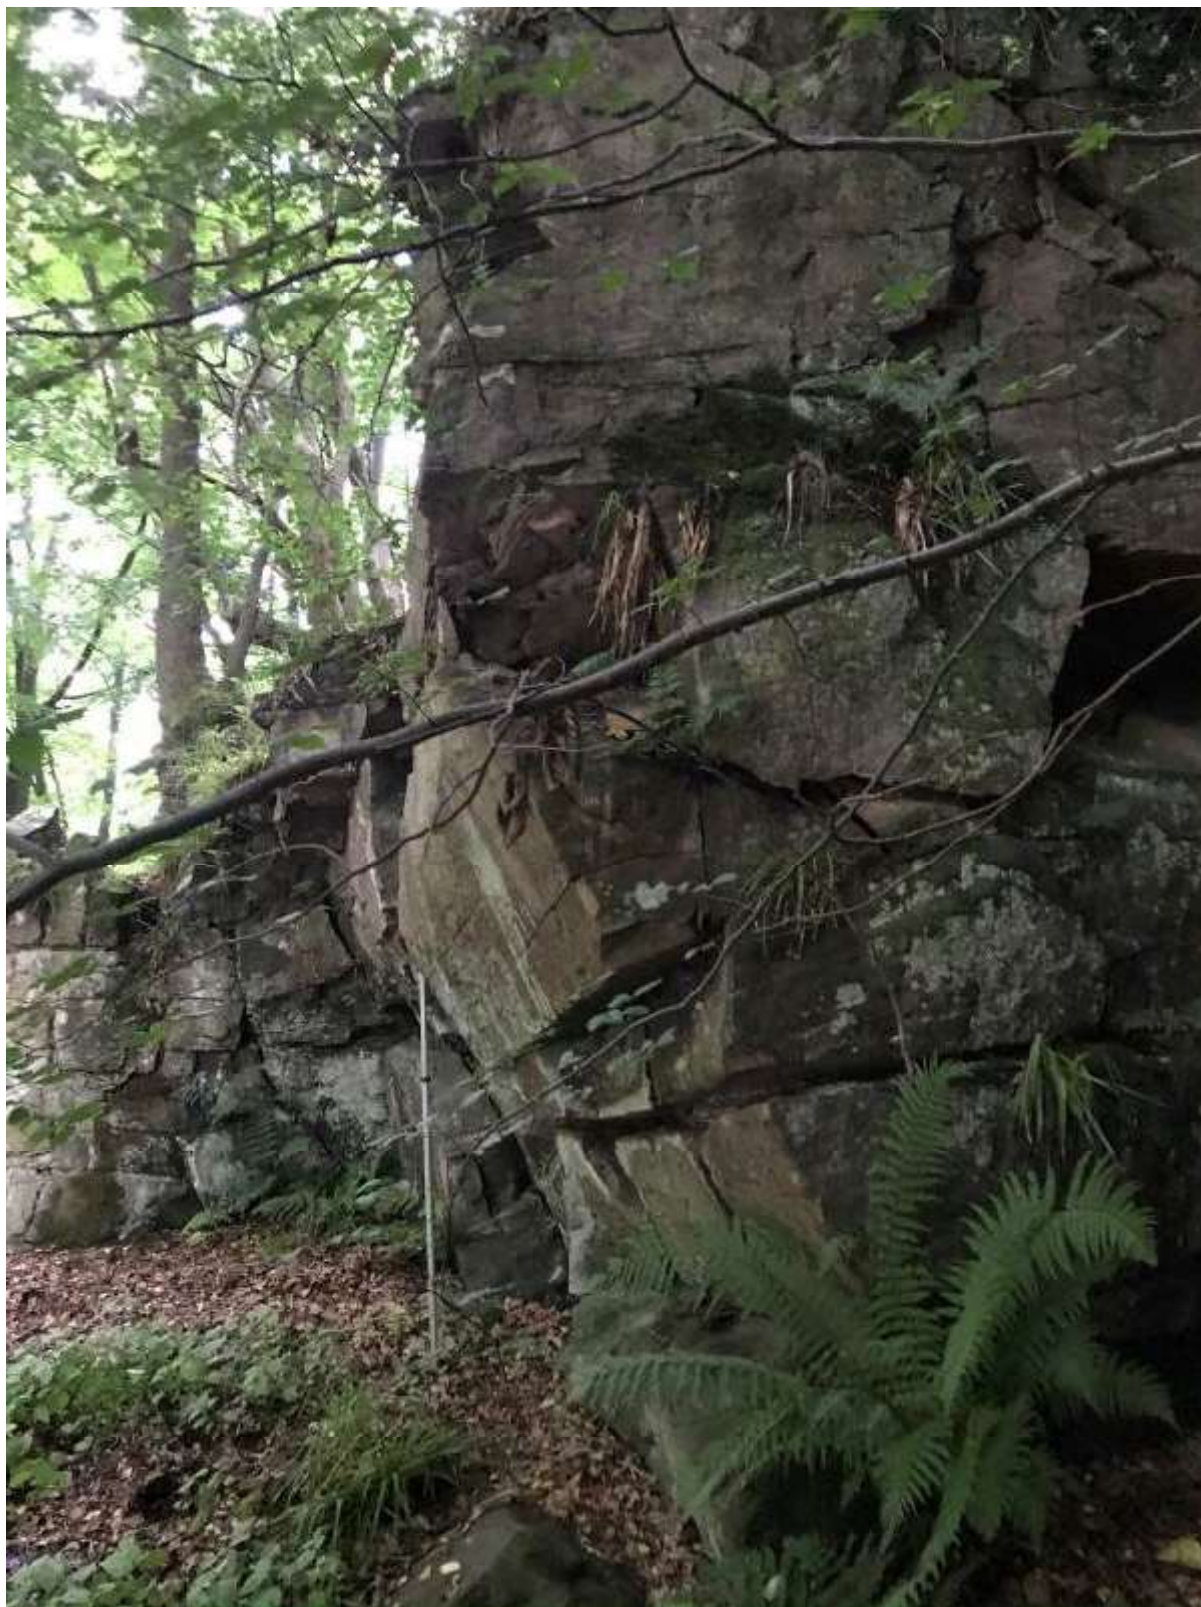
The joints are locally dilated on the face; predominantly caused by root penetration, see Photo 3. Differential/Accelerated weathering of weaker horizons results in local undermining of larger blocks.

**Photo 3** Area 1 – dilated joints and root penetration

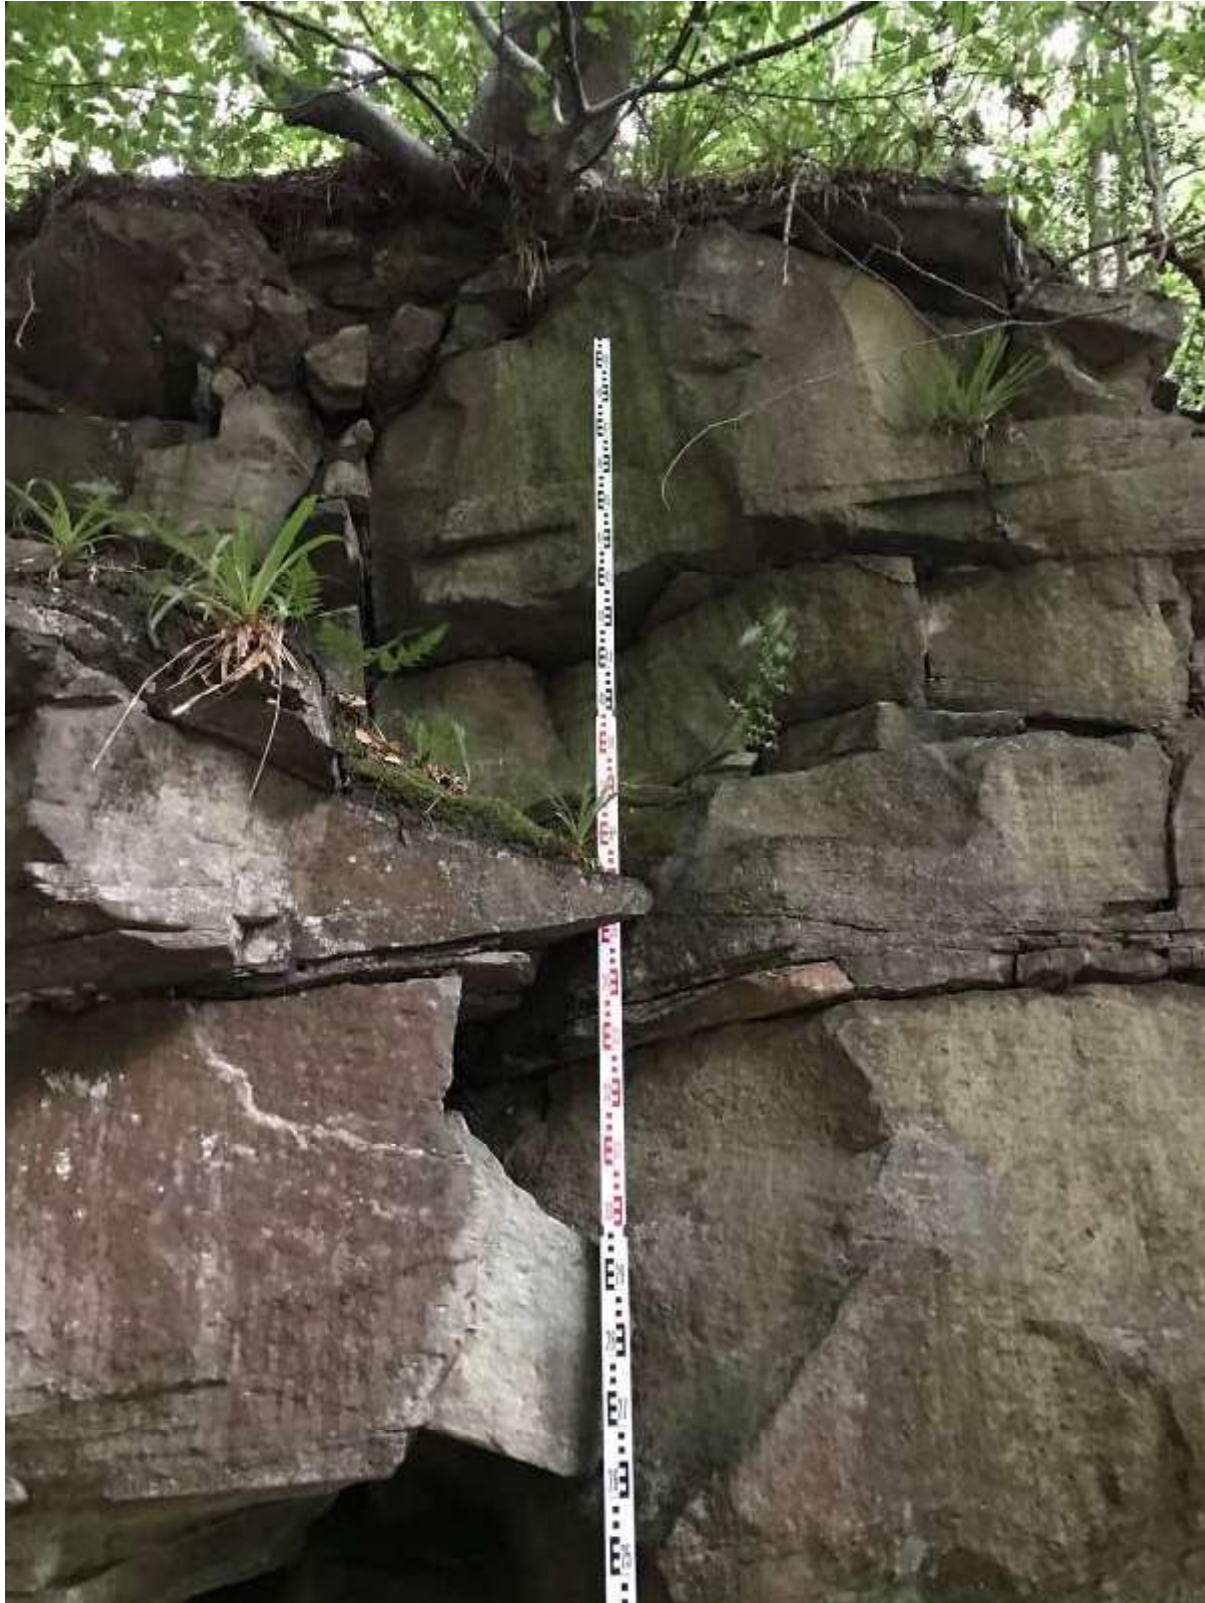
The rock face then returns at 90° (perpendicular to the road) for a distance of 3.5m then continues in line with the road for a further 19m or so, see Photo 4, before returning to the footpath, with the boundary following the natural sloping ground. The 19m section comprises a vertical cut face, 5-7m high, with the appearance of a man made cutting orientated E-W. The cut was shown on the earliest OS map although no buildings were shown.

**Photo 4** – 19m long rock face, offset by c. 7m from verge

- 19m section adjacent to footpath – there is sufficient space in this area to construct a bund to intercept any rockfalls before they reach the footpath or road. A fence and warning signs could be erected to prevent/discourage site users from crossing the Bund. The bund may be formed from granular or suitable cohesive fill and should be covered with site won topsoil and seedbank to allow natural localised vegetation to re-establish, see Figure 5 for details.

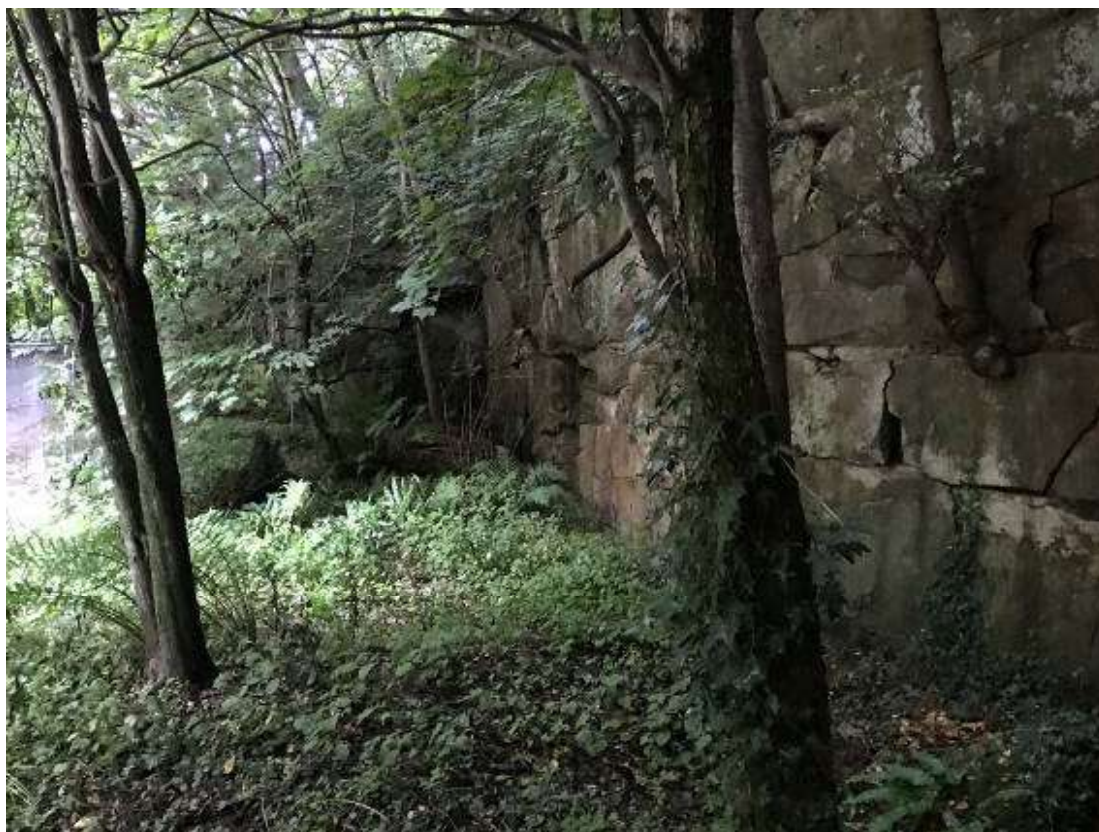
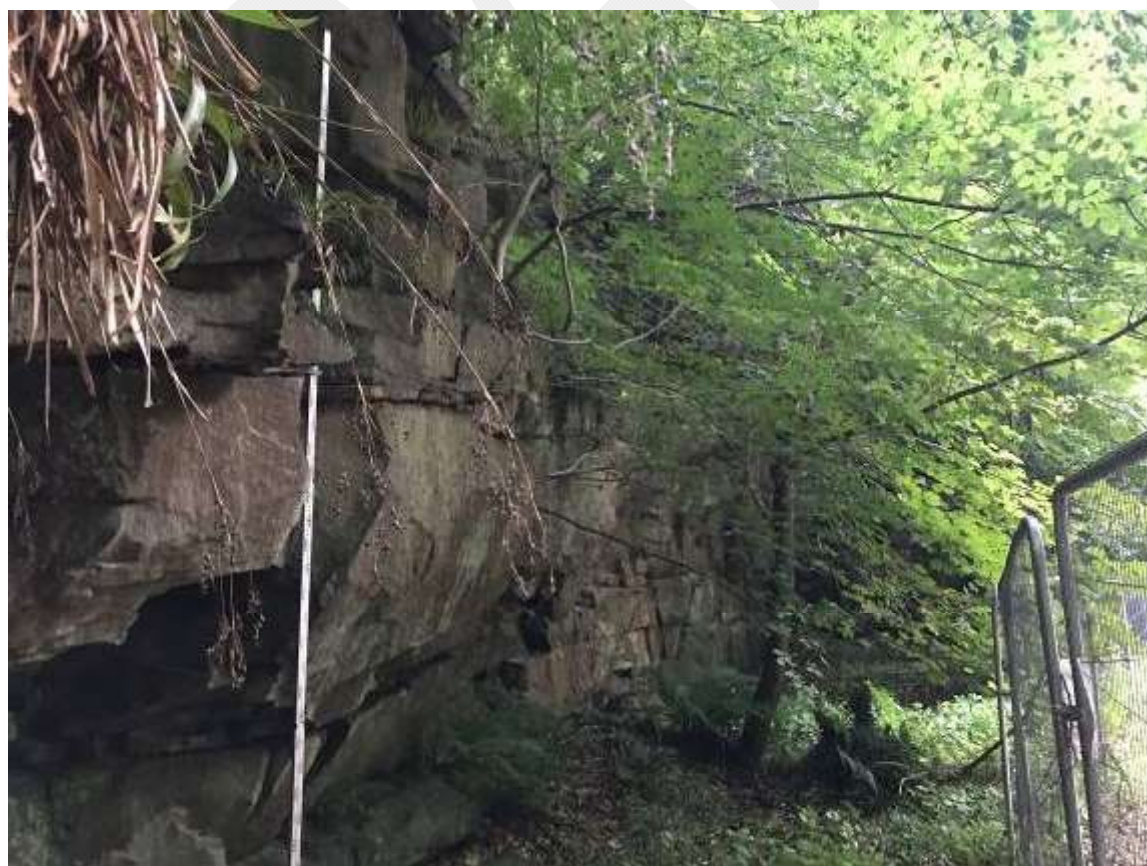
**Photo 5** – displaced clocks and rock face along path (up to 25m from gate)

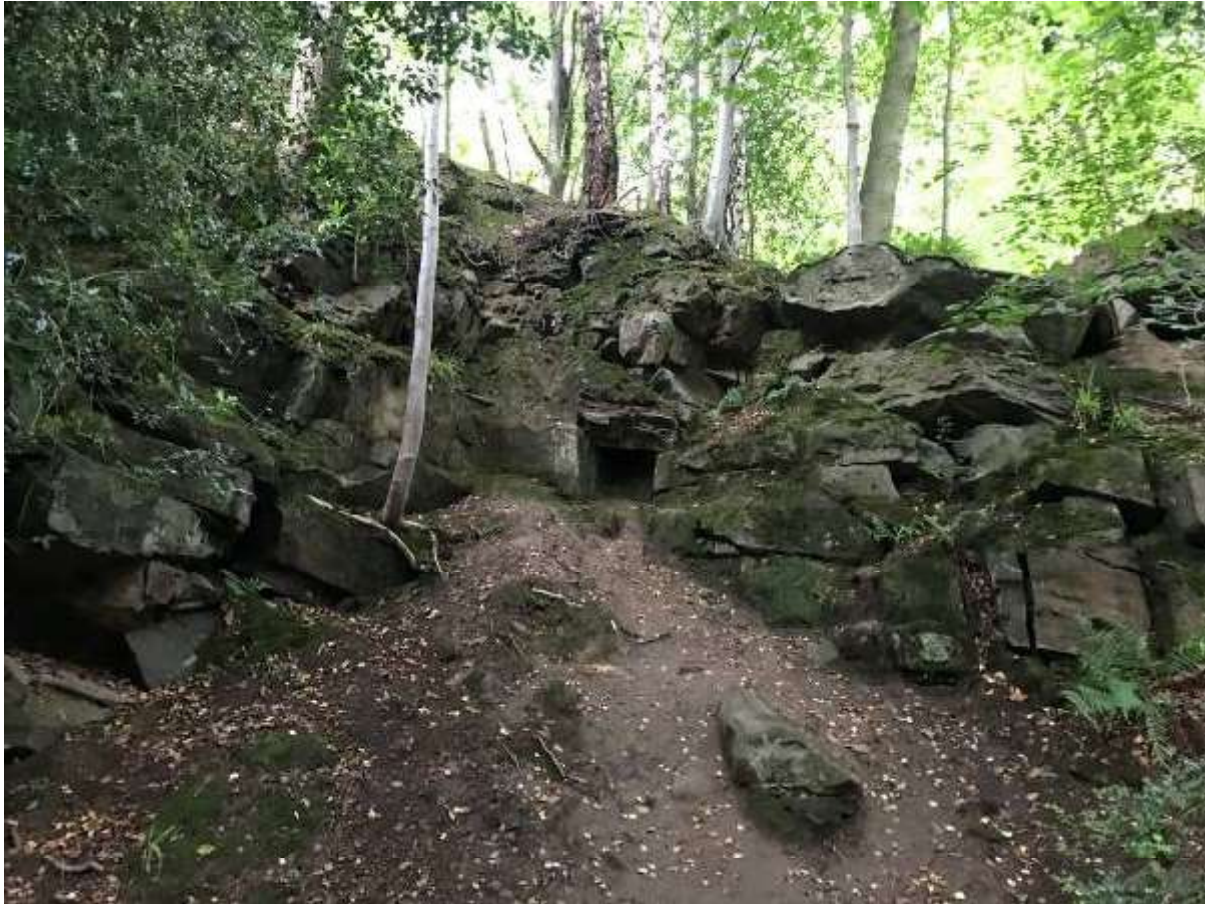
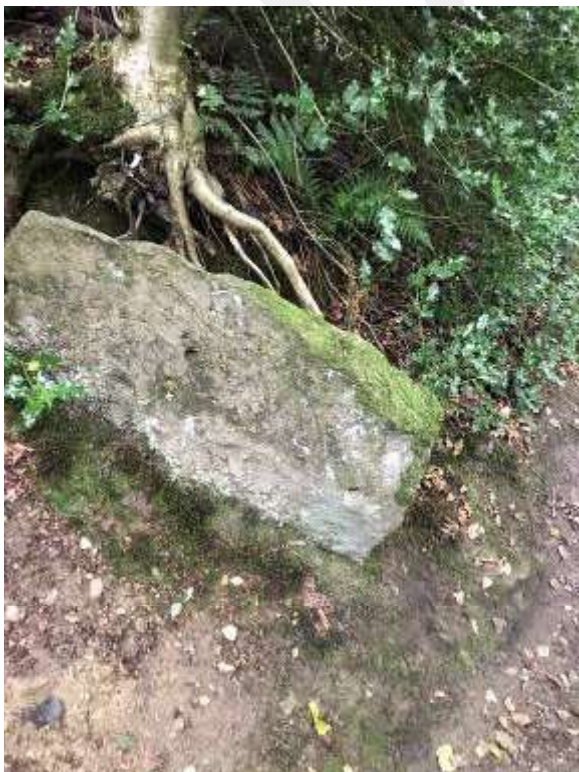
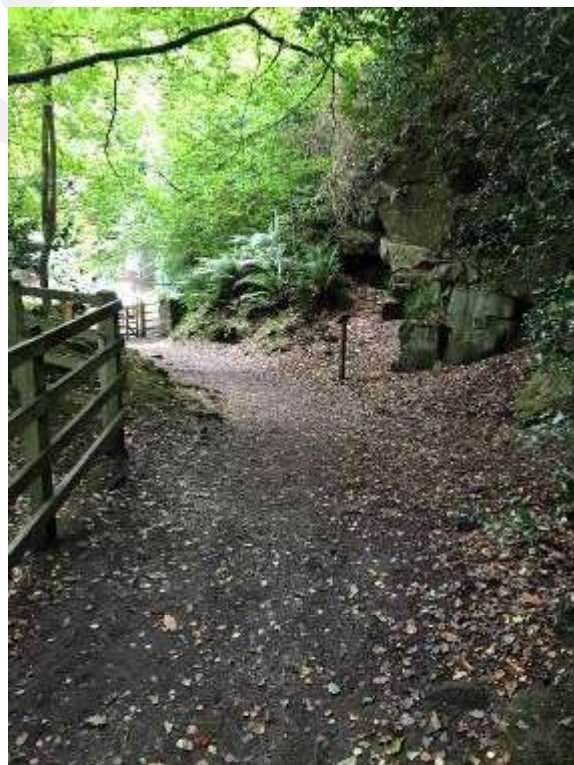
**Photo 6 – Area 2; Ch. 0-3**

| Ch. | Description |
|---|---|
| 0-3 | Gently sloping ground, low risk of failure, see Photo 6; |

| Ch. | Recommended Stabilisation Treatment |
|---|---|
| 0-3 | None required |

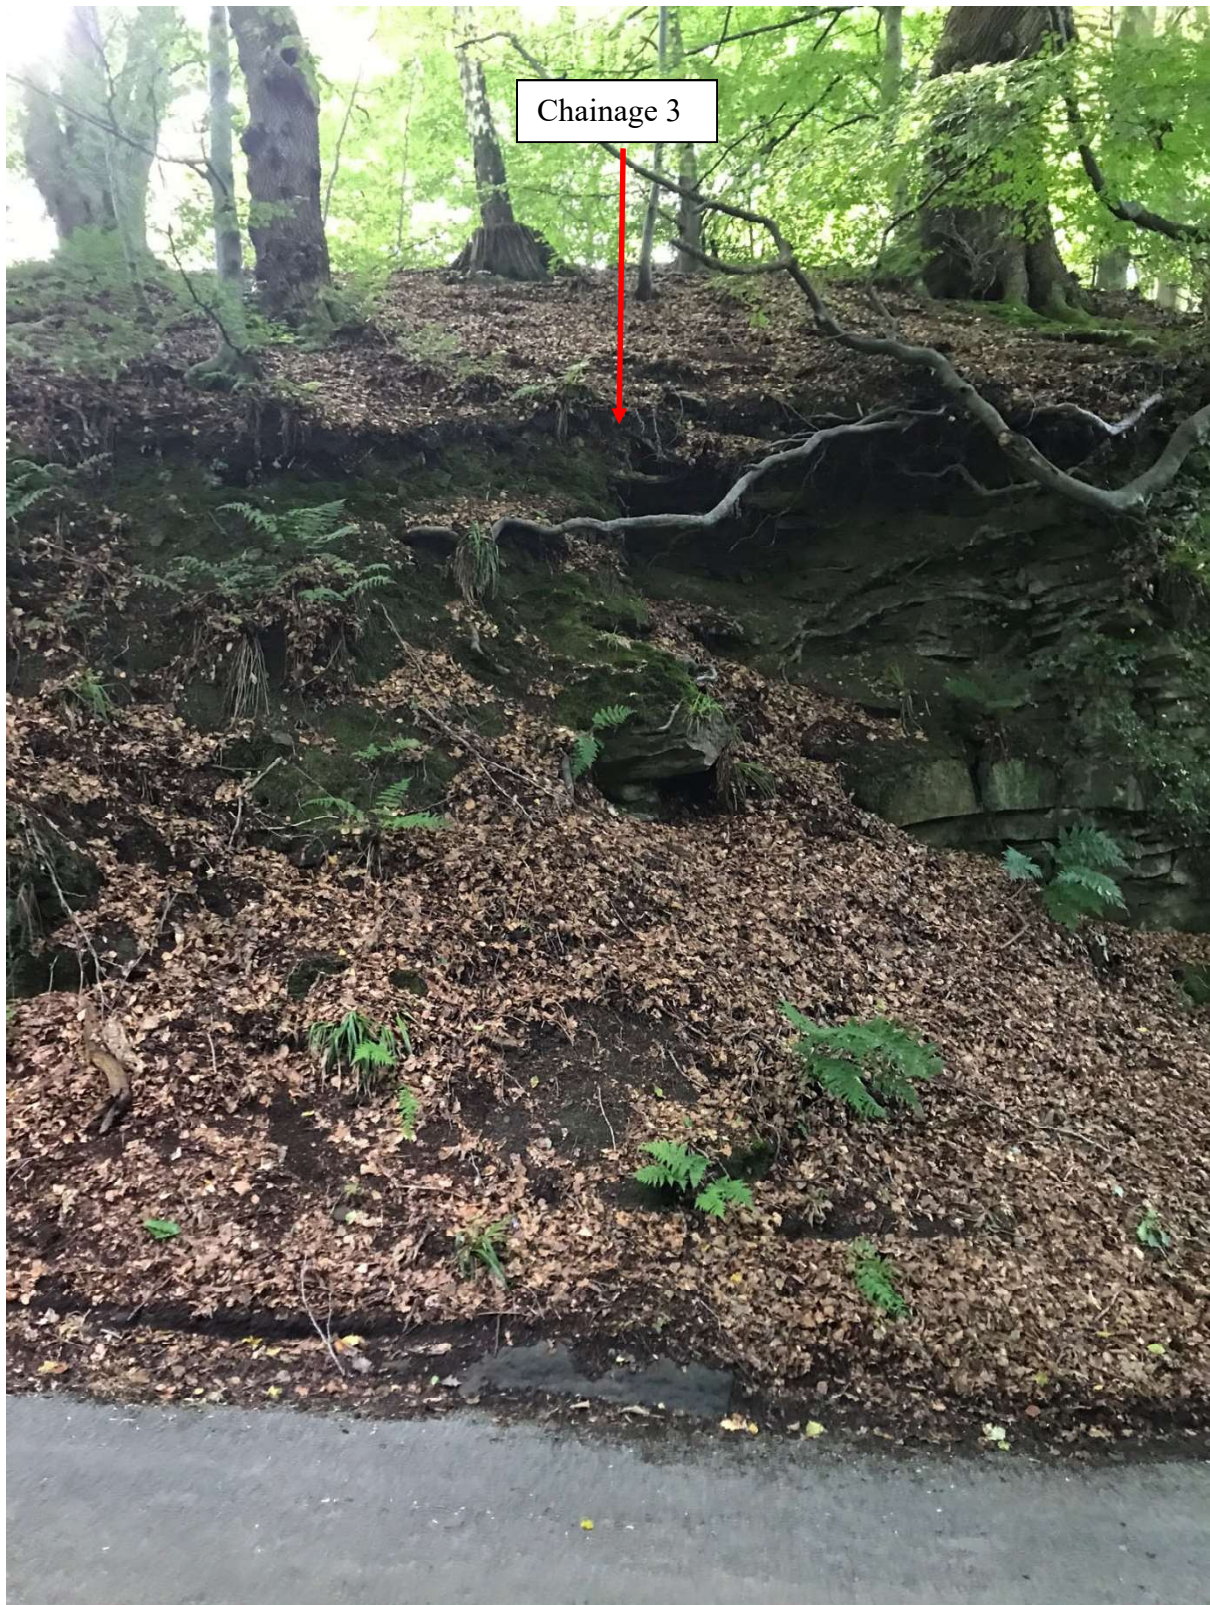
**Photo 7 – Area 2 Ch. 3 - 8**

| Ch. | Description |
|---|---|
| 3-13 | Appears to have been a significant historic failure, triggered by a large tree being blown over and roots ripping out the rock mass. Some well-developed roots are evident on the face, which has a very blocky appearance. Mature tree at top of slope therefore future risk of similar failure. Upper rock face is 3 - 4m from road with slope below leading to road; no verge, see Photo 7 & 8 |

| Ch. | Recommended Stabilisation Treatment |
|---|---|
| 3-20 | Regular rope access inspections and maintenance schedule to carry out hand scaling of loose blocks and keep new vegetation growth under control. |

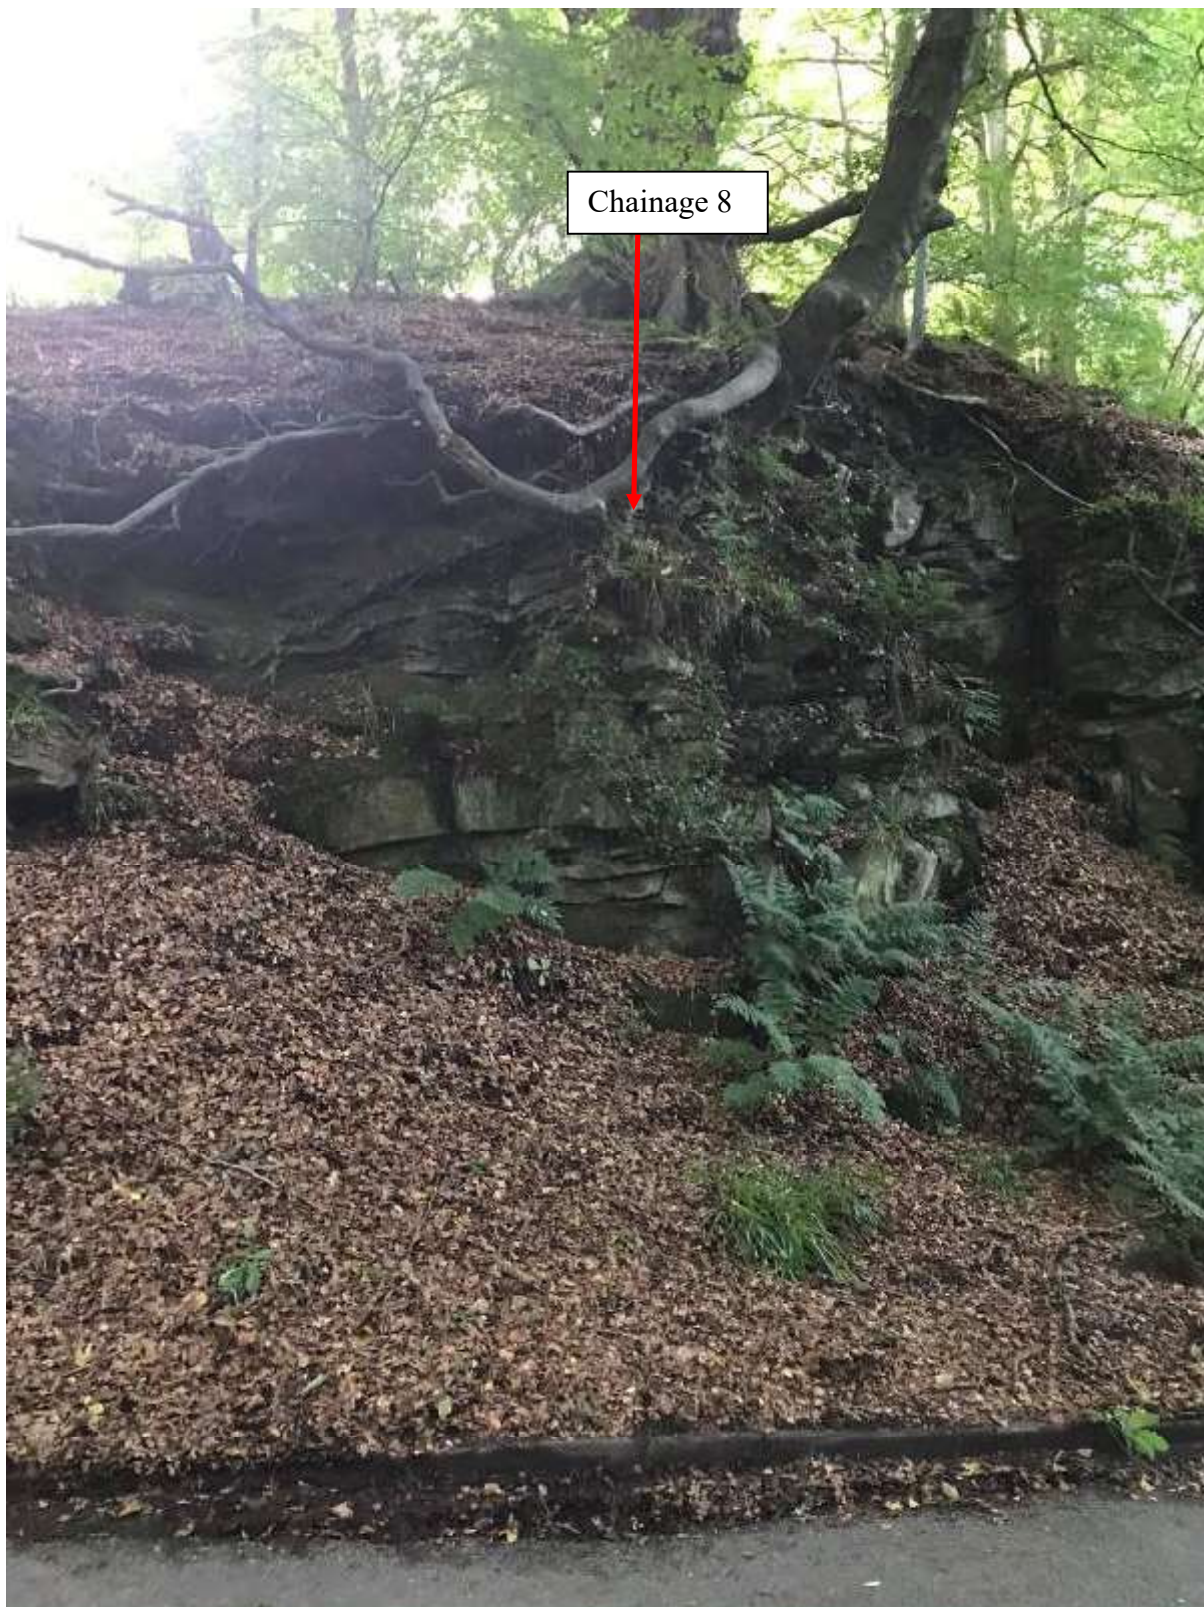
**Photo 8 – Area 2 Ch. 8 - 20**

| Ch. | Description |
|---|---|
| 13-20 | As above but upper rock face is 6-7m from road with slope below leading to verge. |

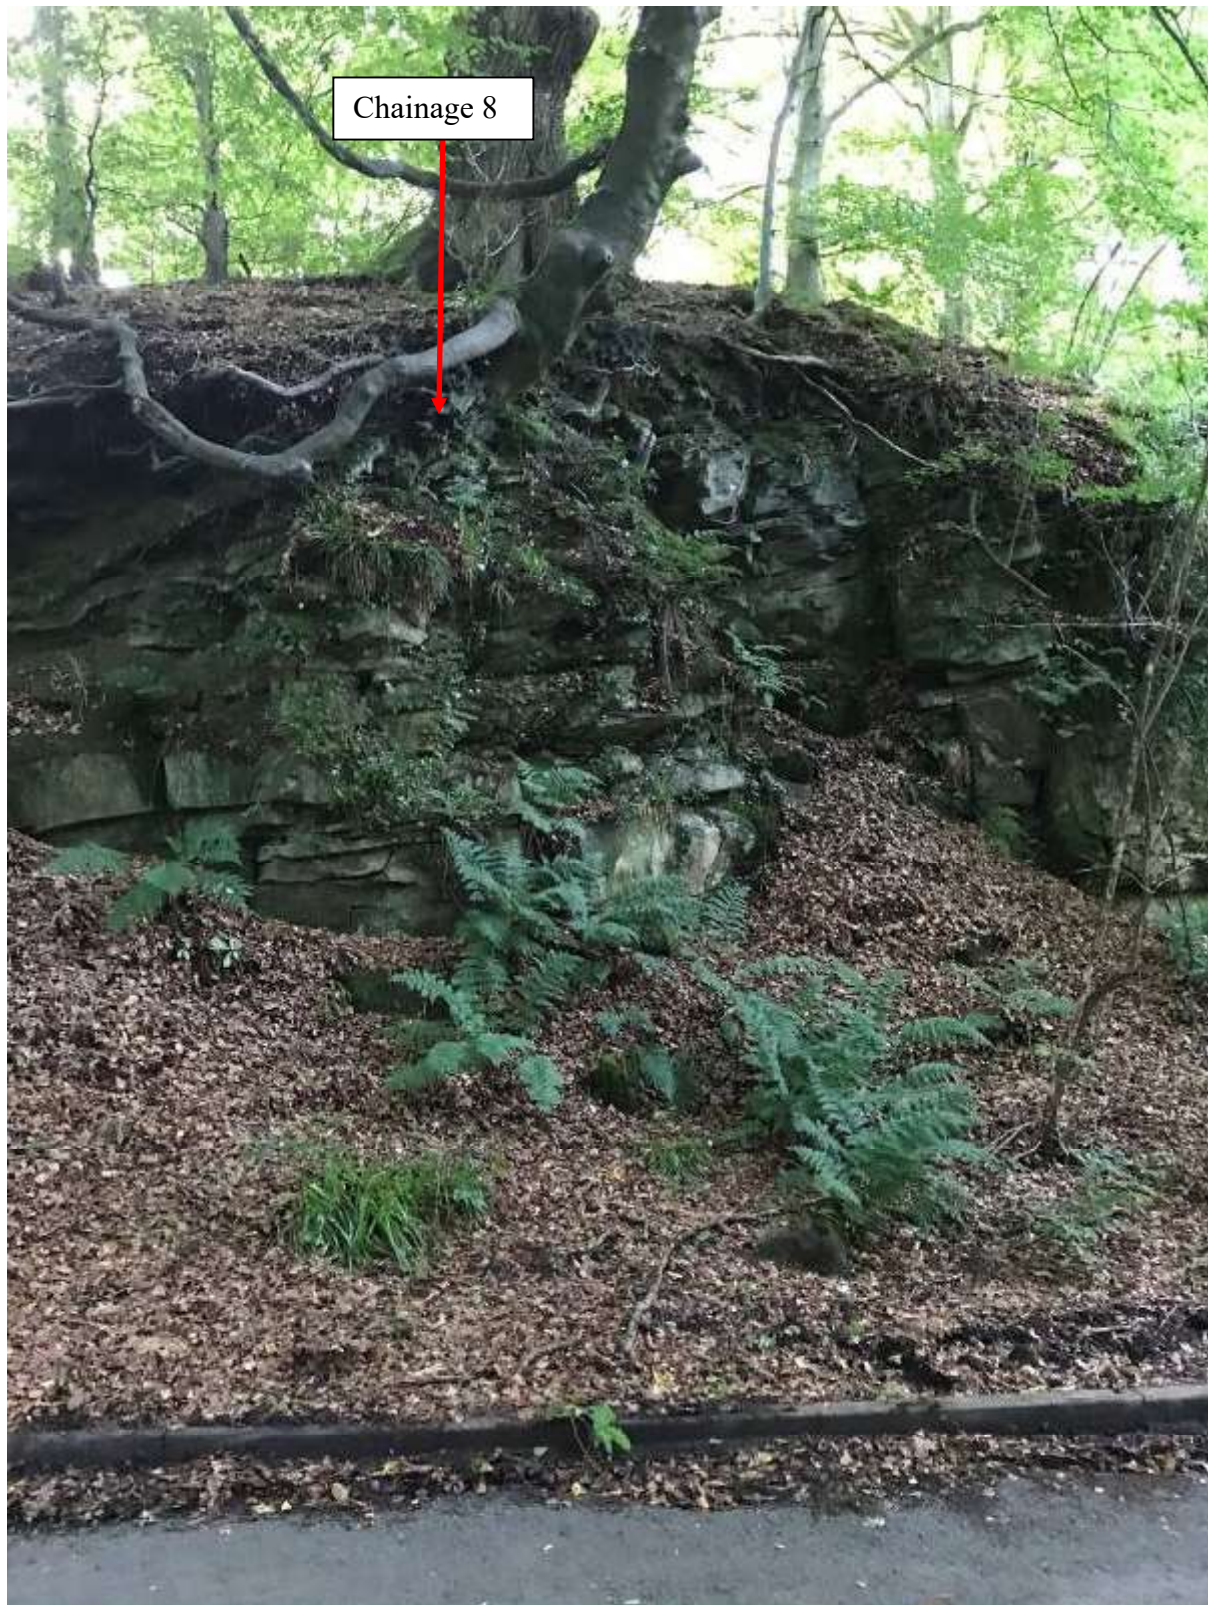
**Photo 9 – Area 2 Ch. 20 - 24**

| Ch. | Description |
|---|---|
| 20-24 | Vertical sandstone faces, 2-3m from road. Large oak at crest with roots penetrating the rock mass. Oak has previously been felled, but is still above and roots are causing significant risk of instability. There are large dilated joints perpendicular to the road and also a large diagonal joint dipping towards the road with risk of large failure, see Photo 9 & 10. |

| Ch. | Recommended Stabilisation Treatment |
|---|---|
| 20-24 | Removal of large block risk by long reach excavator. This rock debris could be broken down using a crushing bucket to gain material to construct the bunds in Area 1 and 2. See Figure 6 for details |

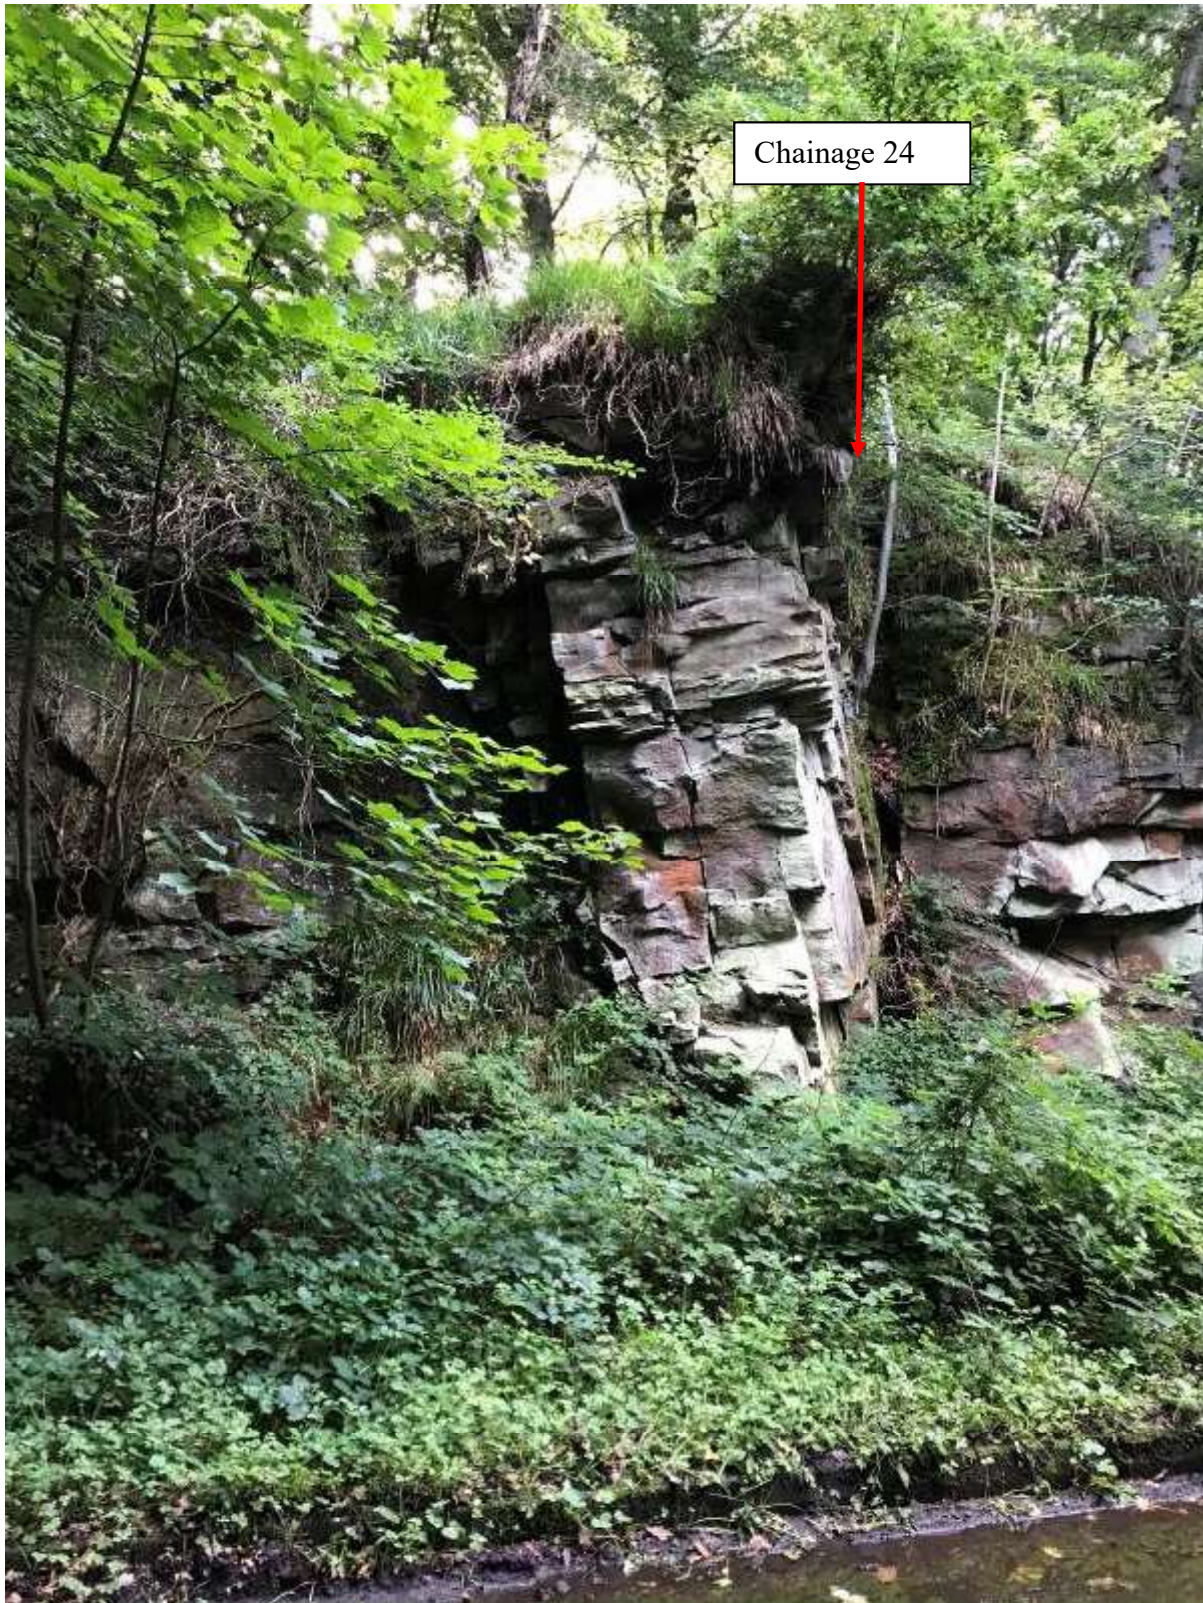
**Photo 10** – looking onto Ch. 24 from the bridge

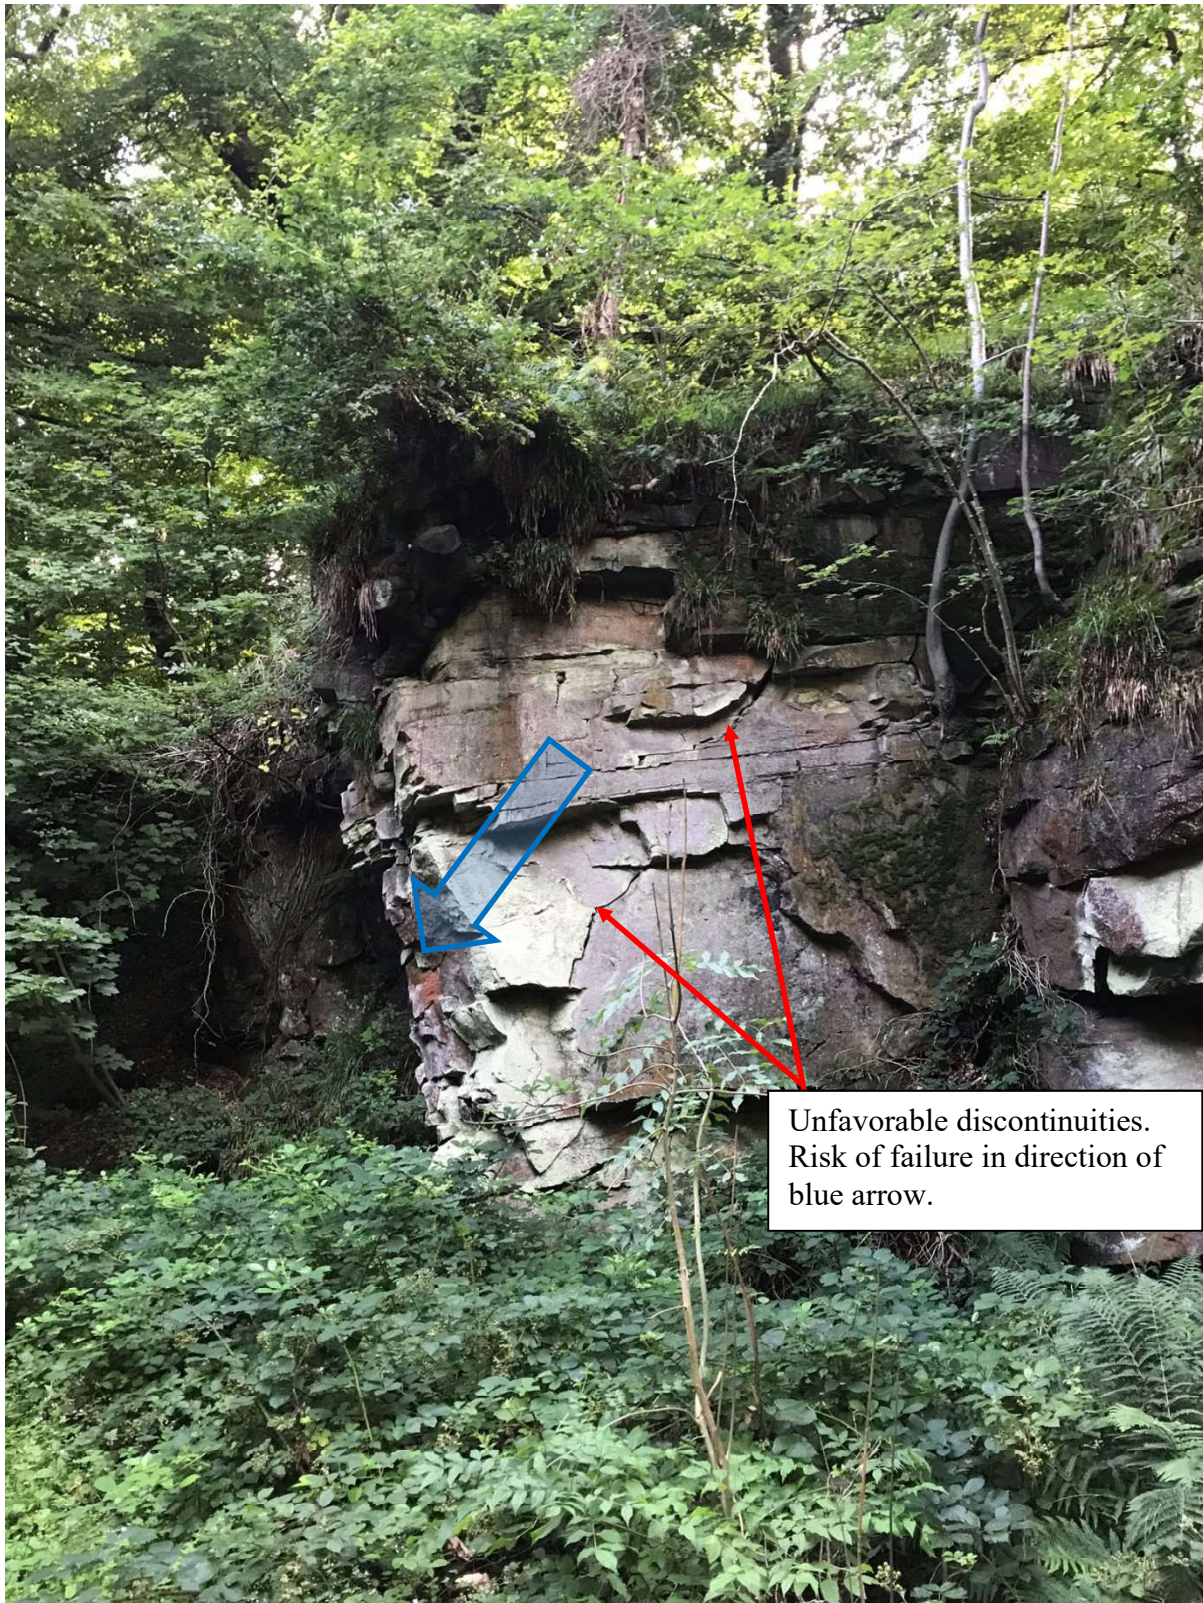
**Photo 11 – Area 2 Ch. 24 - 35**

| Ch. | Description |
|---|---|
| 24-35 | Rock face generally vertical and offset from road by c,10m, therefore consequence of failure is low, see Photo 11. |

| Ch. | Recommended Stabilisation Treatment |
|---|---|
| 24-35 | Place bund to segregate rock face and prevent potential use of area for car parking, as Area 1. Erect fence and warning signs, see Figure 5 for details. |

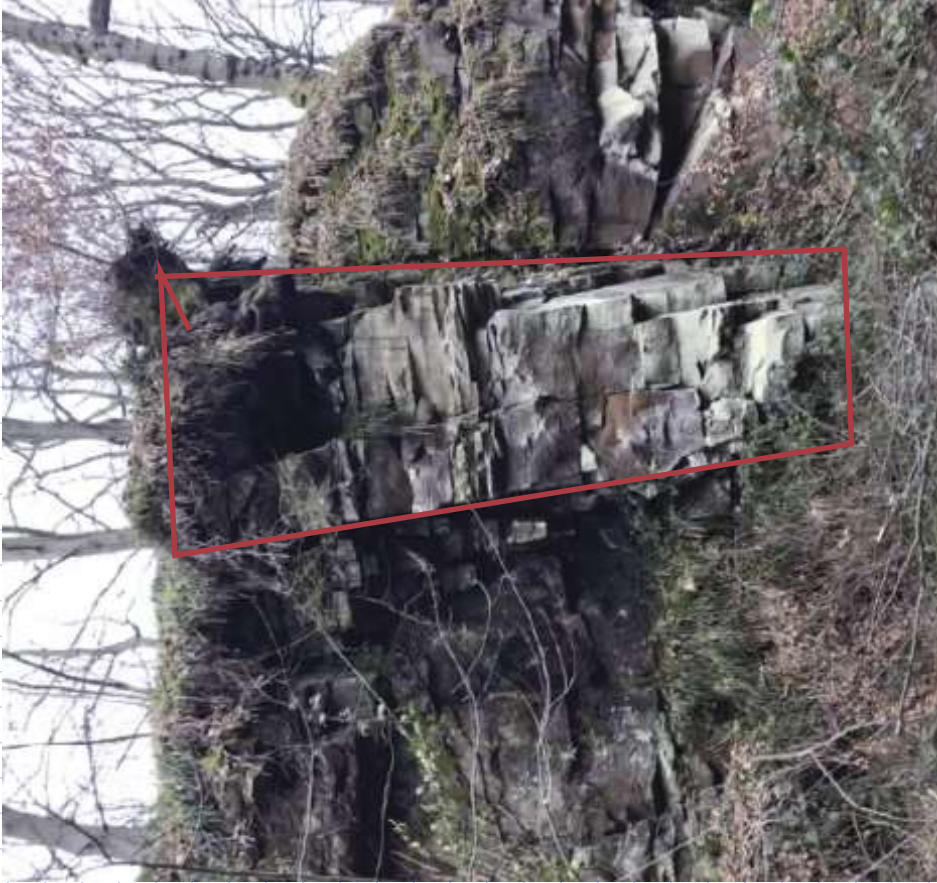
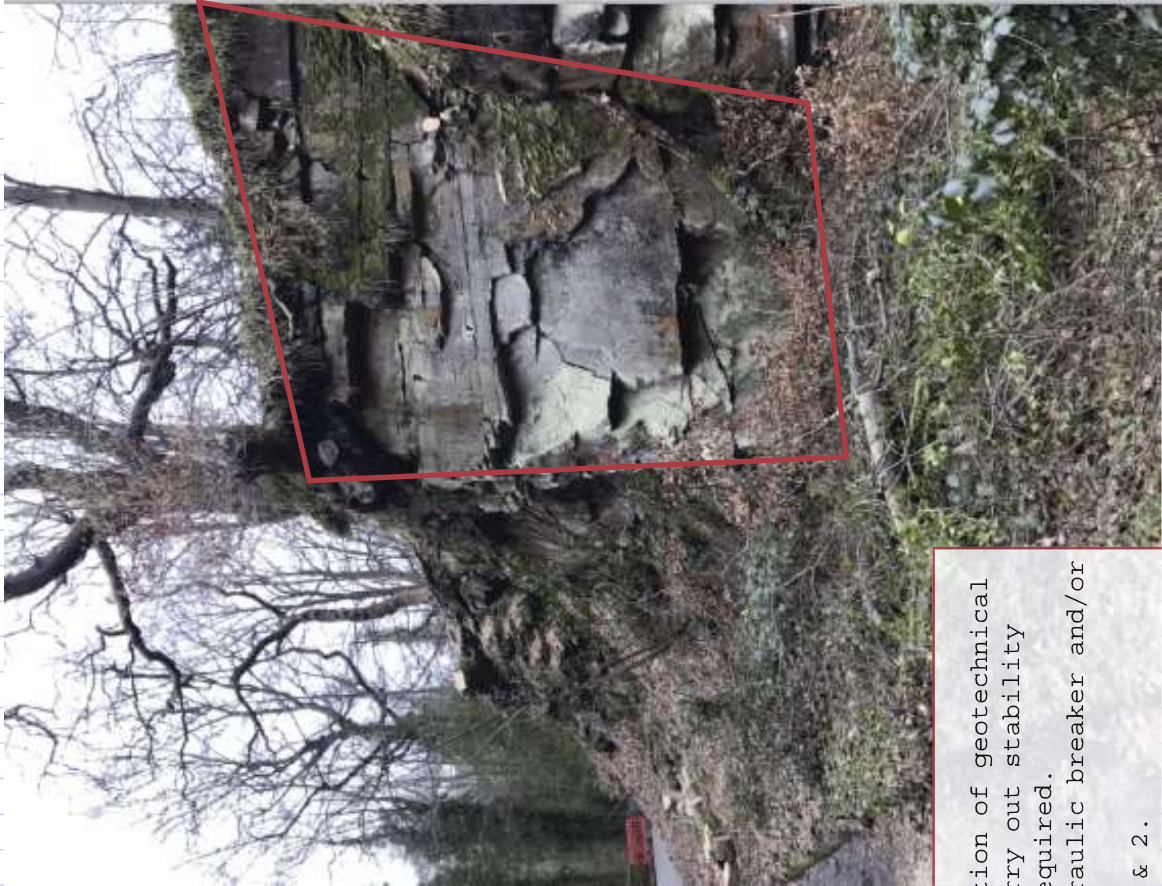
| Work Element / Reference:<br>Large Block Removal Area 2 / Figure 6 | Prepared by<br>APJ | Date:<br>07/21 | | | |

Block to be removed highlighted in red above.

Removal with Long reach excavator under supervision and direction of geotechnical engineer to ensure that rock mass left stable. Engineer to carry out stability assessment of exposed face to rear and design rock bolts if required.

Rock Debris to be broken down crushed on site with use of hydraulic breaker and/or crusher bucket.

Rock fragments to be retained on site in rock bunds in Area 1 & 2.
