### REPAIR METHODOLOGY FOR REPOSITIONING THE WINDOW TO THE FRONT ELEVATION OF HOLT HILL, HOLT, WREXHAM.

This work is to be carried out when the front door is to be moved and set back into its original location in the front elevation of the building and the Georgian window sash frame will be repositioned where it originally sat to replace it. The methodology is to cover Condition 09 of the LBC consent P/2020/0065.

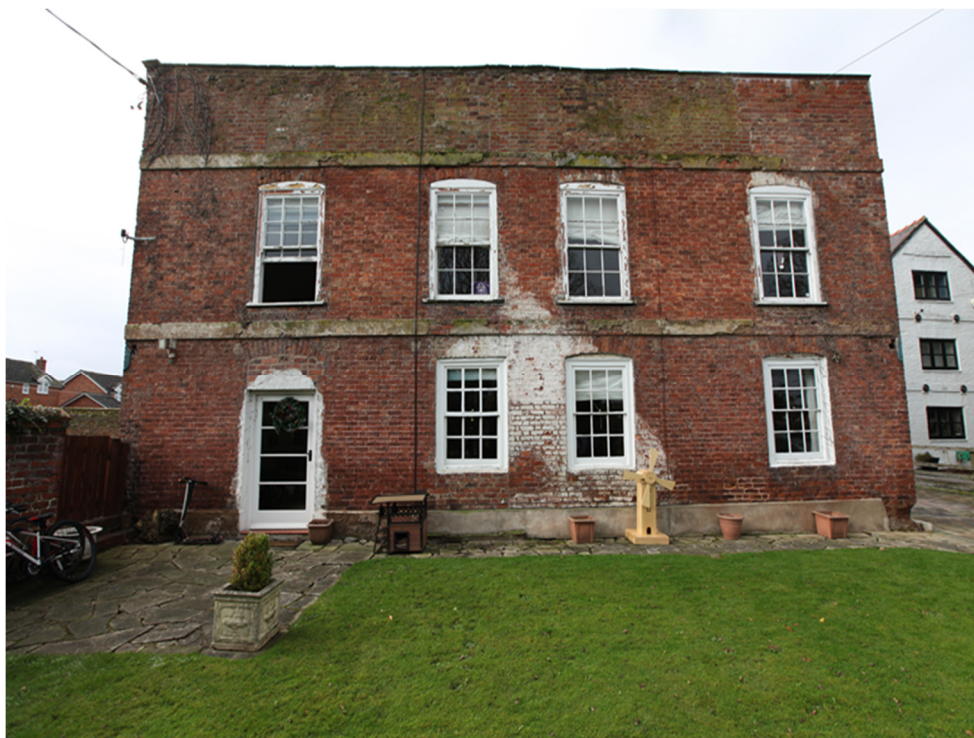
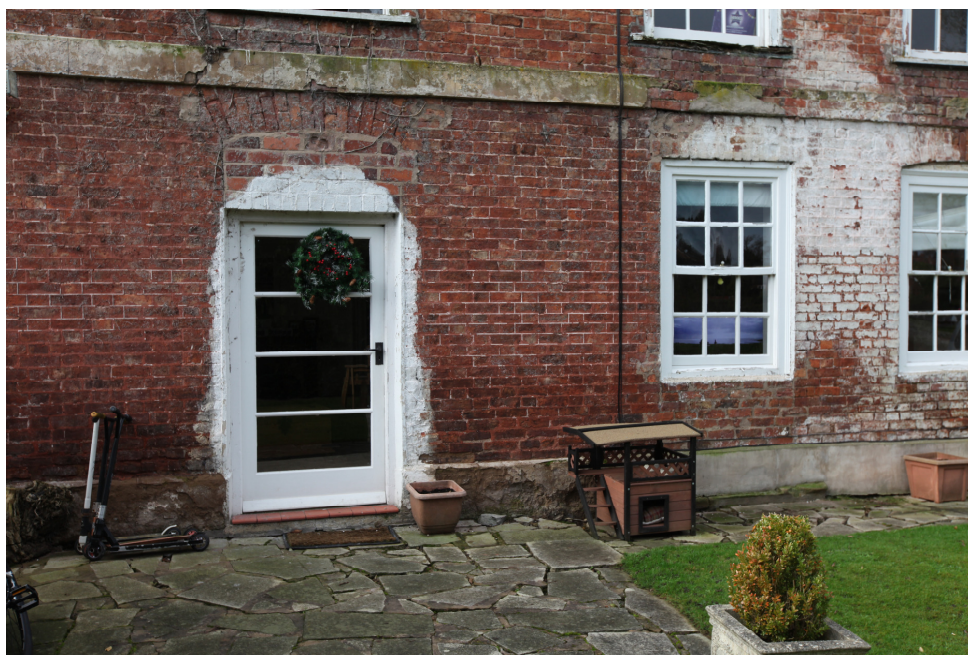
The window on the ground floor to be swapped with the front door is the oldest extant box sash frame to the front of the building.

The box sash now needs to be taken out and repaired so that both opening lights work again with weights and cords.

The front wall and detailed view of the door and window to be swapped around.

It is intended to swap/reset the front door and adjoining sash box window back to their earlier locations in the front elevation of Holt Hill. The front door is presently modern but drawing 0759PL14/B shows a design for the new door with glazed fan light above. We would recommend the following work to be appropriate now.

The fully exposed opening will enable the new front door to be re-located in its original position. The size of the opening remains as originally designed, set presently by the extant window and the straight joints seen in the brickwork below the window. However, a new 16-piece segmental arch will have to be re-built using new spring point brickwork at either end of the opening lintel. The arch must line up with existing arched openings on either side of the front door opening. Bricks must be set out to be self-supporting to the outer skin of brickwork and be of the same size bricks as seen in the other window/door openings at the front of the building. Any damaged brickwork can be made good to the reveals of the opening in matching brick to the original and the brick pattern/bond must be observed.

Drawing 0759/PL19 shows the detail for the reset box sash window once repaired. For the sake of keeping damp out of the building a cavity wall design has been chosen. We can advise that this is acceptable but the pattern of bricks to this new spandrel panel beneath the window should be set out in a loose Flemish bond style to be laid out so that the brick bonds run through the new panel to continue each side of the old opening in matching bonding. There should be no continuous vertical lines left in the brickwork below the window opening once the spandrel panel has been rebuilt. The new base plinth

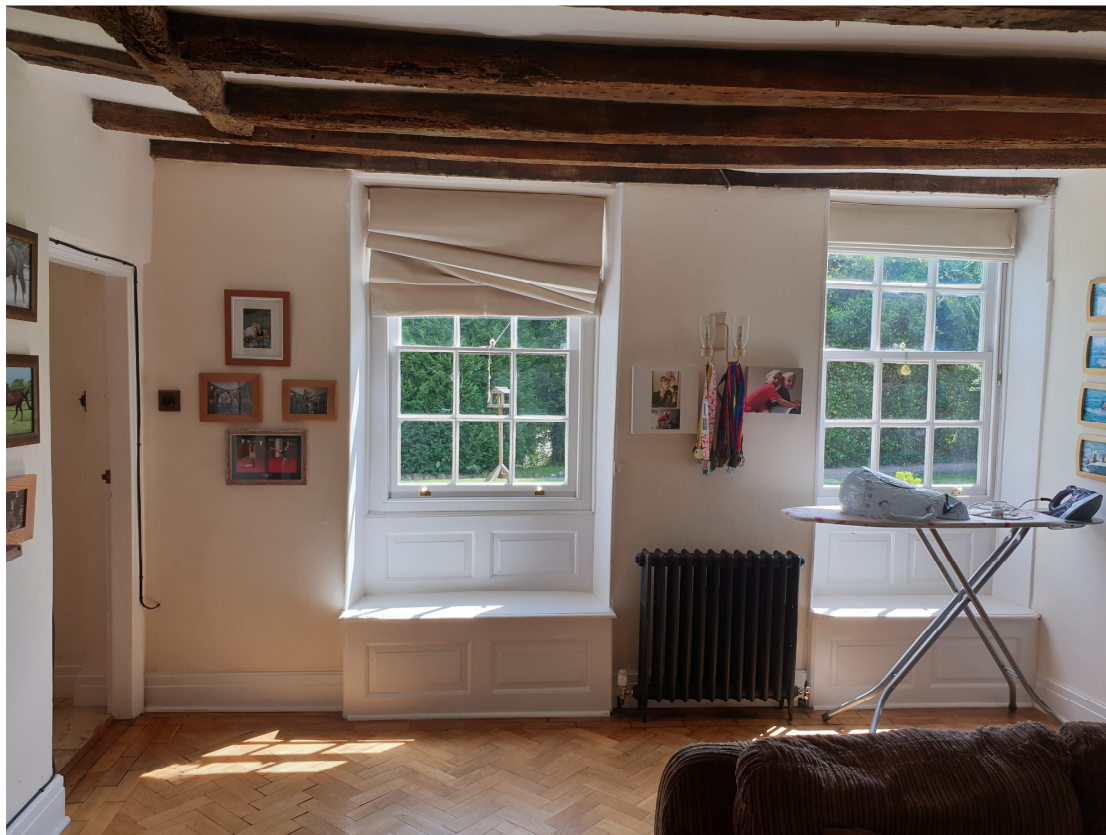
The right-hand Internal window seat to be rebuilt in the next room.

Internally the window seat and split-level timber panelling should be preserved and re-used beneath the new window opening.

The Panelling and seat should be recorded and marked up so it can be put back together correctly.

Taking it apart will require any fixing screws to be found and removed. Timber that is fixed using nails can be eased apart using soft wood wedges so as not to damage the original timber.

Once the window and spandrel panel have been repositioned the panelling and seat can be reconstructed beneath the window and decorated to finish. As far as possible all fixings should be hidden.
