# CPAT Report No. 1771

## 4-6 Regent Street, Wrexham

### Building Survey

Client name: I Harding  
 CPAT Project No: 2508  
 Project Name: 4-6 Regent Street, Wrexham  
 Grid Reference: SJ 3340 5037  
 County/LPA: Wrexham  
 Planning Application: P/2020/0672  
 CPAT Report No: 1771  
 HER Enquiry No: N/A  
 Event PRN: 140355  
 Report status: Final

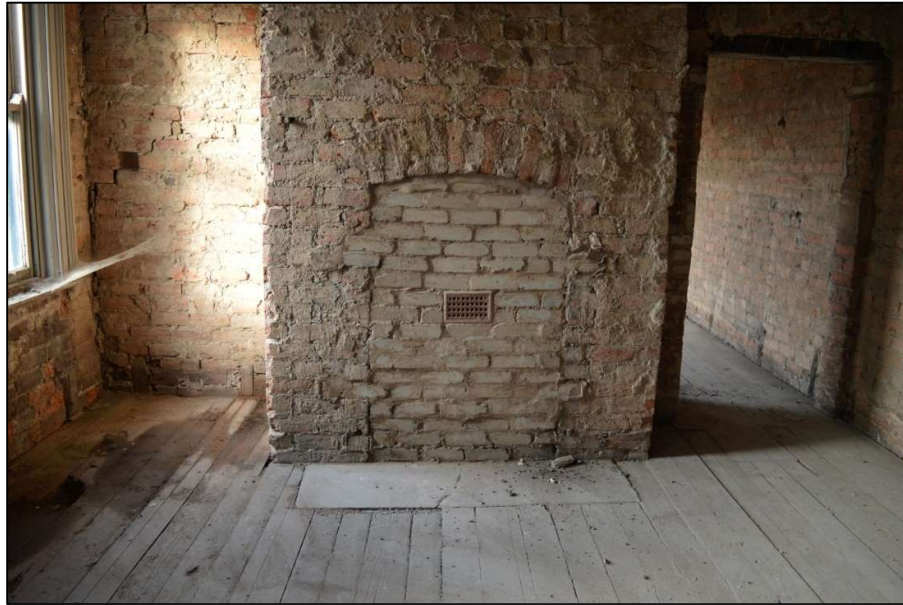
- 3.11. As with the first floor, the plan of the second floor comprises four rooms centred on the two chimney structures, though in this case the two rear rooms (1 and 4) are not linked and access was gained from the east and west stairs. What seems to have been an inserted doorway linked Room 1 and 2, but the original access to the two front rooms was clearly via doorways from the respective stairs, where the door heads were arched. Later modifications meant that the east door (Fig 9) had been blocked and the head of the west door (Fig 13) blocked up while still allowing access. The two front rooms were directly linked by a doorway to the north of the chimney. All four fireplaces on this level had been blocked up but each had retained its hearth stone on the floor in front (see Fig 10).

*Fig 10: Blocked fireplace with hearth stone in Room 2 on second floor. Also shows wall cracks (CPAT 4853-0009)*

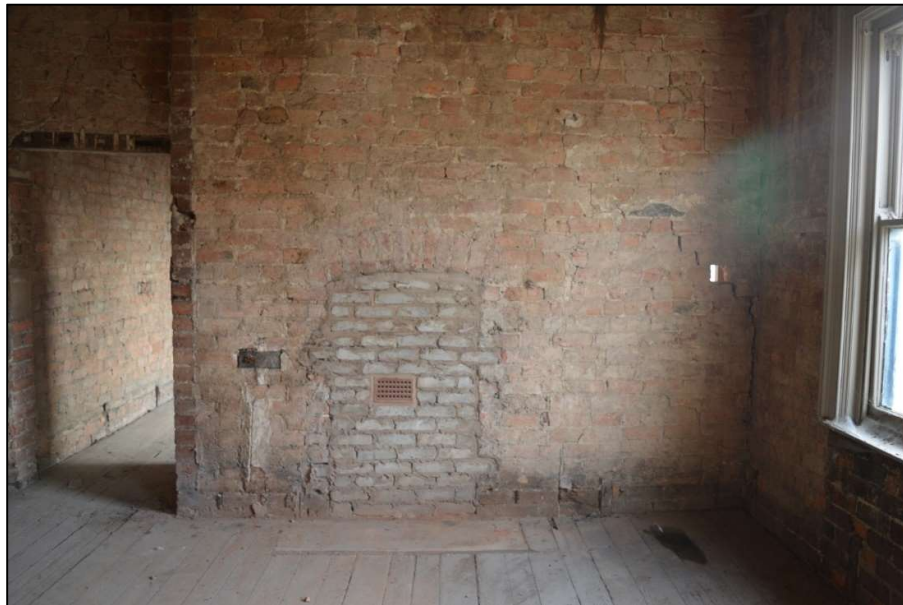
- 3.12. Again, cracking of the wall which links the southern chimney structure with the front of the building was revealed by the removal of its internal covering (Fig 12). This further supports the suggestion above that there had been differential settling between the two when the interior of the ground floor was removed.

*Fig 12: Blocked fireplace with hearth stone in Room 3 on second floor. Also shows wall cracks (CPAT 4853-0011)*

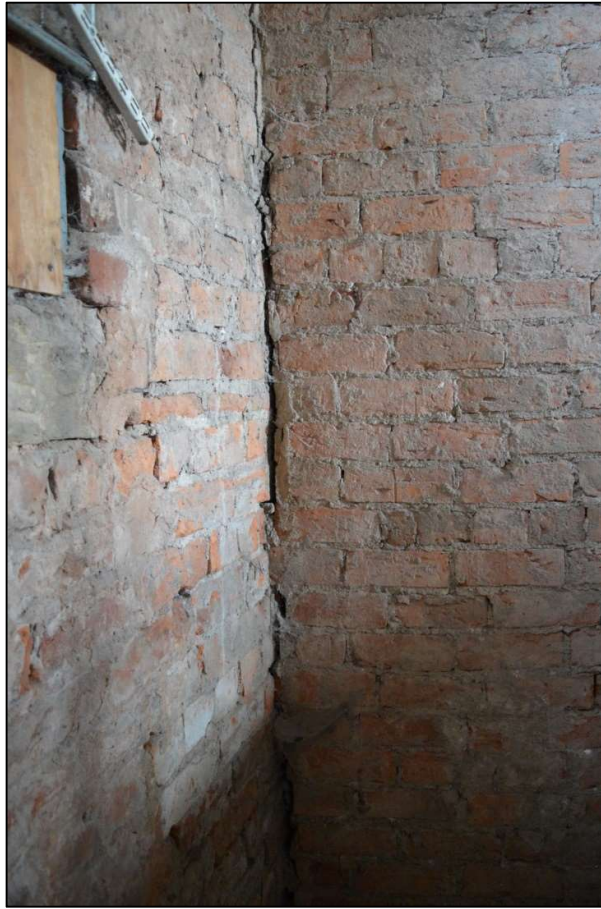
*Fig 20: Poorly tied-in and possibly inserted wall (to right) on east side of west stair (CPAT 4853-0019)*

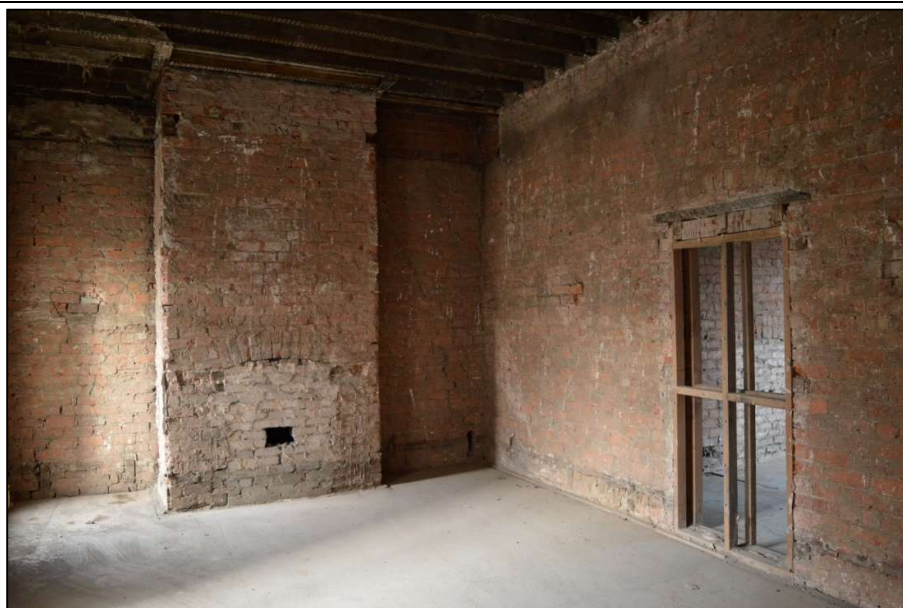
*Fig 39: Blocked fireplace and door in Room 6 on first floor. Also shows wall cracks (CPAT 4853-0038)*

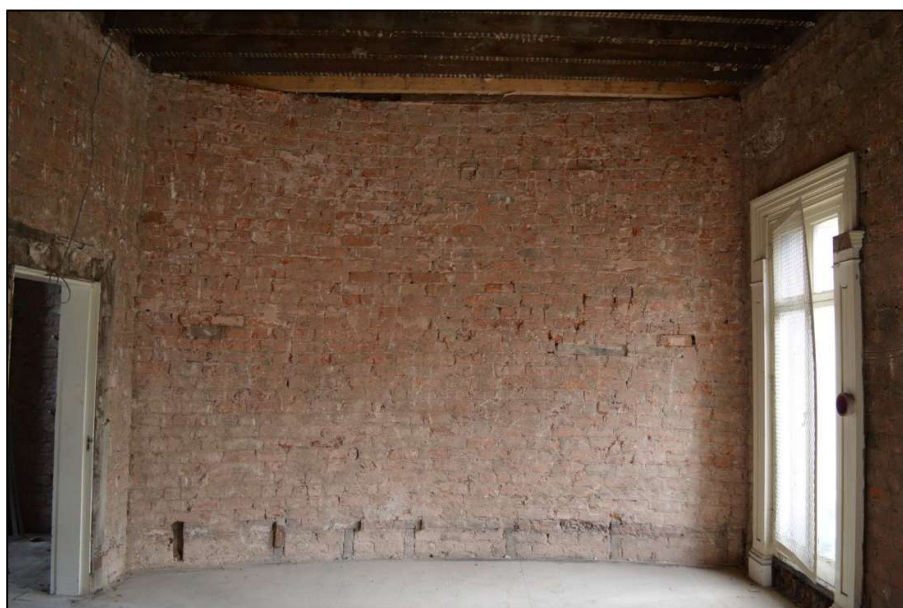
- 3.9. Room 6 was unusual in that its east wall had a marked curve (Fig 40), which suggested a special function but could not be explained by the surviving structure. Originally, rooms 5 and 6 and rooms 7 and 8 were linked but the respective doorways (Figs 34 and 26, respectively) had been blocked, probably at different times in the building's history. This implies that the original layout had been redesigned on a number of occasions. It seems likely, therefore, that some of the other doorways were later insertions but it was not possible to confirm this suspicion.

*Fig 40: The curved east wall of Room 6 on first floor, doorway to east stair (CPAT 4853-0039)*

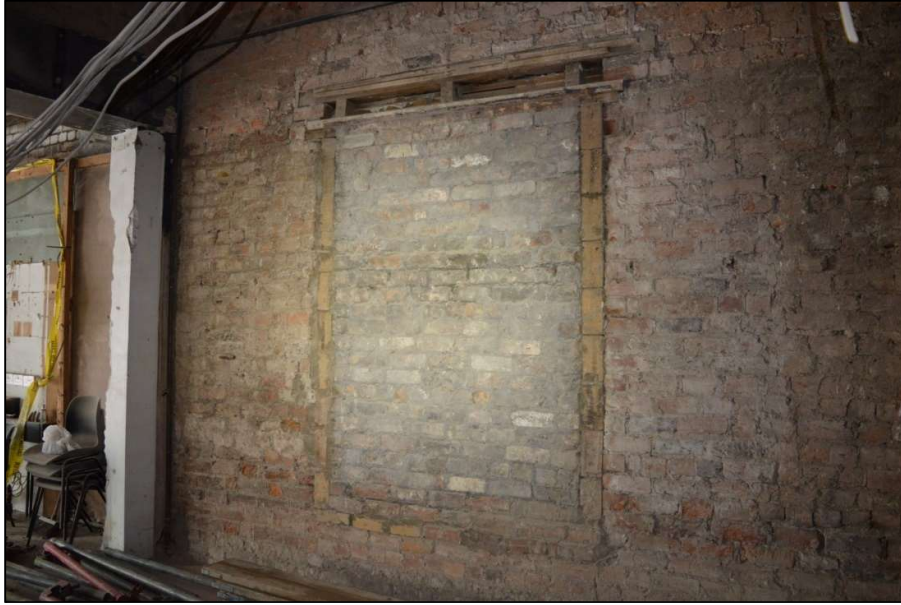
- 3.6. What appeared to be a blocked window (Fig 47) was found in the west wall, again implying that the building was originally designed to be free-standing. Unfortunately, the east wall was hidden behind modern brick facing and it was not possible to determine if there was any additional supporting evidence on that side. In the wall extending north from the north-west corner of the original building, a blocked doorway (Fig 56) was observed which tends to imply that there was some form of yard to the rear of the building, to which the door may have given access.

*Fig 47: Blocked window in original west wall of ground floor (CPAT 4853-0046)*

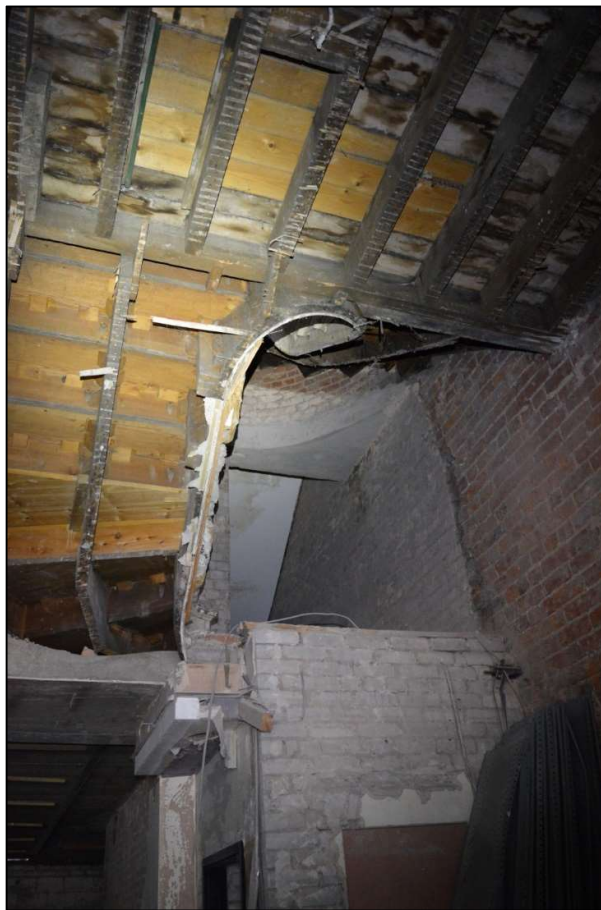
*Fig 50: Bottom of the east stair, showing how it was truncated (CPAT 4853-0049)*

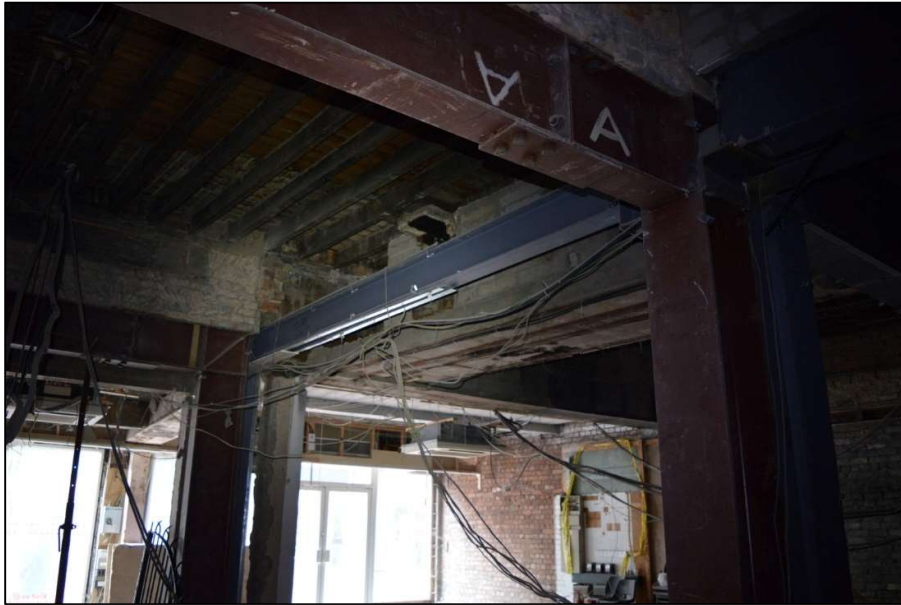
*Fig 51: The inserted steelwork supporting the centre of the building from below. Also shows the surviving upper part of the south wall of the original building (to left) and the beams supporting the southern of the two chimney stacks (CPAT 4853-0050)*

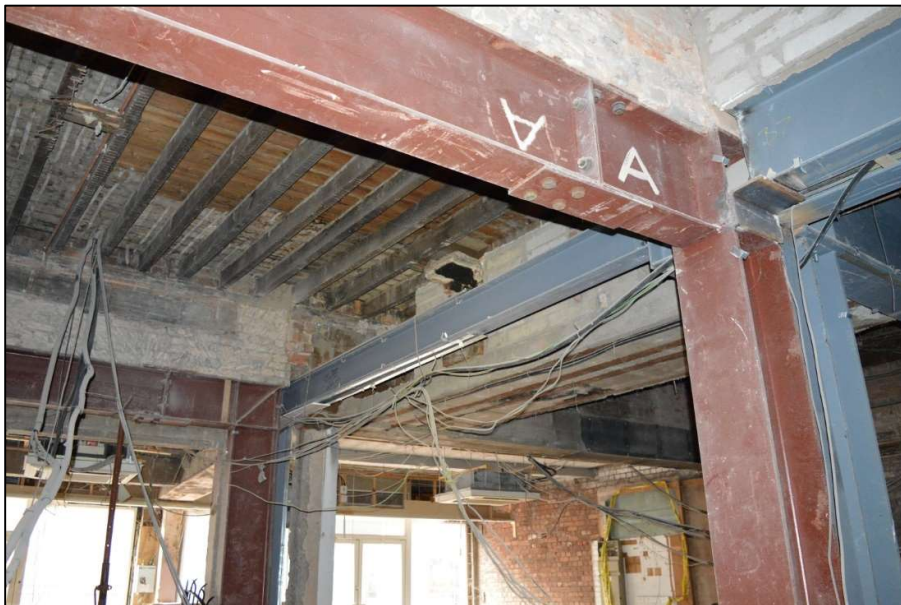
- 3.5. The original interior structures of the ground floor had been removed to create a retail space and their load-bearing capacity replaced by a series of steel and concrete beams (see Fig 52). The topmost portion (less than 1.0m in height) of the internal wall and chimney structures largely survived above the inserted beams. Most of the east and west outer walls of the building also remained but only fragments of the north and south walls. In association with the internal redevelopments, modern extensions to both the front and rear had been used to increase the available floor space, probably in the later 20<sup>th</sup> century.

- 4.2. This gap between 4-6 and the street frontage was filled in when the interior of the ground floor was completely redesigned to provide an open space for retail use, which necessitated the insertion of steel and concrete beams to support the structure that remained above. In this process, there seems to have been some differential settling of the building which led to cracks forming in the internal dividing wall that links the front wall of the building with the southern chimney structure. The nature of this will need to be assessed to ensure the building retains its structural integrity.

*Fig 52: As 51. The inserted steelwork supporting the centre of the building from below. Also shows the surviving upper part of the ground floor south wall of the original building (to left) and the beams supporting the southern of the two chimney stacks (CPAT 4853-0051)*

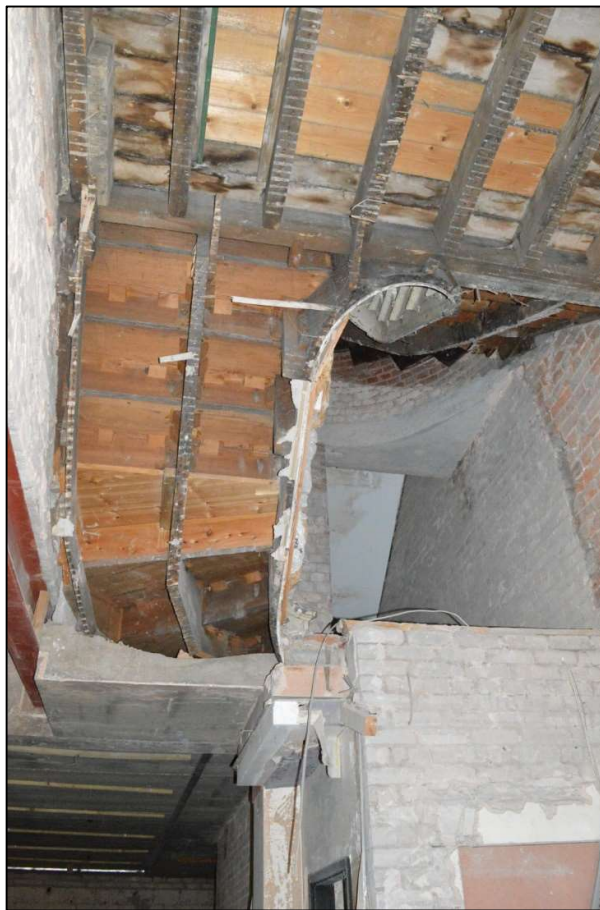
*Fig 54: View looking up from the ground floor to the first floor landing of the east stair showing how it was truncated (CPAT 4853-0053)*

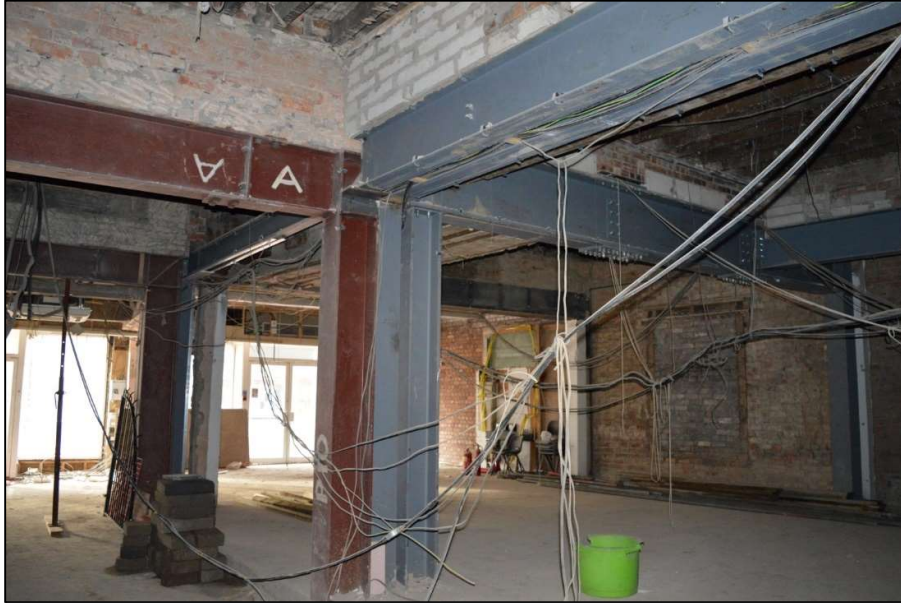
*Fig 55: The inserted steelwork supporting the centre of the building from below. Also shows the surviving upper part of the east/west cross wall (to left) on the ground floor (CPAT 4853-0054)*
