9/25/2020

# Yale College (Coleg Cambria)

Mature Tree Survey

Rob Mays  
EVOLUTION ARBTECH

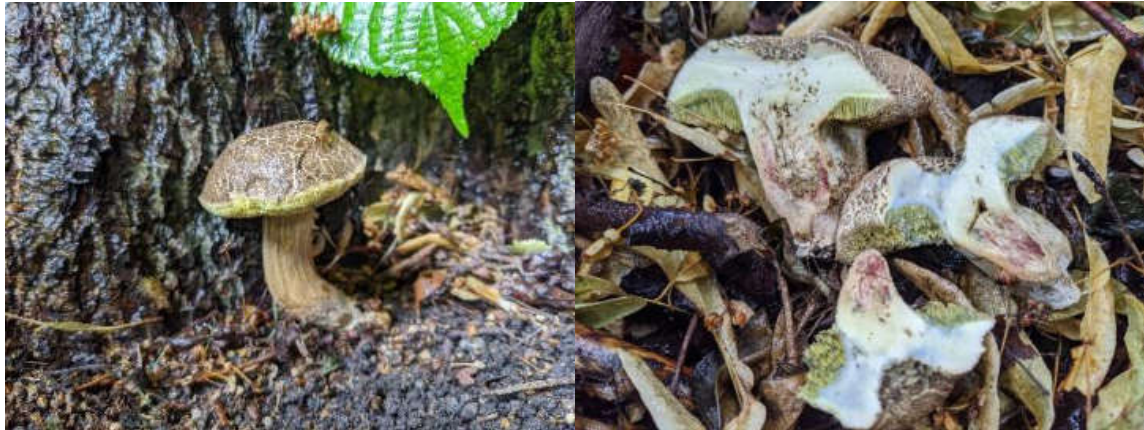
Tree № 15 a *Tilia X europaea* (common lime) was displaying fruiting bodies identified as the red cracking bolete (*Xerocomellus chrysenteron*) (Buczacki, et al., 2012) (O'Reilly, 2016) around the immediate 900mm of ground surrounding the stem. This fungi is a beneficial mycorrhizal fungi with a wide range of host trees.

Figure 4. Red cracking bolete (*Xerocomellus chrysenteron*) fruiting bodies found at the base of tree 15, a common lime tree.

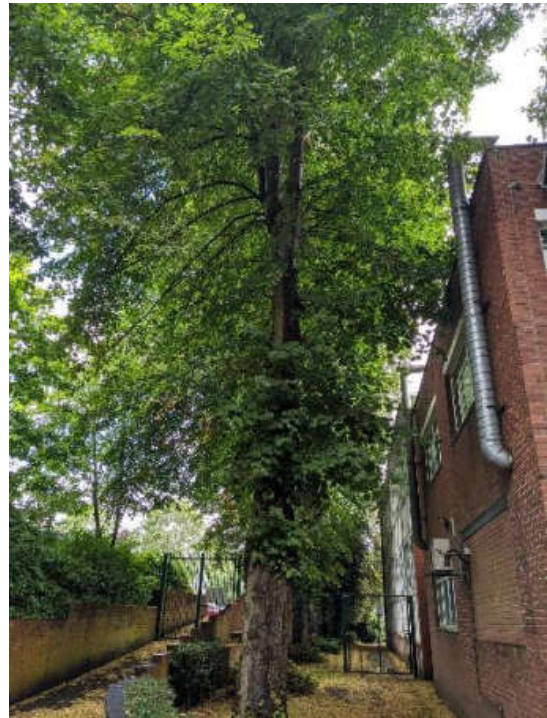
Most of the work required is crown lifting to reduce encroachment on buildings and increase natural daylight entering these buildings. The numbers of these trees are: 12, 13, 14, 15, 16, 17, 18, and 20.

*Figure 5. Branches of one of the many lime trees encroaching on the building and blocking light.*

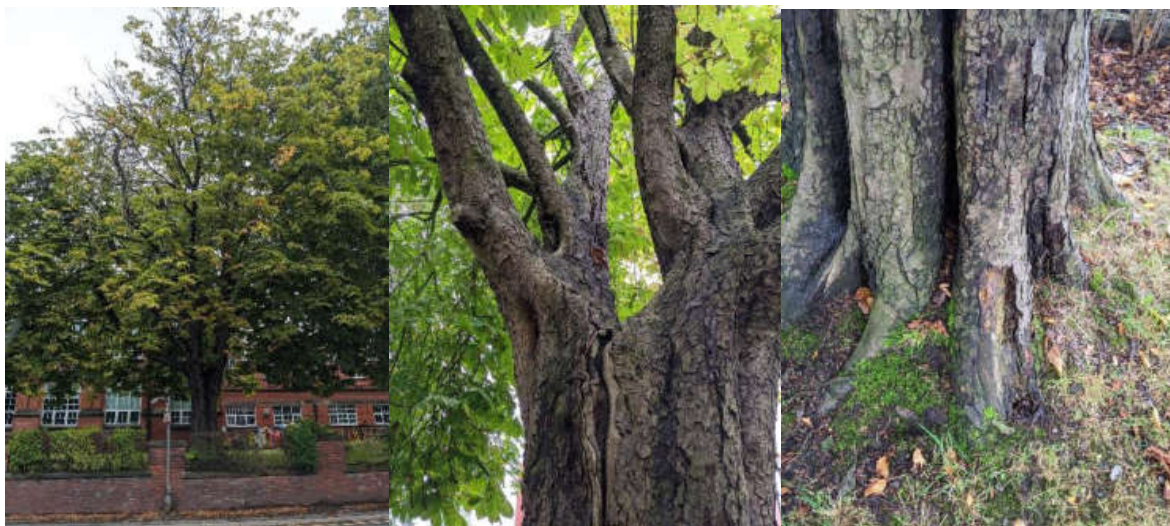
Tree № 29 a horse chestnut requires removal due to its incredibly poor physiological condition and its proximity to the public highway. in such a high traffic area, it is better to remove the risk altogether (Mattheck, et al., 2015).

*Figure 6. Crown dieback and some of the points of the poor physiological condition of tree 29.*

| 29 | - | Horse Chestnut | 870 | 7 | 6 | 7 | 8.5 | M | 13 | Missing bark from floor level and stem is split up to main fork at 2.5m to the W. Splits in bark continue up N side of scaffold limbs.<br><br>Leaf cover throughout the canopy is fairly thin.<br><br>SE section of crown exhibiting fairly heavy dieback. |

| 29 | <i>Aesculus hippocastanum</i> , Horse chestnut | Remove. |

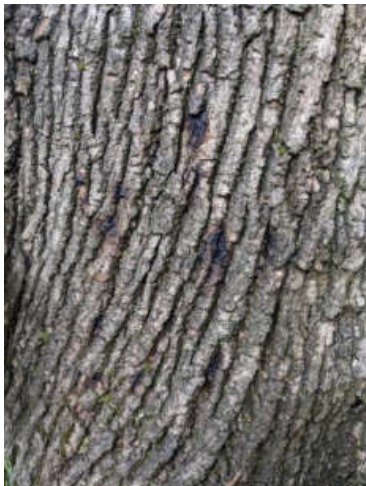
Figure 7. Potential *Phytophthora* spp. infection in the stem of tree 33, a sugar maple.

Thomas, 2018). Nos 31, 32, and 33 are sugar maples. Construction work has been carried out in close proximity to their root protection areas, they should be monitored closely for any detrimental reaction to this work for the next 3 years. Tree 33 is exhibiting some dark bleeding spots around its stem to the eastern side at around 1.3 –

1.8m These could be due to a possible *Phytophthora* spp. infection (University of Massachusetts Amherst, 2020).

| 33 | - | Sugar Maple | 820 | 2 | 6 | 7.5 | 8 | M | 13 | Slight lean to E.<br><br>Crown lifted to 5.5m<br><br>Dark spotting on SE side of stem.<br><br>Potential root damage due to construction work. Monitor health. |

| 33 | <i>Acer saccharum</i> , Sugar maple | Monitor for detrimental effects of construction work within RPA, Also, tree owner should monitor condition of dark bleeding spots in the lower section of the stem and monitor the crown for signs of stress or dieback. |

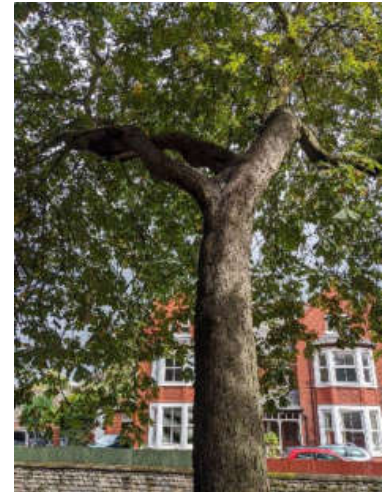
Tree № 28 a horse chestnut requires a crown reduction to reduce lever forces on the root-plate due to the angle the stem has grown at (Mattheck, et al., 2015), and to maintain bio-mechanical integrity and prevent tree failure, a 20% reduction is recommended (BSI, 2010).

Figure 8. Tree 28 heavily leaning towards the public highway.

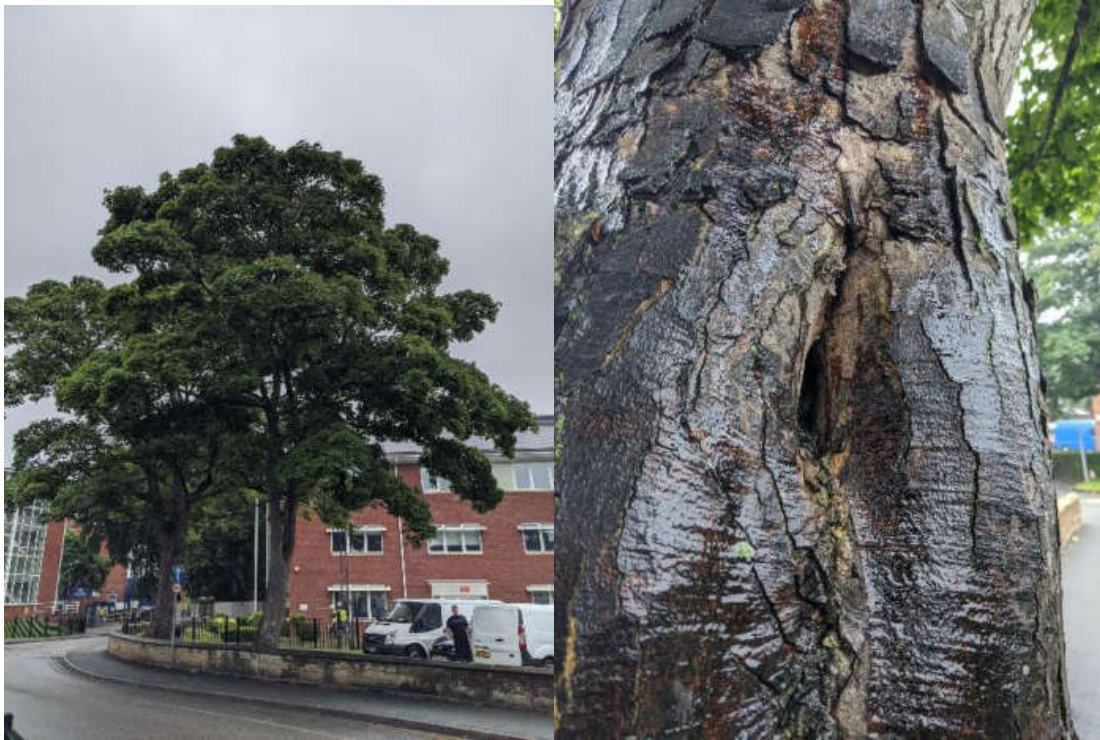
*Figure 9. Tree 1 (sycamore) and its occluding wound on the NW side of the stem at 1.9m*

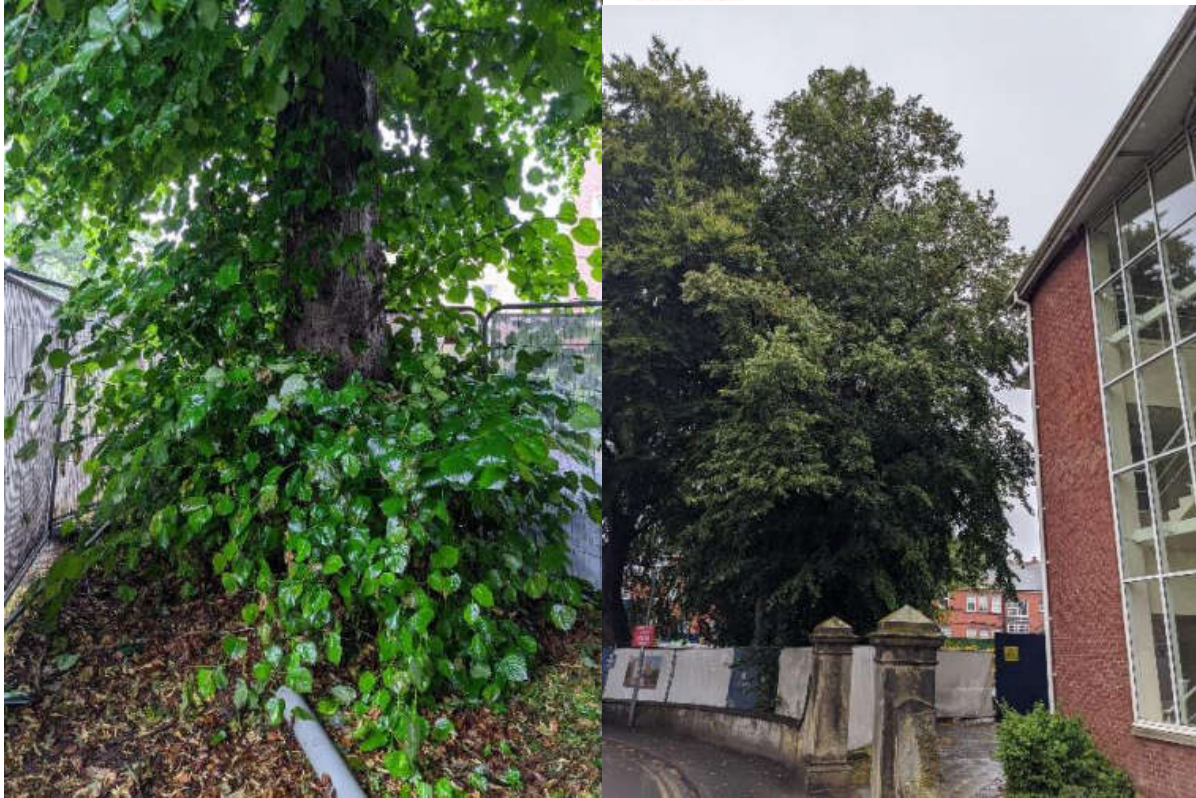
Figure 11. Tree 3 (common lime) with its adventitious growth around the base (left) and its crown proximity to the adjacent building (right).

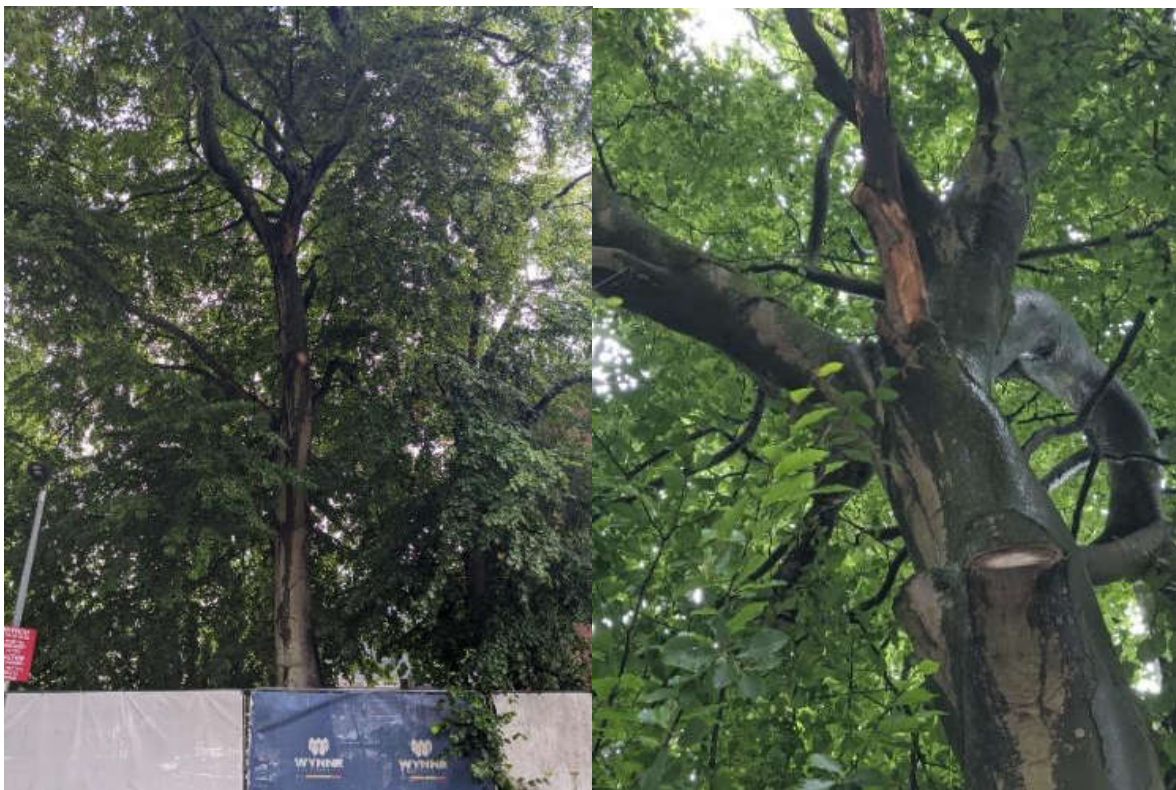
Figure 12. Tree 4 (beech) showing its bark-stripped deadwood above roadway to the right.

| Tree № | Species | Recommended works |
|---|---|---|
| 4 | <i>Fagus sylvatica</i> , Beech | Remove deadwood. |

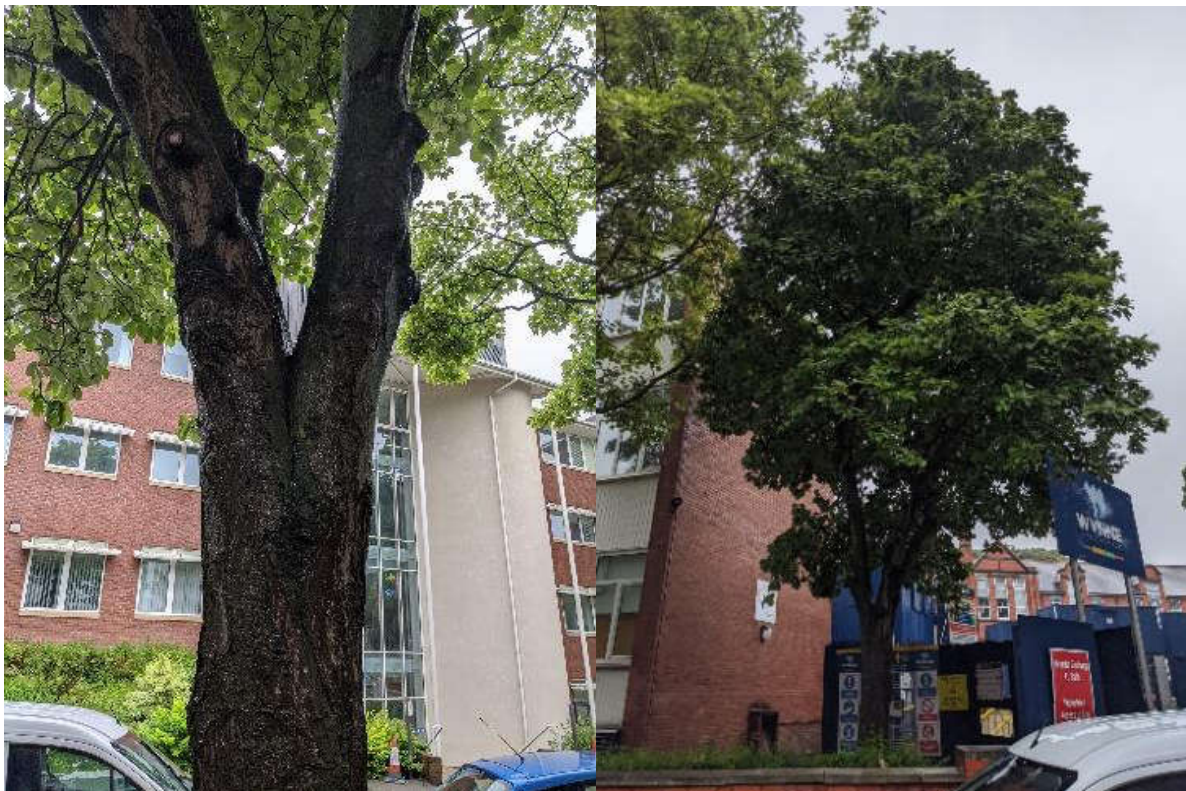
Figure 14. Tree 7 (Swedish whitebeam)) with slight bark inclusion and proximity to building.

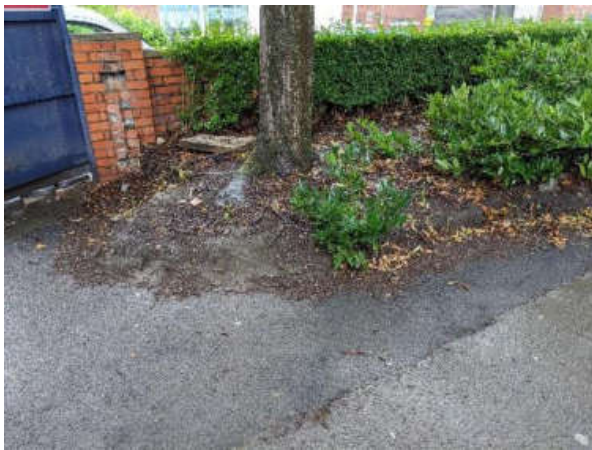
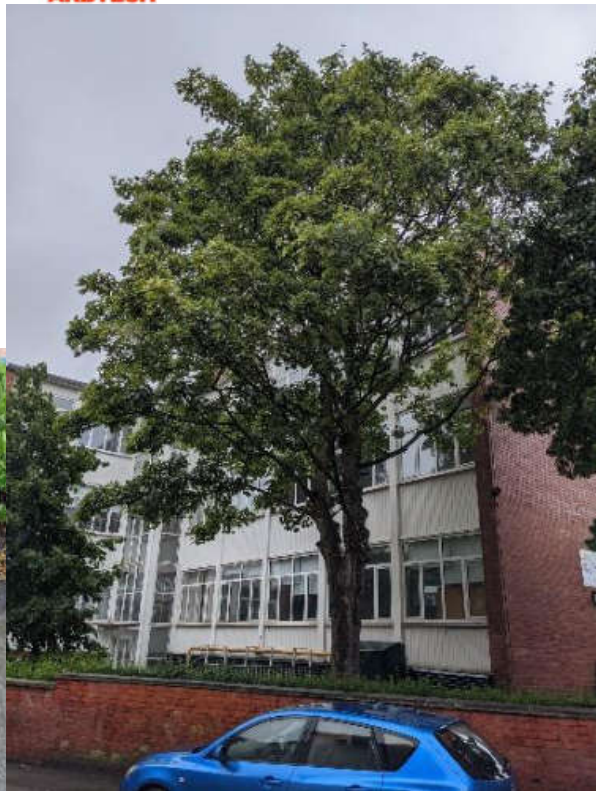
Figure 15. Tree 7 (Swedish whitebeam)( left) showing potential level change having occurred some time ago. Tree 8 (variegated sycamore)(right) proximity to building.

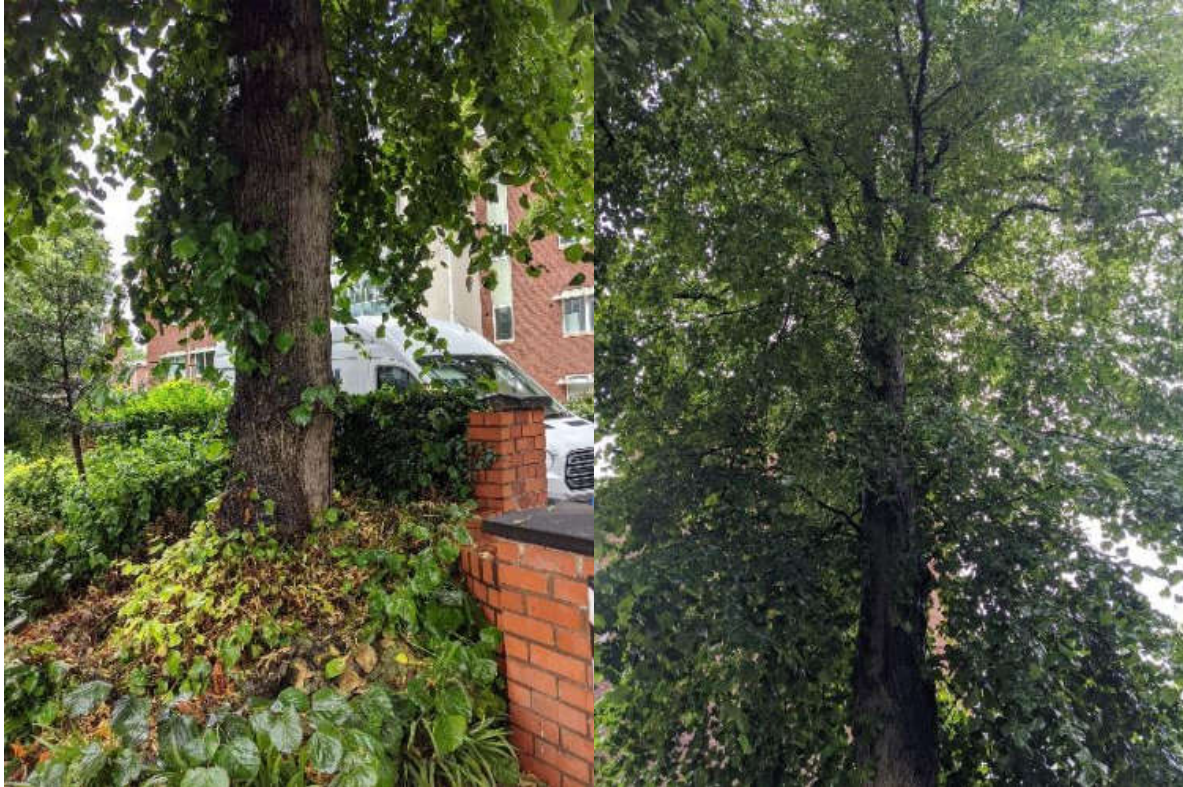
Figure 17. Tree 10 (common lime) basal adventitious growth and crown structure.

| 10 | <i>Tilia x europaea</i> , Common lime | Completely and thoroughly remove all adventitious growth from around base of tree to enable proper inspection of root buttresses. |

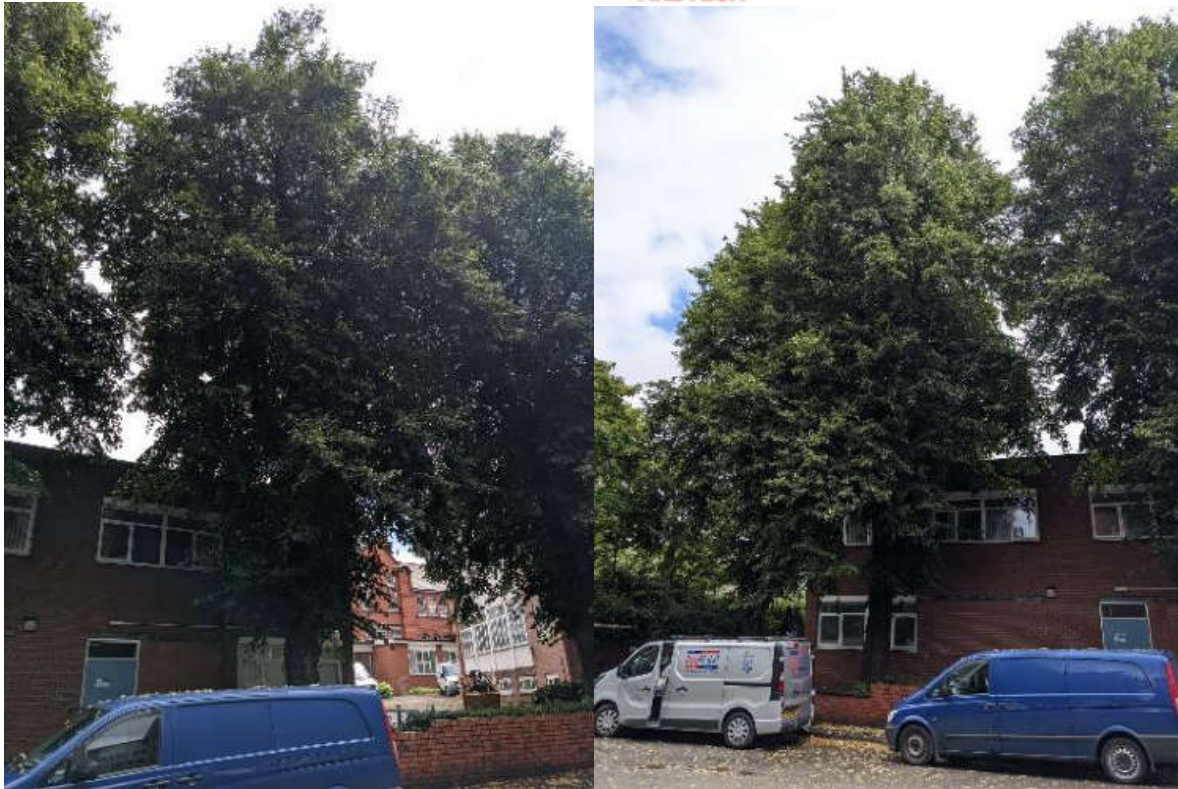
Figure 19. Tree 13 (left) and tree 14 (right) showing crown proximity to the adjacent building (both common limes).

| 13 | <i>Tilia x europaea</i> , Common Lime | Completely and thoroughly remove all adventitious growth from around base of tree to enable proper inspection of root buttresses.<br><br>Crown lift to above the roofline of the adjacent building to prevent further encroachment and to allow natural light into the upstairs windows of the building. |
| 14 | <i>Tilia x europaea</i> , Common lime | Completely and thoroughly remove all adventitious growth from around base of tree to enable proper inspection of root buttresses.<br><br>Crown lift to above the roofline of the adjacent building to prevent further encroachment and to allow natural light into the upstairs windows of the building. |

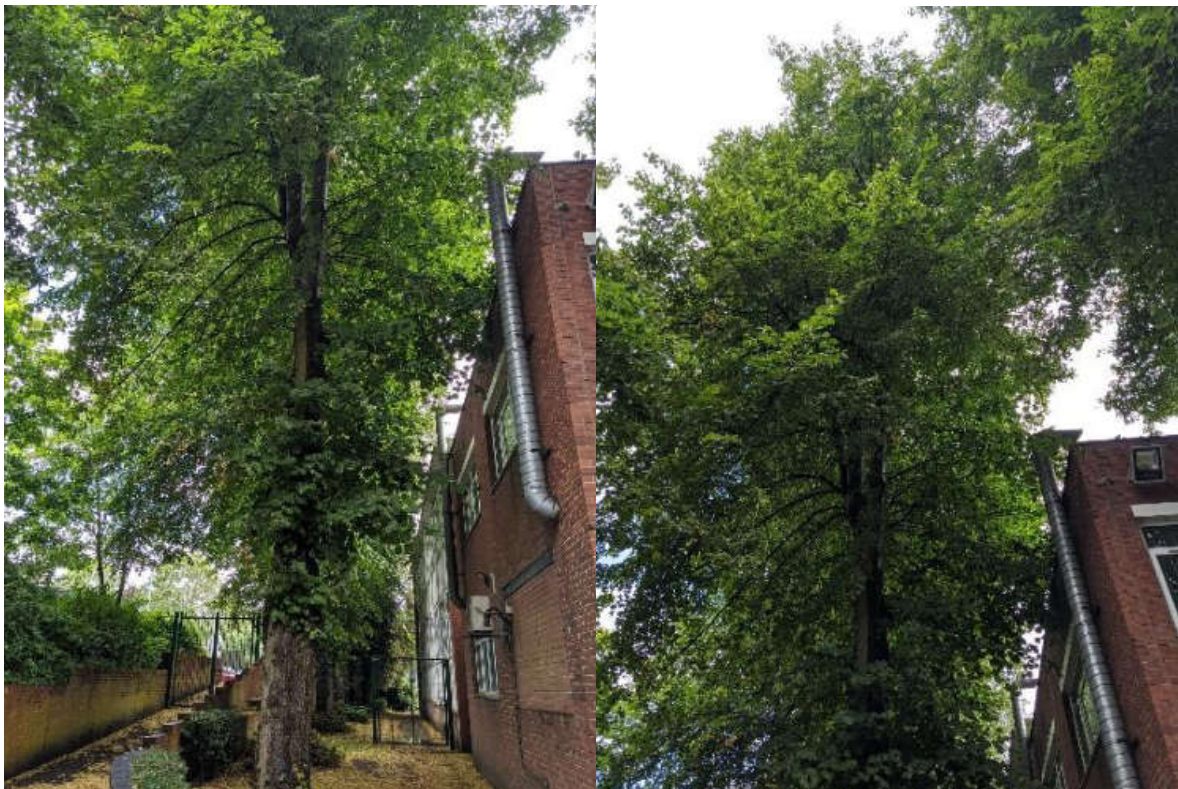
| 15 | - | Common Lime | 630 | 3 | 3 | 4 | 5 | M | 16 | <p>Adventitious growth around base of tree pruned back with hedge cutters.</p> <p>Foliage of tree encroaching upon the upstairs windows of the building blocking natural light.</p> <p>Fungal fruiting bodies found at base of tree identified as the Red Cracking Bolete (<i>Xerocomellus chrysenteron</i>)</p> |

Figure 20. Tree 15 (common lime) and its crown proximity to the adjacent building.

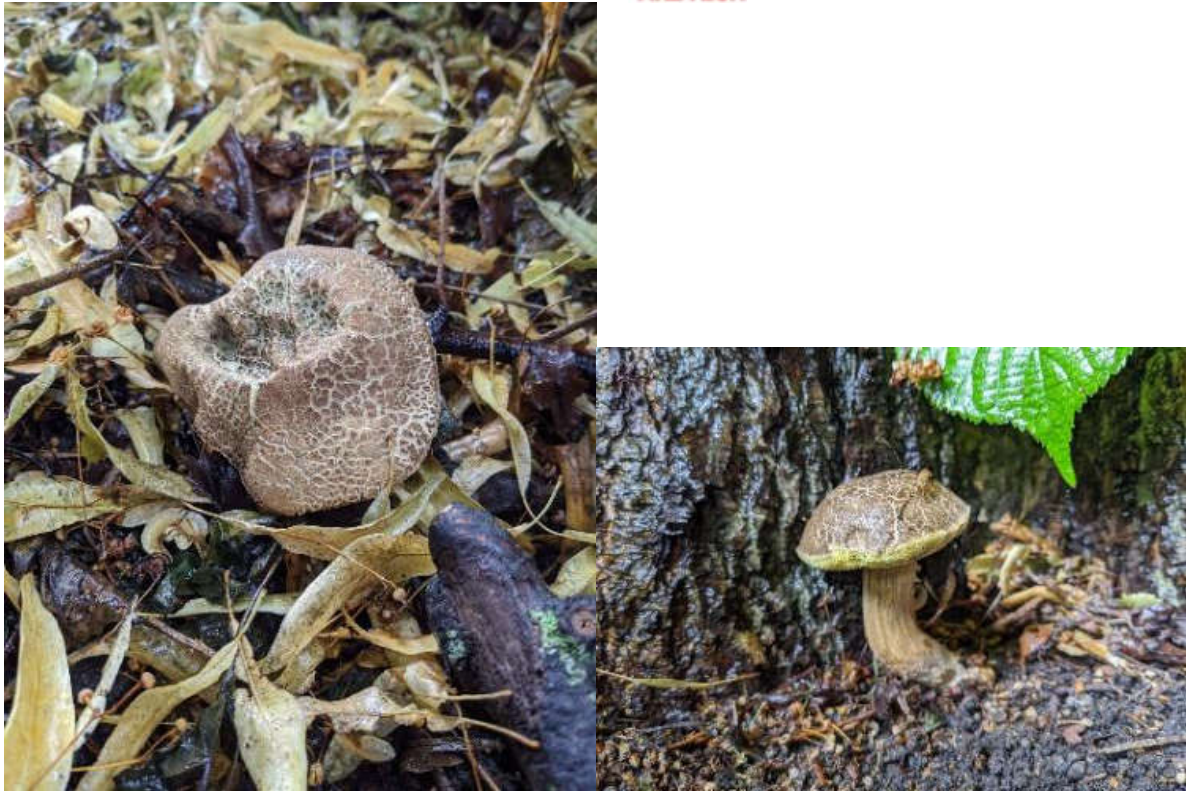
Figure 21. Tree 15 (common lime) red cracking bolete fruiting bodies found around the base of the tree.

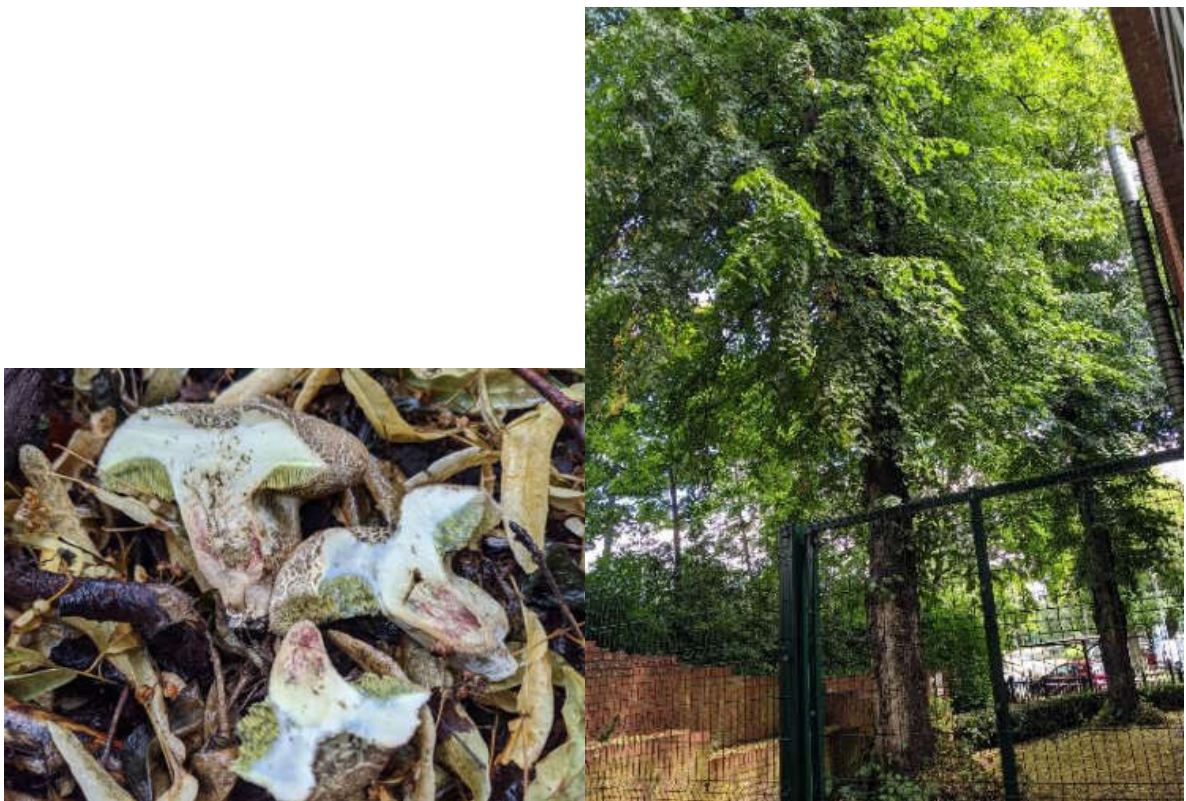
Figure 22. Disected red cracking bolete (*Xerocomellus chrysenteron*) fruiting bodies (left). Tree 16 stem and adventitious growth (right).

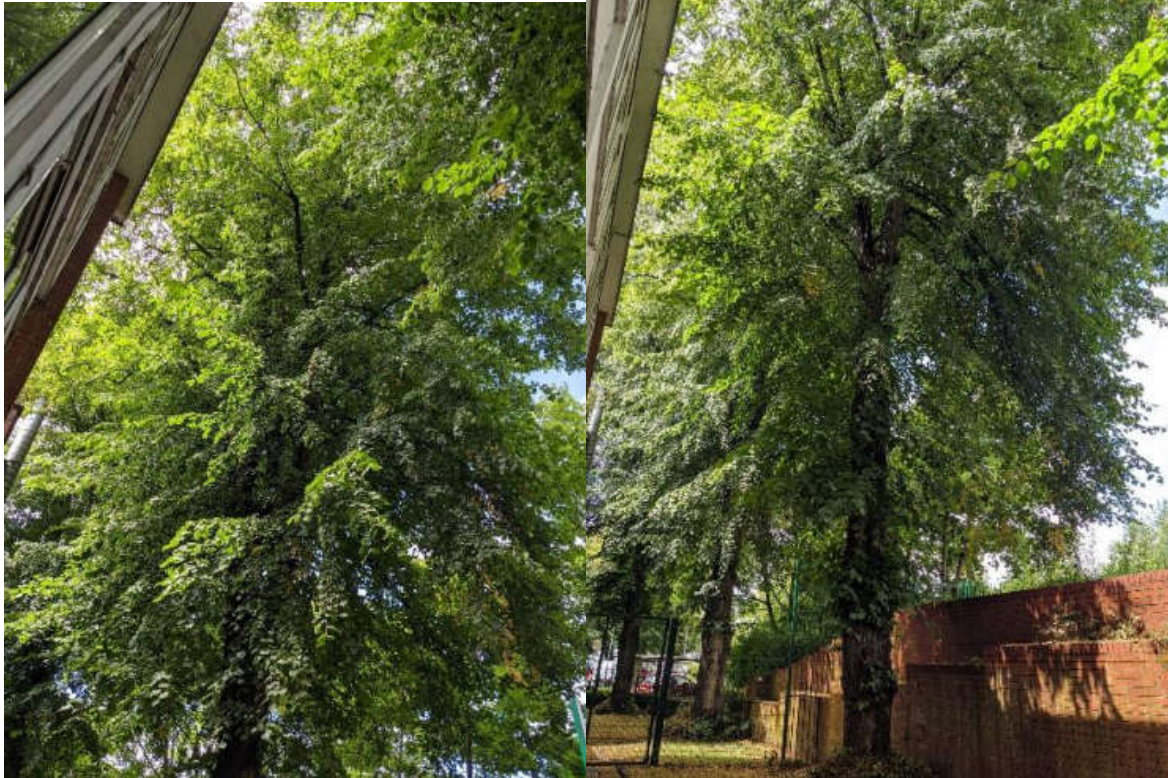
*Figure 23. Tree 16 (common lime) crown proximity to adjacent building.*

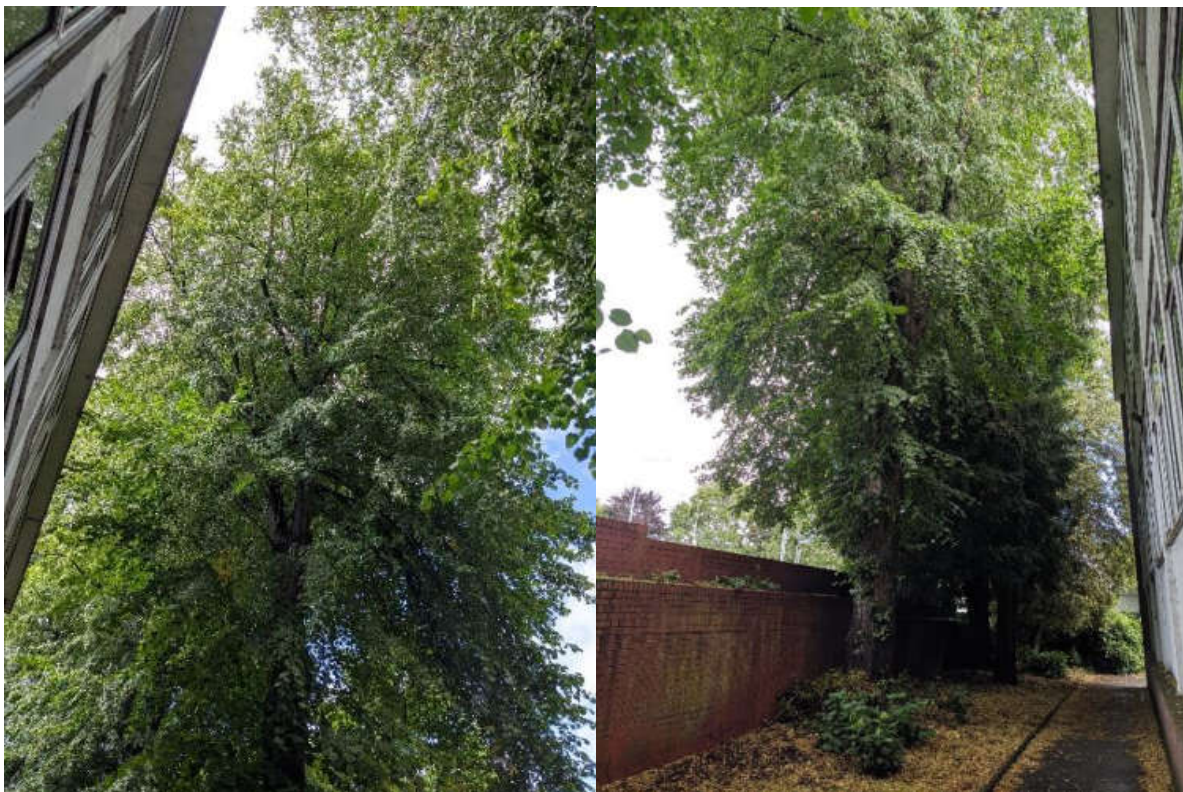
*Figure 24. Tree 17 (common lime) crown proximity to adjacent building (left) and basal adventitious growth (right).*

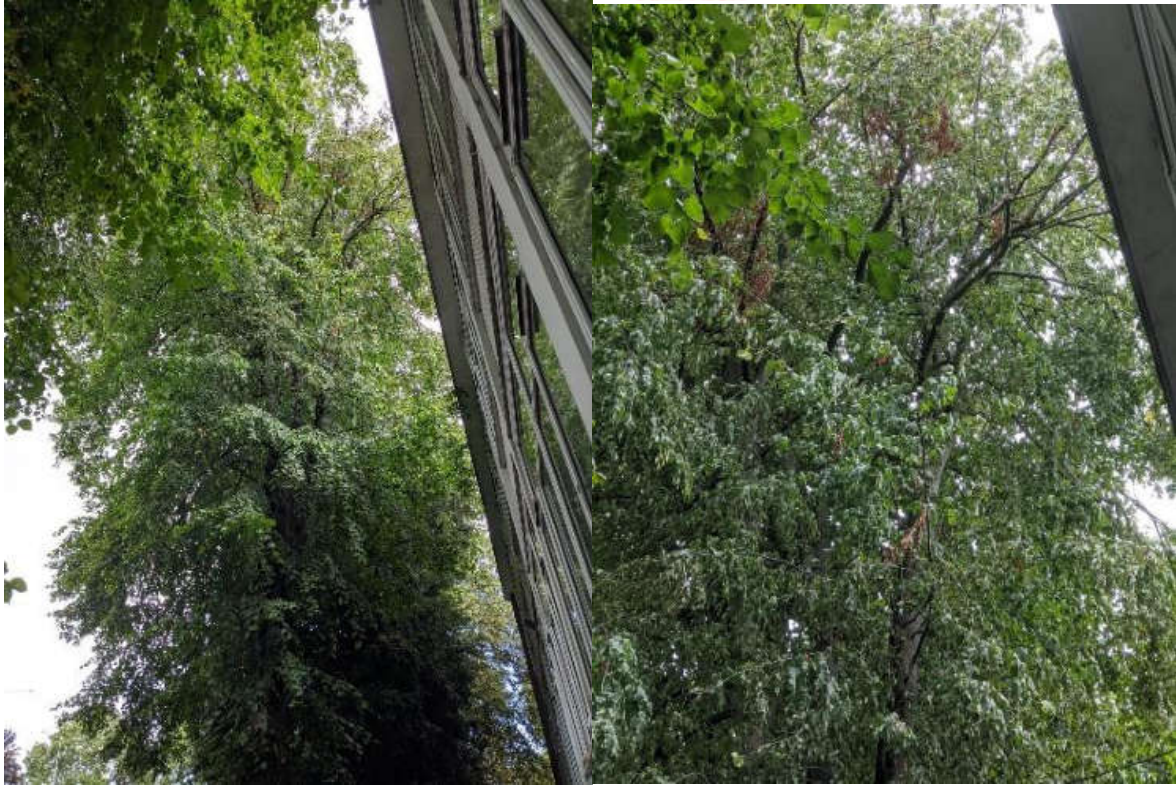
*Figure 25. Tree 18 (common lime) crown proximity to adjacent building.*

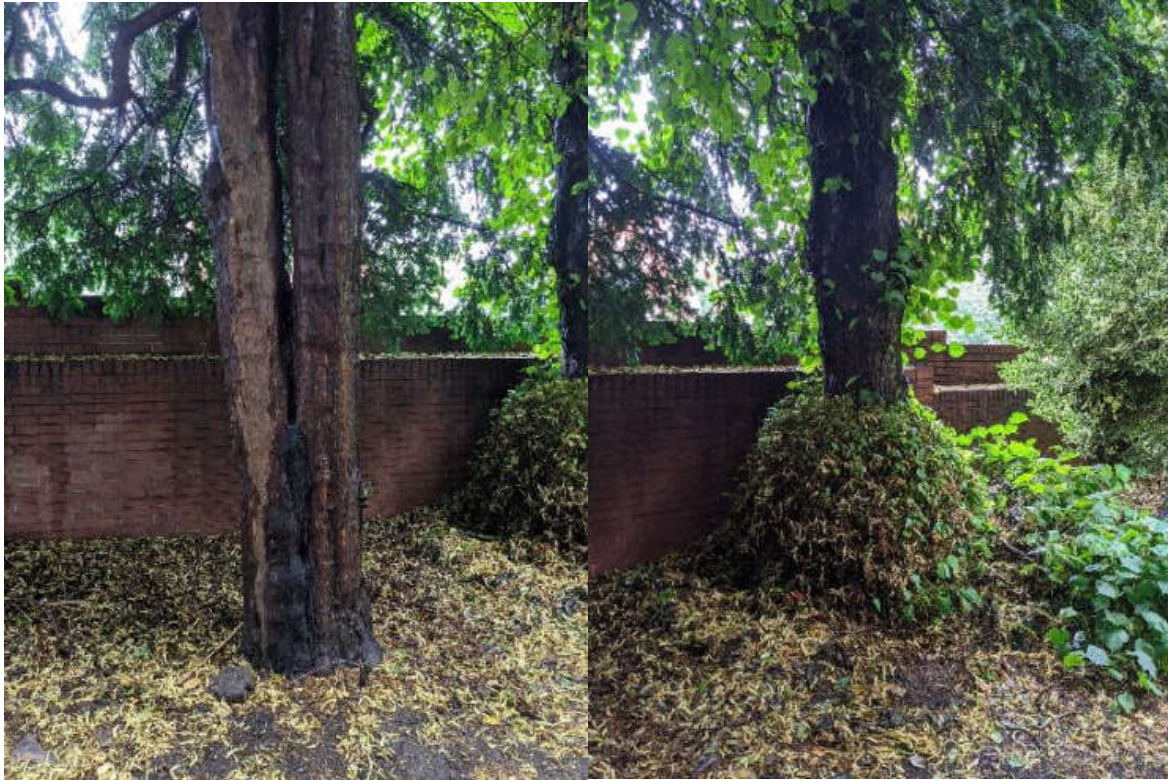
Figure 27. Tree 19 (yew) bifurcation at 1.0m (left). Tree 20 (common lime) basal adventitious growth to 1.5m completely obscuring the root buttresses.

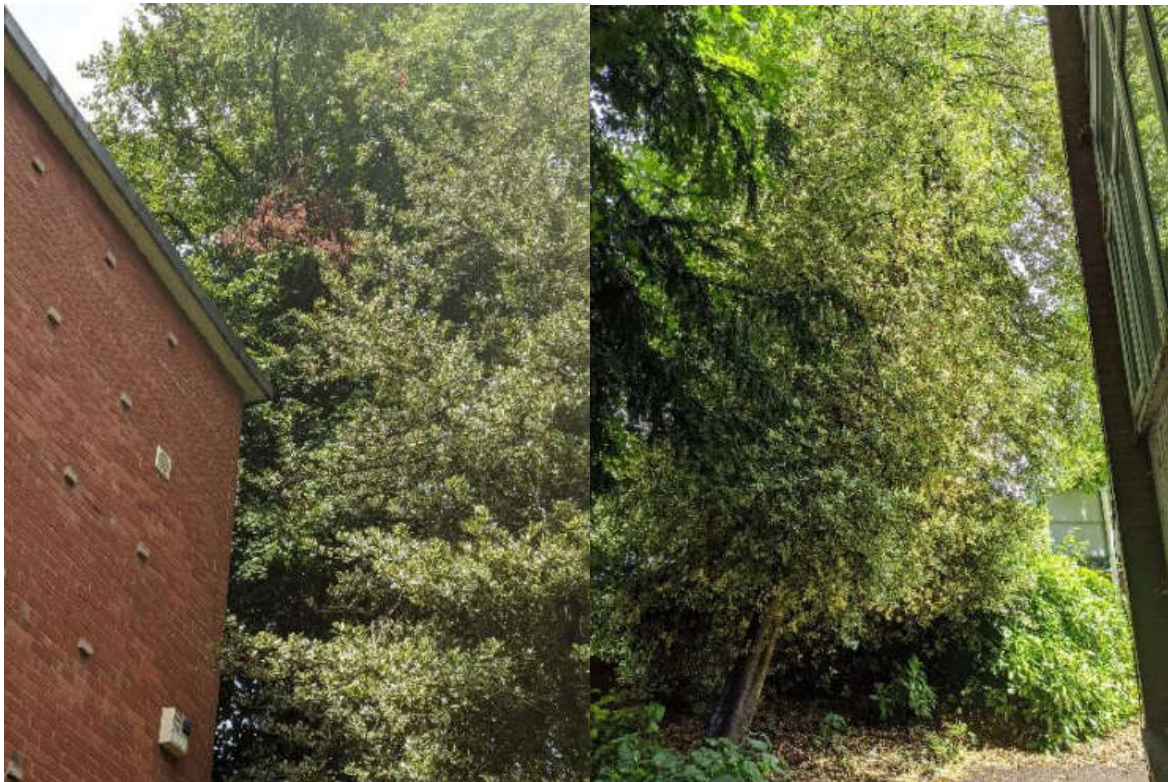
Figure 28. Trees 20 (common lime) and 21 (variegated holly) crown proximities to adjacent building (left). Tree 21 (variegated holly) exhibiting correction of 15° lean.

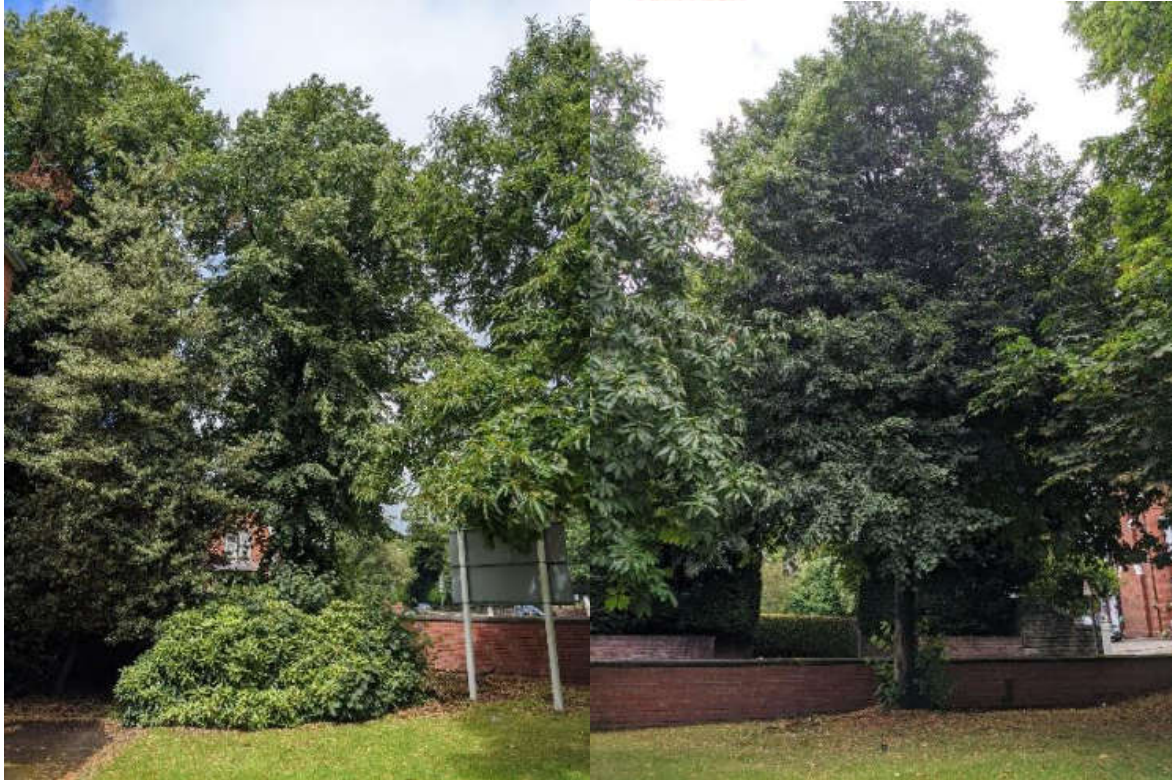
Figure 29. Tree 22 (common lime) has adventitious growth to 1.3m completely obscuring the root buttresses (left). Tree 23 (common lime) with a small amount of basal adventitious growth (right).

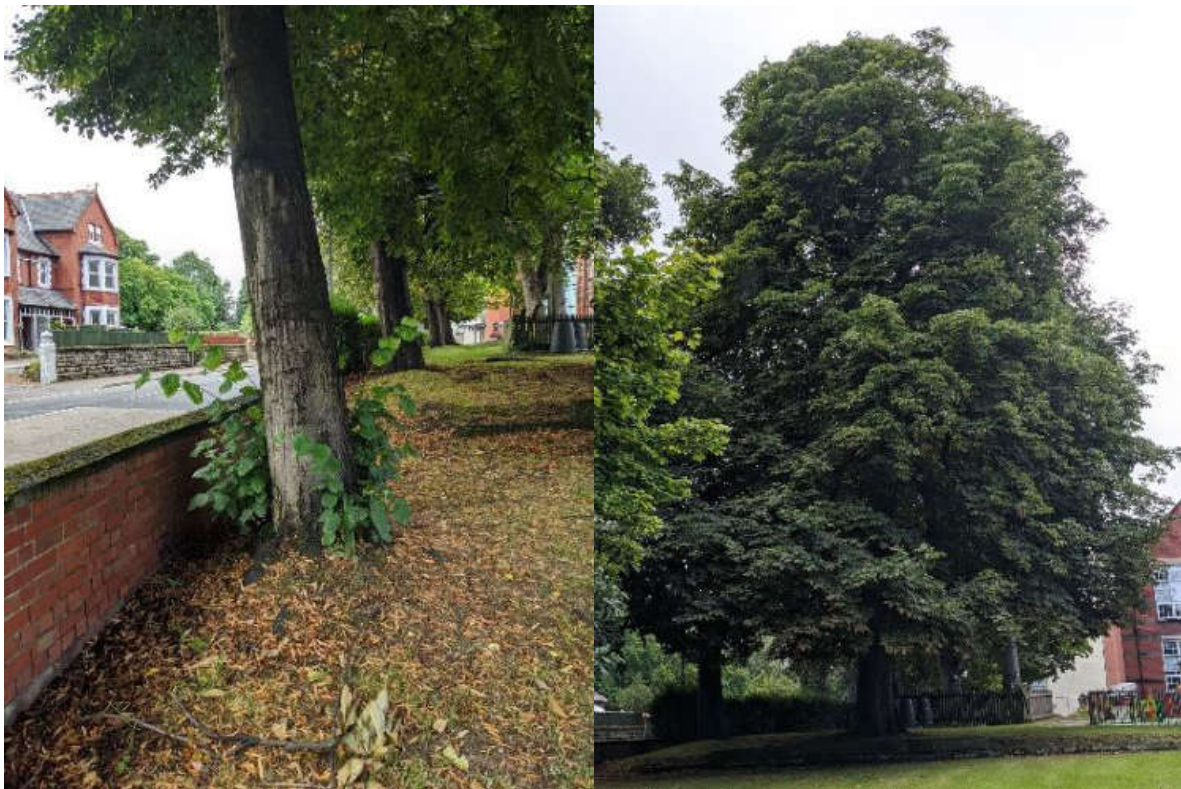
Figure 30. Tree 23 (common lime) exhibiting its small amount of basal adventitious growth (left). Tree 24 (horse chestnut)

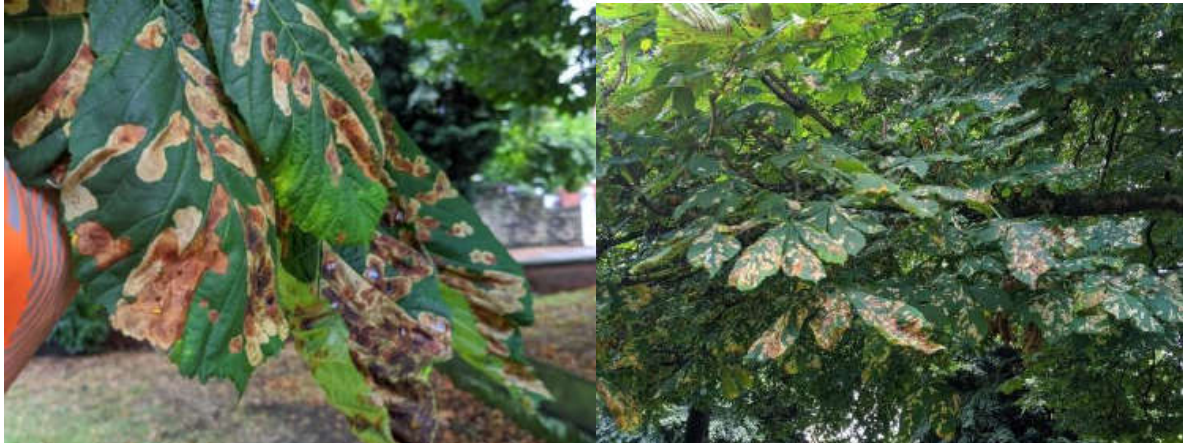
Figure 31. examples of levels of horse chestnut leaf miner affecting all of this species on this site. Taken from tree 24.

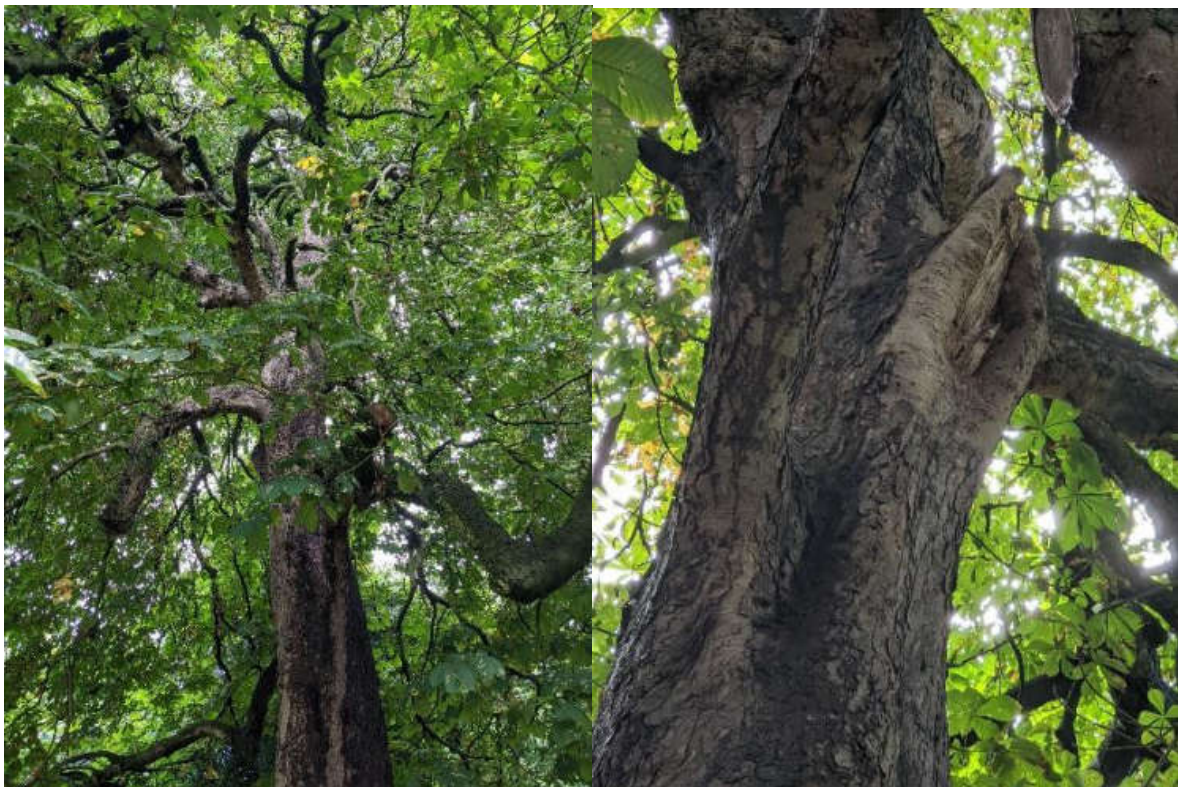
Figure 32. Tree 24 (horse chestnut) crown structure and large limb removed to SW (left). Tree 25 (horse chestnut) occlusion of large limb-loss wound to SW.

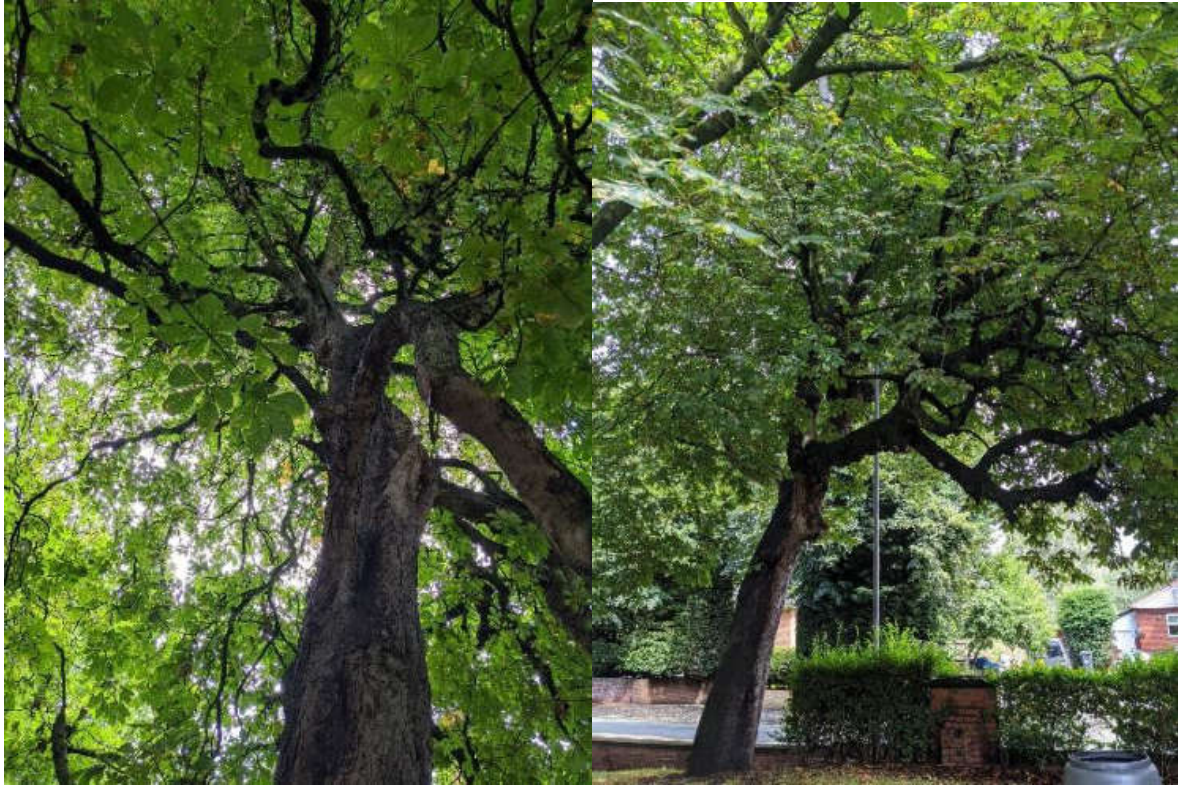
Figure 33. Tree 25 (horse chestnut) large limb-loss wound to SW (left) and exhibiting lean over road to SE (right).

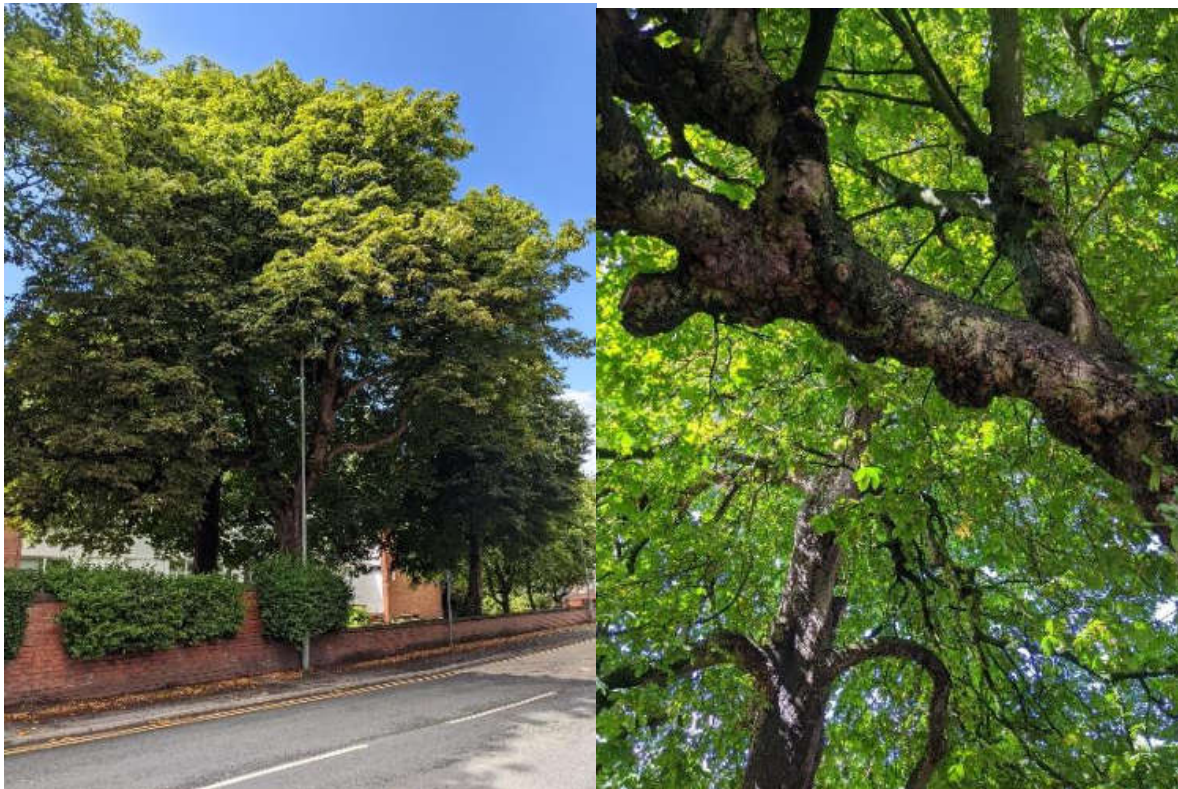
Figure 34. Tree 25 (horse chestnut) extensively pruned away from streetlight (left) and dysfunction shown in lowest limb to the SW probably caused by extensive crown lifting (right).
