9/25/2020

# Yale College (Coleg Cambria)

Mature Tree Survey

Rob Mays  
EVOLUTION ARBTECH

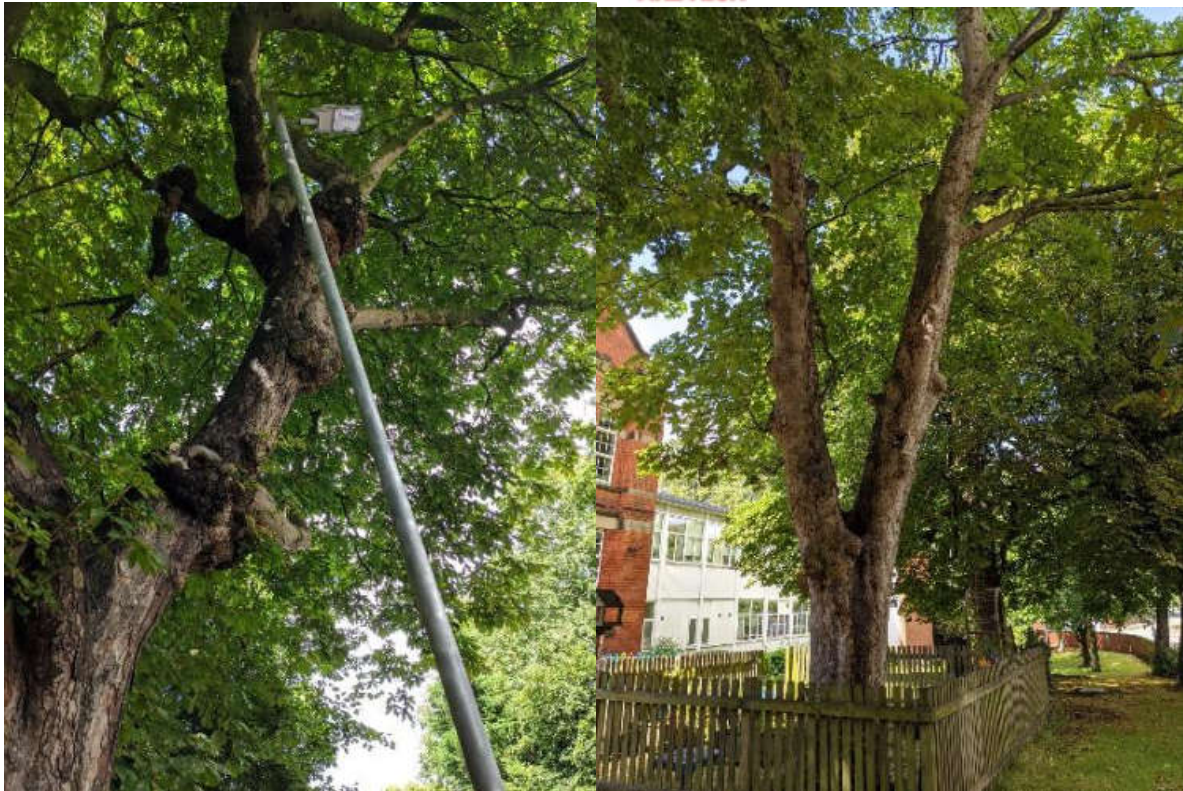
*Figure 35. Tree 25 (horse chestnut) extensively pruned away from street light)(left). Tree 26 (sycamore) bifurcation at 2.3m and showing extensive crown lifting.*

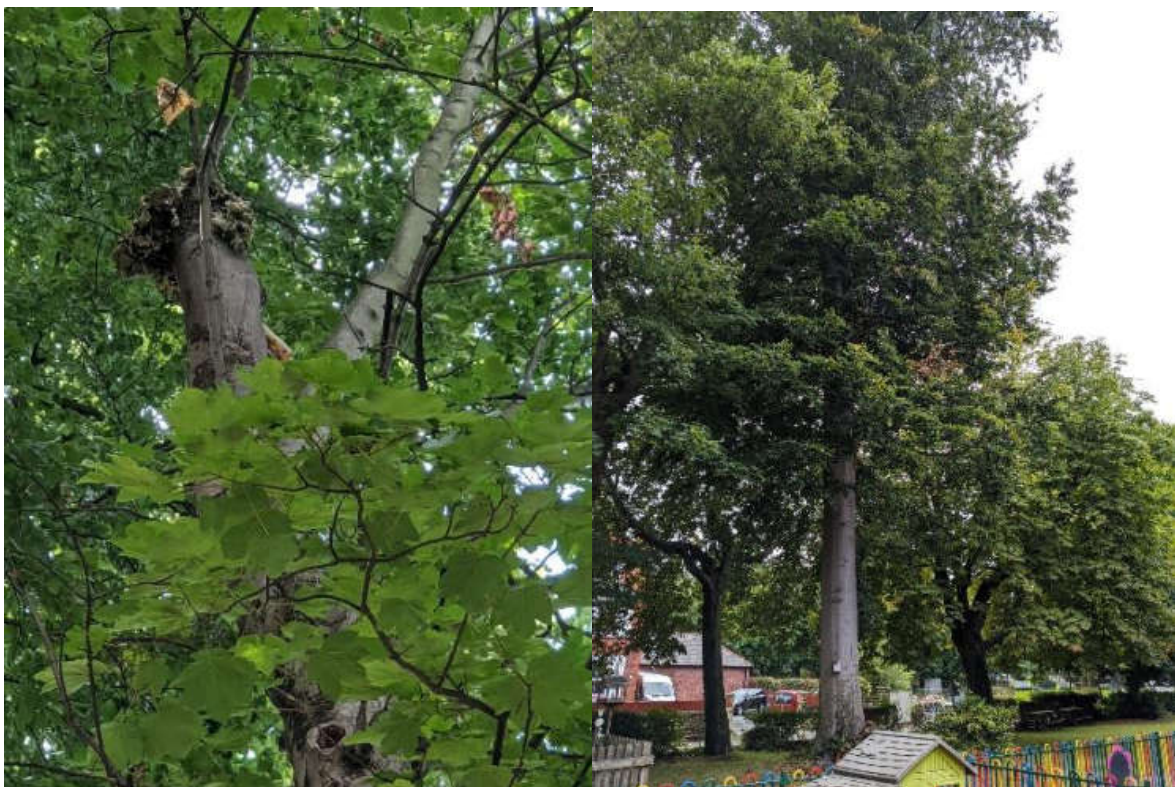
*Figure 36. Tree 26 (sycamore) zoomed-in shot of point where tree has been reduced to around 9m (left). Tree 27 (beech) (right)*

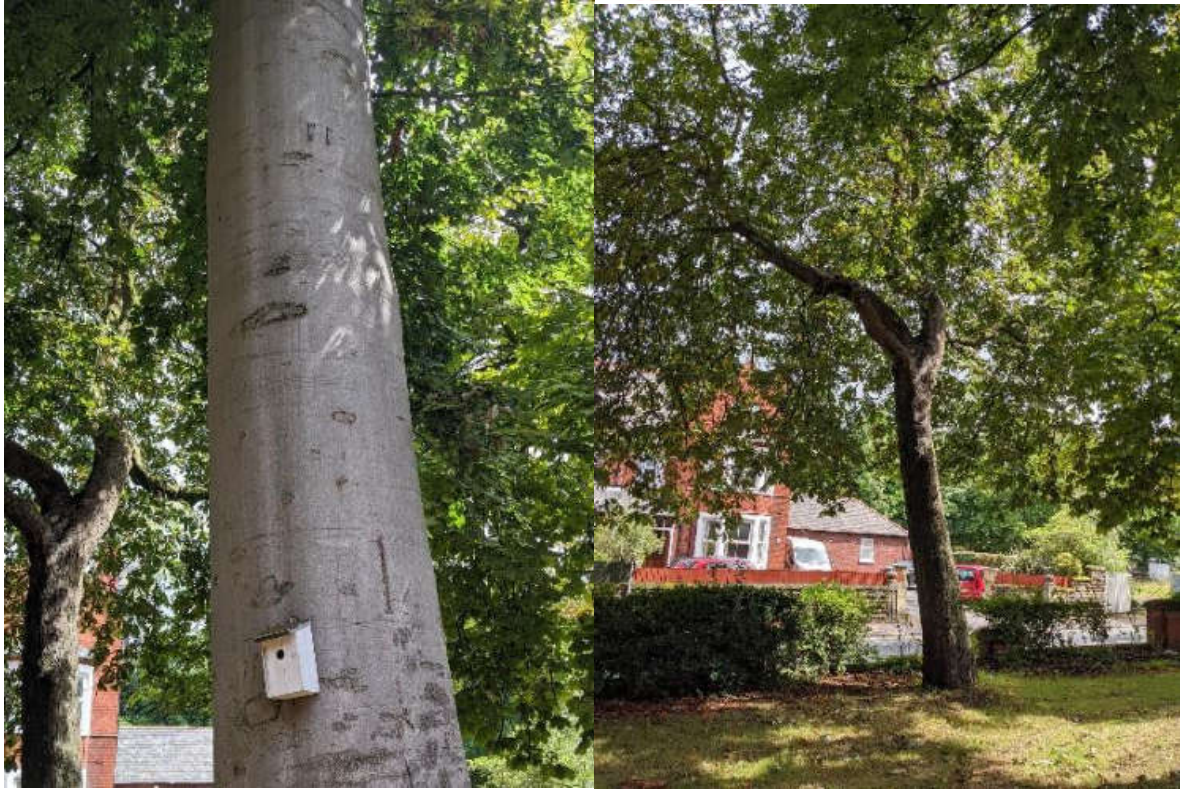
Figure 37. Tree 27 (beech) attachment of bird box to stem at 1.8m to the NW (left). Tree 28 (horse chestnut) exhibiting an asymmetric crown and lean due to shading out from the W side.

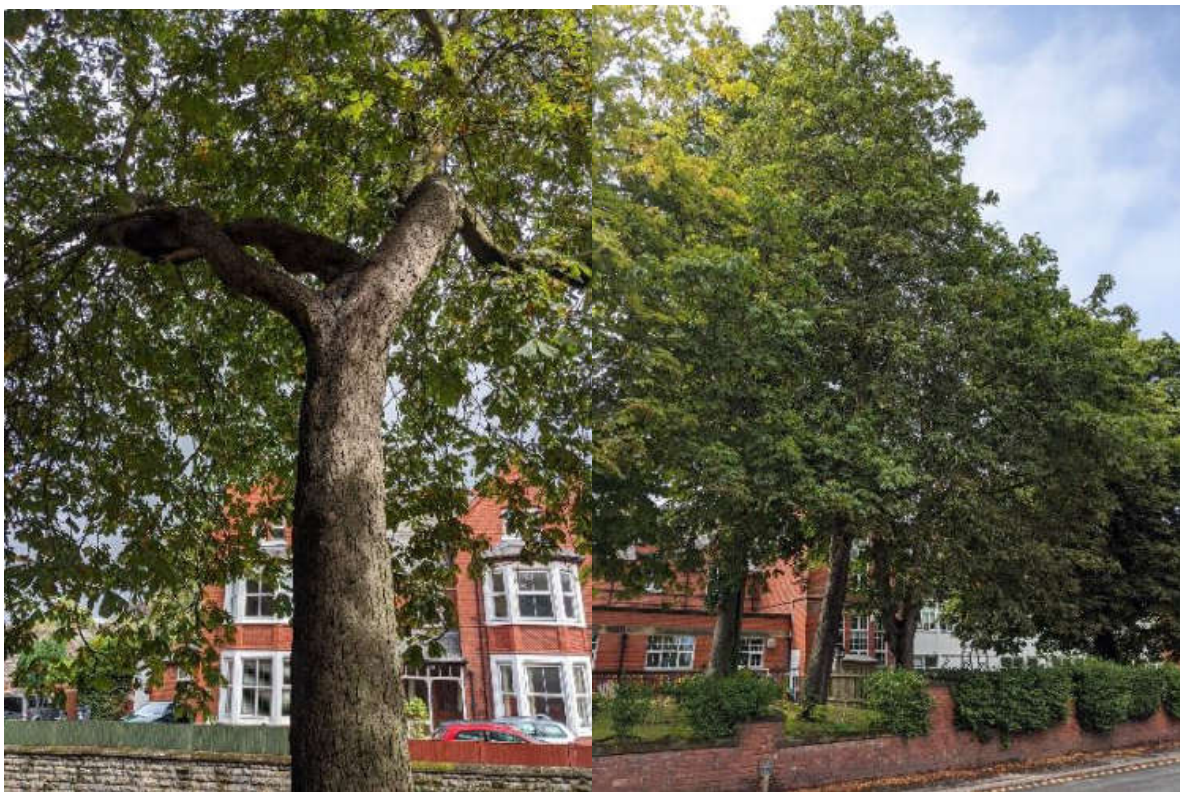
Figure 38. Tree 28 (horse chestnut) from W side showing lean over Chester Road (left) and crown taken from E side (right).

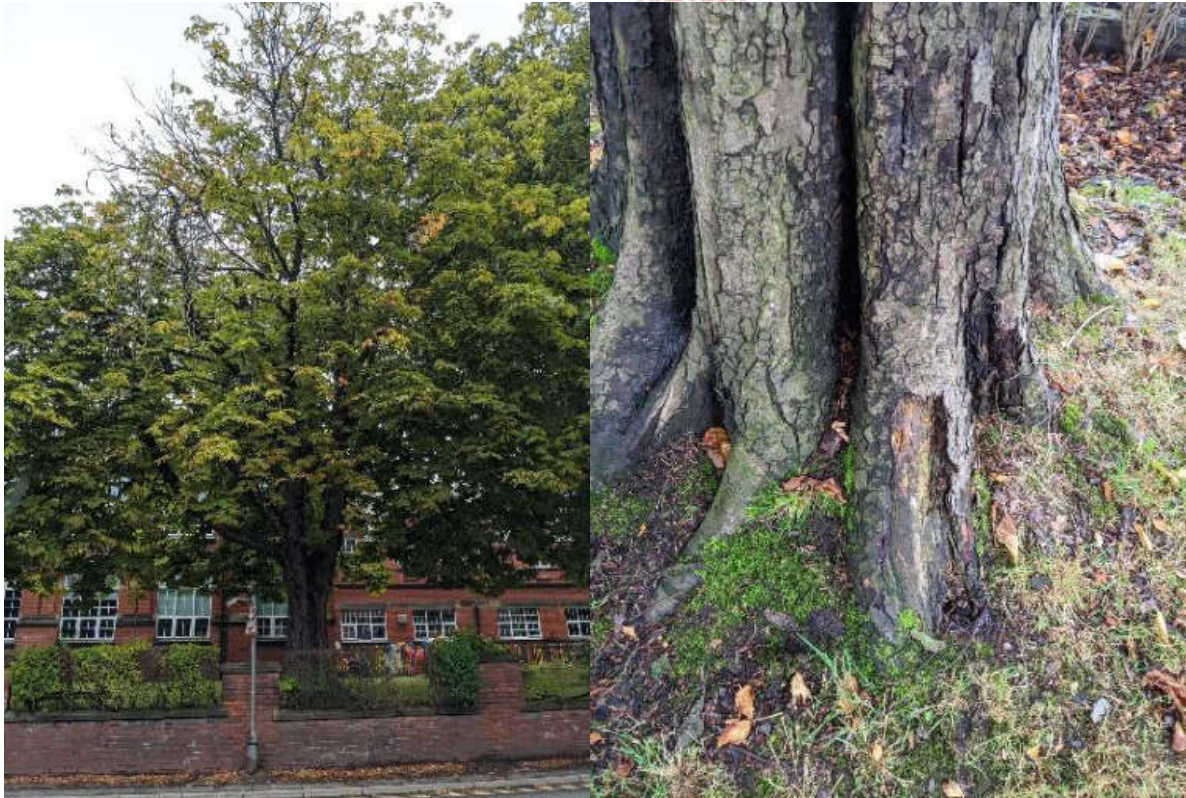
*Figure 39. Tree 29 (horse chestnut) exhibiting dieback in the S side of the crown (left) and bark missing from the root buttresses exposing very soft timber beneath.*

| 29 | <i>Aesculus hippocastanum</i> , Horse chestnut | Remove. |

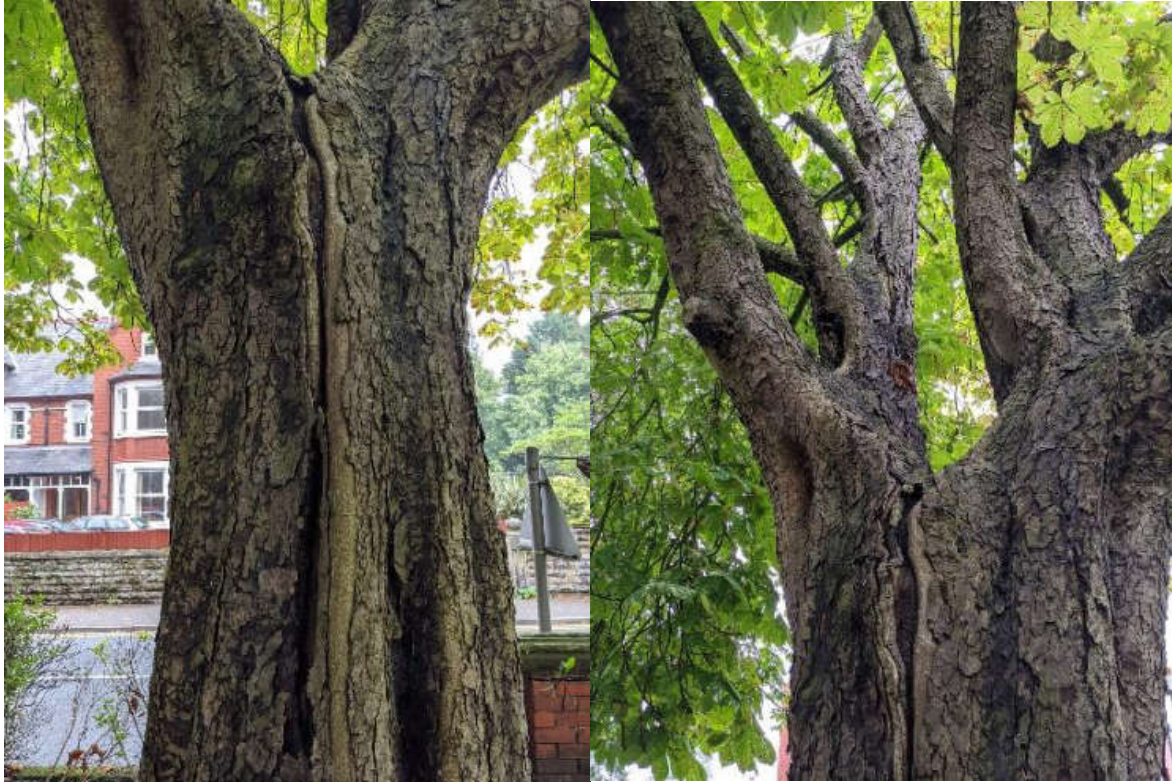
*Figure 40. Tree 29 (horse chestnut) exhibiting a large split that runs from the floor to the main fork. This is showing some signs of occlusion but exposed timber is soft and degrading. The crown above is showing many areas of missing bark and dieback above these areas.*

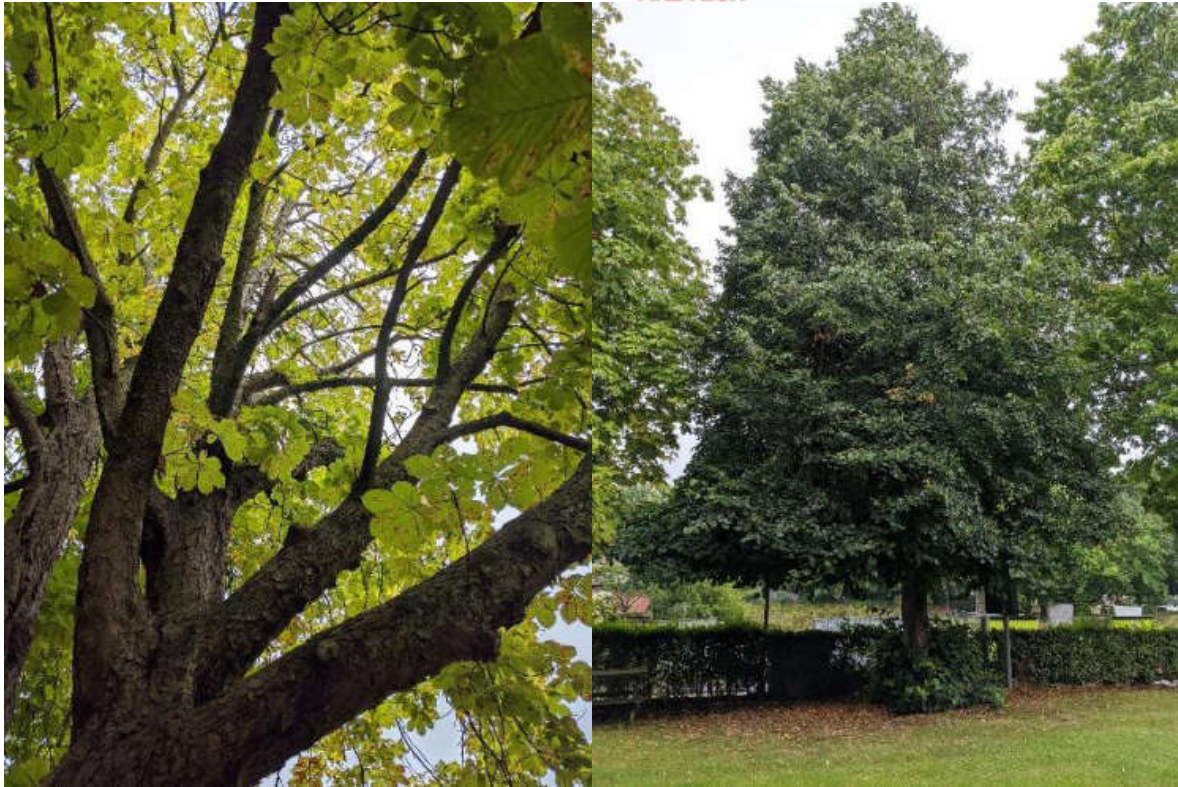
Figure 41. Tree 29 (horse chestnut) showing its main area of thinning and dieback in the crown to the S side from below (left). Tree 30 (common lime) with basal adventitious growth obscuring the root buttresses (right).

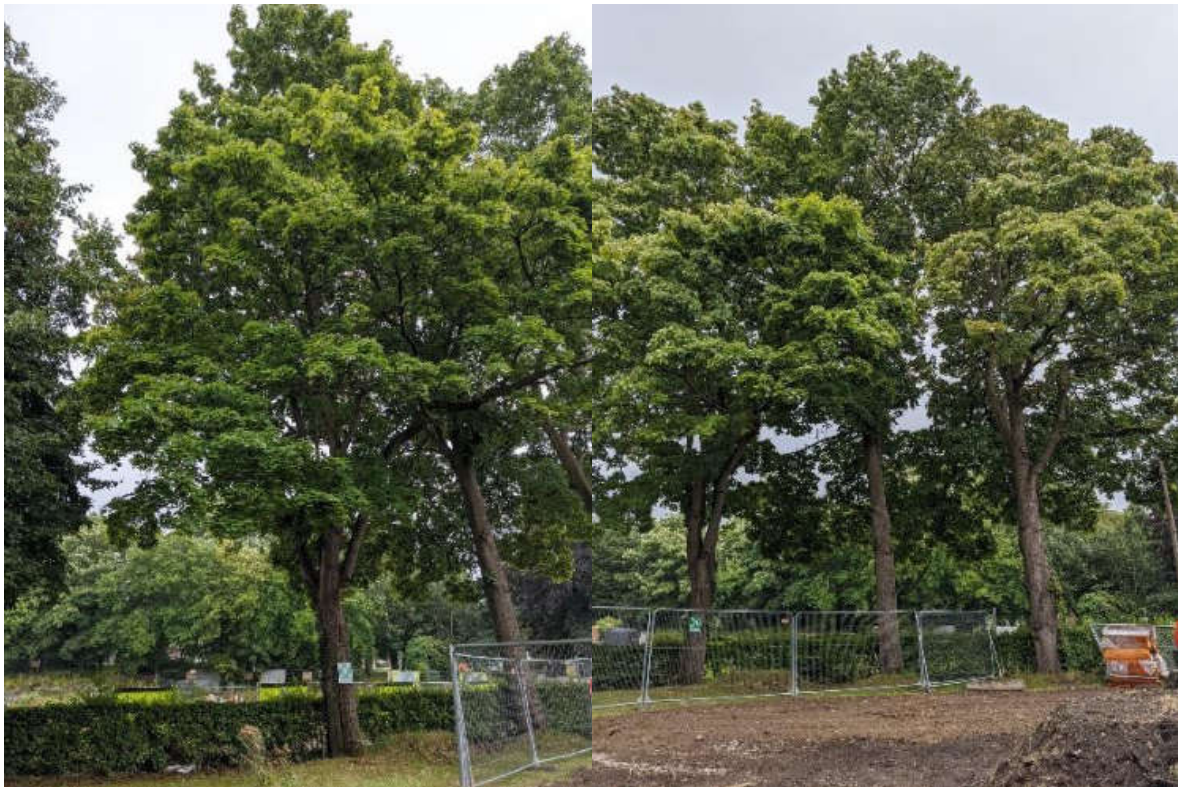
Figure 42. Tree 31 32 and 33 (sugar maples) all exhibiting a slight lean to the E and crown lifts between 4.5m ad 5.5 m

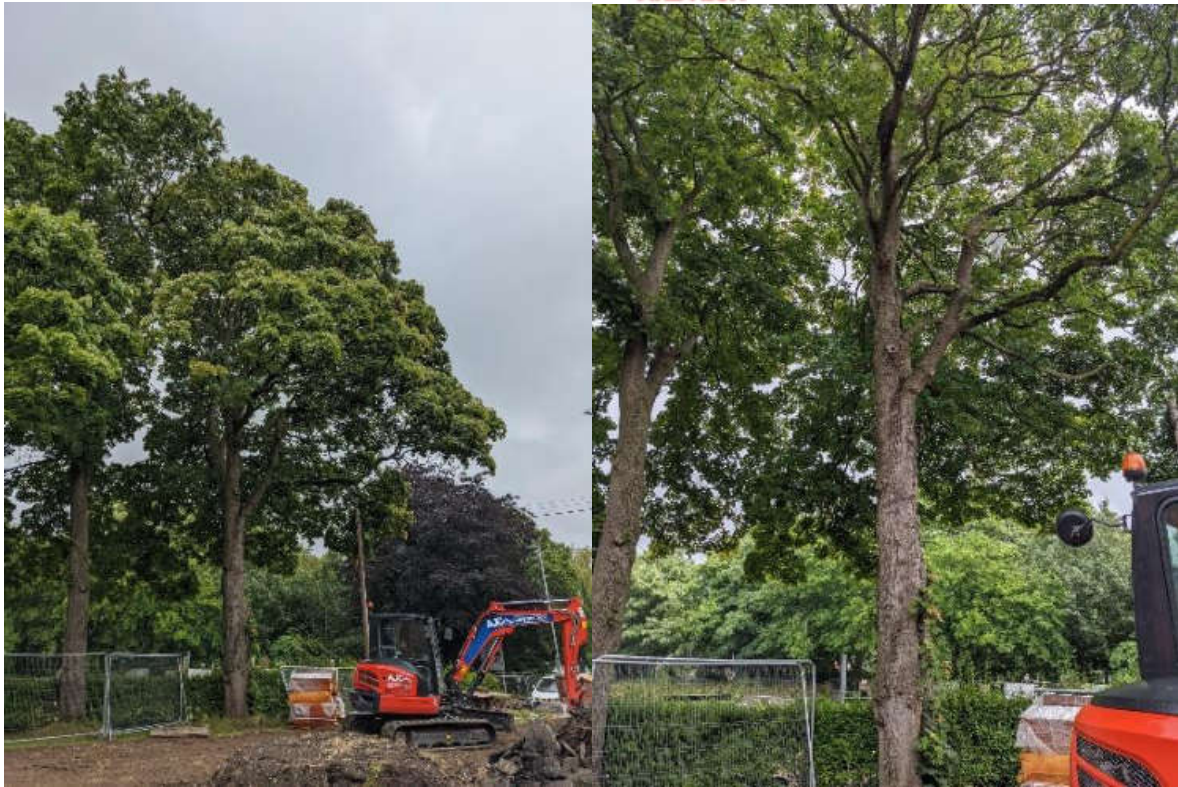
| 31 | - | Sugar Maple | 655 | 4 | 6 | 2 | 8 | M | 13 | Slight lean to E.<br><br>Crown lifted to 4.5m<br><br>Potential root damage due to construction work. Monitor health. |
| 32 | - | Sugar Maple | 615 | 2 | 6 | 2 | 8 | M | 13 | Slight lean to E.<br><br>Crown lifted to 5.5m<br><br>Potential root damage due to construction work. Monitor health. |

Figure 43. Trees 31, 32, and 33(sugar maples) and their proximity to the current construction work.

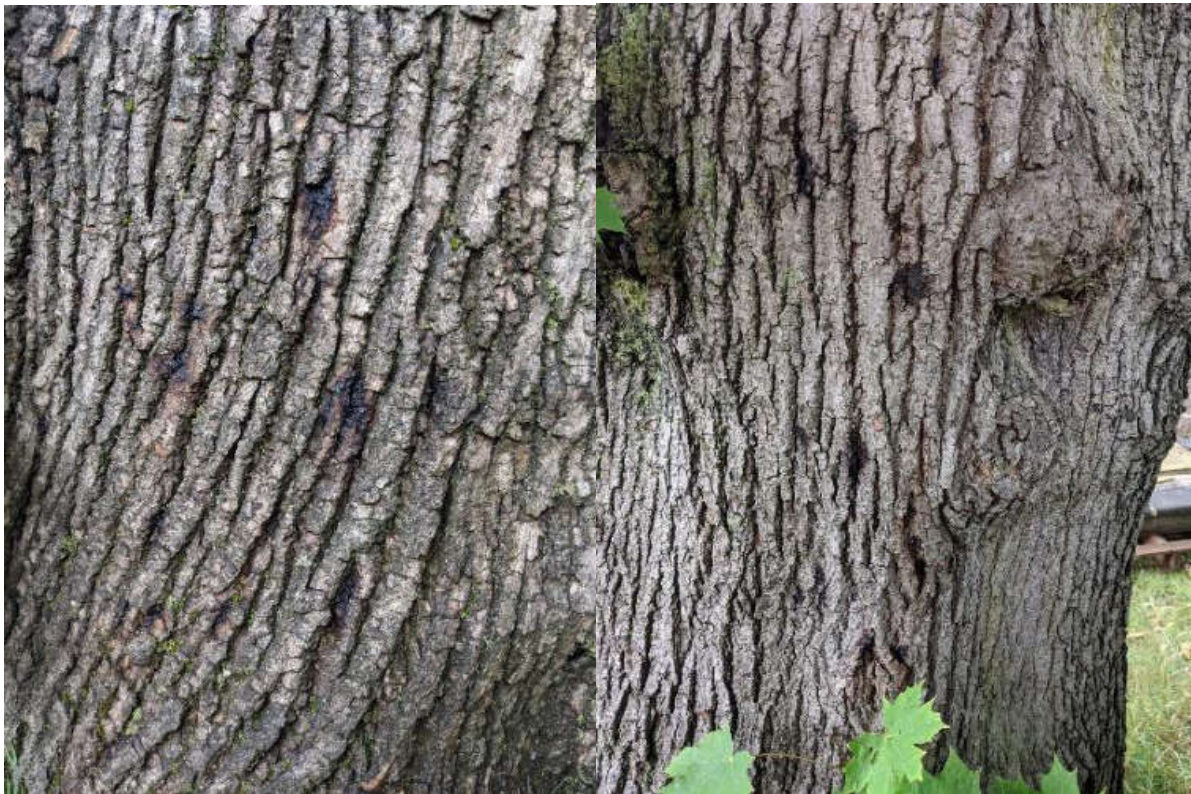
| 33 | - | Sugar Maple | 820 | 2 | 6 | 7.5 | 8 | M | 13 | Slight lean to E.<br><br>Crown lifted to 5.5m<br><br>Dark spotting on SE side of stem.<br><br>Potential root damage due to construction work. Monitor health. |

Figure 44. Tree 33 (sugar maple) Dark spotting found on stem at 1.3m to SE.

| 33 | <i>Acer saccharum</i> , Sugar maple | Monitor for detrimental effects of construction work within RPA, Also, tree owner should monitor condition of dark bleeding spots in the lower section of the stem and monitor the crown for signs of stress or dieback. |

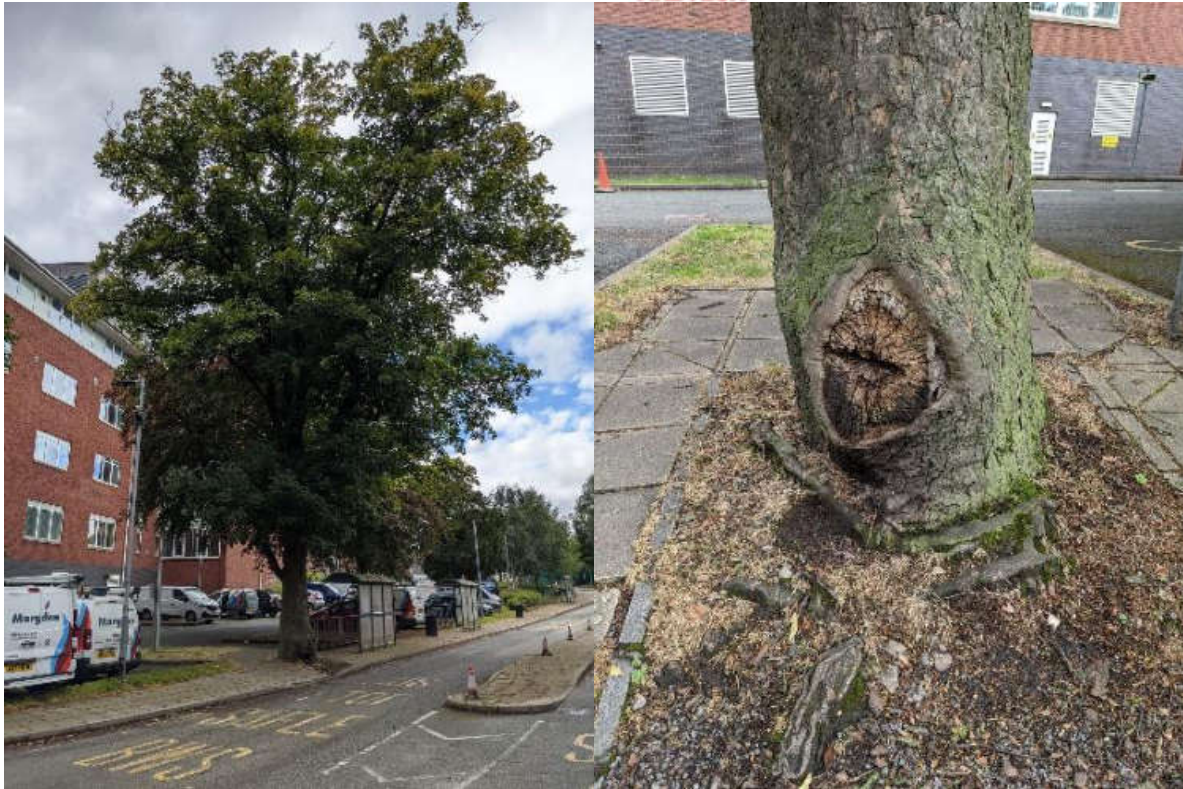
Figure 45. Tree 34 (sycamore) well contained within a hard-standing environment (left). Large limb removed at ground level showing beginnings of occlusion.

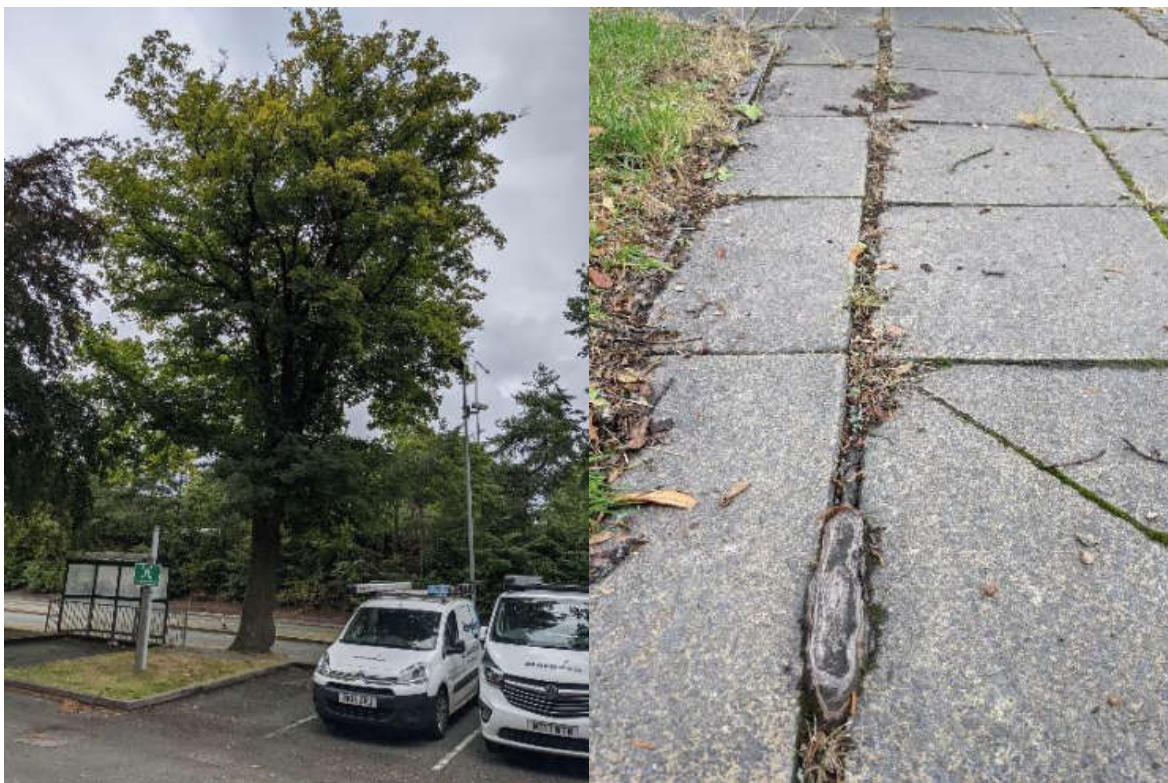
Figure 46. Tree 34 (sycamore) Crown size and structure (left). Roots pushing up between flags (right).

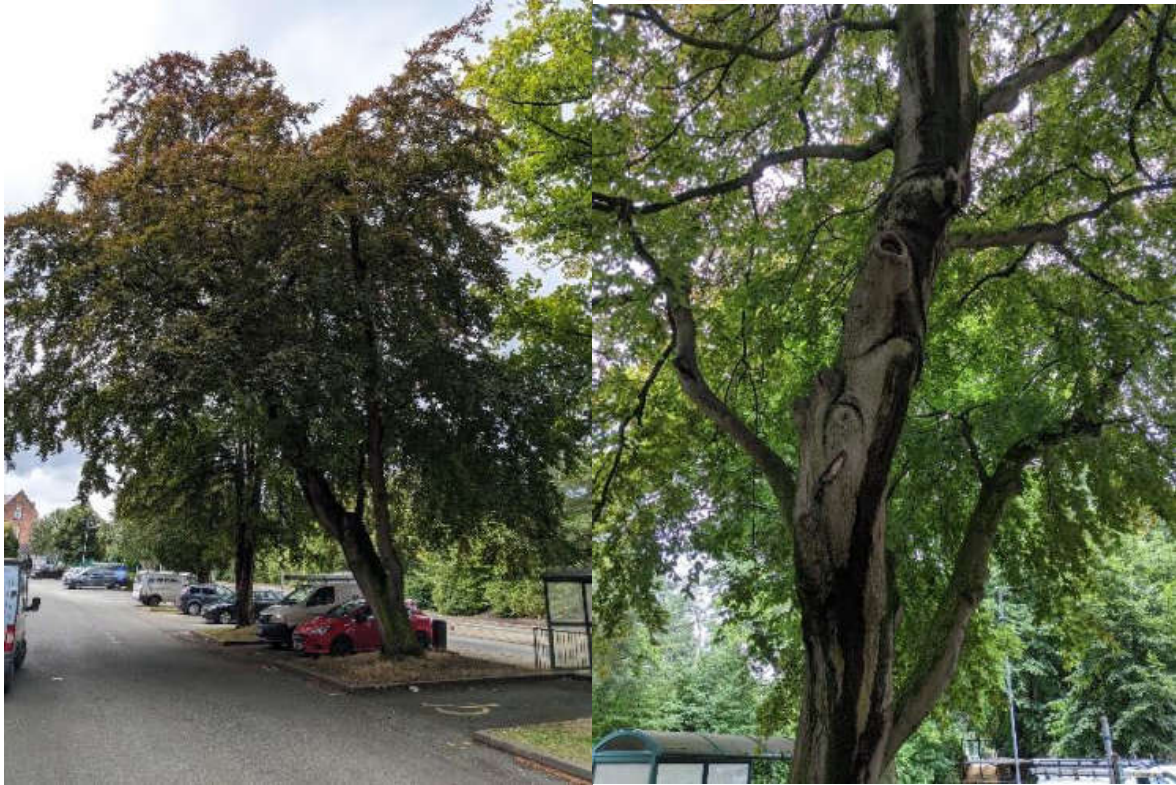
| 35 | - | Copper Beech | 800 | 4.5 | 5.5 | 9 | 9 | M | 13.5 | Heavy lean to the SW.<br><br>Hollowed branch socket @ 2.3m.<br><br>Mechanical damage @3.2m to the W most likely caused by tall vehicles parking next to tree. |

Figure 47. Tree 35 (copper beech) leaning heavily to the SW (left) and extensive crown lifting work including hollowing branch sockets and some areas of mechanical damage (right).

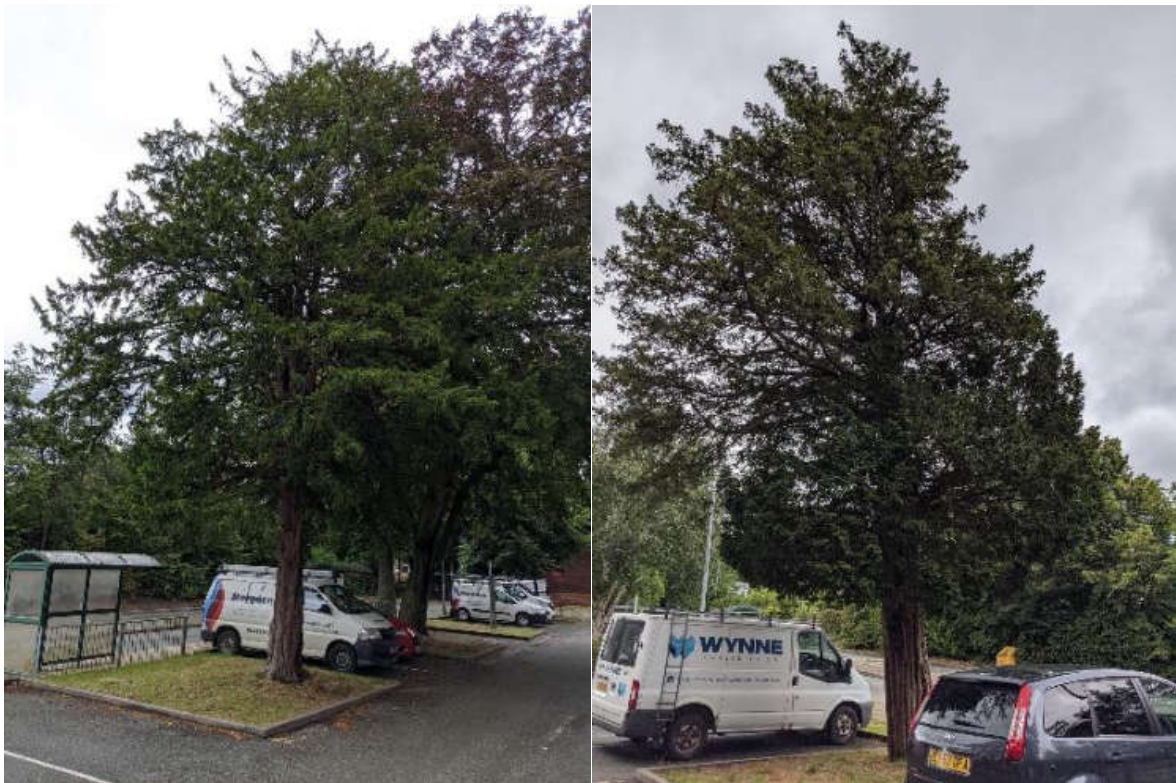
| 37 | - | Yew | 614 | 2.5 | 3 | 5 | 5 | M | 10 | Some lower limbs have been reduced around E, S and W CL to 2.5m.<br><br>Slight lean to S and slightly asymmetric crown. Open crown, Healthy tree. |

Figure 48. Tree 36 (yew)(left). Tree 37 (yew) exhibiting a slightly asymmetric crown.

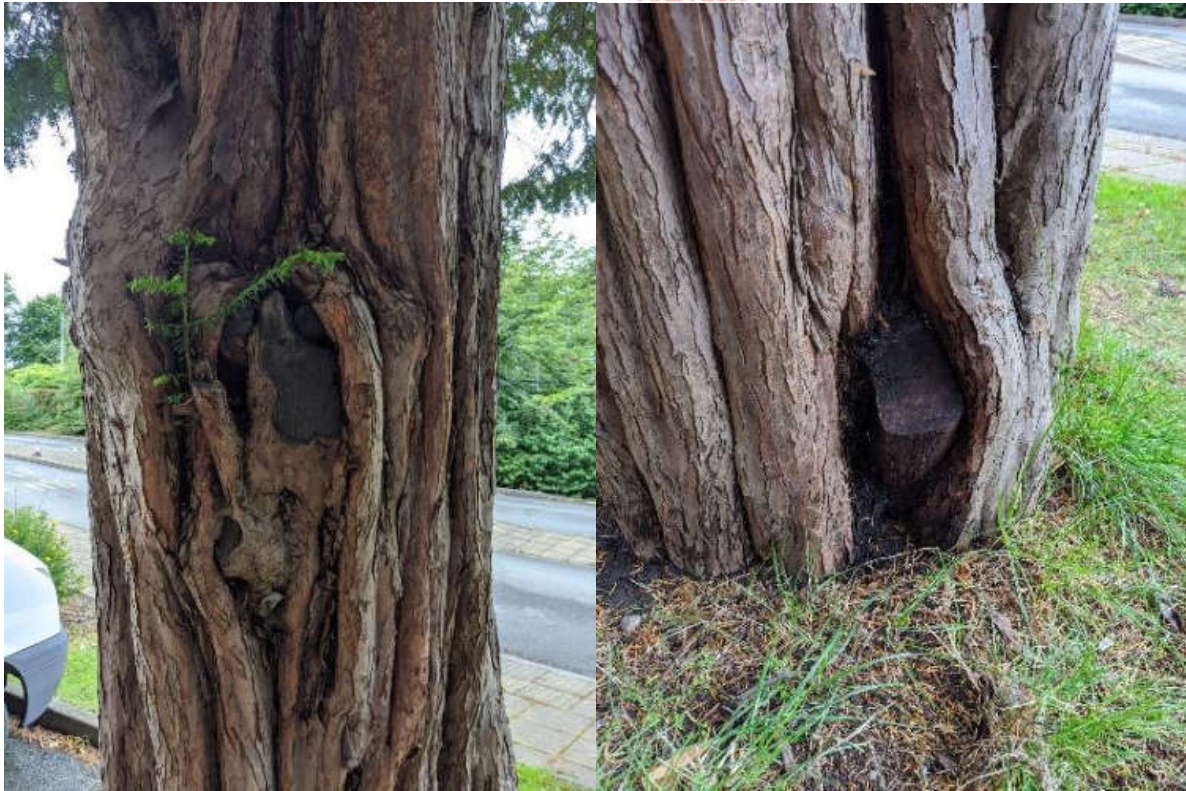
*Figure 49. Tree 37 (yew) lower branches showing beginnings of good occlusion.*

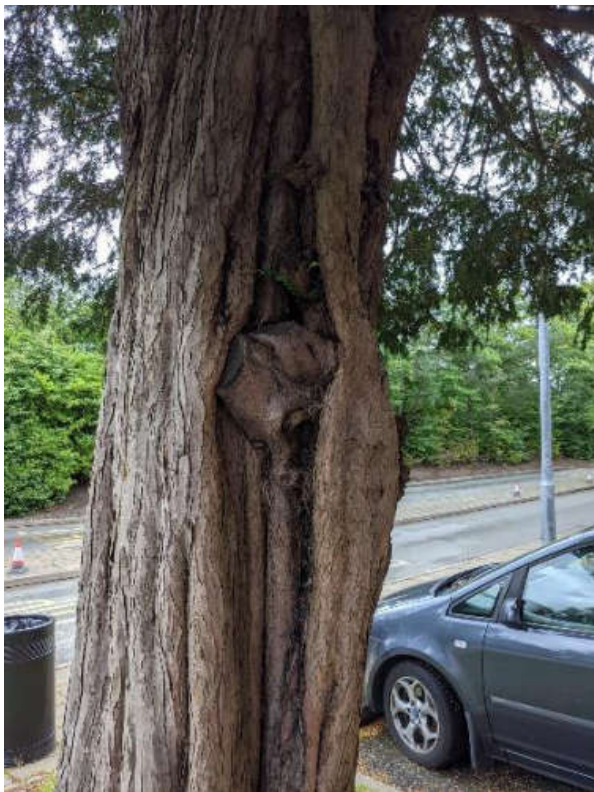
*Figure 50. . Tree 37 (yew) lower branches showing beginnings of good occlusion.*
