# Conversion of Outbuildings, Esp Hill Farm, Frog Lane, Holt, Wrexham

## Structural Appraisal Report

June 2021

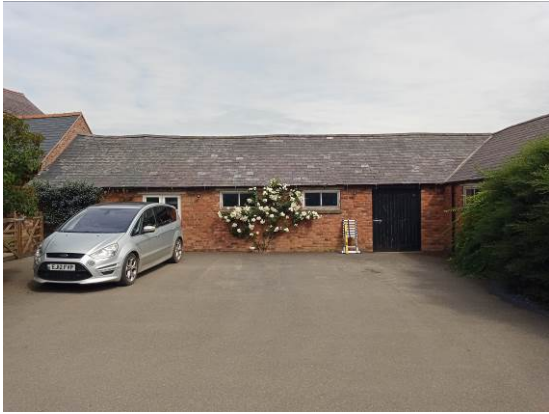
Photo 1 – Front Elevation.

The elevation comprises brickwork to full height with timber lintels to openings (see Photos 1 and 2). The roof over is finished with slate.

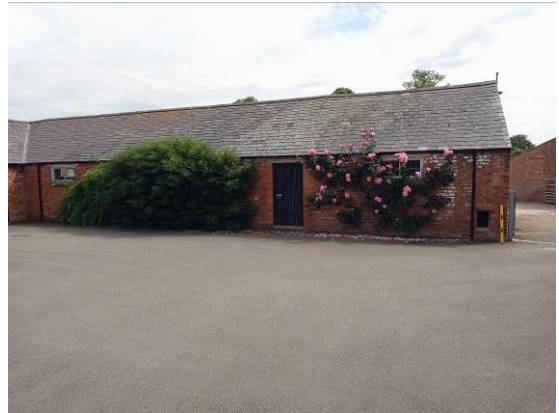
Photo 4 – Left Hand Side Elevation.

The elevation comprises brickwork to full height with timber lintels to openings. The roof over is finished with slate (see Photo 4). The central section appears to have been rebuilt in past indicated by a different brick type.

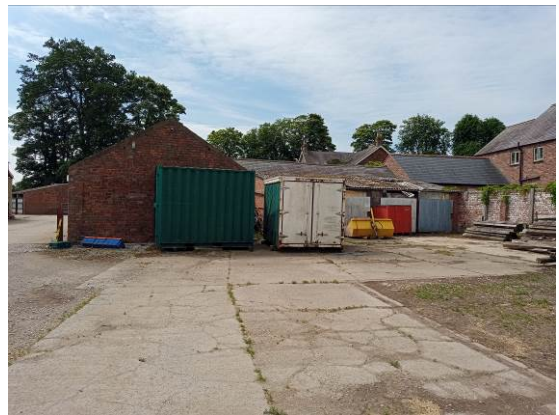
Photo 5 – Rear Elevation.

The elevation comprises brickwork to full height with timber lintels to openings (see Photo 5). The roof over is finished with slate. The lean-to roof is finished in asbestos cement sheets and is due to be demolished and is considered to be outside the scope of this report.

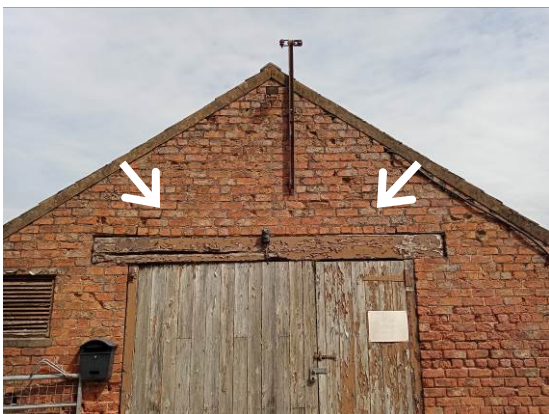
Cracking is apparent extending diagonally upwards from both ends of the lintel on the gable elevation. The cracking was noted as up to 3mm wide and has resulted from degradation to the timber lintel over the large opening (see Photo 3).

Deterioration is apparent to the timber lintel over the large opening on the gable with a significant split at one end and apparent section losses throughout (see Photo 3). The bed joints over the opening show a significant sag at mid span. The timber lintels to the smaller openings all show evidence of slight degradation, however no distress was apparent.

Photo 3 – Cracking extending from timber lintel.  
Note: sag to bed joints over lintel.

- Replace existing lintels with new precast concrete units as required.
- Carry out repairs to eroded brickwork by replacing individual units. Repoint elevations by raking out existing pointing to a minimum depth of 30mm. New pointing shall comprise a 1:1:6 lime:cement:sand mortar packed tight into joints and finished flush with the face of the wall.

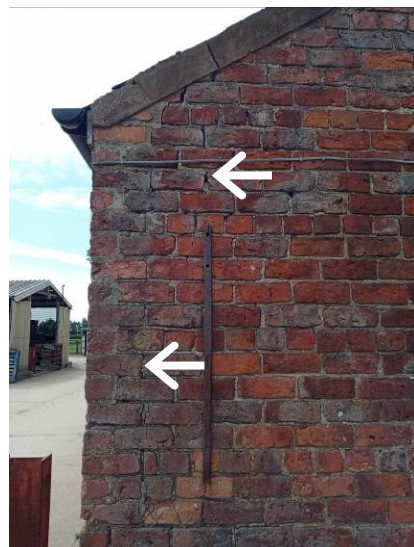
Cracking is apparent extending vertically at both ends of the gable down from eaves level. The cracking was noted as up to 3mm wide and would appear to have resulted from roof spread (see Photo 6). Further cracking up to 3mm wide was also apparent to the return adjacent to the gable. Rot was apparent to the exposed ends of the purlins and wall plates with significant section losses noted to the purlin ends.

Photo 6 – Cracking extending down from eaves.

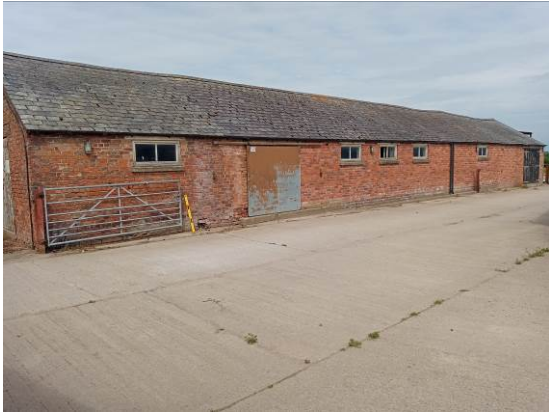
Photo 7 – Right Hand Side Elevation.

The elevation comprises brickwork to full height with timber lintels to openings. The roof over is finished with slate (see Photo 7).

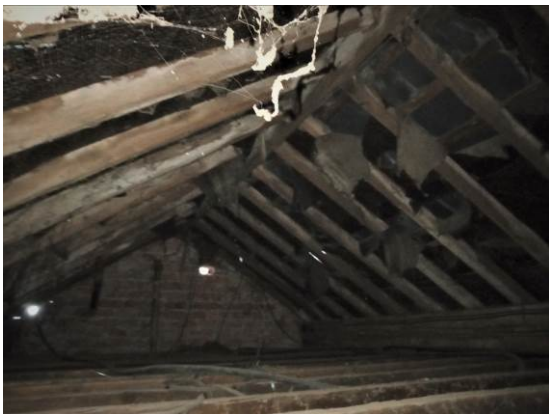
The roof over the room appeared to be in generally fair condition. The felt membrane has degraded significantly and is now torn and drooping down (see Photo 8). Staining is apparent to the rafters and purlins though all areas appeared dry at the time of inspection. No daylight was visible through finishes. A slight sag was apparent in the purlins which is consistent with that noted externally.

Photo 8 – General view of roof over store.

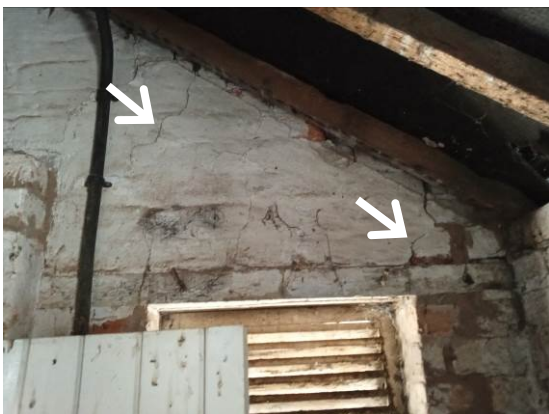
Minor cracking was apparent above the opening to the end elevation (see Photo 9). The cracking was noted as less than 1mm wide and appeared longstanding. Erosion to brickwork units was apparent at low level particularly on the end elevation wall (see Photo 10). This type of defect is typically attributable to rising damp and soft units. This type of defect is not uncommon on outbuildings of this age. The erosion is quite deep in places and localised repairs will need to be implemented. Lintels to openings comprise timber sections which all appeared to be in good condition.

Photos 9 – Cracking above opening.

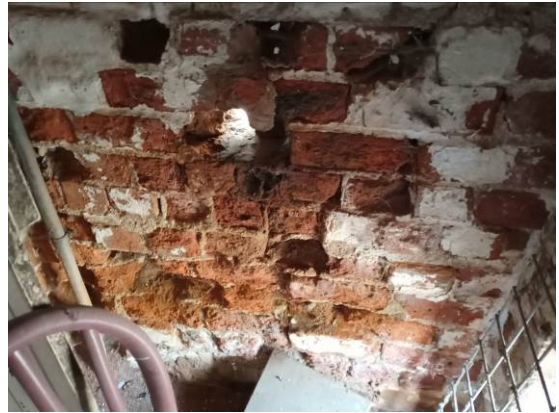
Photo 10 – Erosion to brick units.

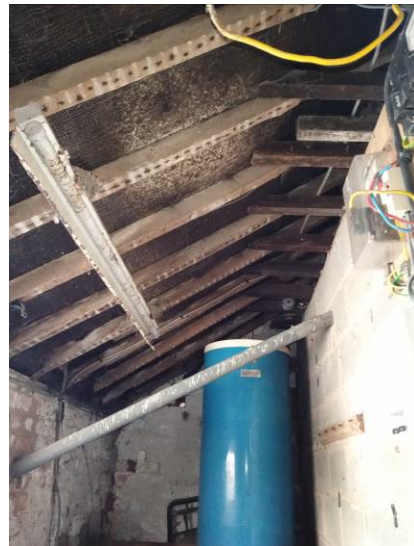
The roof over the room appeared to be in generally fair condition. It is apparent that a lath and plaster ceiling has been removed in the past (see Photo 11). The felt membrane has degraded and is torn in several locations. Staining is apparent to timbers, though all areas were noted as dry at the time of inspection.

Photo 11 – General view of roof over WC.

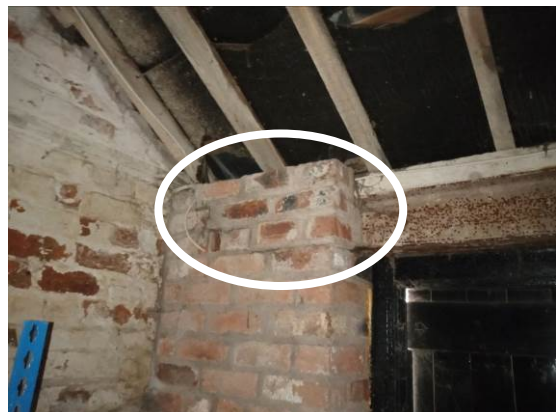
Dislodged brickwork was apparent at the end of the steel lintel at the top end of the room (see Photo 12). A section of brickwork above the lintel over the supporting pier is cracked and slightly dislodged, possibly resulting from an impact on the elevation. The lintels to openings all appeared to be in good condition with no significant defects apparent.

Photo 12 – Dislodged brickwork at lintel end.

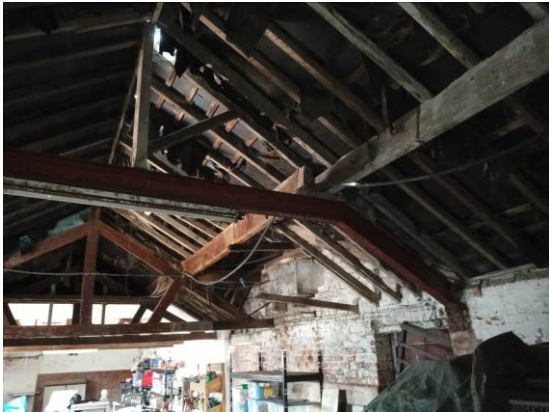
The roof over the room appeared to be in generally fair condition with several areas noted as poor (see Photo 13). Several of the timber trusses/frames supporting the roof show evidence of significant sagging at midspan. It is apparent that several of the trusses/frames have been modified in the past – some of which have weakened the structure. The purlins appear to be slightly undersized and show evidence of sagging between supports which is reflected in the alignment of the ridge line noted externally. The purlins generally have very little bearing onto their supports and some movement is apparent in scarf joints where present. Timbers around the intersection of the roofs show evidence of section losses resulting from rot following weather penetration (see Photo 14). A purlin supporting valley blades shows section losses along the top edge possibly due to insect infestation. The felt membrane has degraded and is torn and hanging down in several locations. Staining is apparent to timbers, though all areas were noted as dry at the time of inspection. Significant repairs will have to be implemented to ensure long term durability.

Photo 13 – General view of roof over barn.

- Remove existing slated finishes to the roof and set aside for re-use. Demolish all existing rafters, purlins, trusses and steel frames supporting the roof. Provide new rafters and timber/steel supporting beams as required to suit new layout.

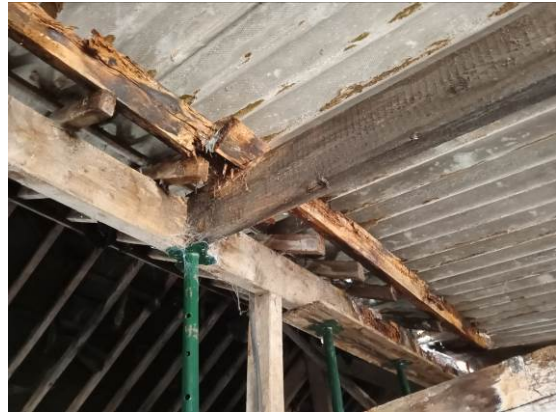
Photo 15 – Severe rot to timbers.  
Note propping to timber beam.

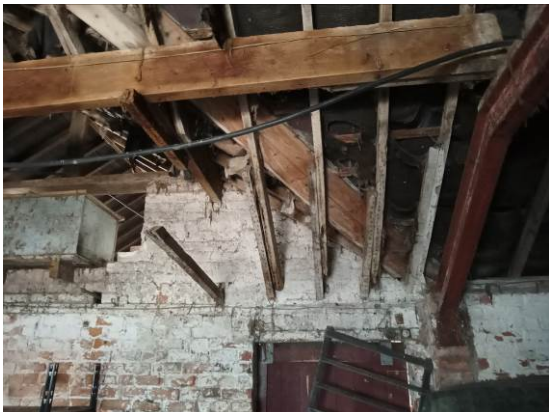
Photo 14 – General view of roof at intersection.

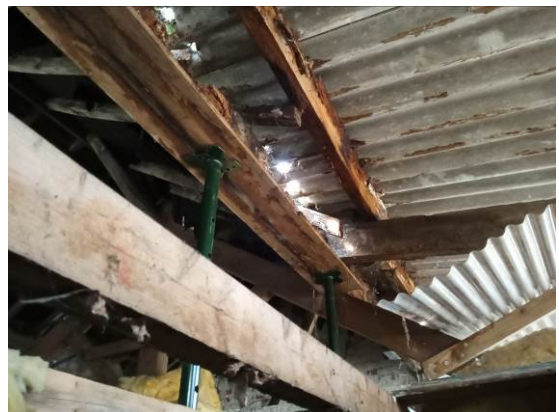
Photo 16 – Severe rot to timber  
with props to underside.
