## Project

**Project Name:** 14154 EURO GARAGE WREXHAM  
**Project Description:** CCTV Drainage Inspection Report  
**Project Date:** 09/04/2021  
**Inspection Standard:** MSCC5 Sewers & Drainage GB (SRM5 Scoring)

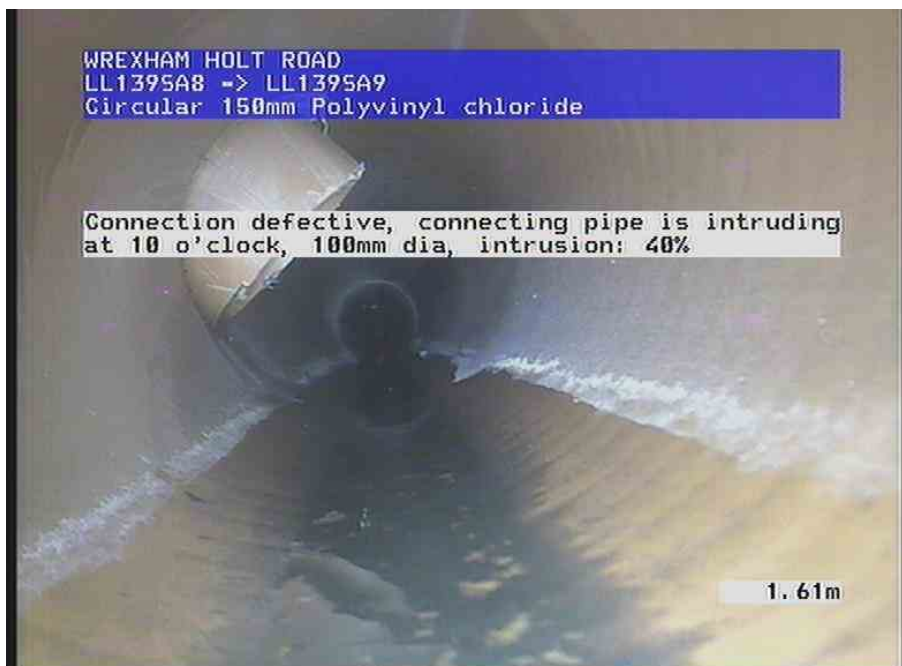
| 3 | 1.61 | CXI | Connection defective, connecting pipe is intruding at 10 o'clock, 100mm dia, intrusion: 40% | | |

1, 00:00:43, 1.61 m  
Connection defective, connecting pipe is intruding at 10 o'clock, 100mm dia, intrusion: 40%

| <b>Recommendations:</b> | ROBOTIC CUT | | | | |

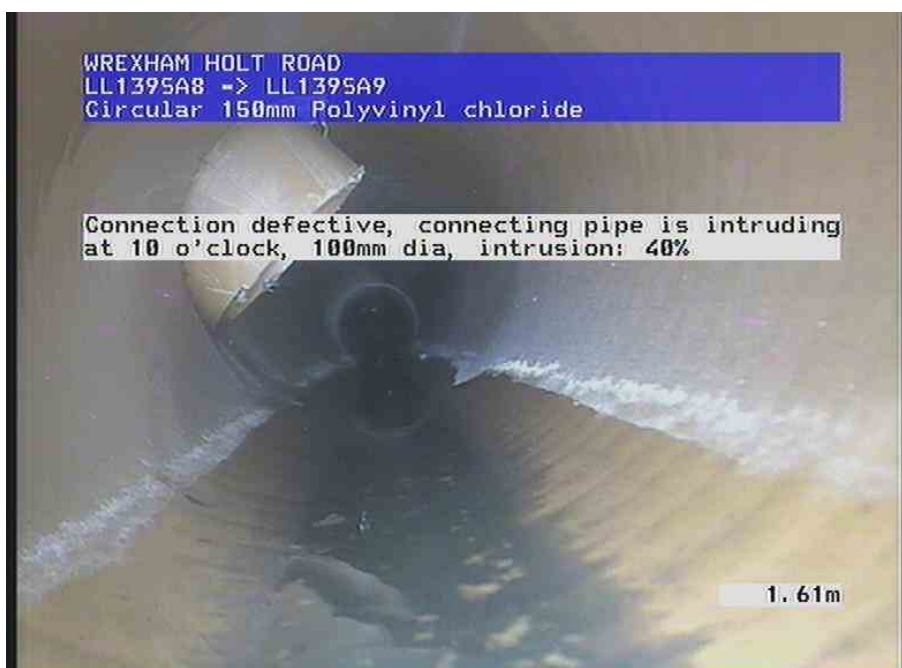
2, 00:00:43, 1.61 m  
Connection defective, connecting pipe is intruding at 10 o'clock, 100mm dia, intrusion: 40%

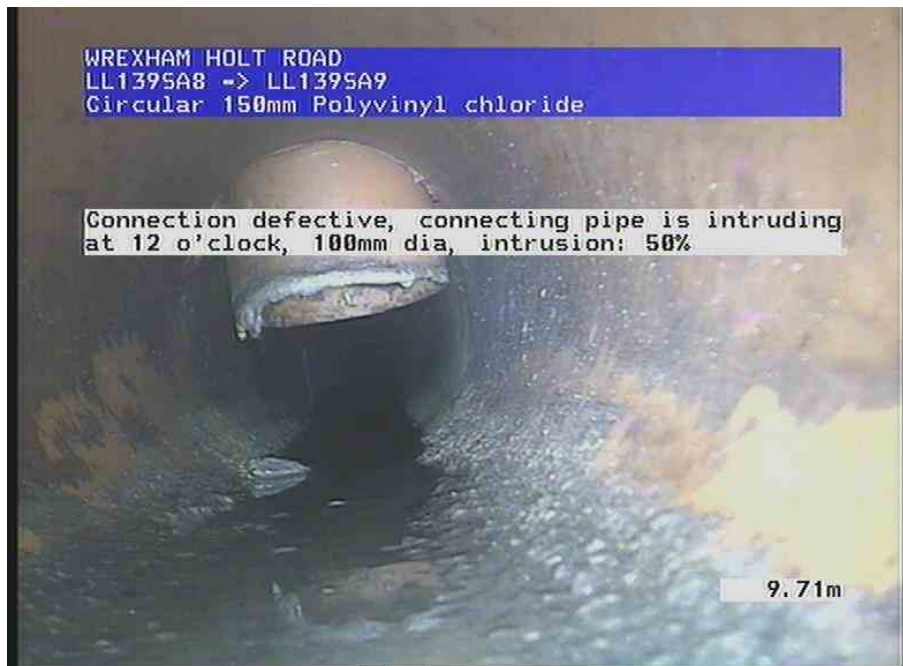
| 4 | 9.71 | CXI | Connection defective, connecting pipe is intruding at 12 o'clock, 100mm dia, intrusion: 50% | | |

3, 00:01:47, 9.71 m  
Connection defective, connecting pipe is intruding at 12 o'clock, 100mm dia, intrusion: 50%

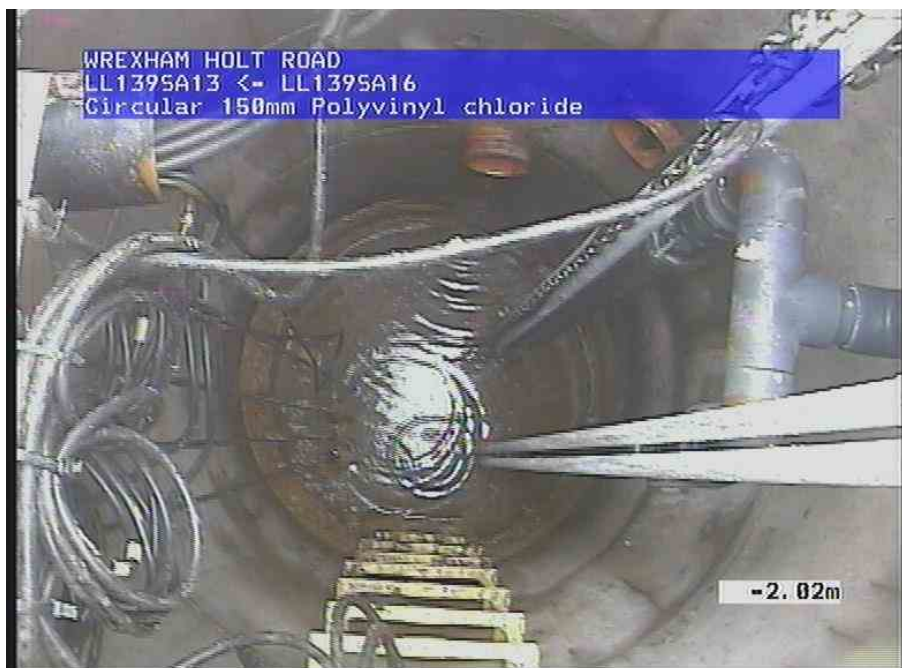
1, 00:00:01, 0.00 m  
Start node, other special chamber, reference: LL139SA16, PUMPING STATION
