# CIRIA 735 Visual Inspection of Gas Protection Measures

| Site Name: Lidl Wrexham | Gas Characteristic Situation: 1 – 2<br>Basic Radon Protection Measures |
| Remada Job No: 525.05 | Type of Development & Building / Block Checked: Ground Bearing Floor Slab. |
| Date: 09.03.2021 | Building Description: New Build Construction. |

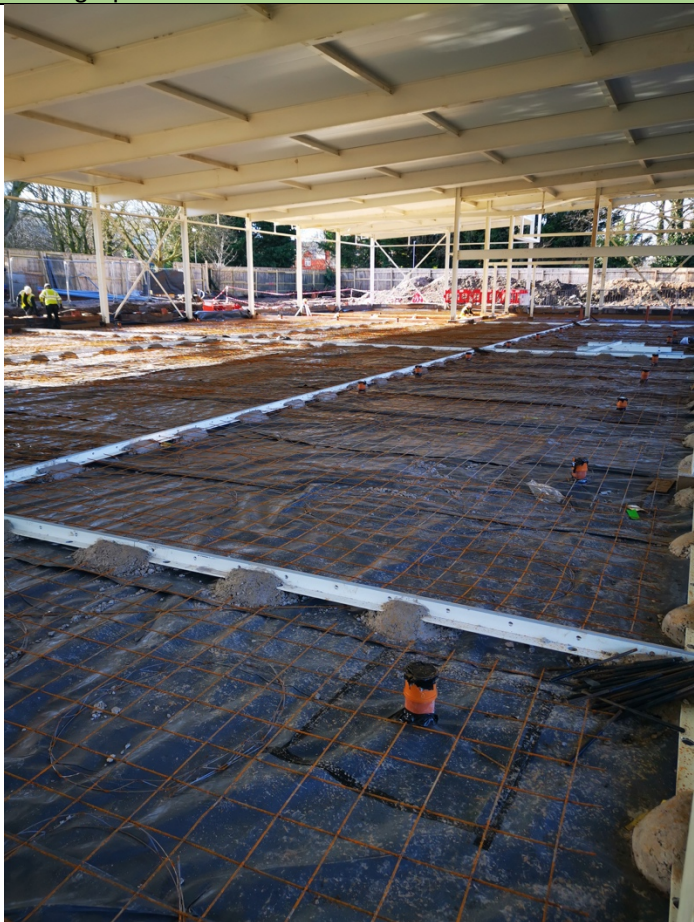
| No | Photograph | Description |
|---|---|---|
| 1 | | <p>View from the entrance across the length of the store dated 22nd February 2021. The installed top-hat covers for the service entries are prominent and patches taped in around the base.</p> <p>(Source: Braithwaites)</p> |

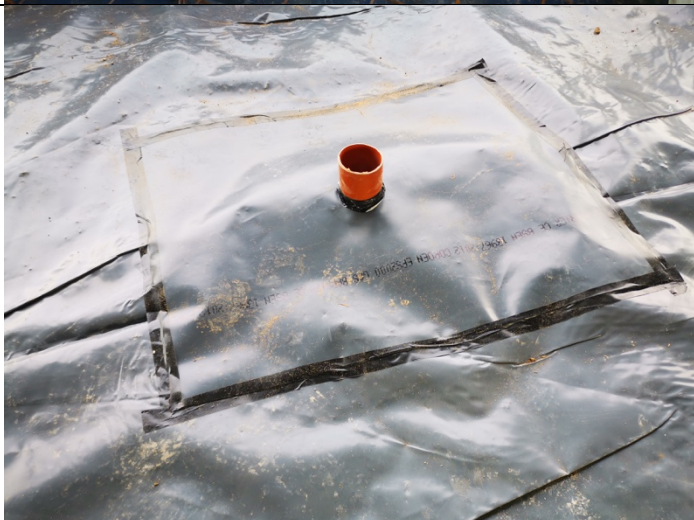
| No | Photograph | Description |
|---|---|---|
| 2 | | <p>Detailed view of one of the service entries on 21st February 2021, showing the installed patch for the service entries taped up around the base.</p> <p>(Source: Braithwaites)</p> |

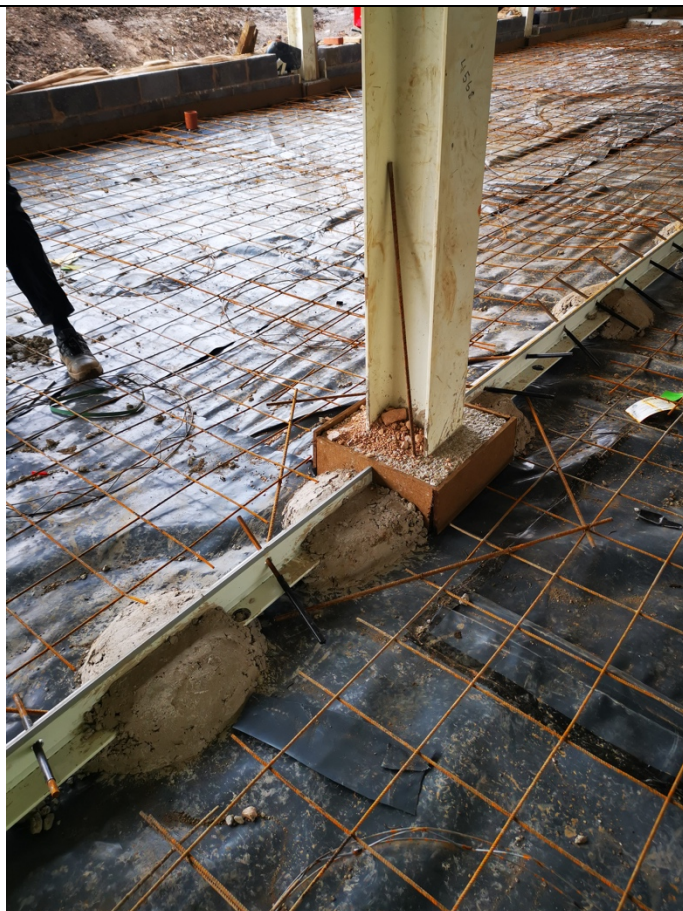
3

Close-up of one of the column bases on 23rd February 2021, showing the metal mesh installed prior to concrete pouring.

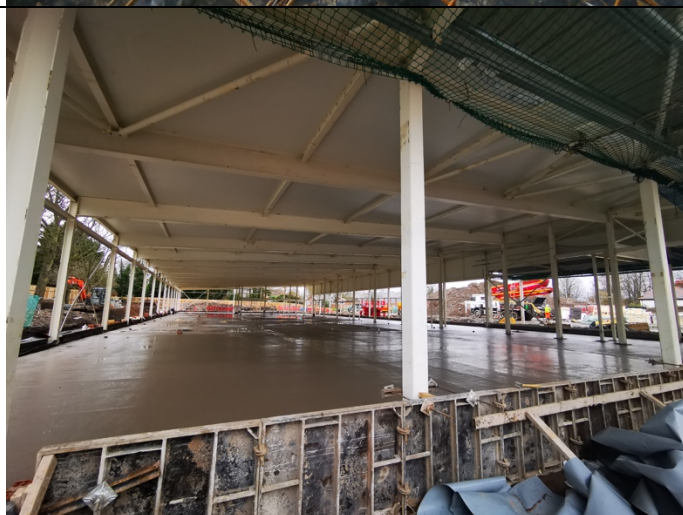
4

View across the store footprint showing the newly poured concrete floor slab on 24th February 2021.

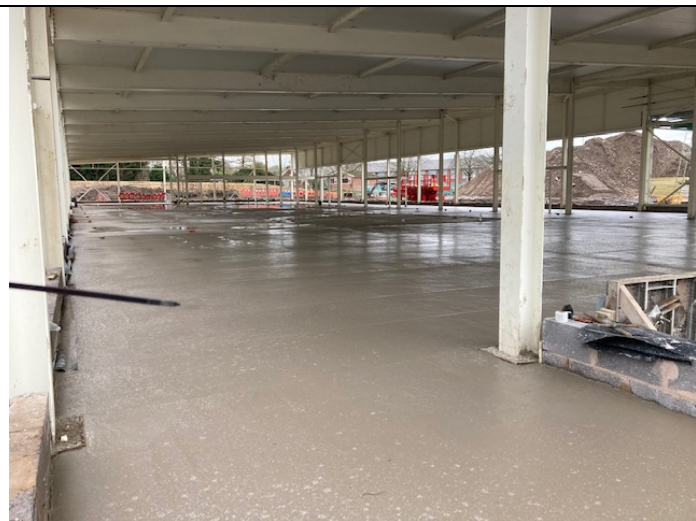
5

View taken by Remada's Engineer during a site visit on the morning of 25th February 2021. Pouring of the concrete floor slab within the store footprint has been completed.
