# BAT SCOPING SURVEY

**Cae Brymer Farm**

**23<sup>rd</sup> September 2020**

**SCALES Consultancy Ltd**

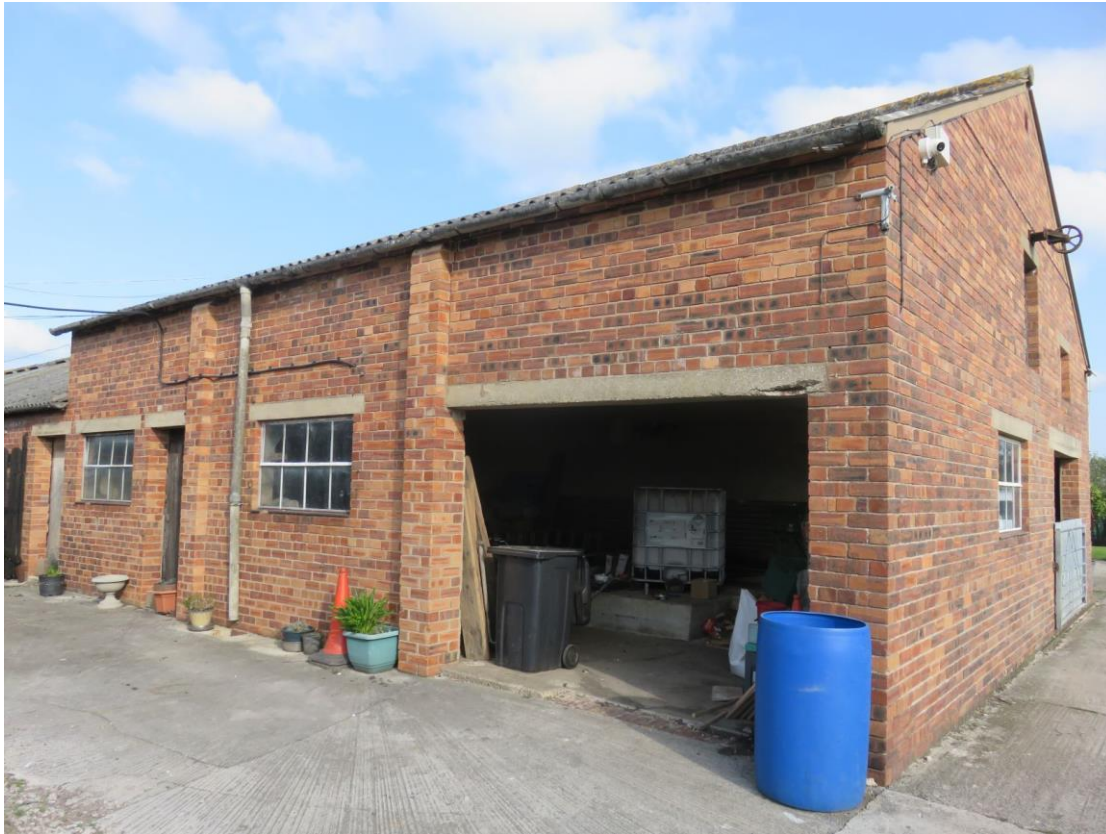
Photograph 1 – Southern aspect of barn

The southern aspect of the barn has a large opening on the ground floor allowing open flight access to the interior. A single poorly-fitting timber door is also present, along with two single-glazed metal-framed windows. Concrete lintels are present above doorways and windows. At the top of the wall mortar lines the contours of the corrugated roofing sheets. The wall of the first storey above the large opening has some gaps in the mortar as a result of subsidence. The gaps in the mortar reach approximately 10mm in width and lead to the interior of the first floor. The gaps were inspected closely using ladders, torch and endoscope and no evidence of use by bats was found.

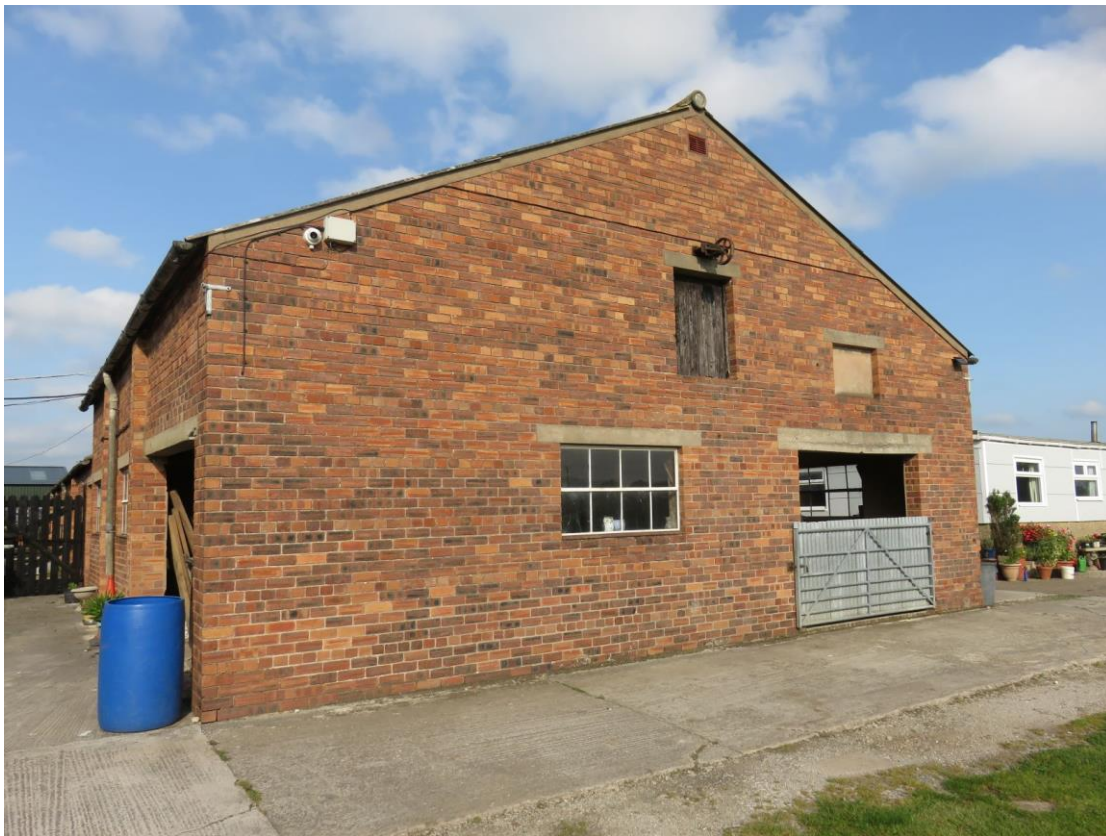
Photograph 2 – Eastern aspect of barn

The eastern aspect of the building is a gable end and has a large opening on the ground floor allowing flight access to the interior. The top of the walls on both pitches of the roof are fitted with concrete which lines the top of the wall and the roofing sheets with no gaps present. Three PRFs were identified on this wall – a narrow gap to the south of the lintel above the doorway, and two drilled holes in the brickwork of the first storey. All were inspected and no evidence of the presence of bats was identified. The holes in the brickwork lead through into the first floor of the barn.

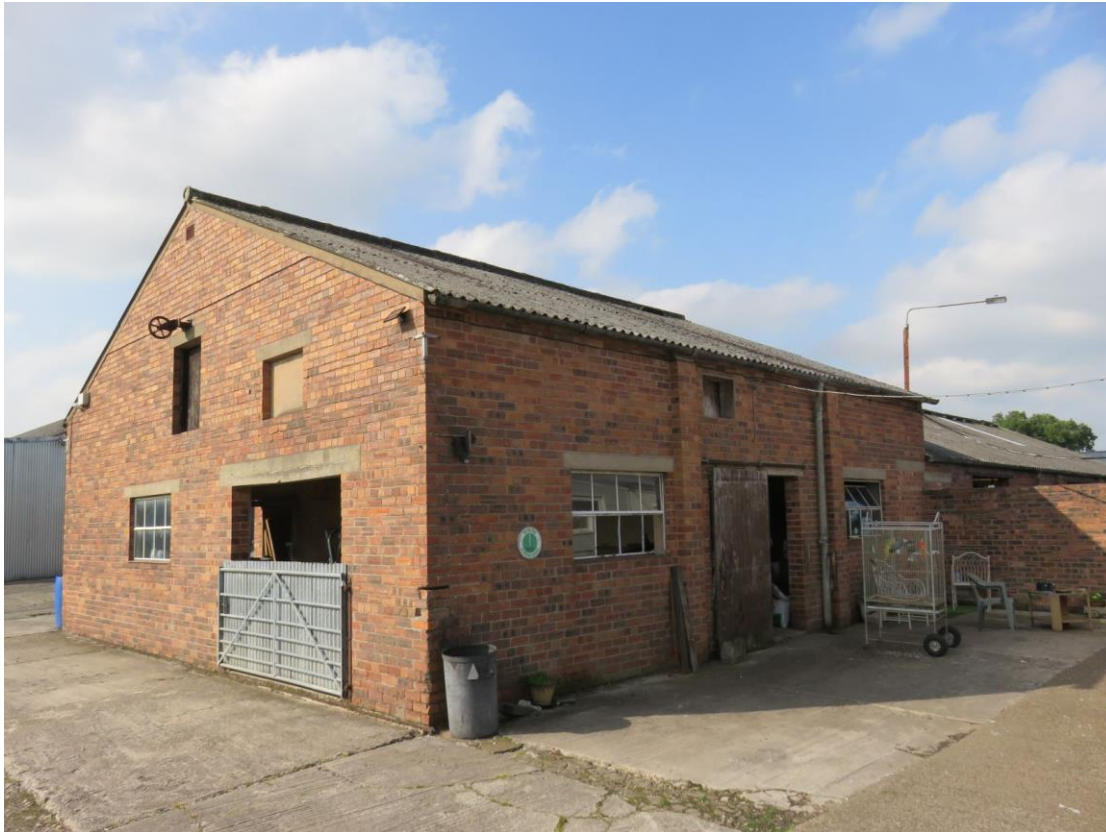
Photograph 3 – Northern aspect of barn

The northern aspect of the building has an open doorway and two single-glazed metal-framed windows, all of which provide flight access to the interior of the ground floor though missing glass panes and open windows. A boarded aperture leads to the first floor. No PRFs are present on this aspect of the building.

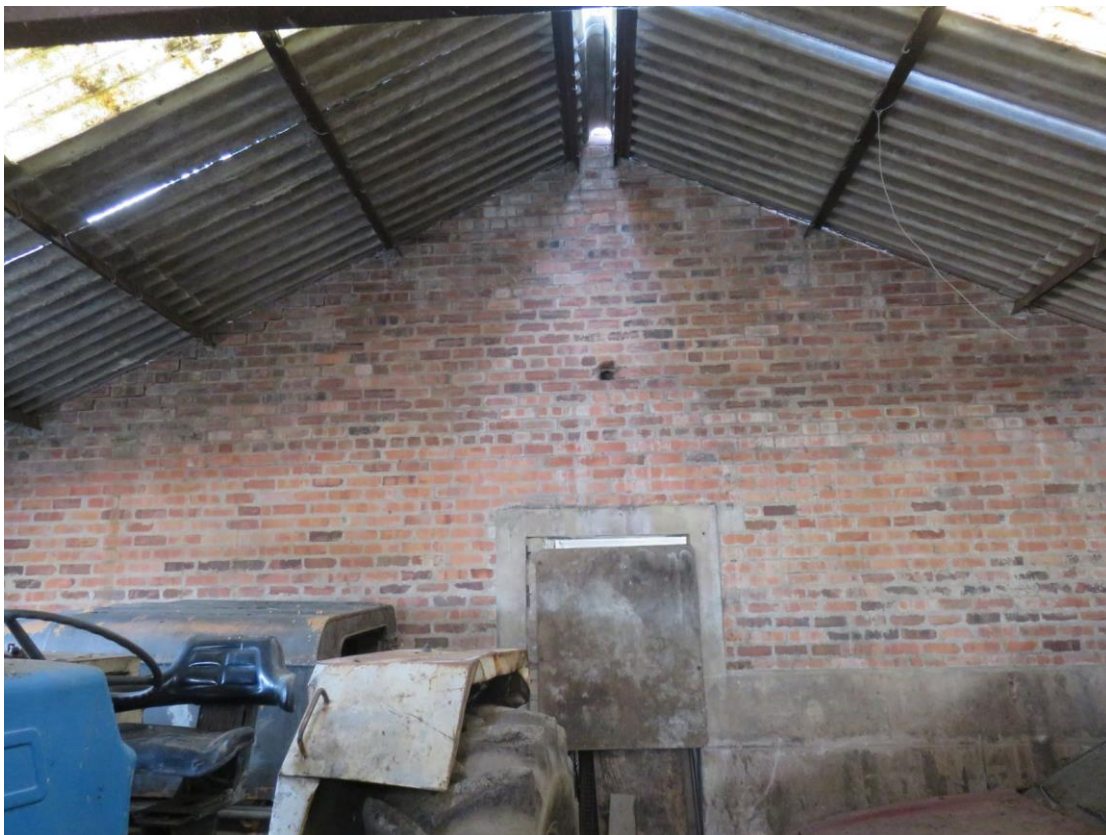
Photograph 4 – Western aspect of barn from interior of adjacent barn

The western aspect of the barn is adjacent to an agricultural barn constructed from corrugated sheeting, with the lower section of the wall forming the end wall of this larger barn. The apex of the gable has a gap at the end of the ridge sheeting. A single PRF is present in the wall accessible from inside the larger barn, where there is a gap in the brickwork. No evidence of use by bat was identified.

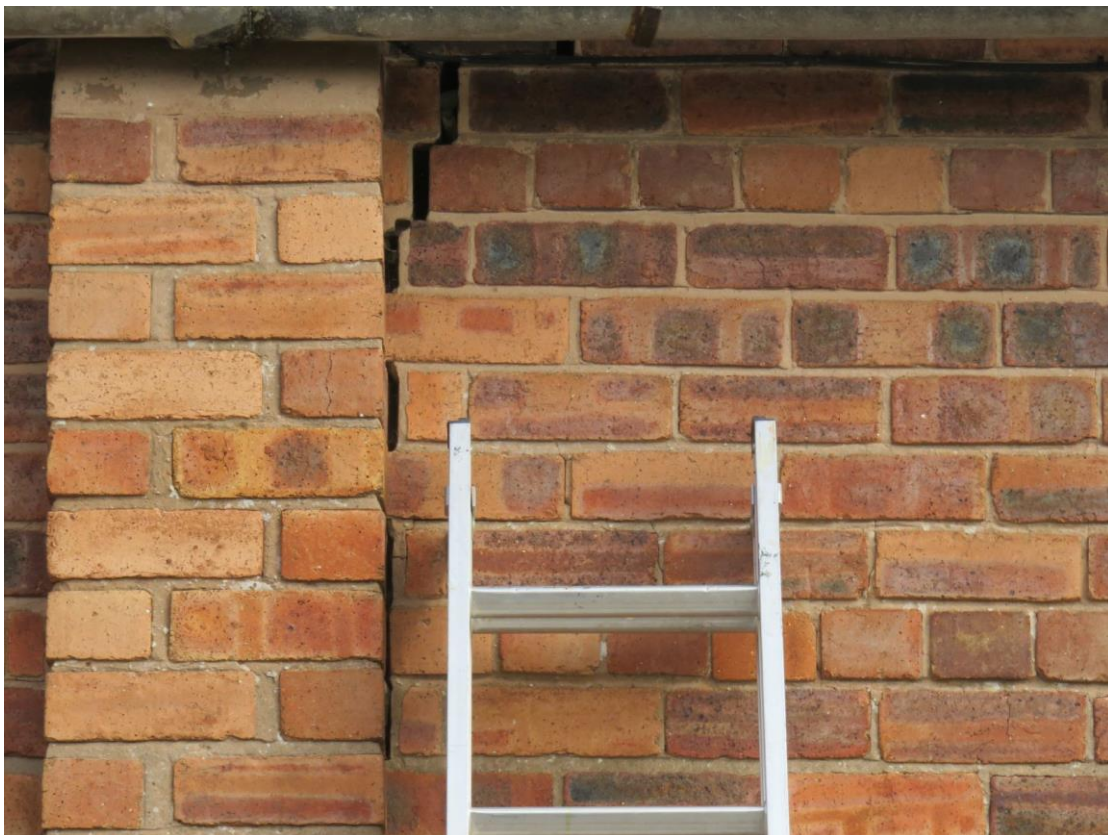
Photograph 6 – PRFs on southern aspect

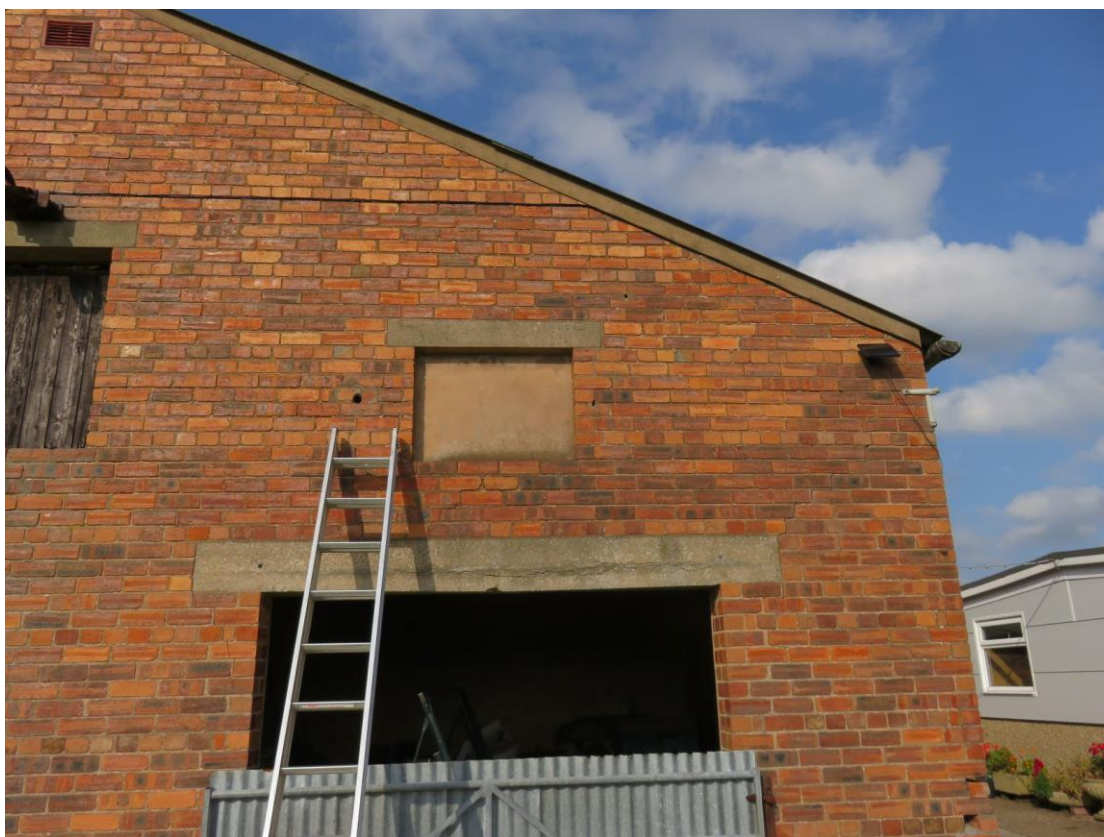
Photograph 7 – PRFs on eastern aspect

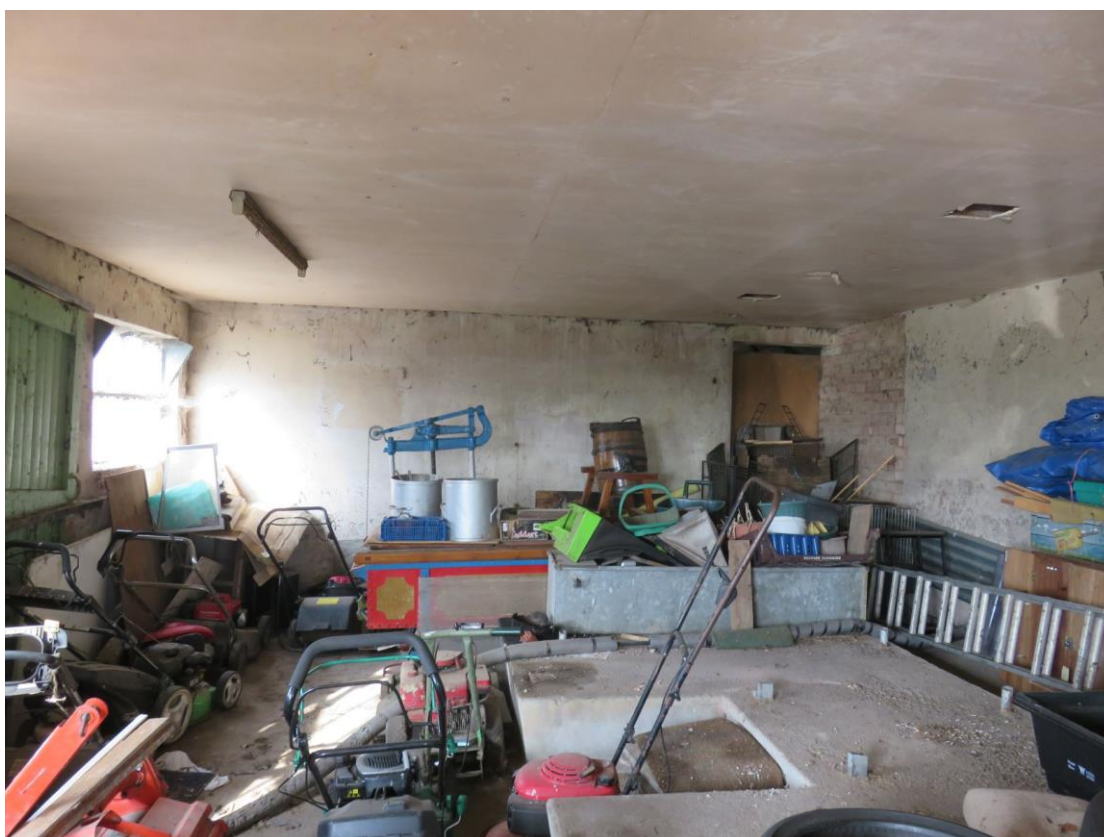
Photograph 8 – Ground floor larger room

The ground floor of the barn is divided into three rooms. The first room, along the southern aspect of the barn, is open to flight access through a large aperture. This also permits extensive light ingress. The room has plastered walls and ceiling with some gaps in the plaster. These gaps have been used by birds, with disused nests of barn swallow *Hirundo rustica* present, and extensive bird droppings throughout the room. All features and items were searched for the evidence of presence of bats, and a single bat dropping was found in the centre of the room.

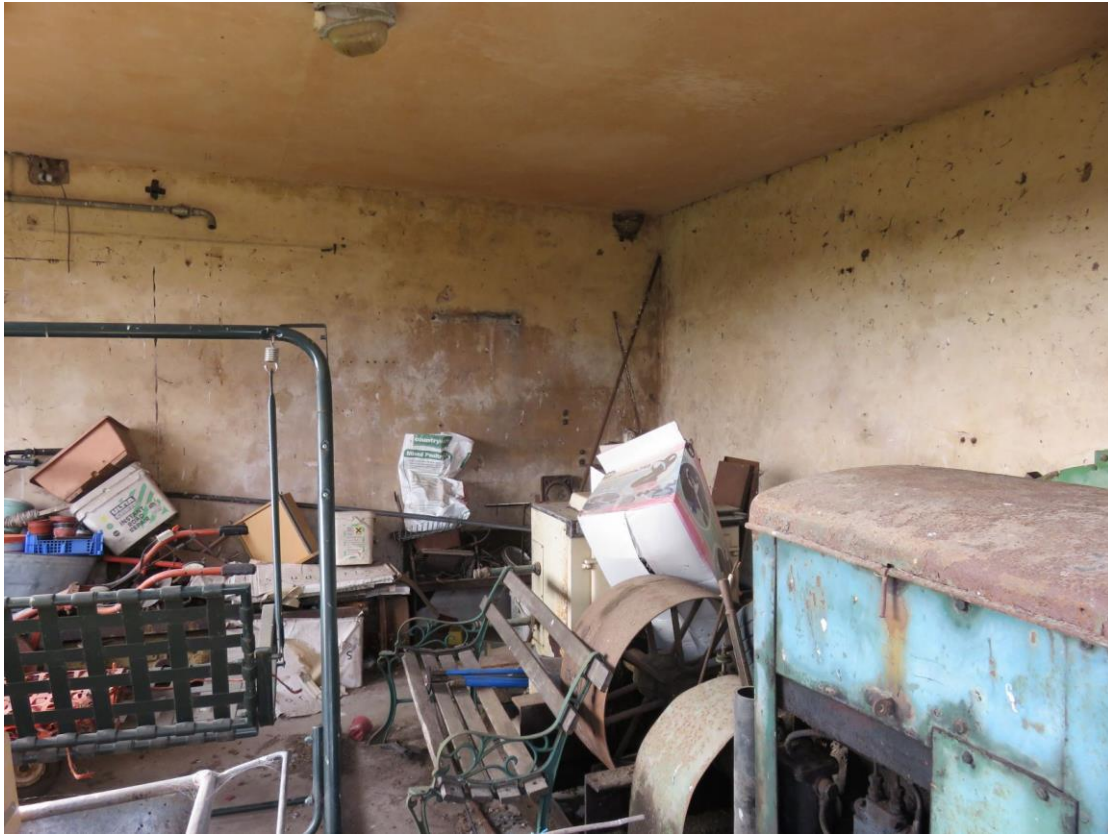
Photograph 9 – Ground floor second room

The second room, located in the northeastern corner of the barn, leads directly from the first room through an open archway. Flight access is also possible from the exterior via an aperture in the eastern aspect. The walls and ceiling are fitted with plasterboard with some small gaps but no PRFs. Bird droppings and old barn swallow nests indicate extensive use by birds.

Old barn swallow and house sparrow nests were present in all rooms of the barn. Due to the potential presence of breeding birds within the building, it is recommended that the works take place outside of the breeding bird season (March to August inclusive). If this is not possible, a breeding bird nest check should be undertaken prior to the commencement of works by a suitably experienced ecologist and an ecological clerk of works appointed if considered necessary.

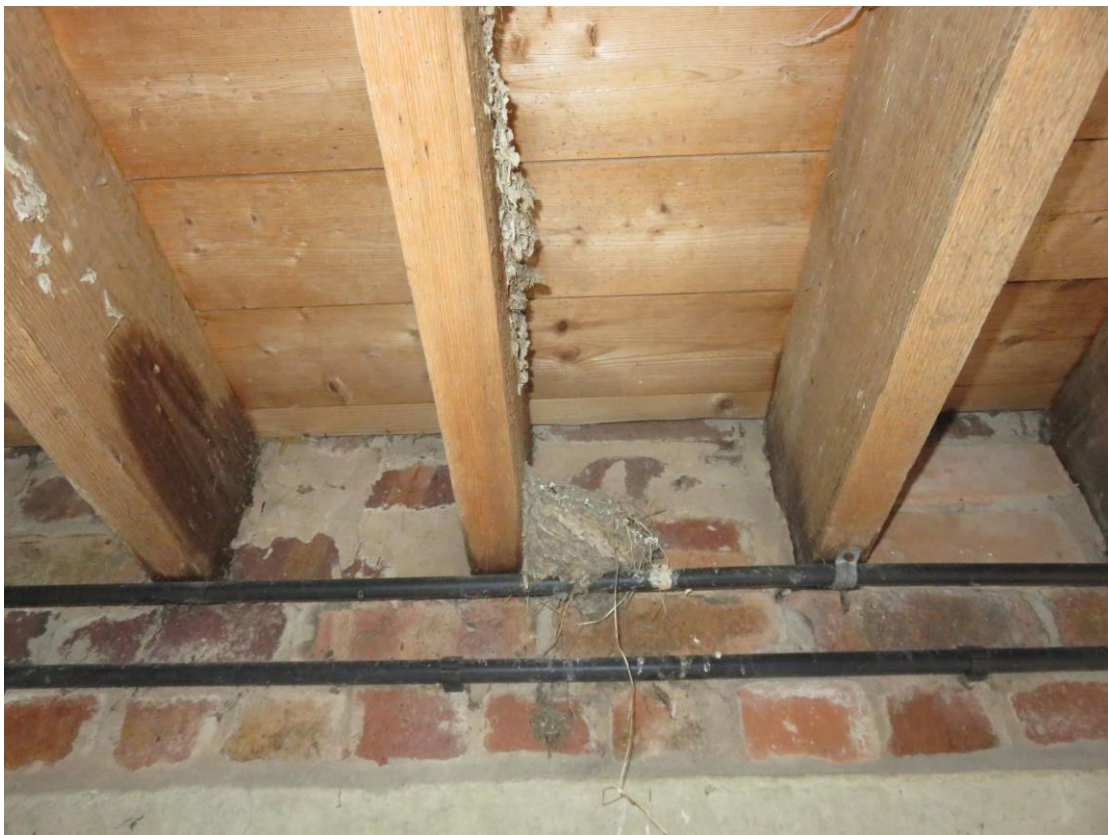
Photograph 10 – Ceiling of third ground floor room

The third room on the ground floor is accessed via a door in the northern aspect of the barn. The room has a timber ceiling which is well fitted and in good condition with no gaps or crevices. The brick walls are in good condition with no PRFs. The room has been used extensively by birds, with old barn swallow nests present and chickens using the room. A timber staircase leads from this room to the first floor.

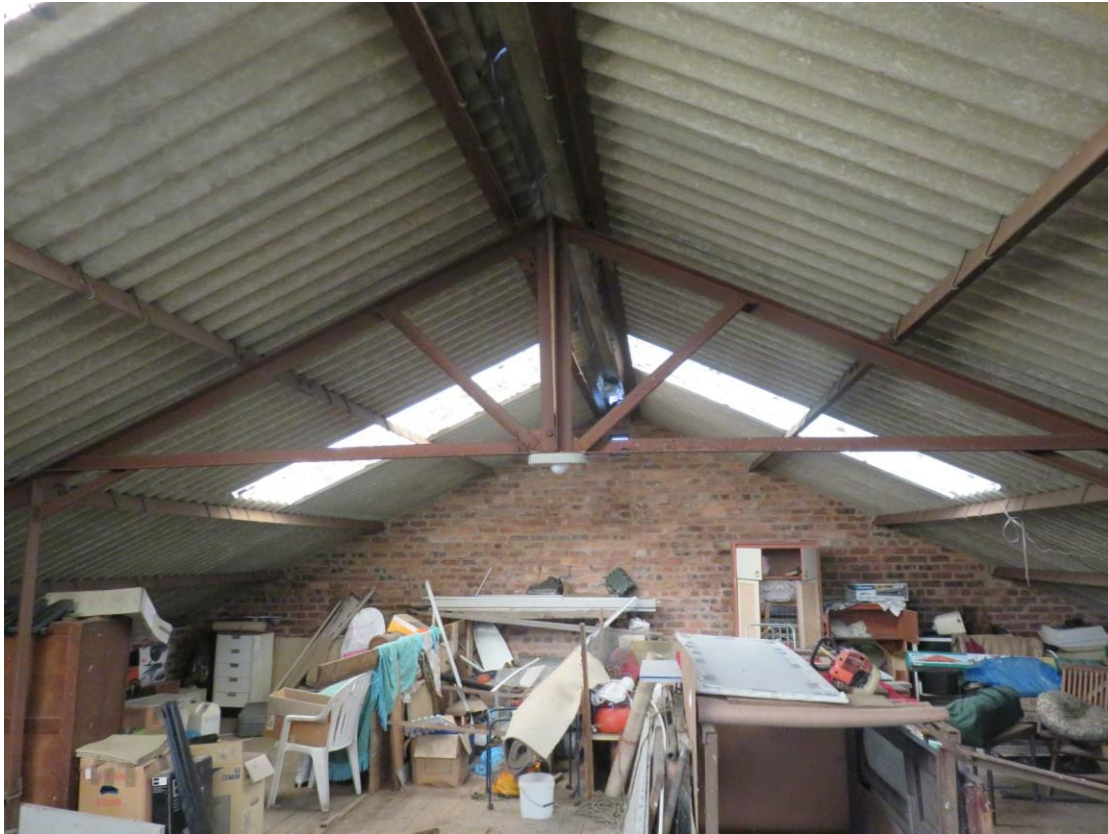
Photograph 11 – Upstairs room

The first floor consists of one large room, with timber floorboards. The walls are of exposed brick and mortar, with the only gaps being the PRFs identified on the eastern aspect of the building. The room has no ceiling or separate roof space, extending upwards into the metal frame and corrugated asbestos roof. Perspex panels allow ingress of daylight into the room. The room has been used extensively by birds, with old house sparrow *Passer domesticus* nests present and a large amount of bird droppings.

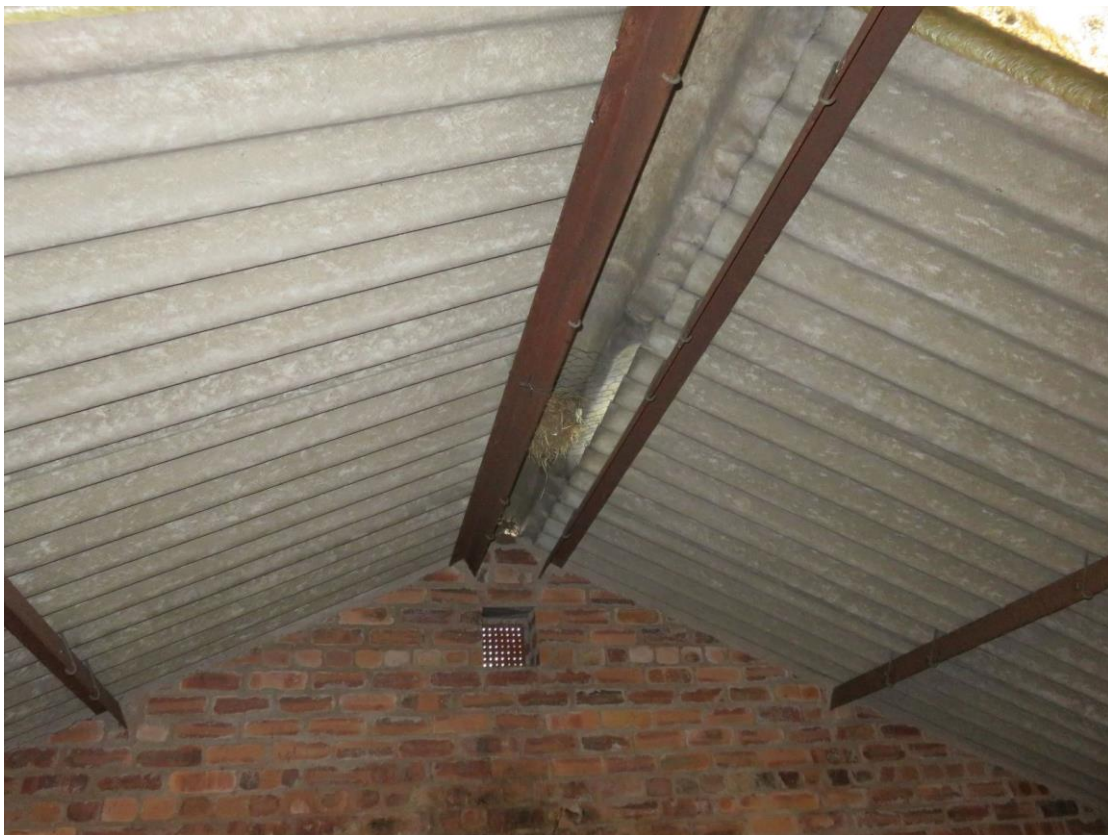
Photograph 12 – Interior of asbestos roof

The barn building is of standard brick and mortar construction, two lines of bricks with no cavity. The roof consists of a single layer of corrugated asbestos with Perspex panels allowing light ingress. The asbestos panels are supported by an internal metal frame.

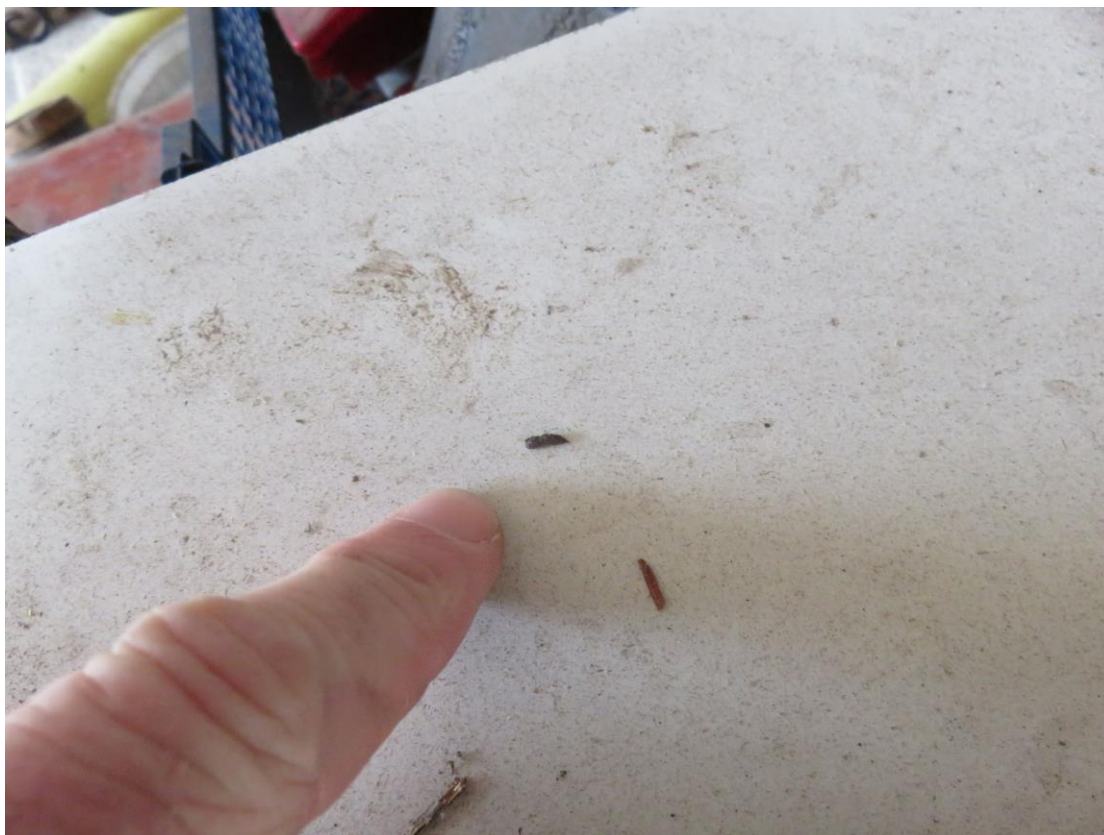
**No evidence of use by roosting bats was identified during the internal inspection. All PRFs including walls and furniture were extensively searched. A single bat dropping was discovered in the centre of the large ground floor room. As the room is open to flight access it is considered that this dropping came from a bat flying inside or through the barn.**

Photograph 13 – Single bat dropping found in larger ground floor room

As no roosts were found in the barn and the few PRFs present were found to contain no evidence of the presence of bats then no further surveys with regard to bats are necessary. A single bat dropping found in the larger ground floor room of the barn indicates that bats have used the area, and therefore any lighting scheme for the proposed development must consider the presence of foraging and / or commuting bats.
